**STATEMENT OF EVIDENCE OF MARK CHILD (GEOTECHNICAL) ON
BEHALF OF WAIUAU BAY FARM LIMITED**

3 March 2025
Job No: 1020815.2000

Kauri Cliffs Master Plan Change and Subdivision Geotechnical Desktop Assessment

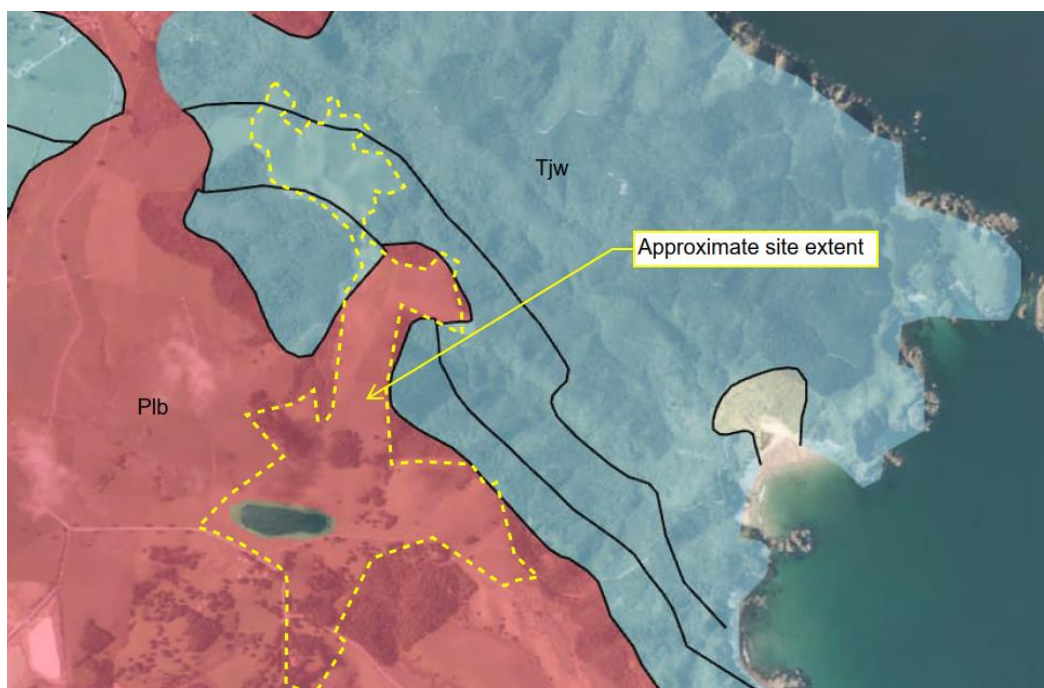
Figure 2.1: Geology of The Site area (Source: GNS Geology web maps)

The GNS Science 1:250,000 geological map of the Whangarei area³ shows The Site as being underlain by basalt lava of the Kerikeri Volcanic Group (Plb) and volcanoclastic sandstone and argillite of the Waipapa Group (TJw). Within the Waipapa Group geology, a band of beds dominated by chert and siliceous argillite is mapped trending in a northwest to southeast direction extending through the northern portion of The Site. An annotated site plan showing the geological units and approximate site extent is presented in Figure 2.1.

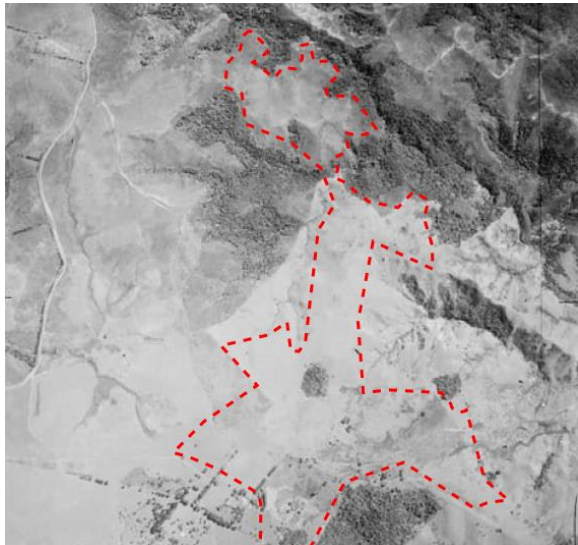
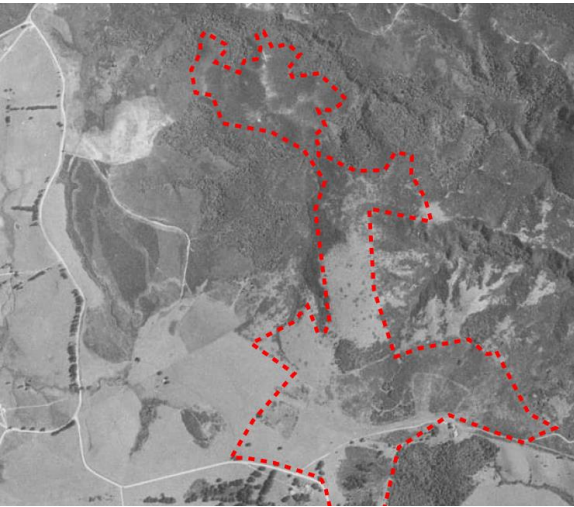
<p>1950 - Retrolens</p> <p>The Site is largely undeveloped. The Site looks covered in grass with only the gully areas containing established vegetation. Old farm tracks are visible off Matauri Bay Road.</p>	<p>1970 - Retrolens</p> <p>Areas to the north and south appear to be covered in regenerating vegetation. Old farm tracks are either more visible or have been established since the 1950 photograph.</p>

As Table 2.1 indicates, historic aerial photography confirms that the site has been maintained predominantly as pasture since at least 1950. With the exception of fencing and the water storage pond, no development or land use change has occurred. The historic aerial imagery does not present any obvious signs of slope instability.

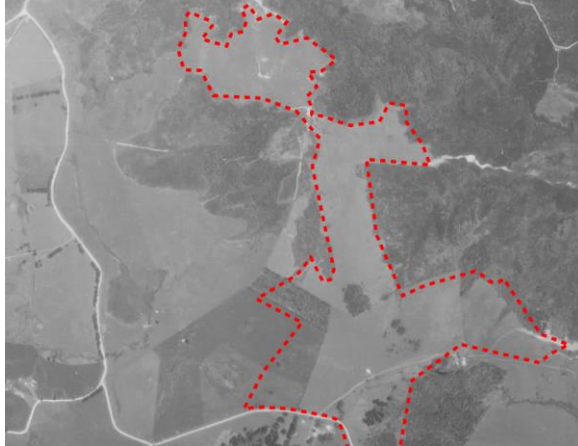
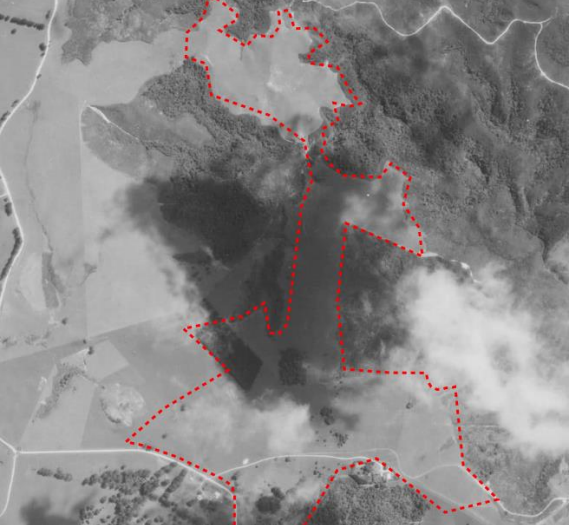
<p>1976 - Retrolens</p> <p>The Site appears to have had the vegetation removed and replaced by grass again. Linear lines are visible in the southern section indicating that fencing for pasture grazing or crops has been established.</p>	<p>1981 - Retrolens</p> <p>Very little change appears to have occurred since the 1976 photograph. Unfortunately cloud cover is limiting the definition of the photography during this time.</p>

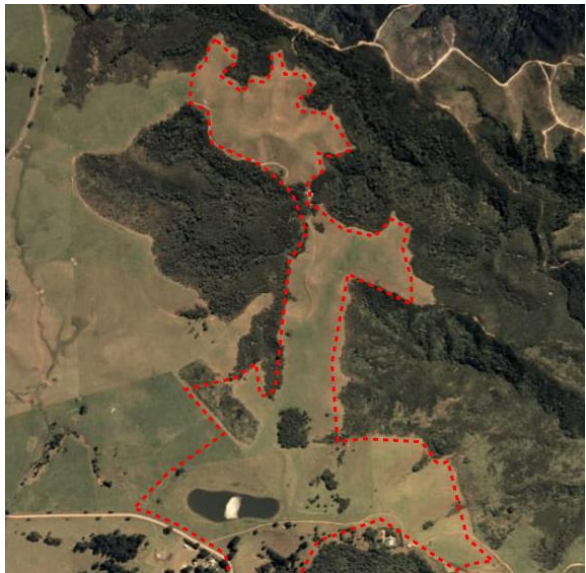
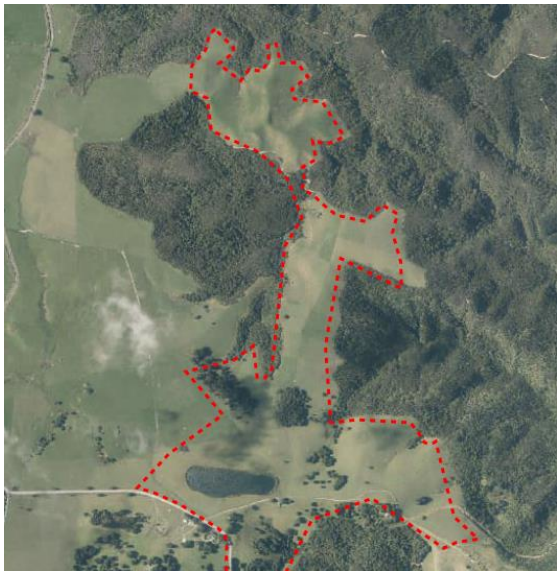
<p>2000 - LINZ</p>	<p>2014-2016 - LINZ</p>
<p>A water storage pond has been constructed in the southern area of The Site since the 1981 photograph. Vegetation appears largely unchanged since the 1981 photograph.</p>	<p>No significant change has occurred to The Site since 2000, and The Site is still largely undeveloped.</p>

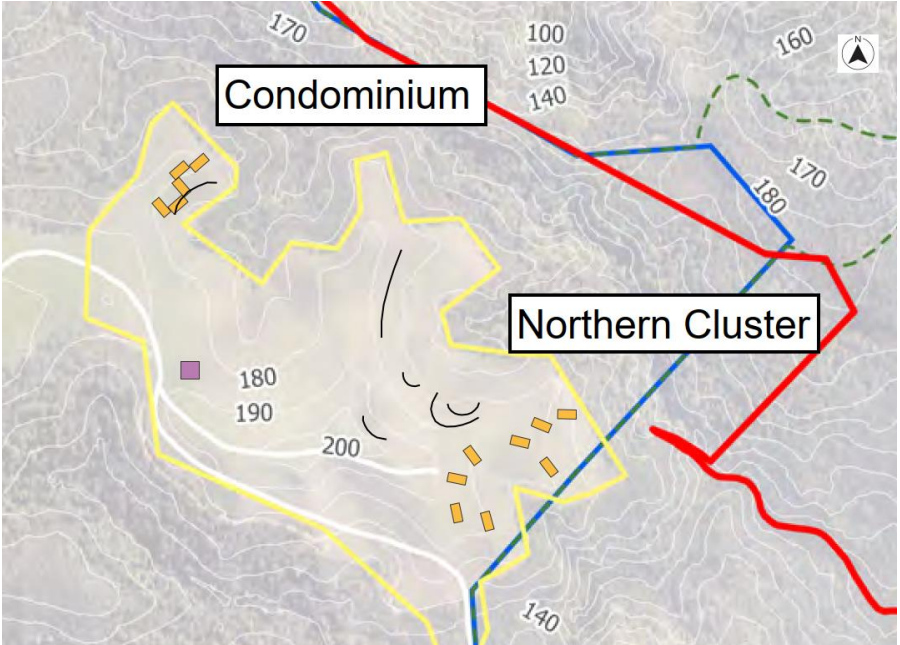
<p>Terrain: This area typically comprises a series of narrow ridge crests and drainage gullies with gently to moderately inclined slopes up to about 25 degrees. This area is considered susceptible to shallow surface creep and local instability within the soil materials on slopes steeper than about 19 degrees. Centrally within gully features reeds and rushes are observed, indicative of a higher groundwater level and wet ground.</p> <p>Data confidence: Published maps for the area indicate that the area is underlain by volcanoclastic sandstone and argillite of the Waipapa Group. No other historic supporting information is readily available for this zone.</p> <p>Inferred ground conditions: It is inferred based on the published geological maps and our site visit observations that this area will comprise of residually weathered soils underlain by weathered greywacke sandstone and argillite rock beds at depths. Within gully features surficial alluvial deposits can also be expected.</p>	<p>Geotechnical Implications: Given that historic and recent slope stability features are present in this area, it will be important to assess whether stabilisation is required achieve design factors of safety required by the FNDC for residential development.</p> <p>In general, this area may be suitable for development with relatively simple stability improvement measures such as minor earthworks possibly coupled with retaining walls, and simple surface water management provided the development sites remain near to the ridges and away from gullies and associated wet ground.</p> <p>Typically, building or site-specific engineering design in this area may comprise solutions such as light-weight raft foundations to reduce adding load to the top of slopes, piled foundations designed to resist soil creep, local earthworks stabilisation, drainage, localised retaining walls and possibly in-ground palisade walls should development encroach toward unstable ground or required factors of safety not be achieved through more conventional improvement measures. Shallow foundations may be suitable in some situations (subject to the proposed structures and loadings) or areas that have been enhanced through earthworks and/or retaining measures.</p> <p>Confirmation of Geotechnical Assessment: Development within this area requires confirmation of ground and groundwater conditions to better understand the slope stability and foundation requirements. This is likely to entail site specific geotechnical investigations and design, typical of the work undertaken prior to the lodgement of a resource consent application.</p>

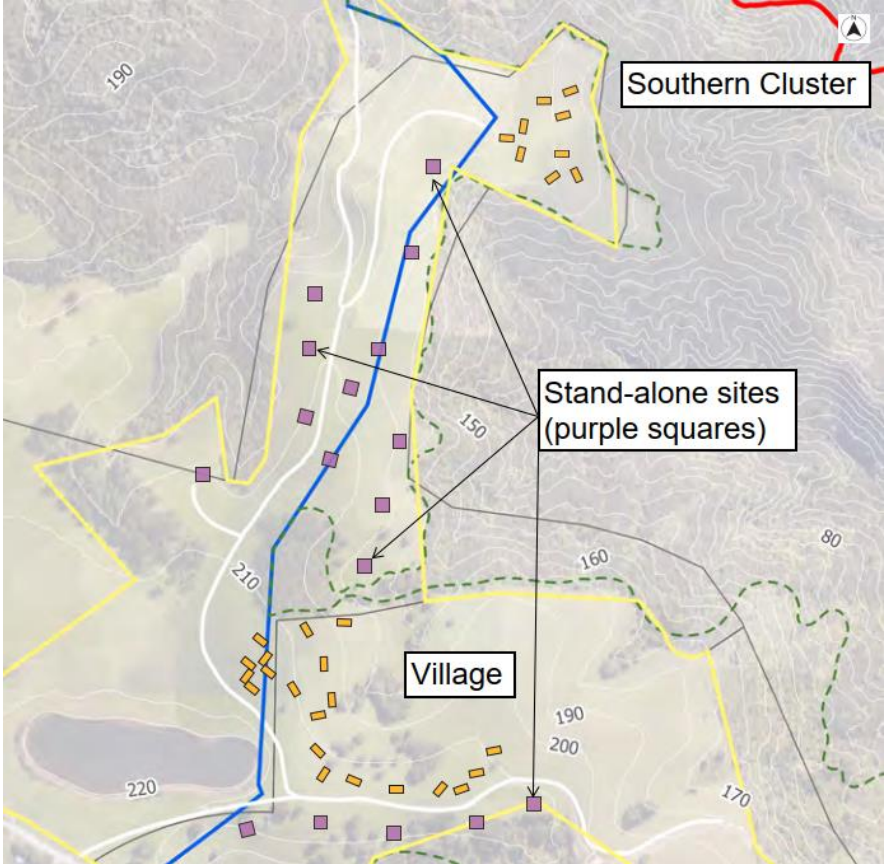
<p>Terrain: This area typically comprises a series of broad ridge crests sloping gently (<math><12^\circ</math>) down towards vegetated local gully features, steepening in the gully features outside the proposed areas of development.</p> <p>Data confidence: Published maps for the area indicate that the area is underlain by basalt lava of the Kerikeri Volcanic Group. Based on our experience at The Site, particularly the proposed reservoir development, and our observations made during The Site visit we consider that the ground conditions are likely to be consistent with the mapped geology.</p> <p>Inferred ground conditions: It is inferred based on the published geological maps that The Site will comprise of residually weathered volcanic soils underlain by weathered basalt rock at depth. Within gully features surficial alluvial deposits can also be expected.</p>	<p>Geotechnical Implications: The inferred ground conditions and topography in this area are generally anticipated to be suitable for shallow foundations provided minor earthworks can economically provide suitable building platforms. Alternatively piled foundations are likely to be suitable.</p> <p>Some sites will require development to be set back (Building Restriction Lines) from steeper slopes to satisfy FNDC minimum factor of safety design requirements. There is sufficient room to achieve complying setbacks.</p> <p>Confirmation of Geotechnical Assessment: Development within this area requires confirmation of ground conditions for foundation design and may require assessment of the slope stability where development is proposed near to steep slopes. This is likely to entail site specific geotechnical investigations and design, typical of the work undertaken prior to the lodgement of a resource consent application.</p>

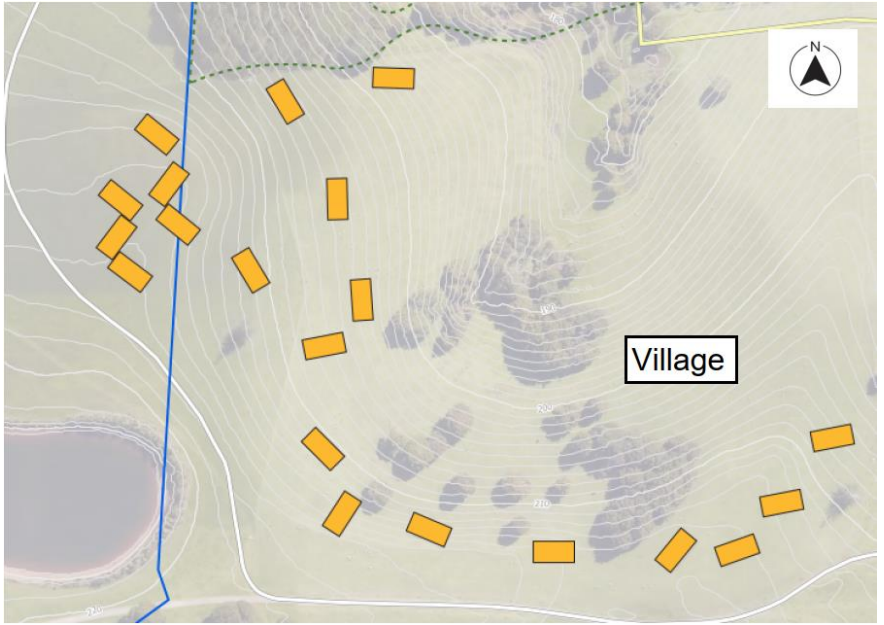
<p>Terrain: This area typically comprises of gently sloping (<math><12^\circ</math>) grassed paddocks with a water storage pond situated up slope to the west of the village.</p> <p>Data confidence: Published maps for the area indicate that the area is underlain by basalt lava of the Kerikeri Volcanic Group. Based on our experience at The Site, particularly the proposed reservoir development, and our observations made during The Site visit we consider that the ground conditions are likely to be consistent with the mapped geology.</p> <p>Inferred ground conditions: It is inferred based on the published geological maps that The Site will comprise of residually weathered volcanic soils underlain by weathered basalt rock at depth. Within gully features surficial alluvial deposits can also be expected.</p>	<p>Geotechnical Implications: The inferred ground conditions and topography in this area are anticipated to be suitable for shallow foundations provided minor earthworks can economically provide suitable building platforms. Alternatively piled foundations are likely to be suitable.</p> <p>Management of surface water will be a consideration in developing the village given many of the houses are located below the ridge crest within a broad gully feature. This can be achieved through conventional open swales and/or subsurface drainage where required.</p> <p>Building platforms should be setback from any low lying, wet ground or overland flow paths. There is sufficient room to achieve this.</p> <p>An existing water storage pond is located on the elevated land above the village. The condition and integrity of the pond has not been assessed as part of this desktop assessment.</p> <p>Confirmation of Geotechnical Assessment: Development within this area will generally require confirmation of ground and groundwater conditions for foundation design and may require assessment of the slope stability where development is proposed on sloping ground greater than about 4H:1V. The condition and integrity of the water storage pond could be assessed, if required, and any safety aspects addressed as part of any pre-consenting work that may be required. This is likely to entail site specific geotechnical investigations and design, typical of the work undertaken prior to the lodgement of a resource consent application.</p>
