Application for resource consent or fast-track resource consent

Name/s:	Quail Ridge Country Club c/o Pete Lawrence	
Email:	[REDACTED]	
Phone number:	Work [REDACTED]	Home
Postal address: (or alternative method of service under section 352 of the act)	82 Rainbow Falls Road, Kerikeri	
	[REDACTED]	
	[REDACTED]	
	Postcode 247

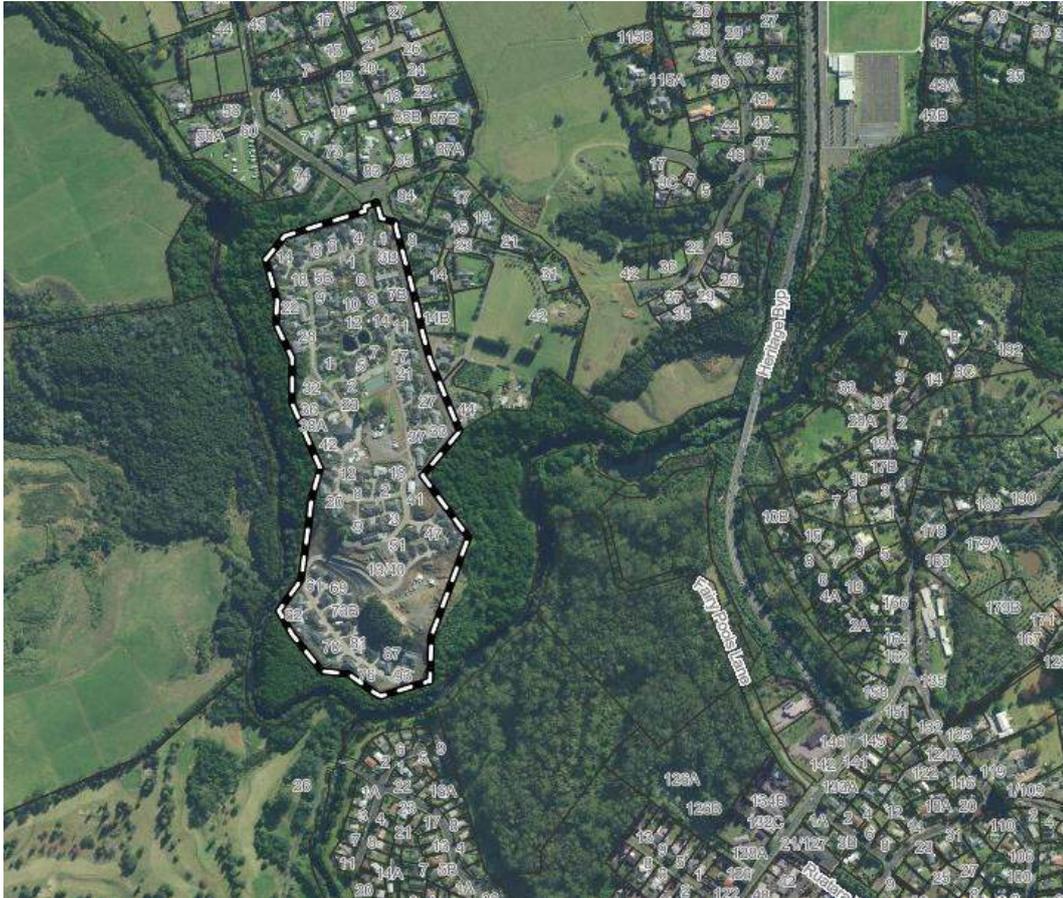
Figure 2: Site Aerial [Source: PDP Maps]

The subject site is located at the end of Rainbow Falls Road ~850m from the intersection of Waipapa Road. The Kerikeri urban centre is located south of the Quail Ridge Country Club zone and is less than 100m in distance as a crow flies.

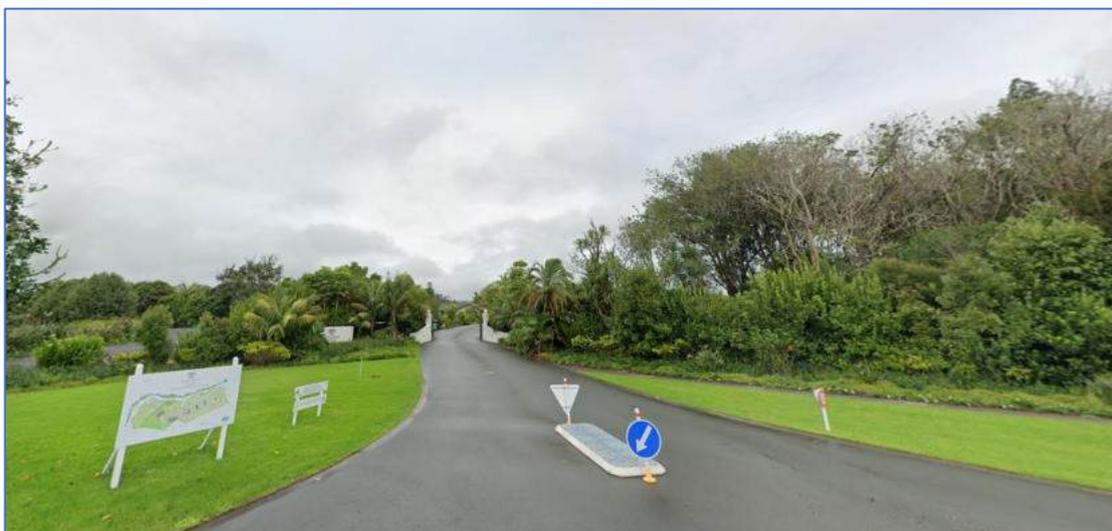
Figure 4: Entrance to the site on the right hand side off the shared crossing [Source: Google]

Access to the site is via a dedicated entrance to the Country Club off Rainbow Falls Road.

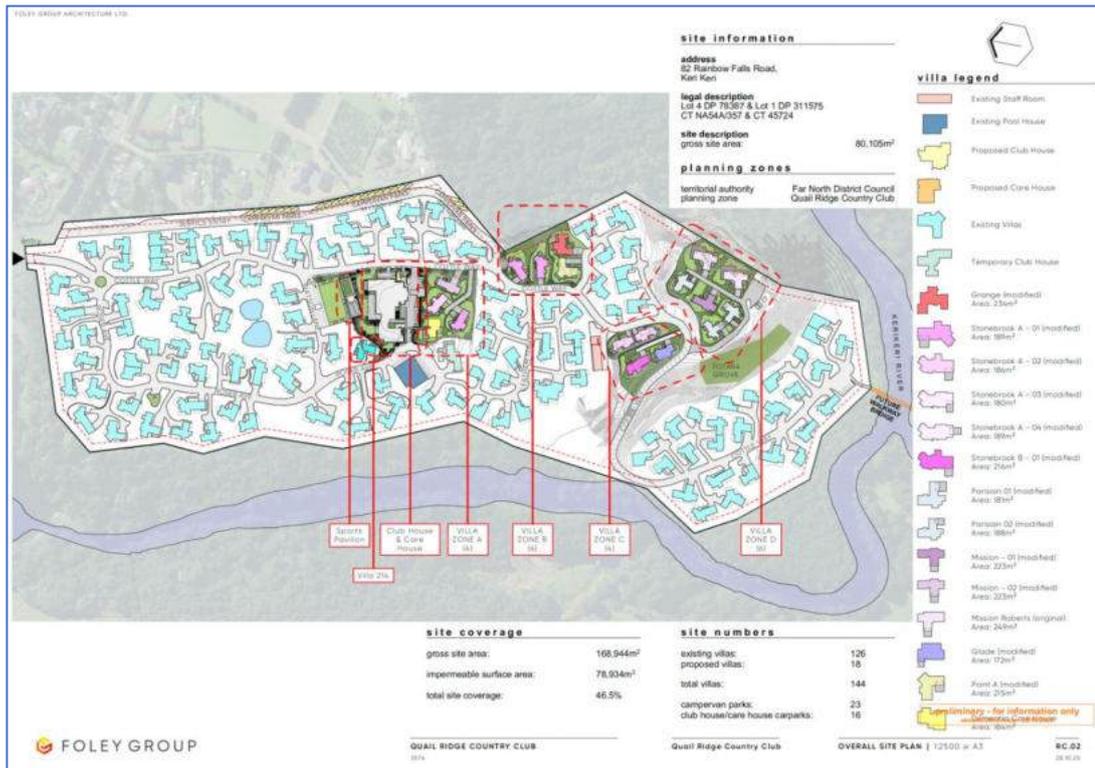
Figure 7: Proposed Site Plan [Source: Foley Group]

As is outlined below, the location of the Club House, Care House and Zone A villas are generally located in accordance with the Master Plan. Villas in Zone B are largely located in an area where apartments were proposed. Villas in Zone C and Zone D are also generally located where townhouse and house units were envisaged.

Notwithstanding the above, consent is required for minor discrepancies from the Concept Master Plan.

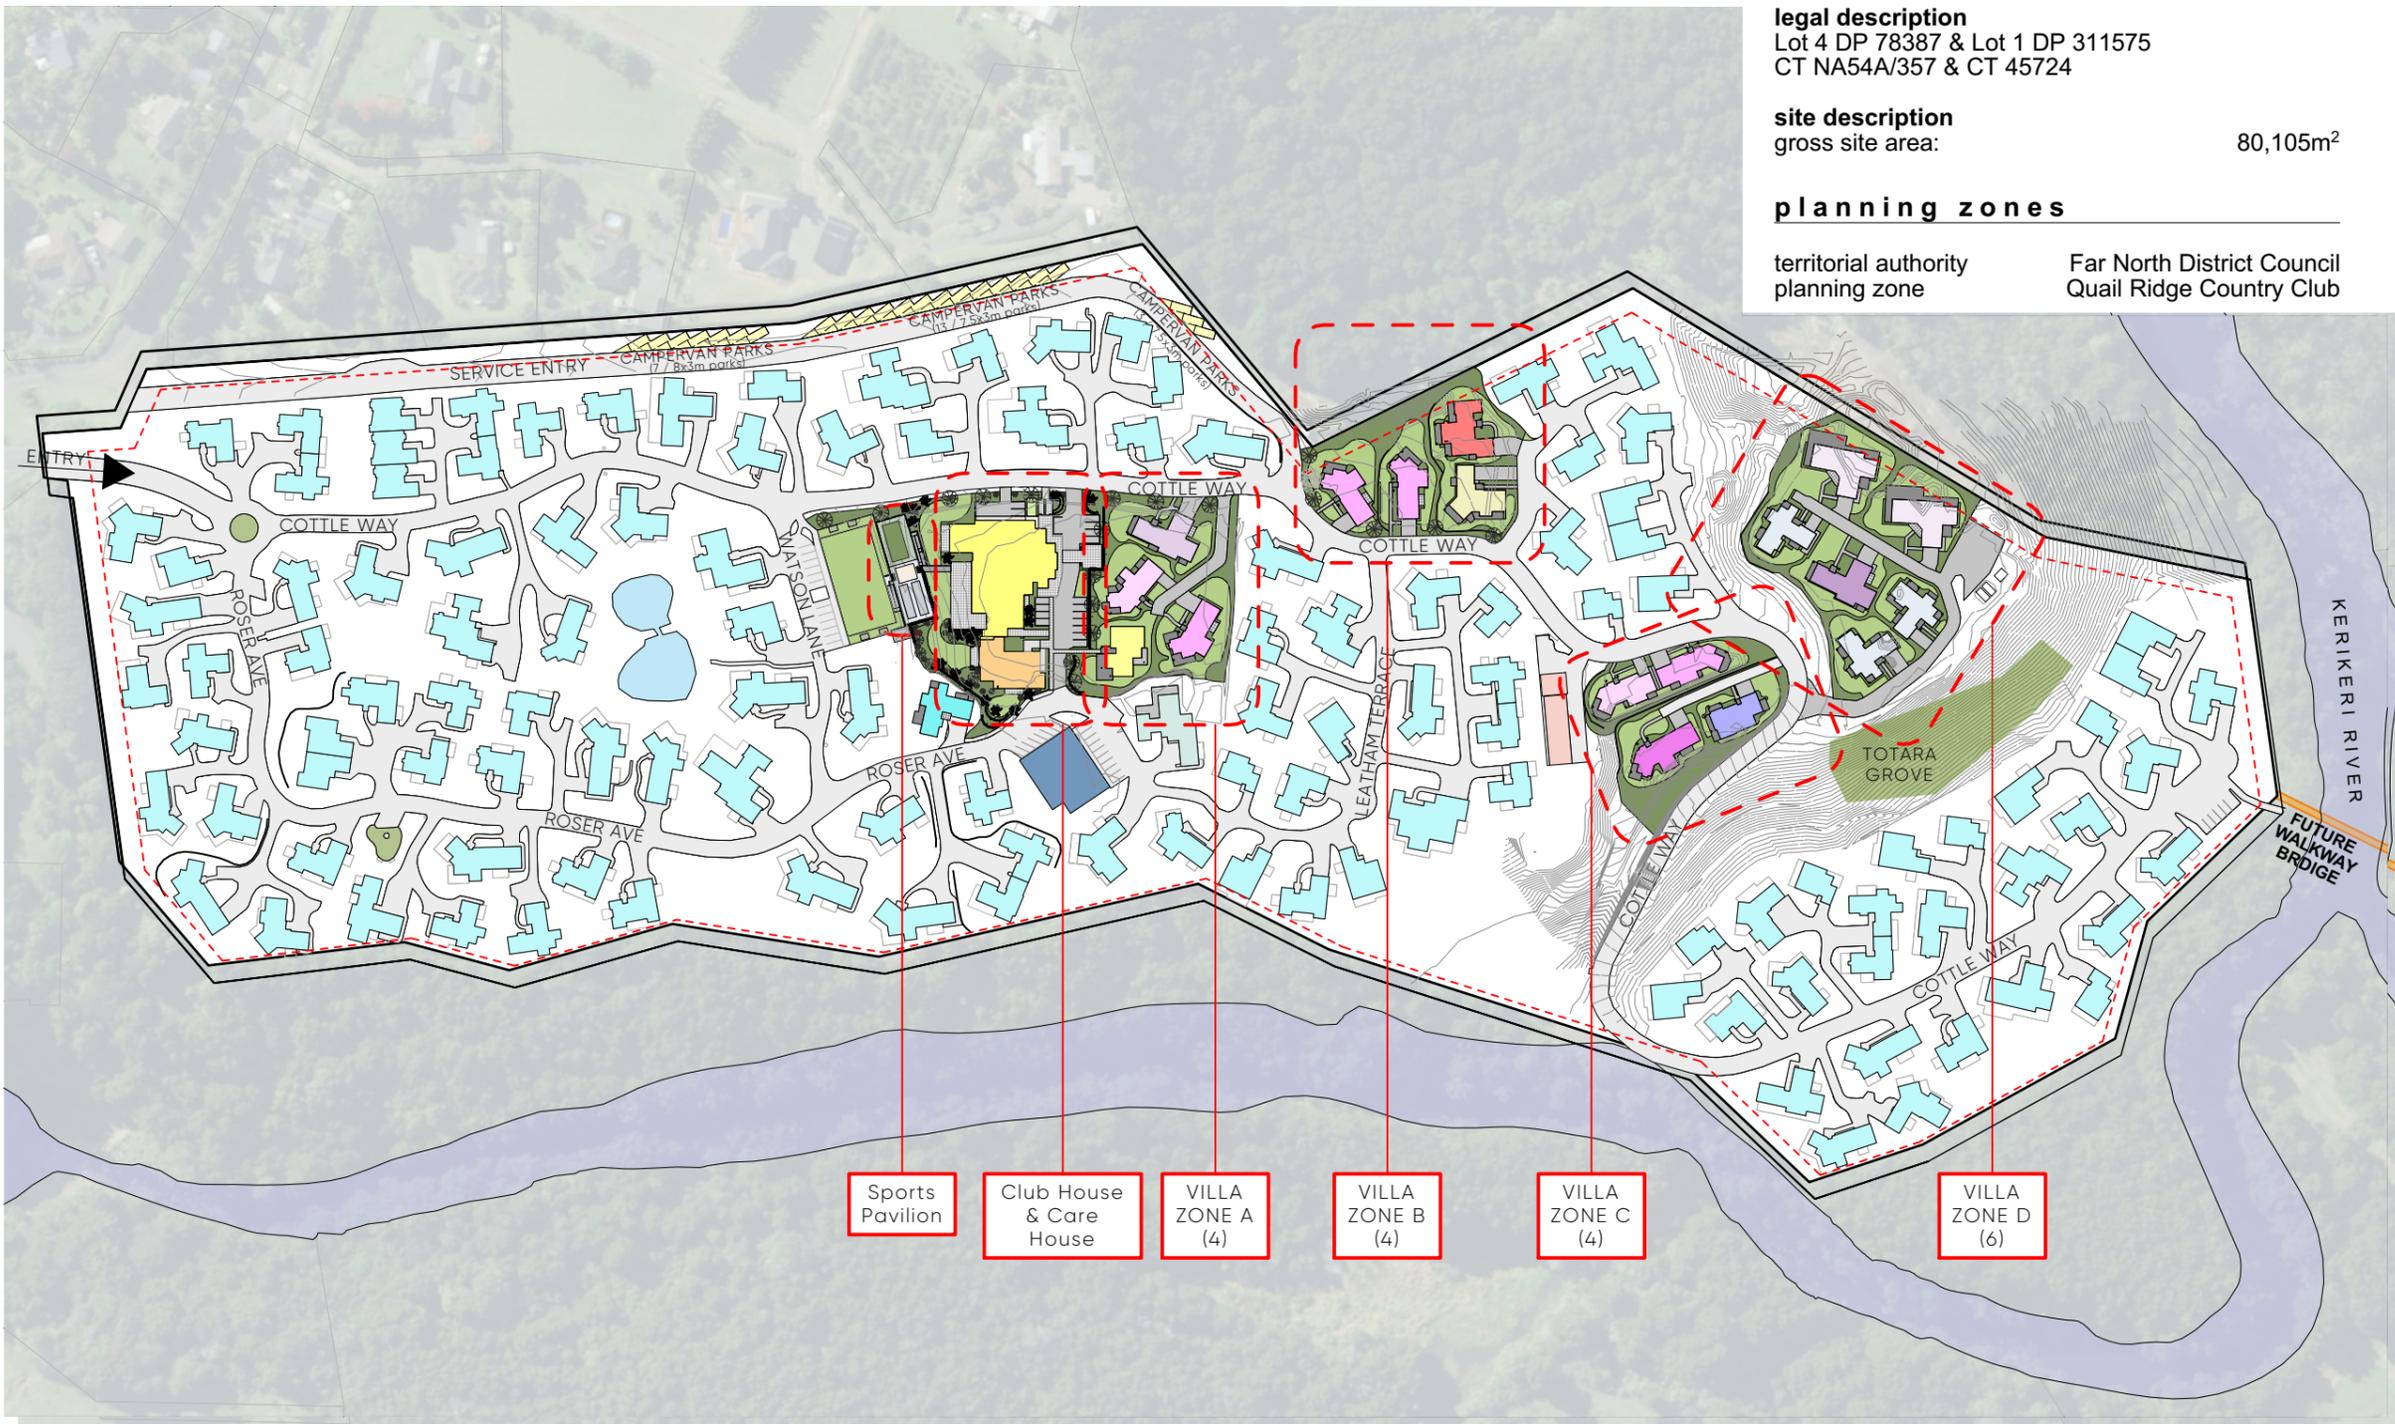
- Sports Pavilion
- Club House & Care House
- VILLA ZONE A (4)
- VILLA ZONE B (4)
- VILLA ZONE C (4)
- VILLA ZONE D (6)

existing villas:	126
proposed villas:	18
total villas:	144
campervan parks:	23
club house/care house carparks:	16

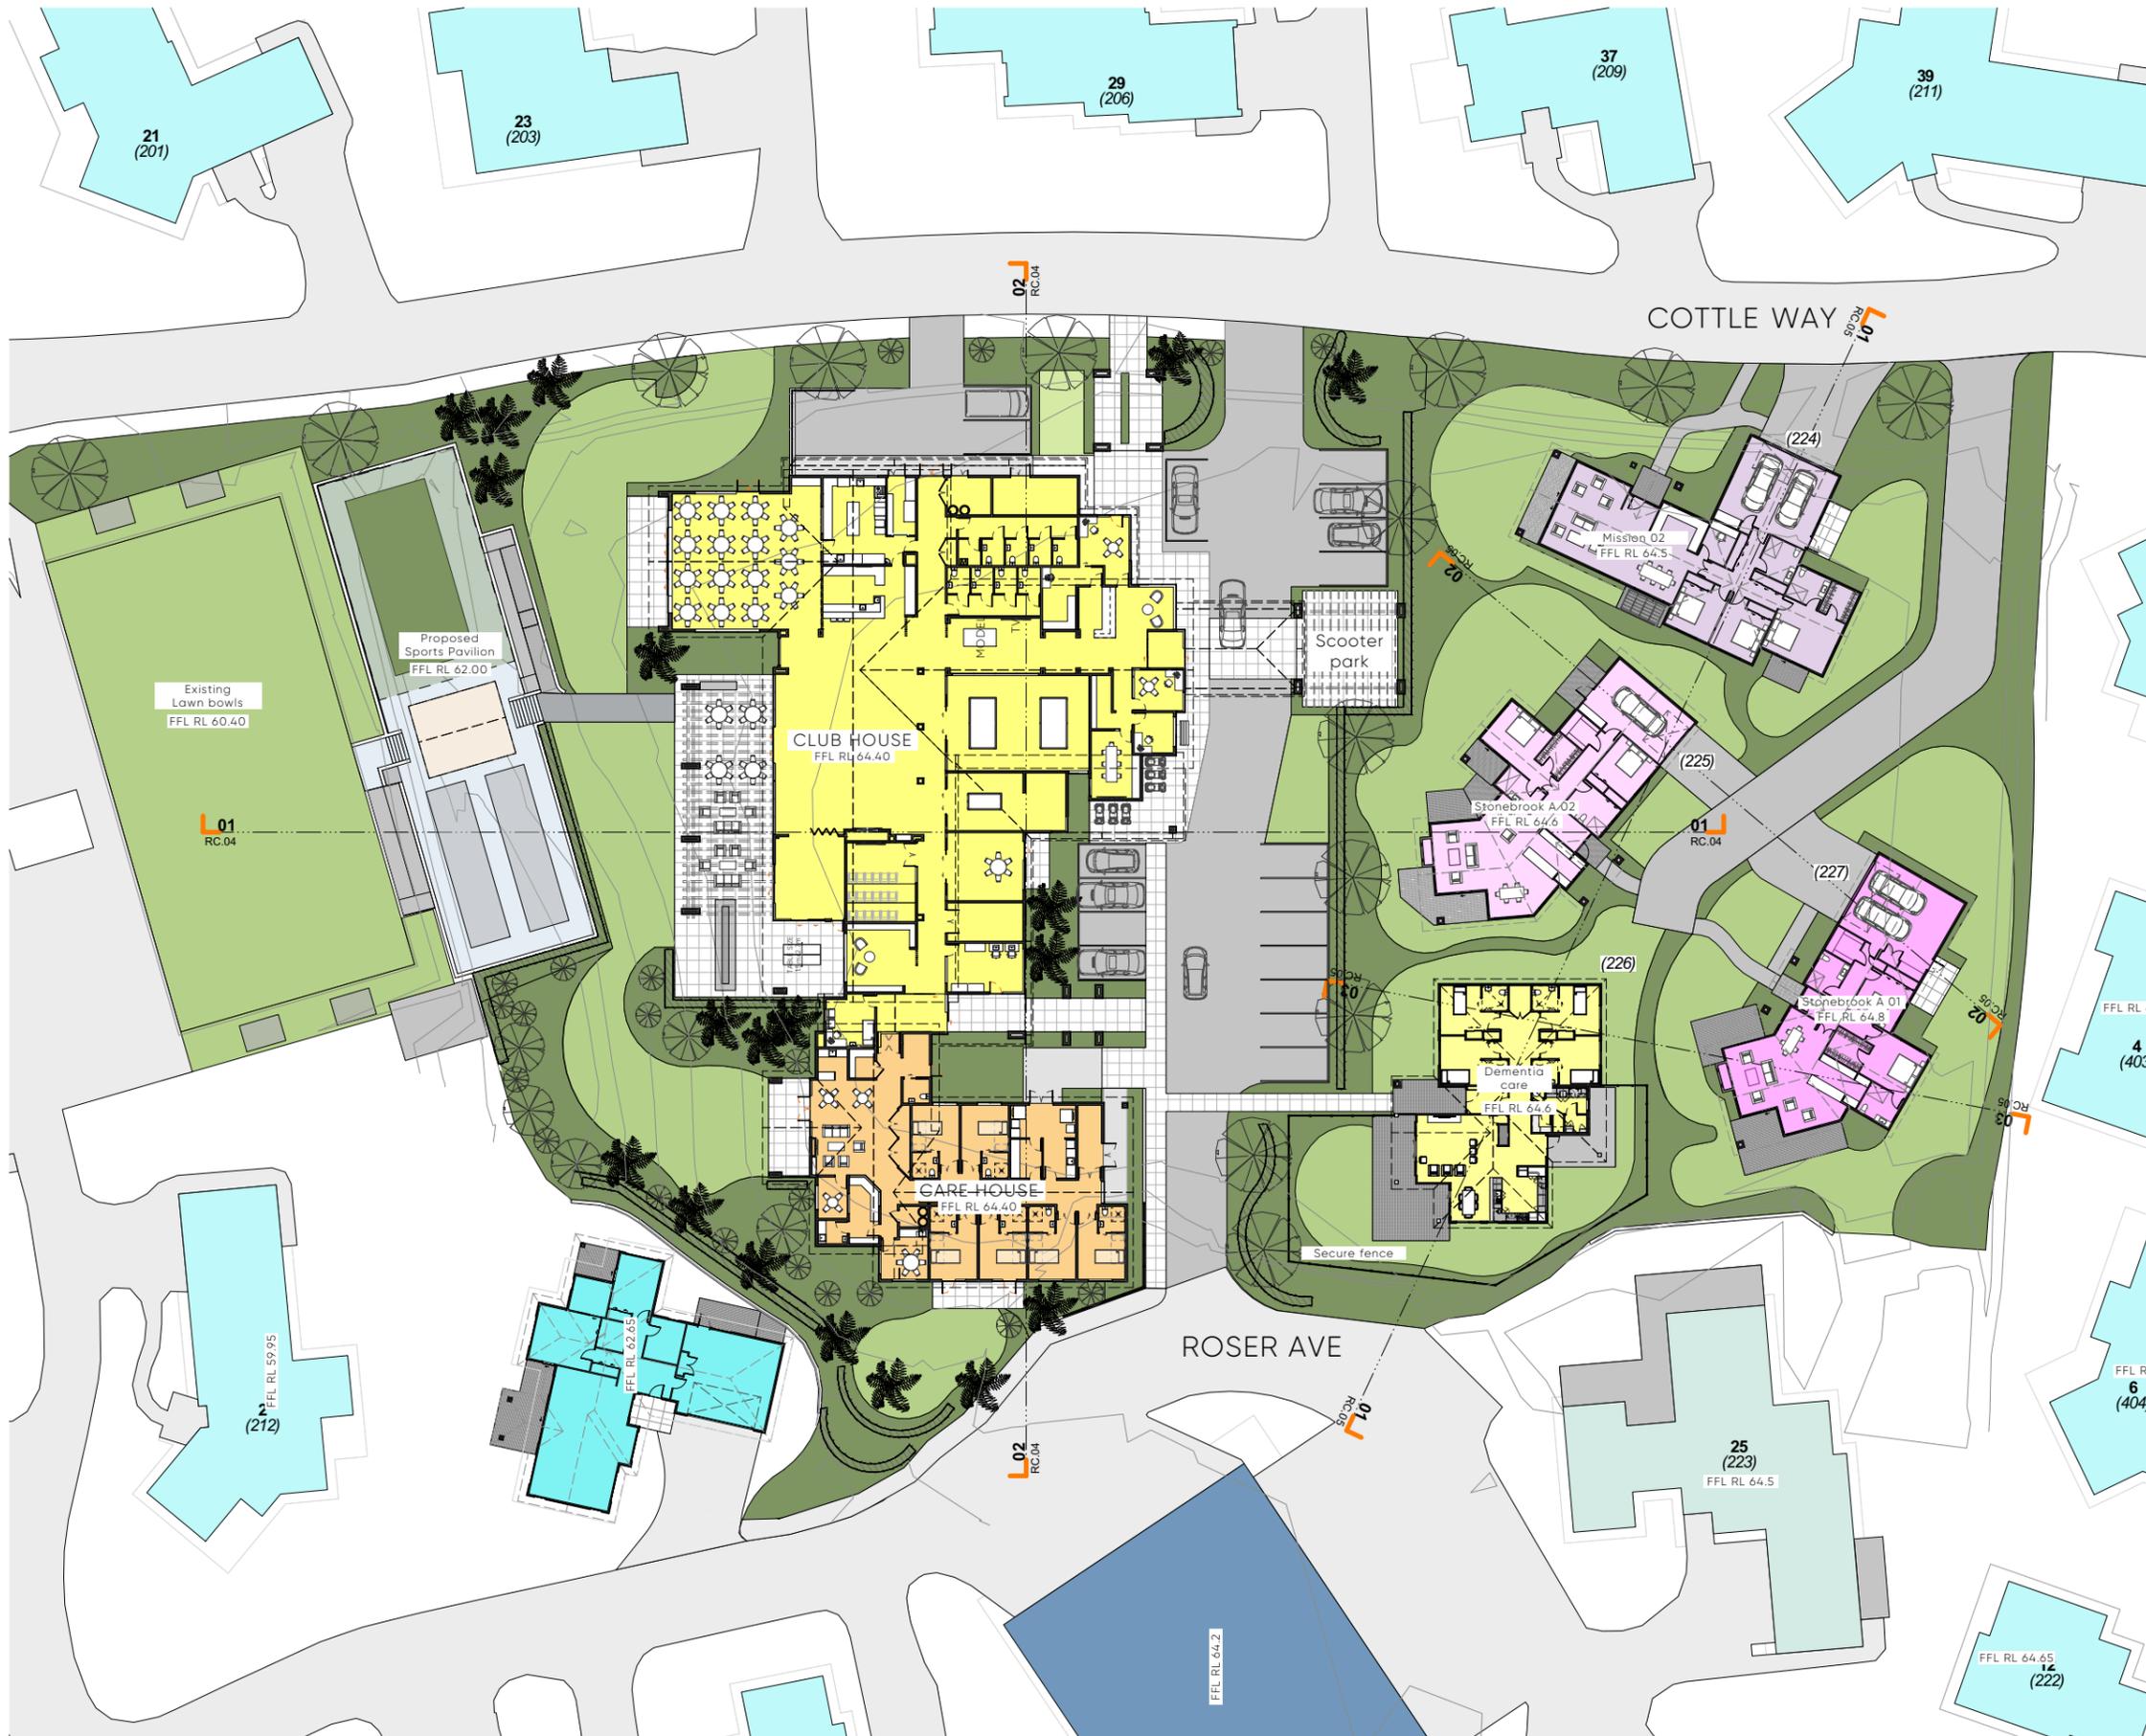
villa legend

- Existing Staff Room
- Existing Pool House
- Proposed Club House
- Proposed Care House
- Existing Villas
- Temporary Club House
- Dementia Care House Area: 184m²
- Stonebrook A - 01 (modified) Area: 189m²
- Stonebrook A - 02 (modified) Area: 186m²
- Mission - 01 (modified) Area: 223m²

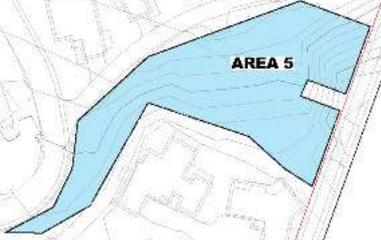
Area 5
2360m²
DIR = 5mm/d (11,800L/d)
Drip line spacing - 650mm

Area 1
964m²
DIR = 2mm/Day (2892L/d)
Drip line spacing - 650mm

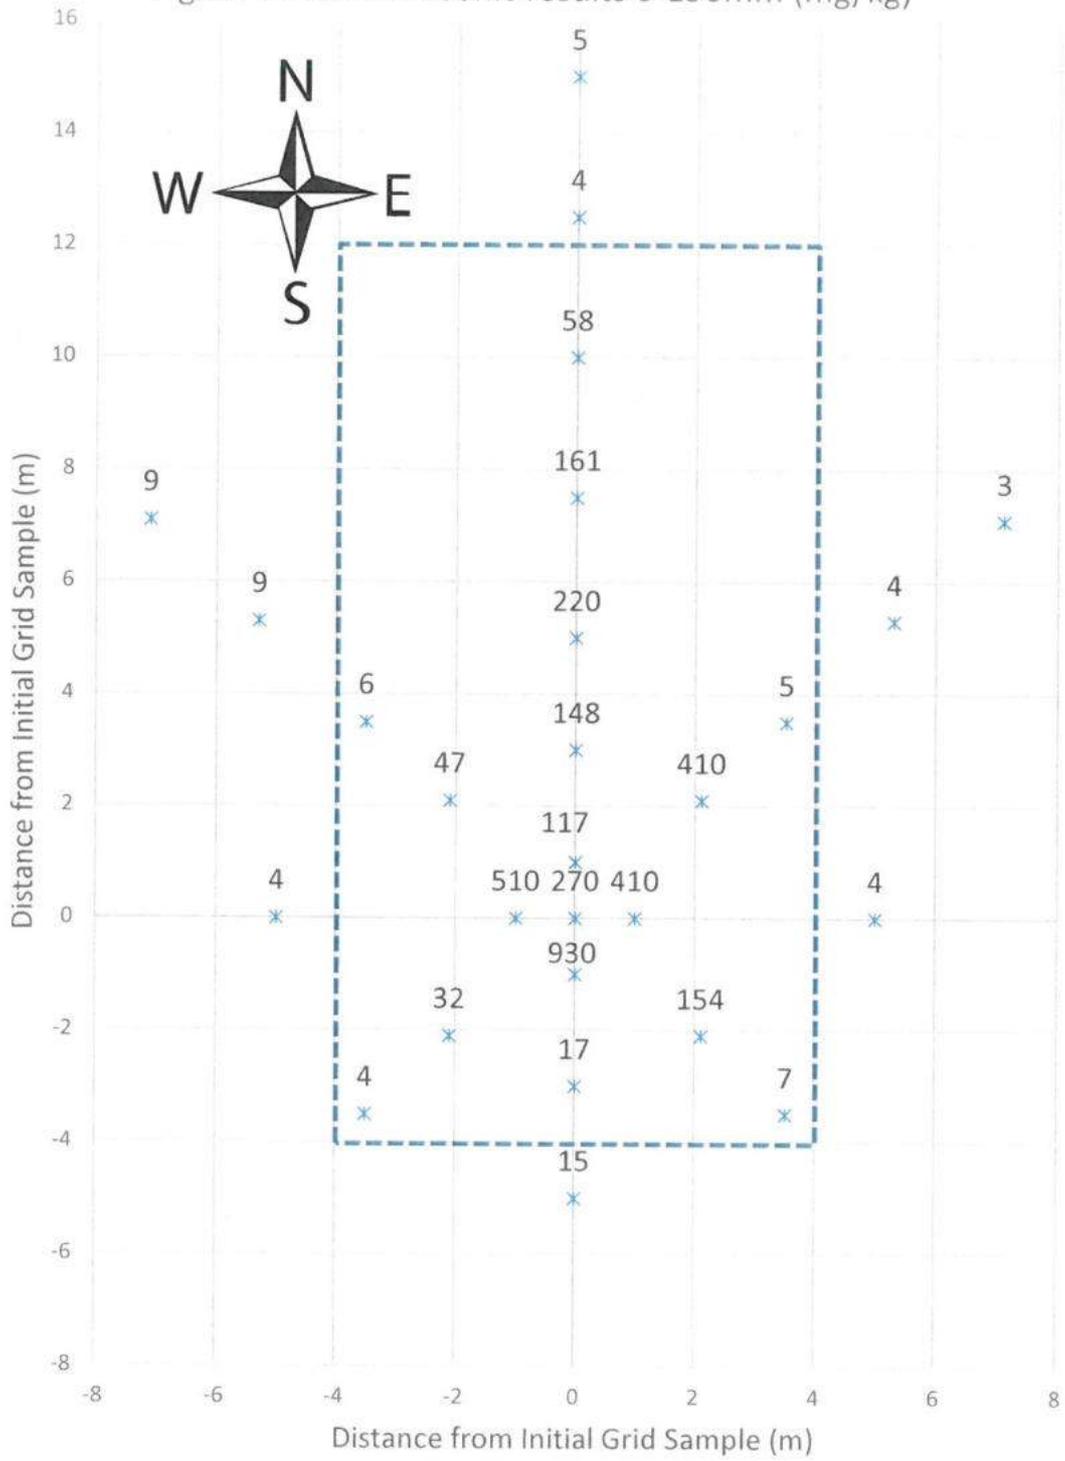
Figure 2: Site 54 Arsenic results 0-150mm (mg/kg)

Following analysis of sites 48 and 52, the hotspot size for site 48 (the smallest hotspot) was estimated as 8m diameter, and a revised grid size of 6.5m calculated using Appendix B of CLMG5 for the subsequent sampling. Subsequent sampling (0-150mm depth) on the reduced grid size was undertaken in the areas of site where it was considered likely that treated timber would be unloaded (at the base of the access track from Stage 4 to Stage 5, and contiguous with Site 48), using a sampling grid size of recommended in CLMG 5 Appendix B. Refer to Sample plan 2 (attached) for sampling locations. Results from these samples are given in Table 7, all are below the relevant SCS.

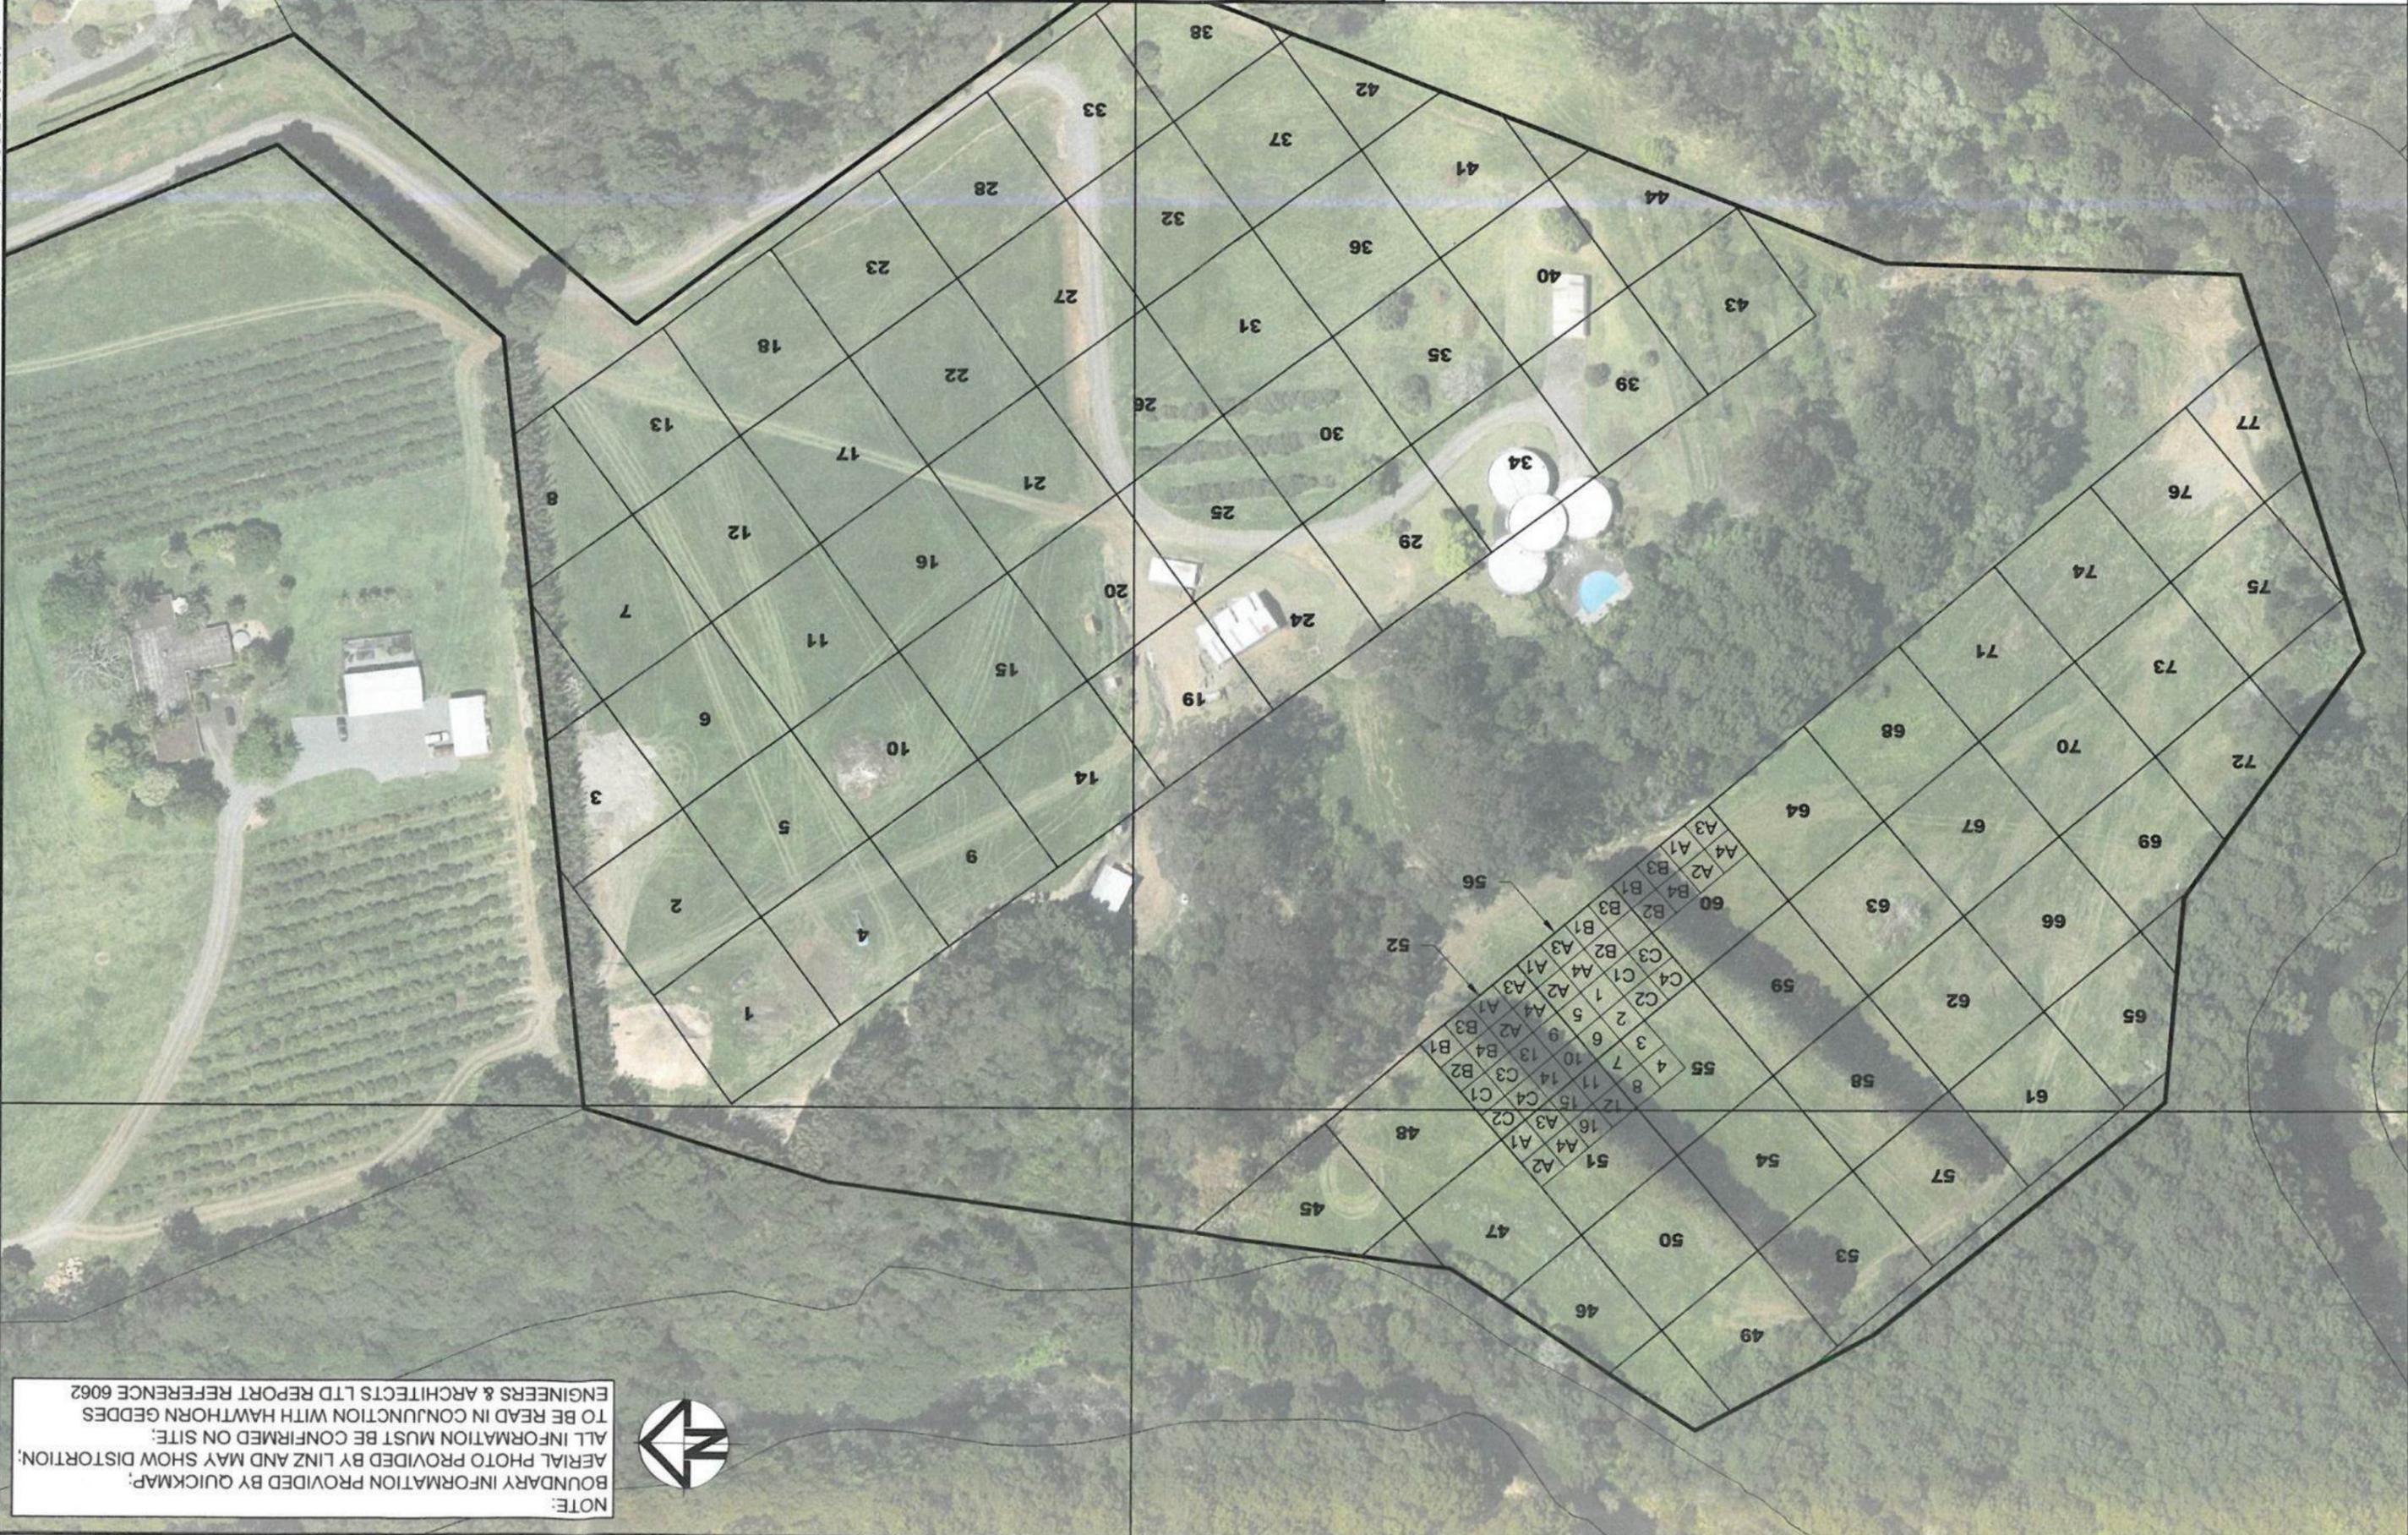
PROJECT No. **6062**
SHEET **Figure 1**

CLIENT: **KERIKERI FALLS INVESTMENT LTD**
PROJECT: **QRCC - NES SITE INVESTIGATION**
DRAWING: **SAMPLING PLAN**
RAINBOW FALLS ROAD, KERIKERI

The site consists of one lot (Lot 1 DP 311575) located at the end of Rainbow Falls Road in Kerikeri. The piece of land is defined as the area of the parcel excluding the accessway and bush clad escarpments areas, an area of approximately 5.9 Ha. Refer to Figure 1 for further details.

For the purposes of this DSI, the piece of land is defined as an area of approximately 5.9 Ha being Stage 4 and 5 of the proposed development, but excluding the bush covered escarpment and accessway. Refer to Figure 1 for further details. The contaminant source in the conceptual model arises from historical application of pesticides to the crops and use of treated timber on site.

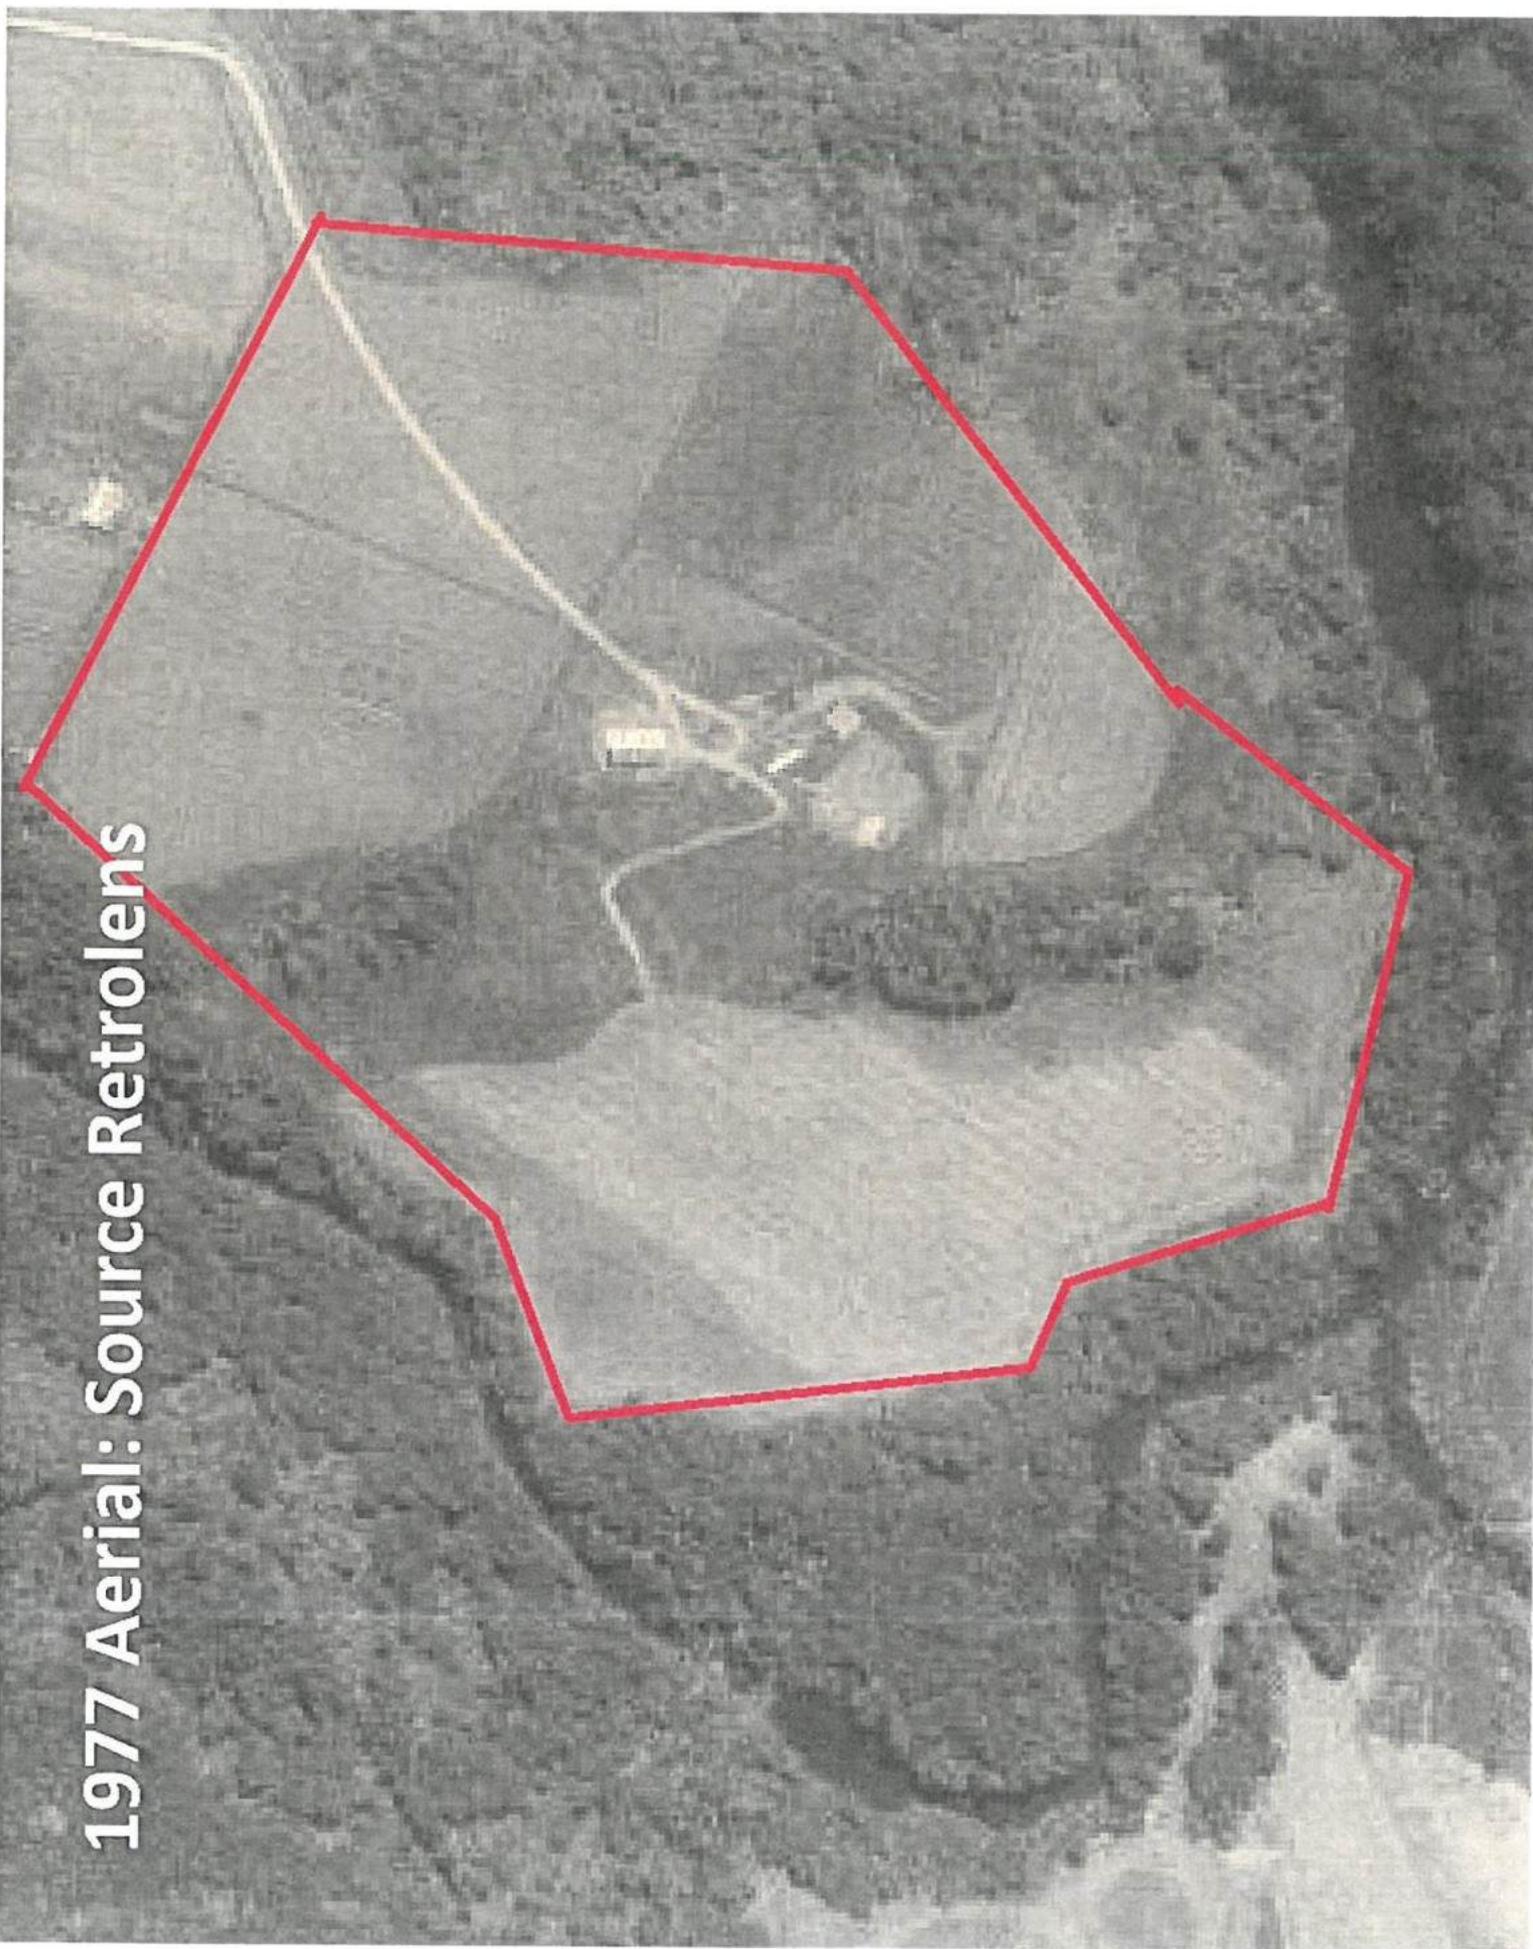
1977 Aerial: Source Retrolens

The aerial photographs from 1953 shows the land in pasture with some bush adjoining to the south and west along the Kerikeri River. The 1977 photo, although not clear, appears to show rows of crops, particularly in the Stage 5 area. 1977 shows horticultural plantings over both Stages 4 and 5. The dwelling and sheds, which still exist today, were observed on the aerial photos from 1979. The accessway was cleared of plantings sometime between 2009 and 2012.

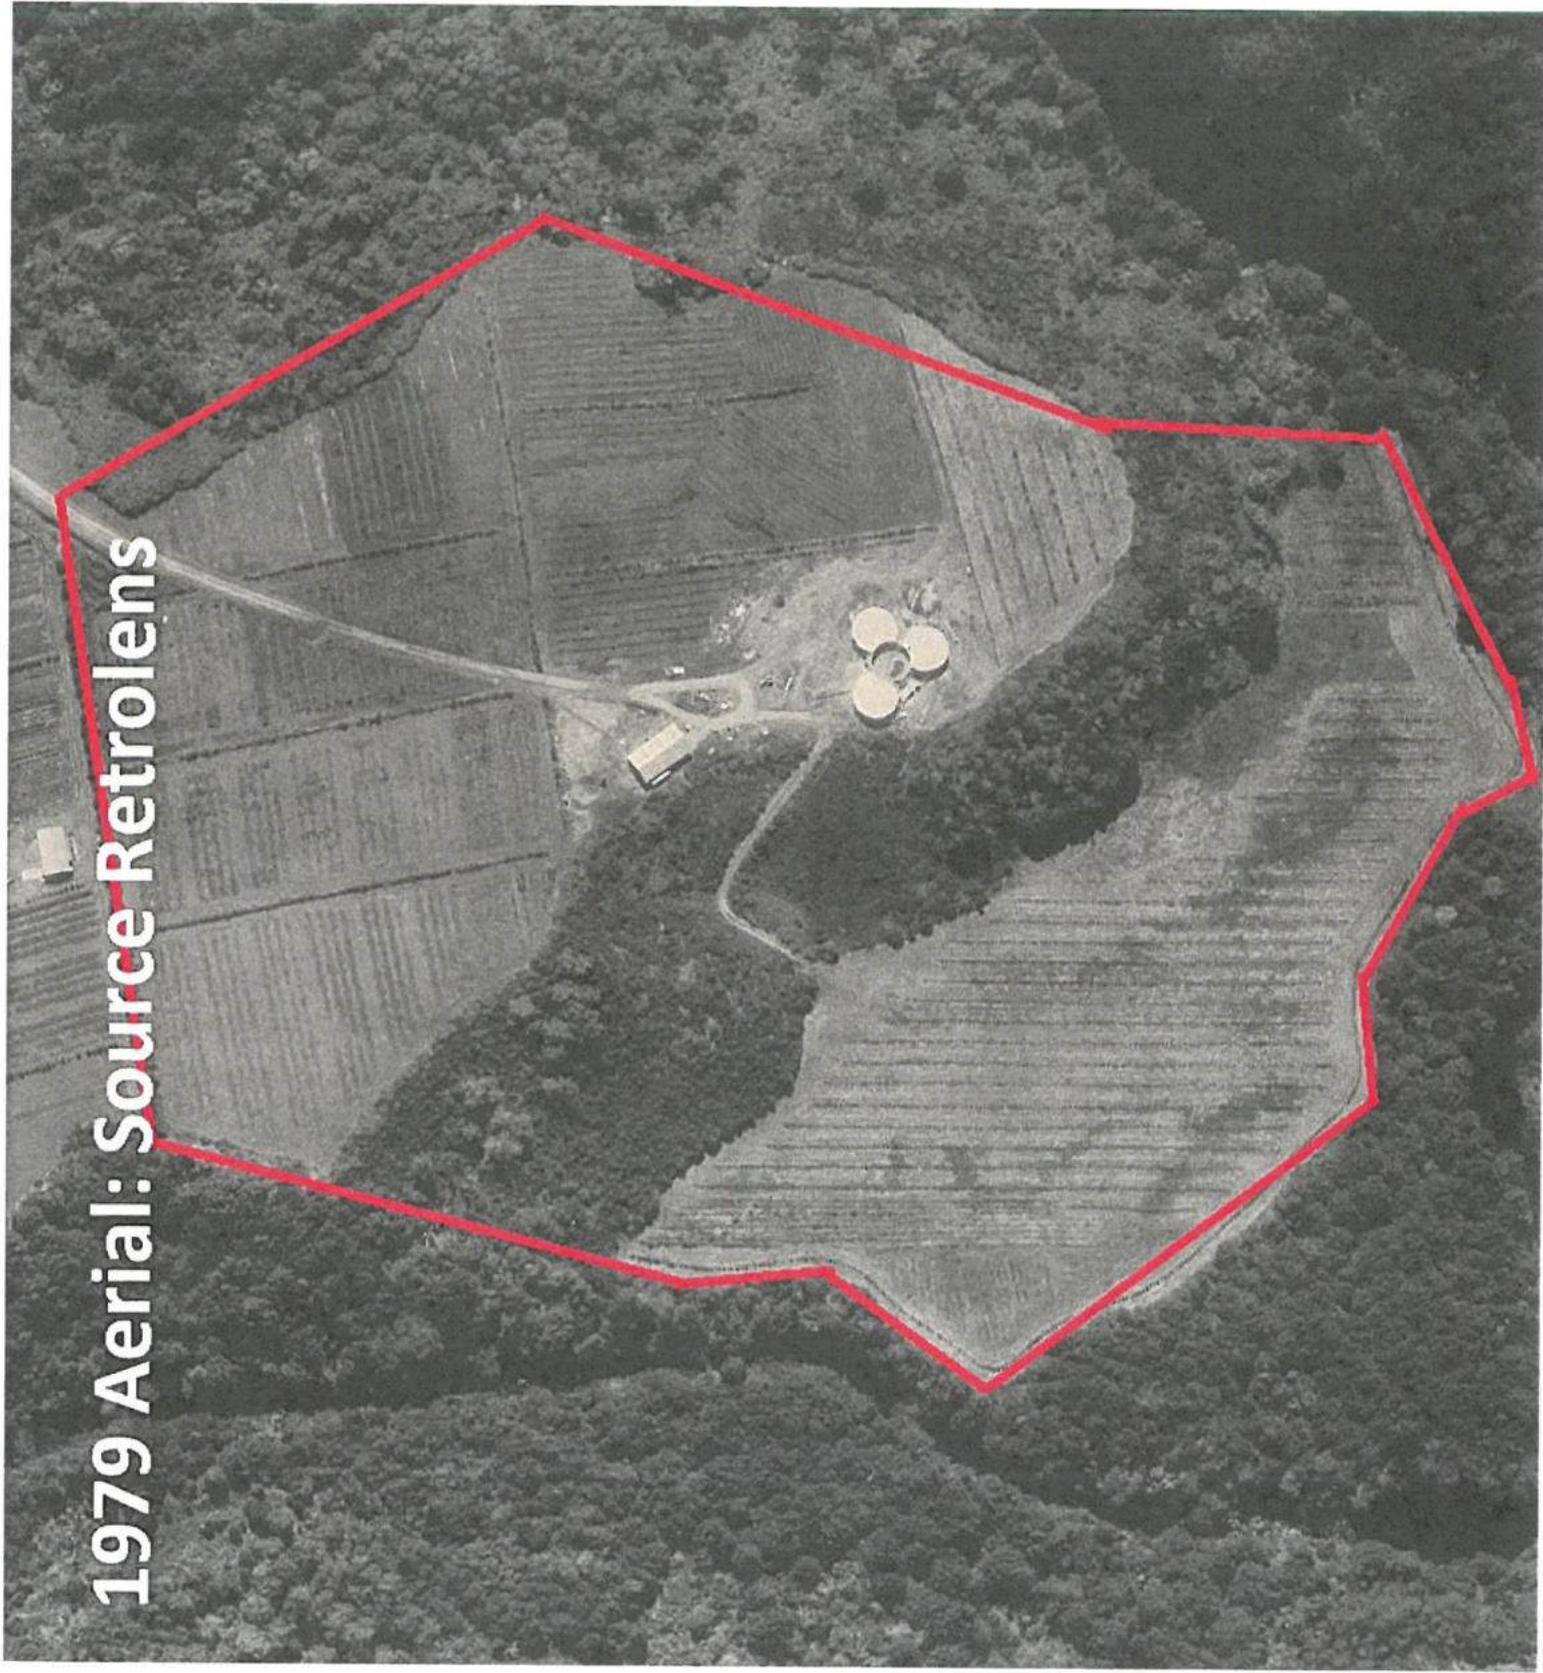
1979 Aerial: Source Retrolens
