Application for resource consent or fast-track resource consent

Name/s:	Quail Ridge Country Club c/o Pete Lawrence	
Email:	[REDACTED]	
Phone number:	Work [REDACTED]	Home
Postal address: (or alternative method of service under section 352 of the act)	82 Rainbow Falls Road, Kerikeri	
	[REDACTED]	
	[REDACTED]	
	Postcode 247

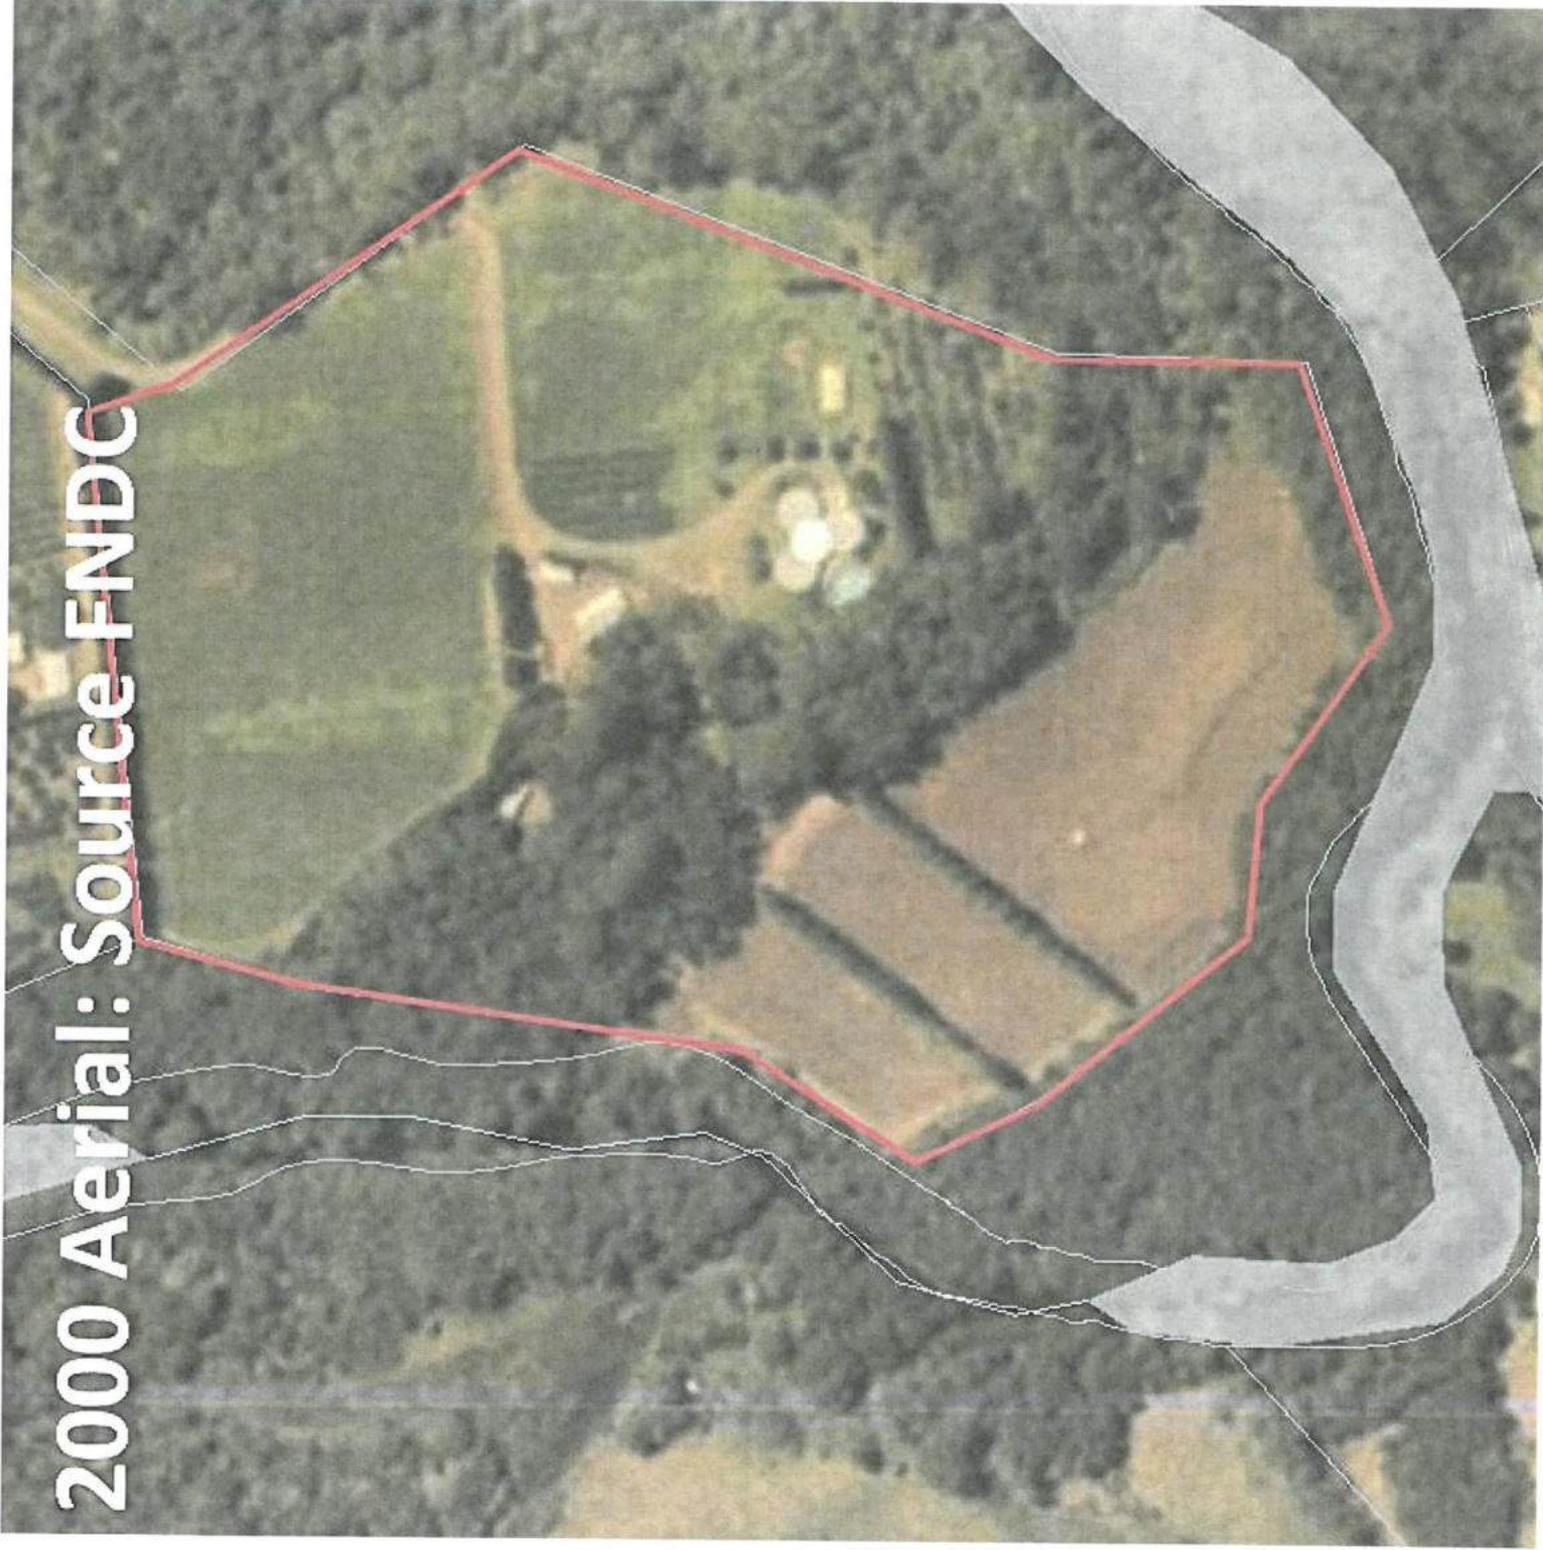
2000 Aerial: Source FNDC

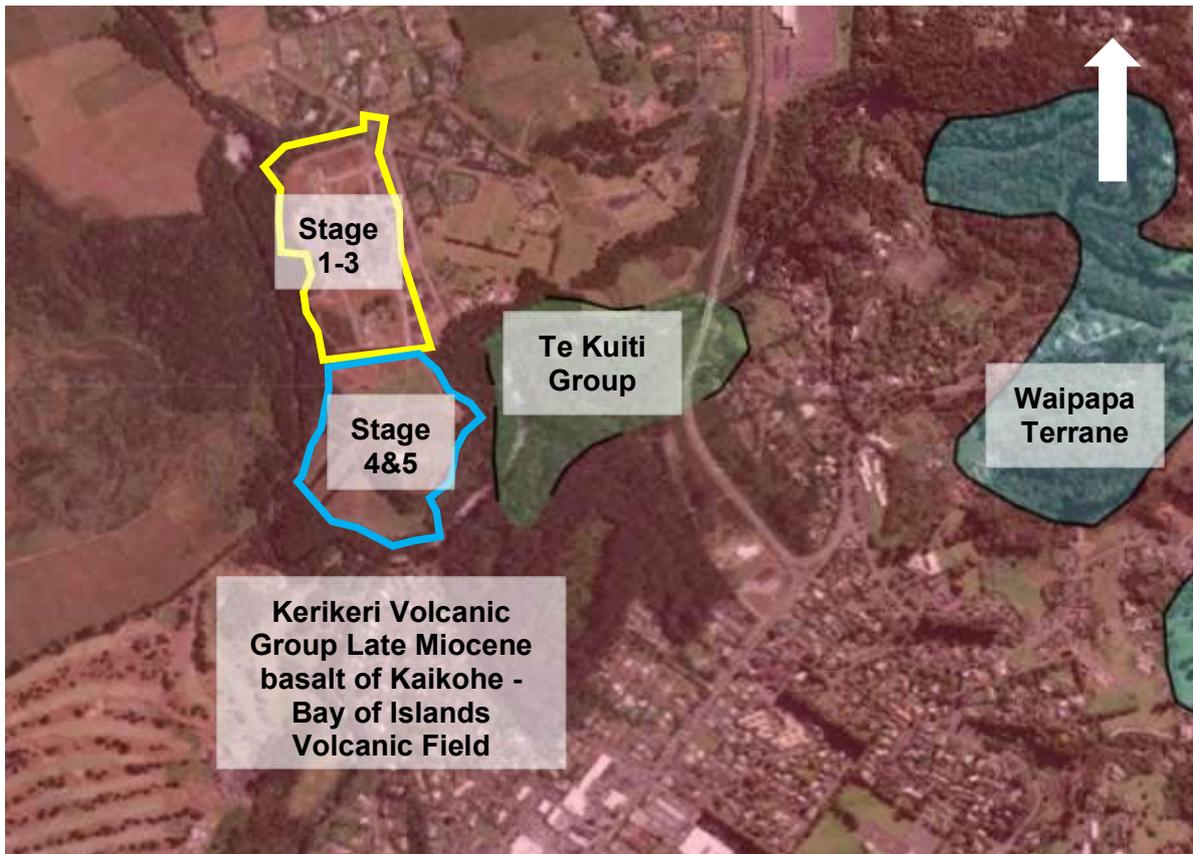
Figure D: Aerial imagery of the property and its surrounds with the published geology overlay

The 1:250,000 scale published geology of the area, viewed online from the GNS Science website indicates that the site is underlain by Kerikeri Volcanic Group Late Miocene basalt of Kaikohe - Bay of Islands Volcanic Field, see Figure D below. The site is closely bordered by an outcrop of the older Ruatangata Sandstone of Waro Subgroup (Te Kuiti Group), likely the basement unit beneath the basalt overlay.

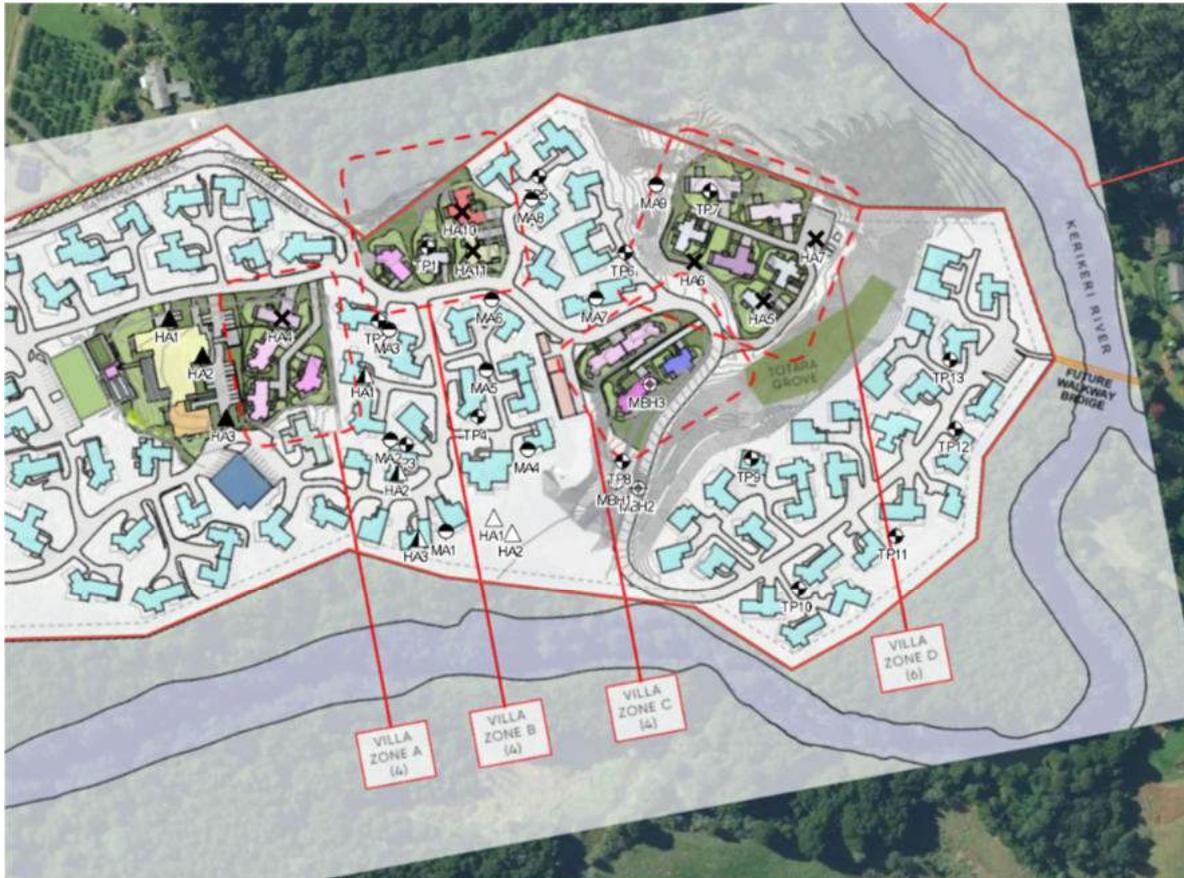
Figure E: HGEA subsoil investigation plan with Foley Group Master Plan overlay

HGEA have been engaged by QRCC to undertake subsoil investigation and engineering oversight to earthworks over the wider development since 2017, for Stages 2 through 5. During this time, extensive subsoil investigation, comprising a combination of hand augered boreholes (HA), machine augered boreholes (MBH), test pit excavations (TP), and rotary augered boreholes (BH), have been undertaken, supervised and logged by HGEA. The extent of this investigation is outlined by Figure E below, and in more detail on the attached Figures 01 through 03.

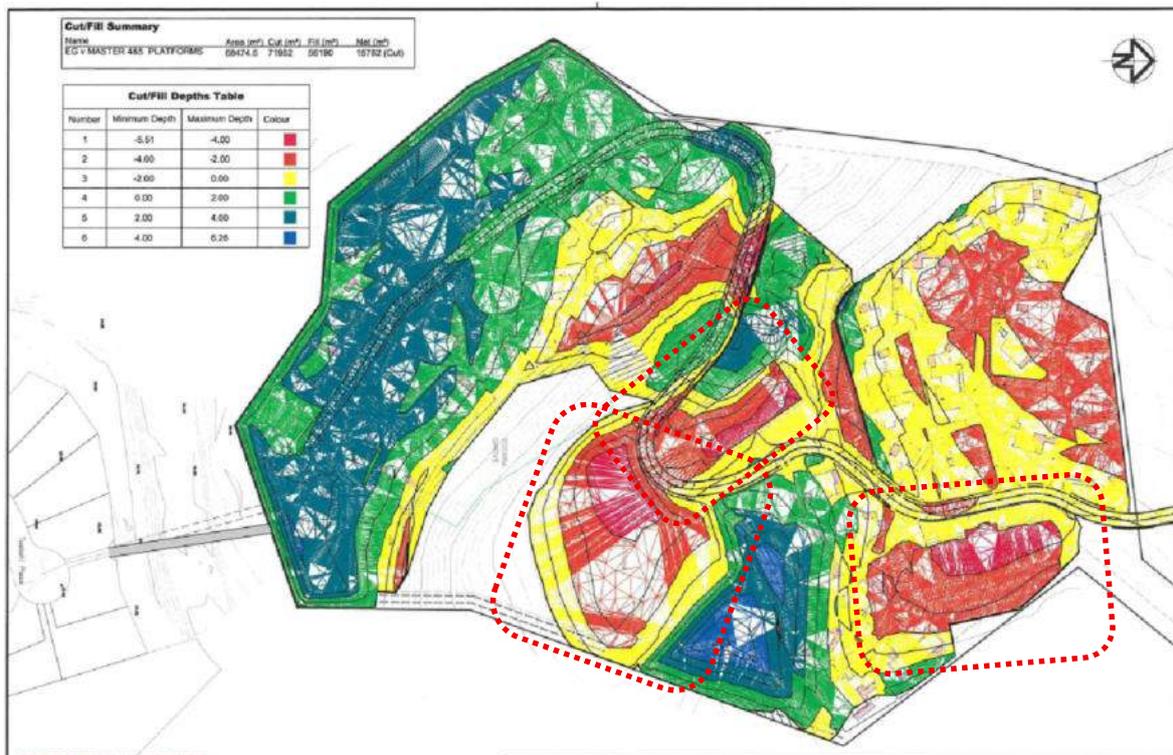
Figure F: as-built cut-fill extents for Stages 4 and 5 (Source: HGEA drawing, Figure 06, Revision R1). Villa zone(s) shown by dashed red lines, shown left to right as Villa Zones D, C and B

The extent of the earthworks undertaken across Stages 4 – 5 is depicted below, Figure F. Villa zones B and D are within areas of mostly excavation, and Villa Zone C is within an area of both excavation and fill, supported by a timber crib retaining wall.

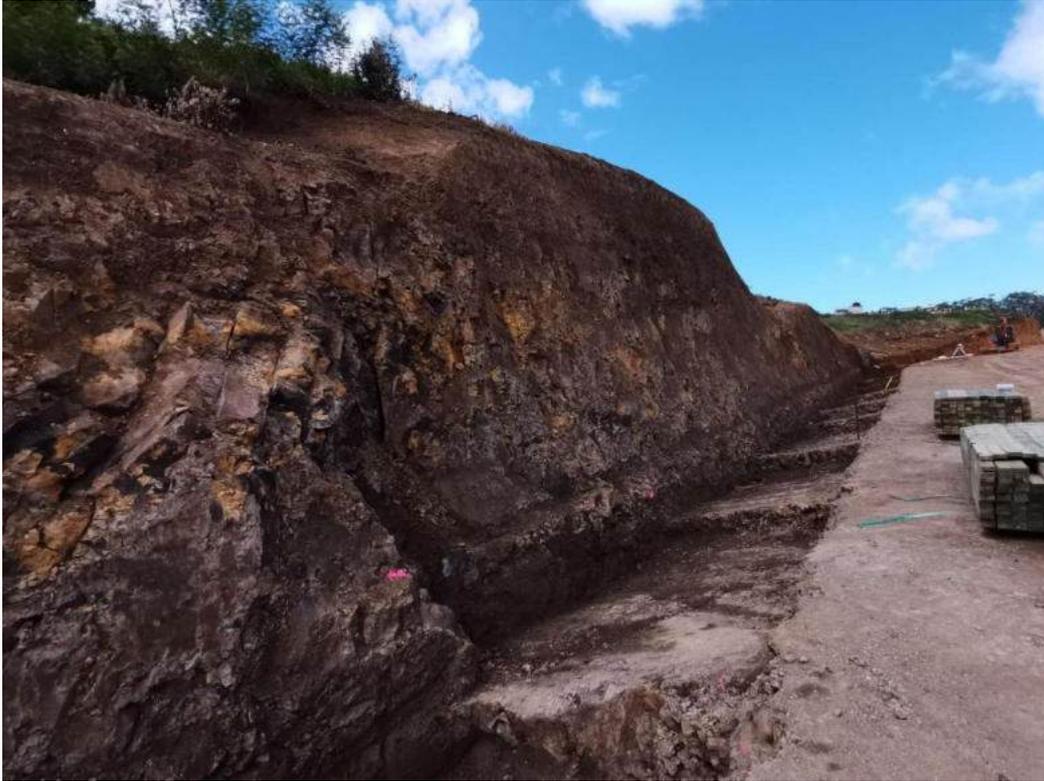
Figure G – View north over excavation above Stage 5 access (photo taken during earthworks 2021). Weathering, Fracturing and faulting are evident in the underlying Basalt Rock

Excavation through Stage 5 resulted in the uncovering of the underlying weathered basalt rock, where fracturing, bedding, and faulting in the rock were observed, see below, Figure G. The same was observed in the MBHs (MBH1 through MBH3) drilled up to 22.5 bgl. The extent of this excavation comprised cuts up to 5.5m bgl, as shown in Figure F.

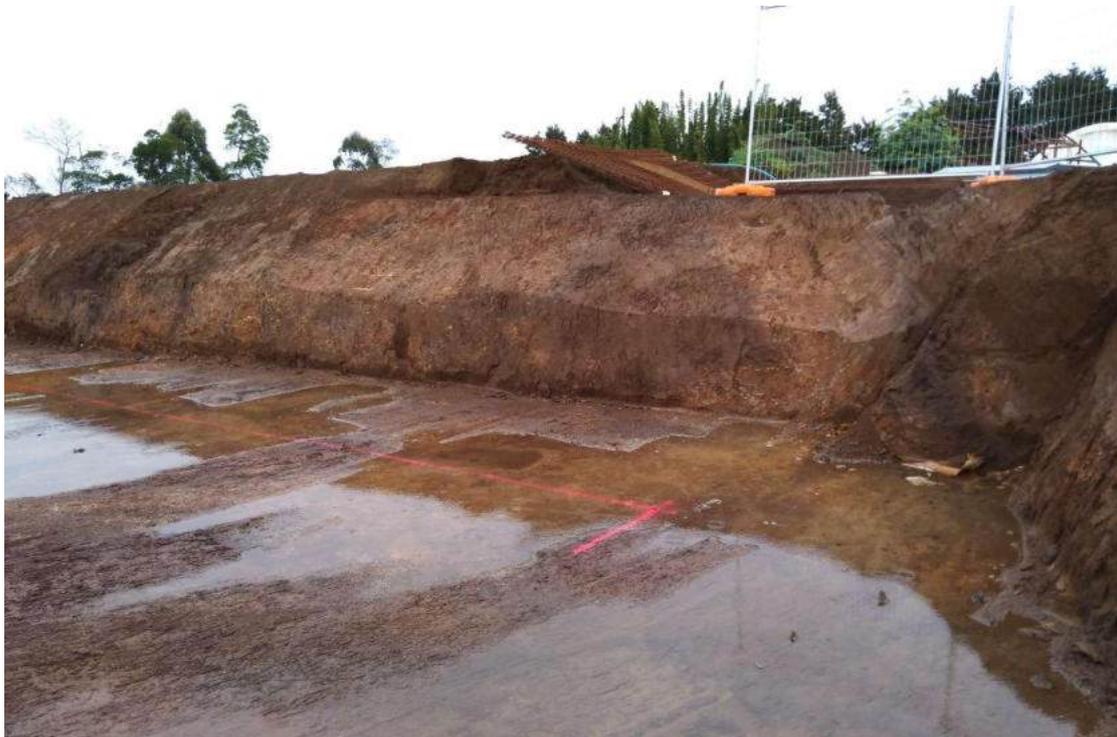
Figure H – View north towards future units 223 to 227 (photo taken during earthworks 2019)

Inspection of an exposed excavation face indicates the site is underlain by the weather tuff of the Kerikeri volcanics.

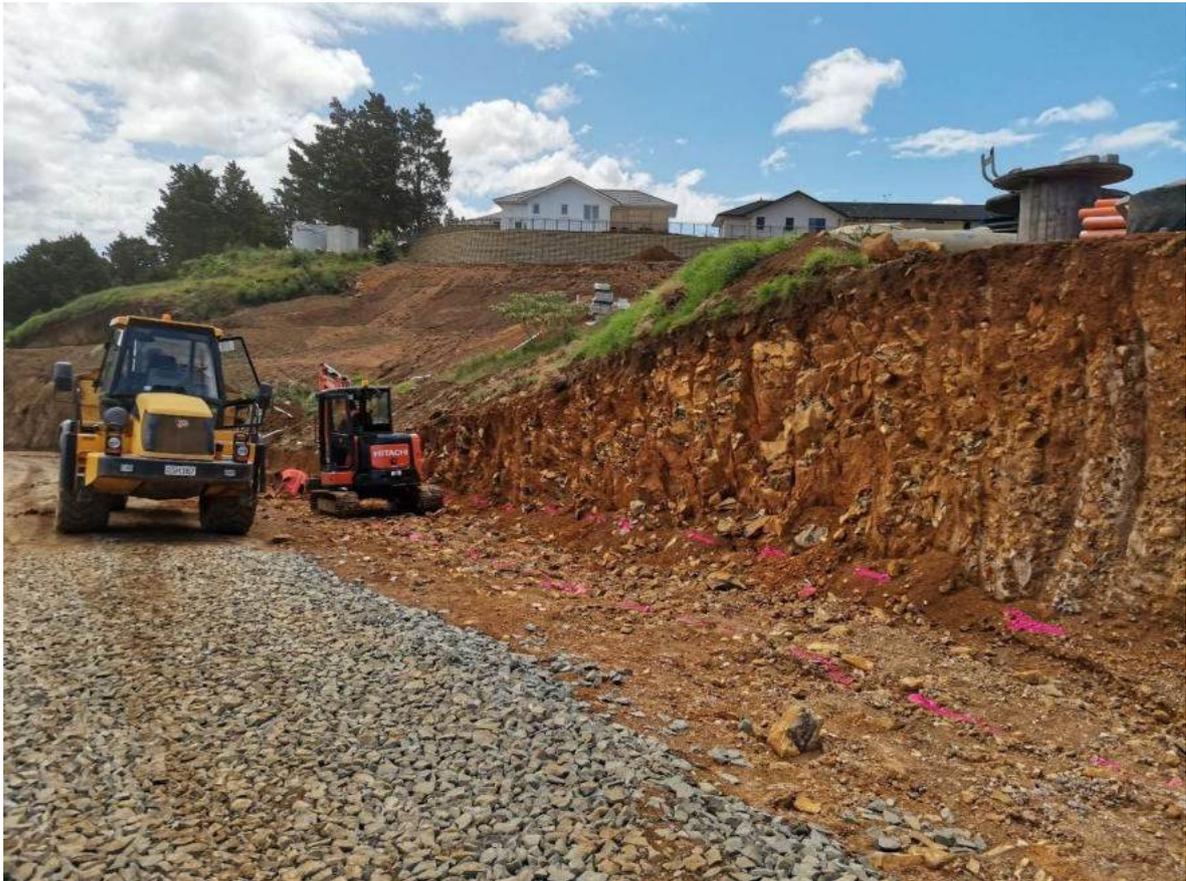
*Figure I – View north-east towards the proposed Zone C, taken during earthworks
25th February 2021*

The overlying saprolitic basalt is characterised by completely weathered columnar basalt formations. The original columnar structure remains visually identifiable, though the rock has undergone extensive chemical weathering, resulting in a soft, clay-rich matrix. Within this matrix, numerous basalt boulders were observed, preserved as core stones amidst the saprolitic material. These boulders vary in size and are embedded within a fine-grained soil matrix, which appears to have infilled the spaces between columns and fractures. This can be observed in Figure F below, taken during bulk earthworks, prior to the construction of the timber crib retaining wall.

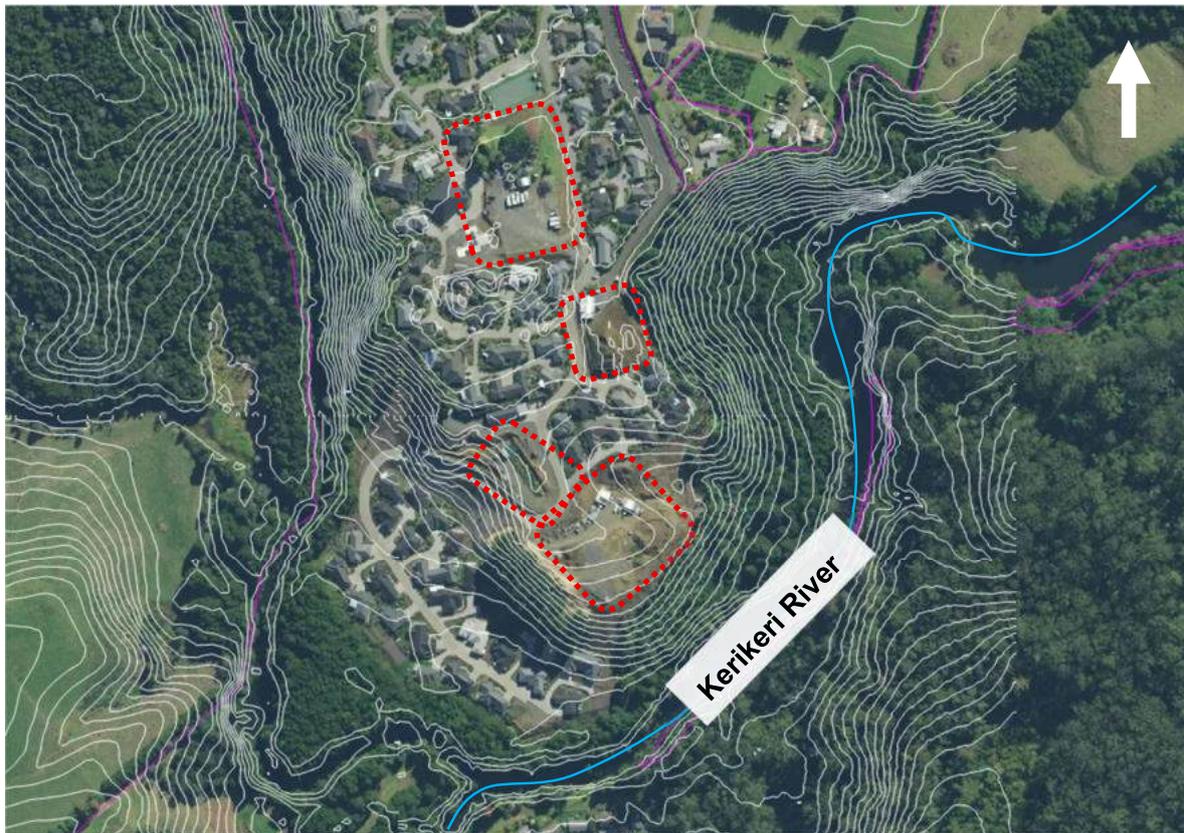
Figure J: Aerial of subject QRCC development area and the surrounding slopes (Source: 2024 LINZ Basemaps Imagery, Northland LiDAR - pre-development 2.0m, contours, using QGIS). Zones depicted A, B, C and D, read down the page, in red dashed lines

The subject property, forming part of the wider QRCC development, is located on a south-facing basalt plateau (or basalt flow), with the Kerikeri River bordering the eastern and southern boundaries as it flows southward. Refer to Figure F below, noting that the LiDAR-derived topographical contours represent conditions prior to bulk earthworks in Stage 5, while the aerial imagery is from 2024.

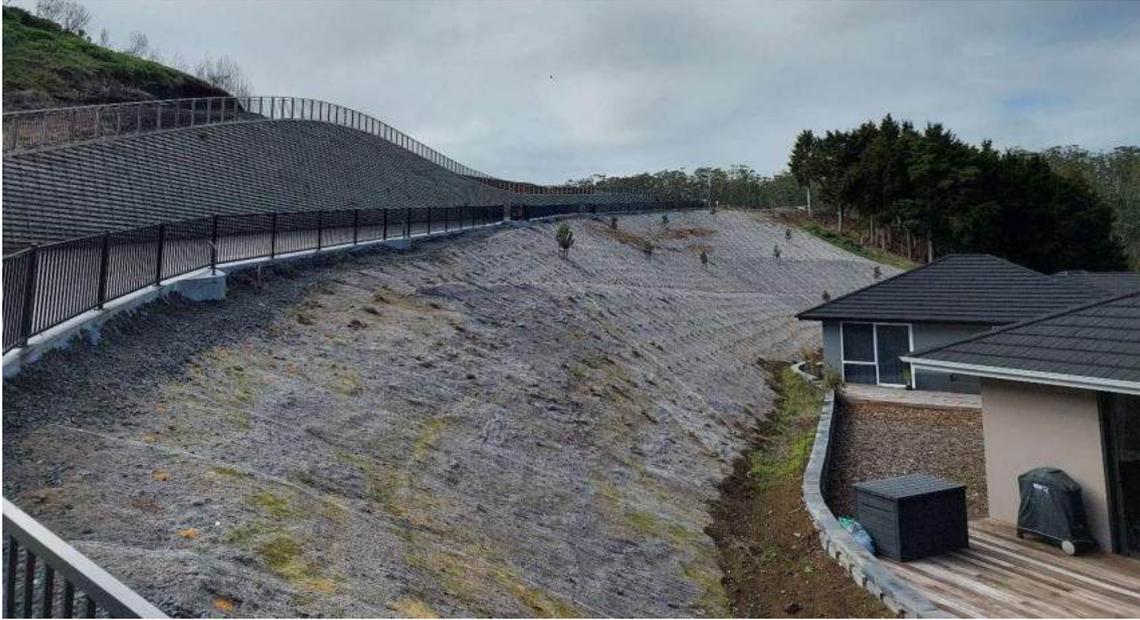
Figure K: View north towards Zones C and D, taken July 2023

The slopes between Cottle Way and Stage Five were treated with heavy-duty coconut matting and sparsely planted with low-lying shrubs in July 2023. Two cutoff drains were constructed parallel to the slopes to control and divert runoff from the limited catchment above. Results of a walkover assessment conducted approximately two years later, in October 2025, indicate that the vegetation has not successfully established. No slumping or erosion was observed; however, the matting has significantly degraded. See Figures G and H below for comparison.

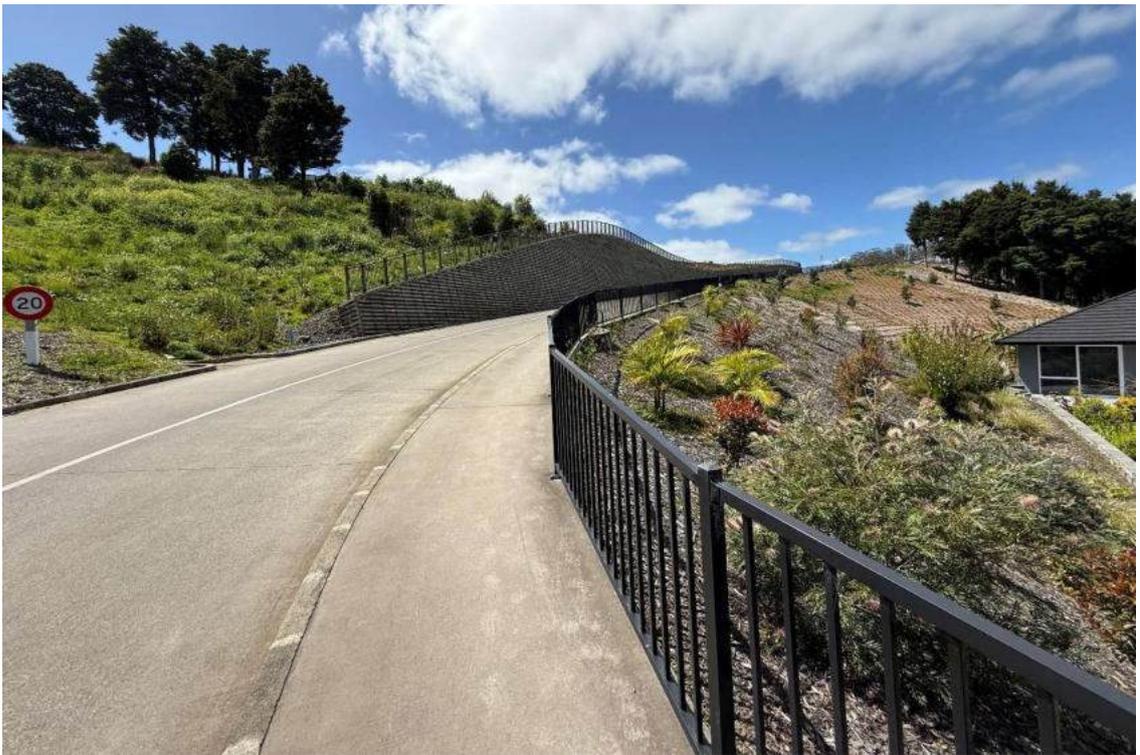
Figure L: View north towards Zones C and F taken October 2025

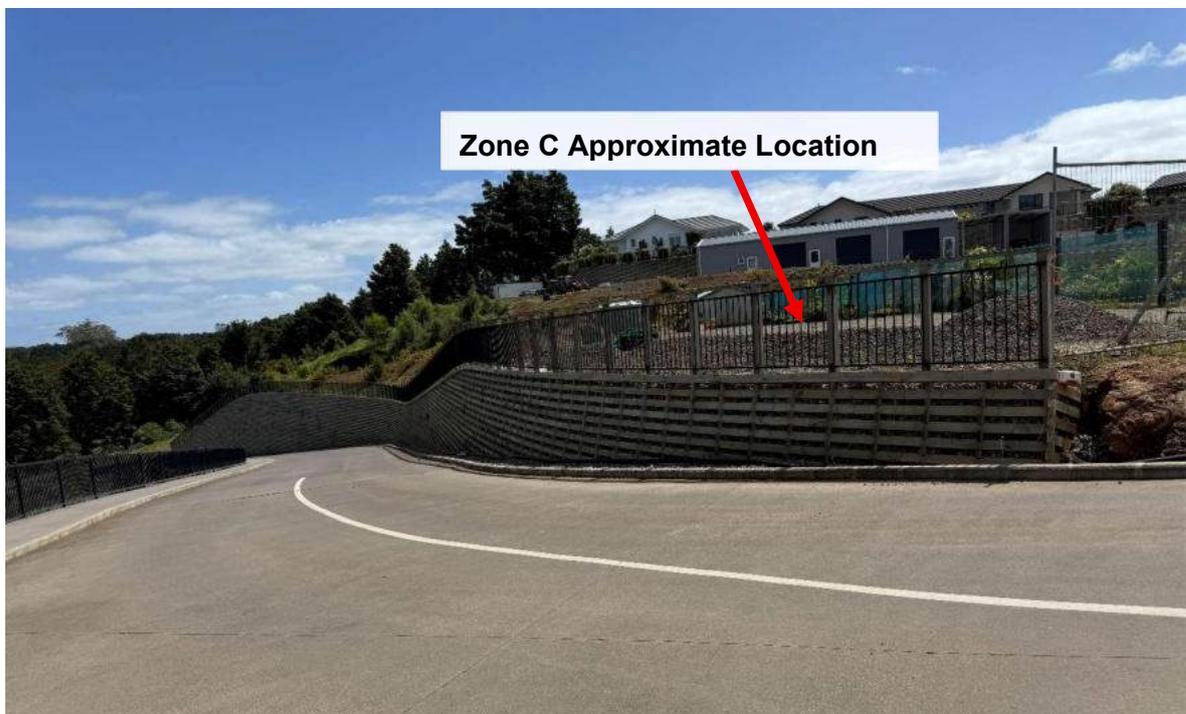
The proposed Zone C is positioned above the Stage 5 escapement and has been historically formed by a combination of excavation and filling, up to 3.0m for both. The southern boundary of these earthworks is supported by an existing timber crib retaining wall that was designed by HGEA in September 2020. This crib wall was designed to support both engineered fill and excavated soils up to 3.0m. The wall was consented and constructed in May 2021.

To the north of Zone C, there is an existing unretained excavation face, some 2.5m high, sloping at up to 1V:1H (45°). This slope shows signs of erosion and slumping, with no vegetation cover.

Figure N: view west across the existing timber crib retaining wall, and proposed Zone C. Photograph taken October 2025

The slopes over the proposed Zone C have been fully engineered, and are supported by existing retaining, to the south, with future retaining walls proposed to support the existing steep excavation batter. Therefore, no numerical analysis is considered necessary and has been undertaken.

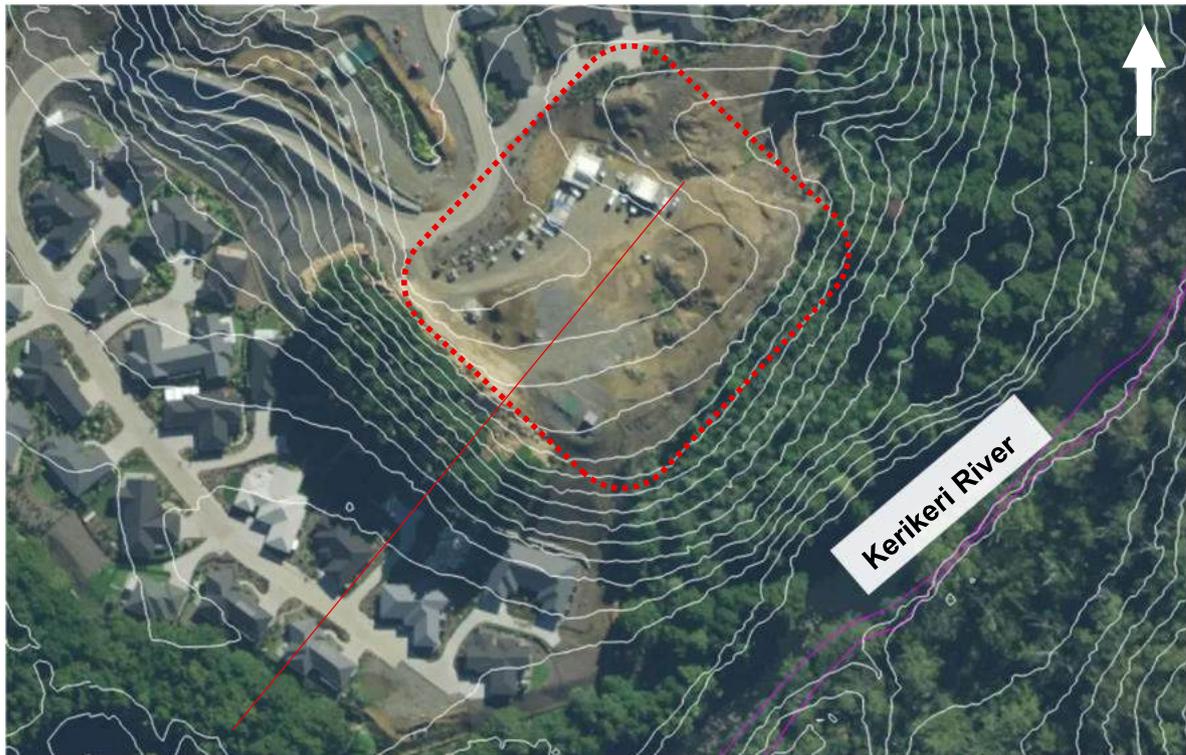
The proposed development Zone D is positioned on the southern end of the Basalt Plateau, with south-west through east trending slopes, sloping at some 22 degrees, towards the Kerikeri River, some 85 m away.

The south-western portion of the slopes is covered with mature Totara trees (Totara Grove). These trees appear to be growing true (straight), with minor bowing in the younger trees where growing at the crest / transition of the slopes. Slopes to the south-east are covered with low to medium shrubs, and native trees such as Kanuka and Manuka

Figure O: Aerial of subject Zone D development site and the surrounding slopes (Source: 2024 LINZ Basemaps Imagery, Northland LiDAR - pre-development 2.0m, contours, using QGIS). Development area in red dashed lines

Given the gradient and proximity of the steep slopes to the south through east, a numerical slope stability analysis has been undertaken for the slopes east through south of the Zone D, including the Totara Grove, using Rocscience Slide2, adopting the parameters outlined in Section 6.3 above. This analysis is undertaken to determine suitable setbacks of future development in Zone D from the crest of these slopes.

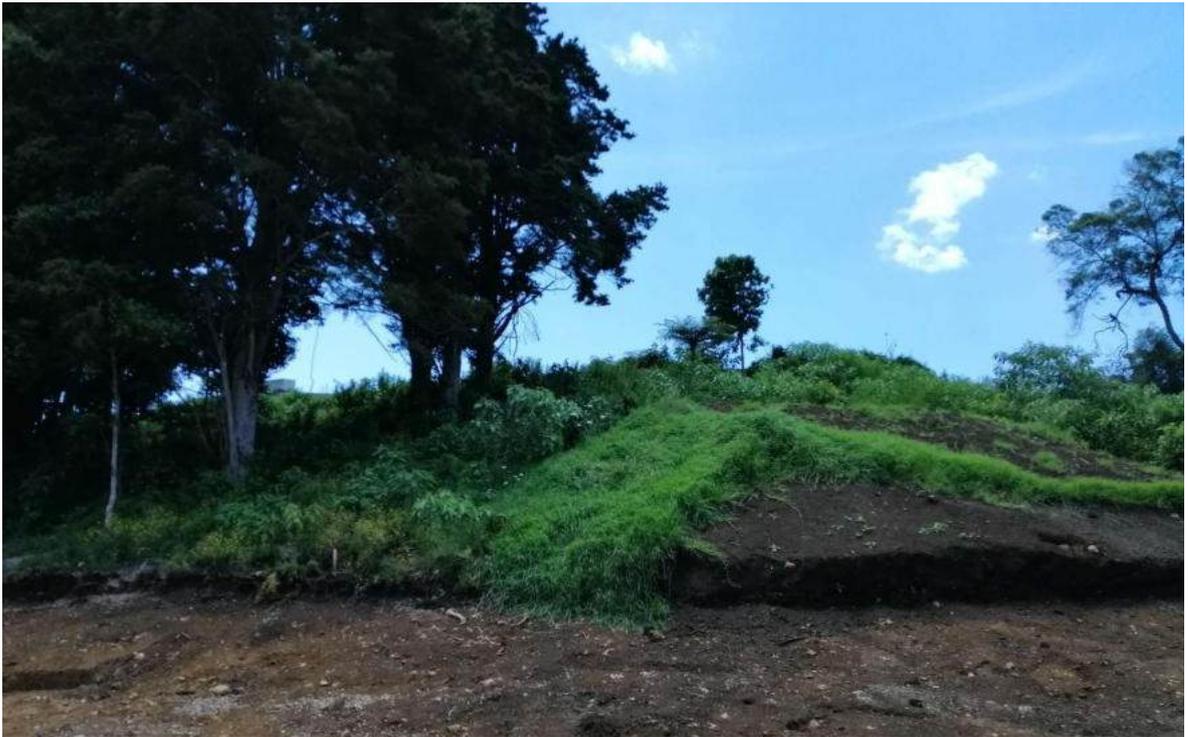
Figure P: View north towards Zone D, showing fill over slopes east of the Totara Grove. Taken 22.11.2021

The slopes to the east of the Totara Grove have historically had uncontrolled fill placed over them. Inspection by HGEA in September 2021, instructed the fill to be removed, and the slopes graded to not steeper than 1V:2H. Inspection again in November 2022 saw this work completed. See Figures L and M below.

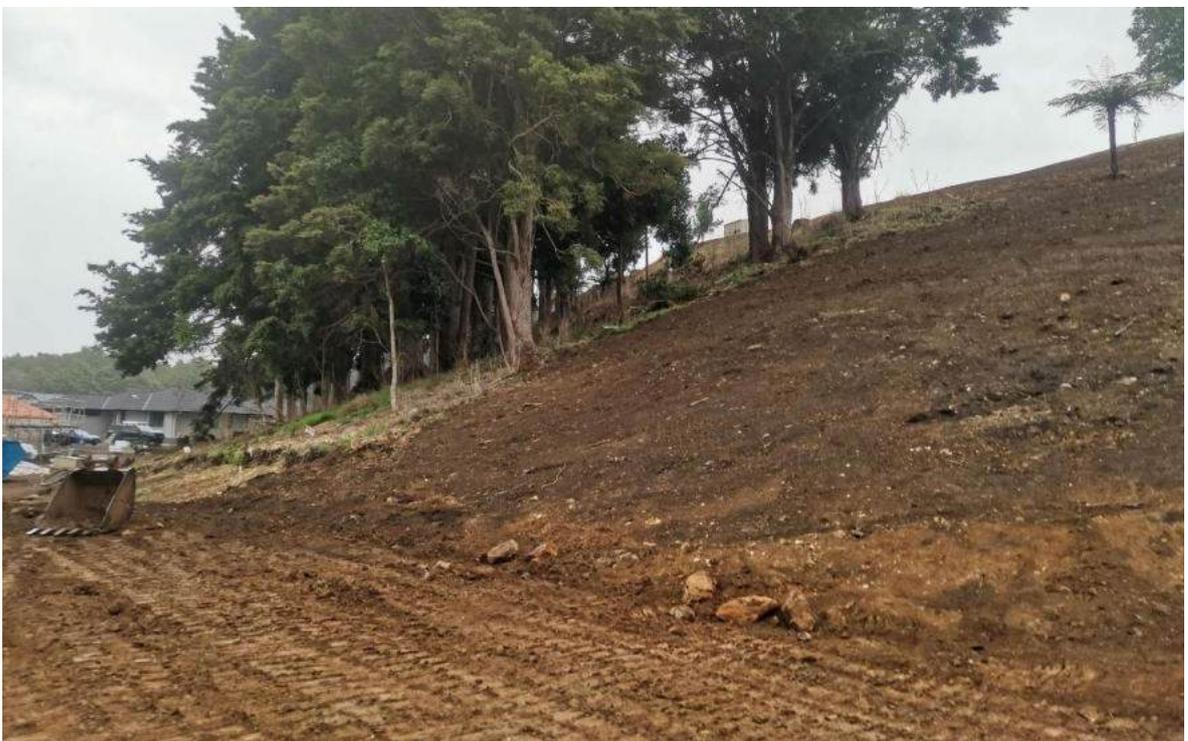
Figure Q: View north-west towards Zone D, showing re-contoured over slopes east of the Totara Grove. Taken 15.11.2022

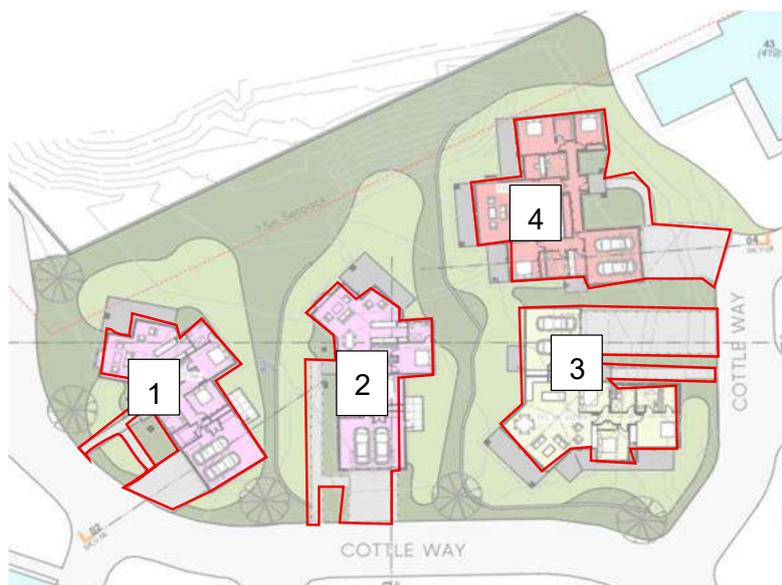
The stormwater catchments of Zone B consist of four proposed villas and their adjoining driveways.

Figure S: Zone B with four villas

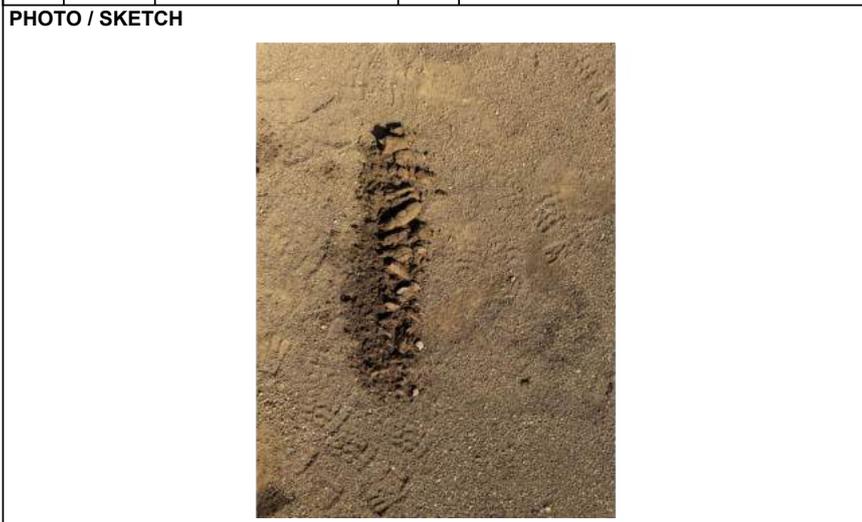
DEPTH (m)	SCALA (Blows / 100mm)	TESTS	GRAPHIC LOG	MATERIAL DESCRIPTION	WATER	DEPTH (m)
		SV = 190+ kPa (Geo 3928)		Clayey SILT, with trace gravel; brown. Very stiff; low plasticity; moist; gravel, fine; Fill.	Groundwater Not Encountered	
		SV = 190+ kPa (Geo 3928)				
		SV = UTP (Geo 3928)				0.90 EOH: 0.90m 0.9m: EOH: Well Compacted Fill.

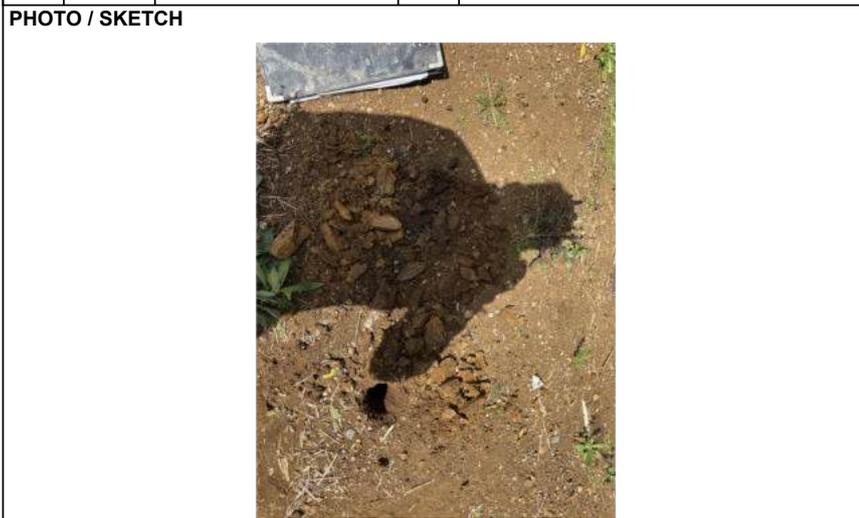
DEPTH (m)	SCALA (Blows / 100mm)	TESTS	GRAPHIC LOG	MATERIAL DESCRIPTION	WATER	DEPTH (m)
0				Clayey SILT, with trace gravel; brown. Very stiff; non-plastic; moist; gravel, fine; Fill.		
0.5		SV = 41 / 14 kPa (Geo 3928)			Groundwater Not Encountered	
1.0		SV = 41 / 14 kPa (Geo 3928)				
1.5		SV = 47 / 14 kPa (Geo 3928)				
2.0		SV = 163 / 27 kPa (Geo 3928)	1.2m: Stiff.			
2.5		SV = 149 / 14 kPa (Geo 3928)				
3.0		SV = 156 / 14 kPa (Geo 3928)				
3.5		SV = 163 / 14 kPa (Geo 3928)	2.50 EOH: 2.50m 2.5m: EOH: Unable to Penetrate.

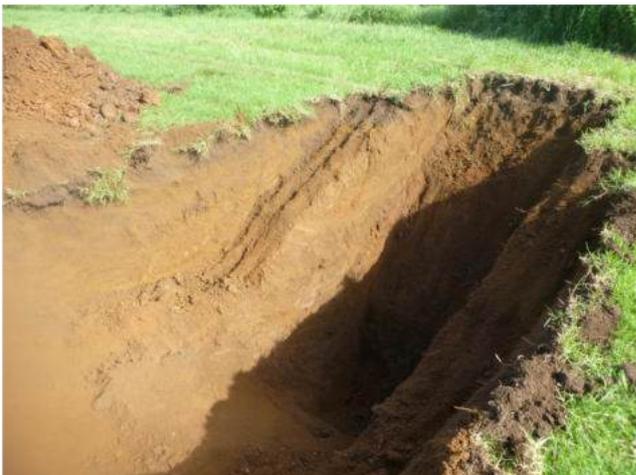
PHOTO / SKETCH

DEPTH (m)	SCALA (Blows / 100mm)	TESTS	GRAPHIC LOG	MATERIAL DESCRIPTION	WATER	DEPTH (m)
0 1 2 3		SV = 86 / 22 kPa (GEO287) SV = 184 / 22 kPa (GEO287) SV = UTP (GEO287) SV = 222+ kPa (GEO287) SV = 159 / 63 kPa (GEO287) SV = 111 / 63 kPa (GEO287)		Clayey SILT TOPSOIL, dark brown, moist, highly plastic, rootlets. 0.20	Groundwater Not Encountered	
				Clayey SILT (MH) brown, dry, highly plastic, very stiff, floury.		
				1.4m: - beginning to see moderately weathered scoria and andesitic boulders MPS 200mm.		
				2.5m: - becoming wet		
				3.00 EOH: 3.00m

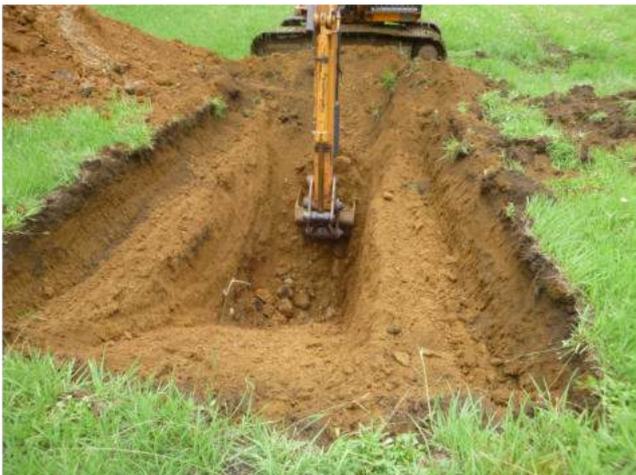
PHOTO / SKETCH

DEPTH (m)	SCALA (Blows / 100mm)	TESTS	GRAPHIC LOG	MATERIAL DESCRIPTION	WATER	DEPTH (m)
0.10		SV = 127 / 35 kPa (GEO287)		Clayey SILT TOPSOIL, dark brown, moist, highly plastic, rootlets. Clayey SILT (MH) reddish brown, moist, very stiff, floury.	Groundwater Not Encountered	
1.0m		SV = 155 / 43 kPa (GEO287)		1.0m: - becoming wet		
1.50				Well graded sandy clayey GRAVEL, whitish grey speckled orange matrix with dark grey rounded boulders and gravels, MPS 700mm, excavator struggling.		
2.50				EOH: 2.50m

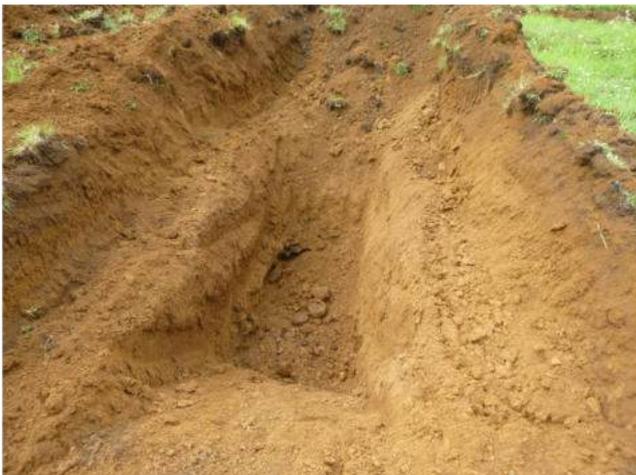
PHOTO / SKETCH

DEPTH (m)	SCALA (Blows / 100mm)	TESTS	GRAPHIC LOG	MATERIAL DESCRIPTION	WATER	DEPTH (m)
0.10		SV = UTP (GEO287)	[Symbol]	Clayey SILT TOPSOIL, dark brown, moist, highly plastic, rootlets.	Groundwater Not Encountered	
				Clayey SILT (MH), reddish brown, moist, highly plastic, very stiff, floury.		
1.0m		SV = 127 / 22 kPa (GEO287)	[Symbol]	1.0m: - becoming wet		
		SV = 108 / 38 kPa (GEO287)	[Symbol]			
2.0m		SV = 92 / 48 kPa (GEO287)	[Symbol]			
			[Symbol]	2.50 Well graded sandy clayey GRAVEL, whitish grey speckled orange matrix with dark grey rounded boulders and gravels, MPS 700mm, excavator struggling.		
3.0m			[Symbol]	3.00 EOH: 3.00m

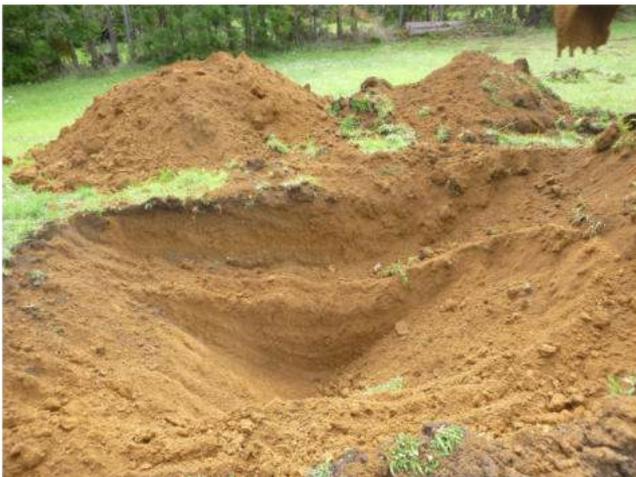
PHOTO / SKETCH

DEPTH (m)	SCALA (Blows / 100mm)	TESTS	GRAPHIC LOG	MATERIAL DESCRIPTION	WATER	DEPTH (m)
0 1 2 3		SV = UTP (GEO287)		0.10 Clayey SILT TOPSOIL, dark brown, moist, highly plastic, rootlets. Clayey SILT (MH) reddish brown, moist, highly plastic, very stiff, floury.	Groundwater Not Encountered	
		SV = UTP (GEO287)		2.0m: - becoming wet		
		SV = 146 / 44 kPa (GEO287)				
		SV = 79 / 22 kPa (GEO287)				
				2.90 Well graded sandy clayey GRAVEL, whitish grey speckled orange matrix with dark grey rounded boulders and gravels, MPS 700mm, excavator struggling.		
				3.50 EOH: 3.50m

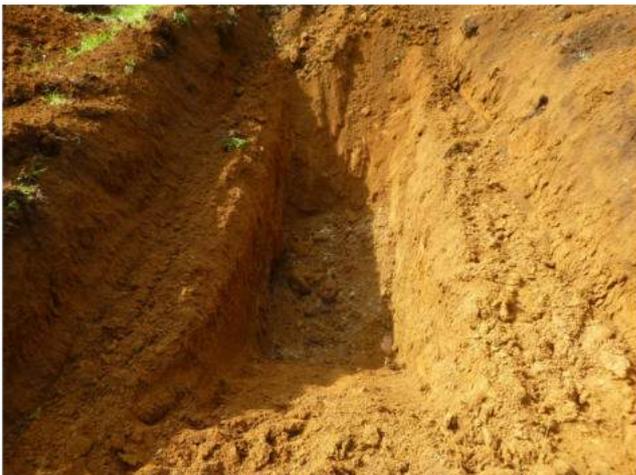
PHOTO / SKETCH

DEPTH (m)	SCALA (Blows / 100mm)	TESTS	GRAPHIC LOG	MATERIAL DESCRIPTION	WATER	DEPTH (m)
1		SV = 159 / 22 kPa (GEO287)		0.10 Clayey SILT TOPSOIL, dark brown, moist, highly plastic, rootlets.	Groundwater Not Encountered	
				Clayey SILT (MH), reddish brown, moist, highly plastic, very stiff, floury.		
				1.0m: -becoming more greyish brown speckled orange and wet		
2		SV = UTP (GEO287)		2.00 Well graded sandy clayey GRAVEL, whitish grey speckled orange matrix with dark grey rounded boulders and gravels, MPS 700mm, excavator struggling.		
				2.50 EOH: 3.00m		
3		SV = 82 / 38 kPa (GEO287)

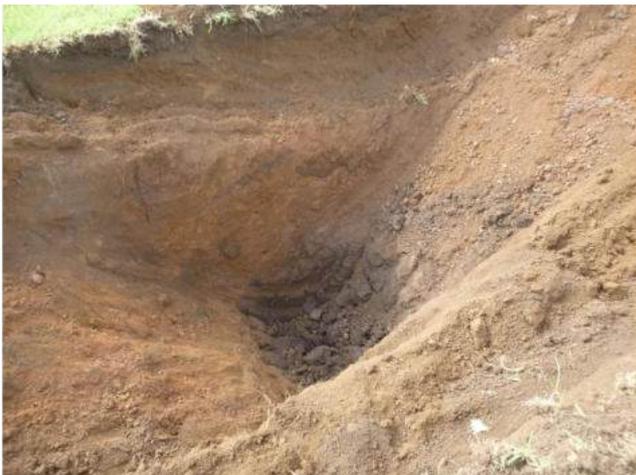
PHOTO / SKETCH

DEPTH (m)	SCALA (Blows / 100mm)	TESTS	GRAPHIC LOG	MATERIAL DESCRIPTION	WATER	DEPTH (m)
0 1 2 3		SV = 111 / 32 kPa (GEO287)		0.10 Clayey SILT TOPSOIL, dark brown, moist, highly plastic, rootlets.	Groundwater Not Encountered	
				Clayey SILT (MH) brown, moist, highly plastic, minor gravels MPS 80mm (completely weathered Andesite), floury.		
				0.70 Clayey SILT (MH) with gravels, brownish grey, moist, highly plastic, MPS 80mm (completely weathered Andesite).		
		SV = UTP (GEO287)				
		SV = UTP (GEO287)				
		SV = 159 / 51 kPa (GEO287)				
		SV = 159 / 48 kPa (GEO287)		2.70 EOH: 2.70m

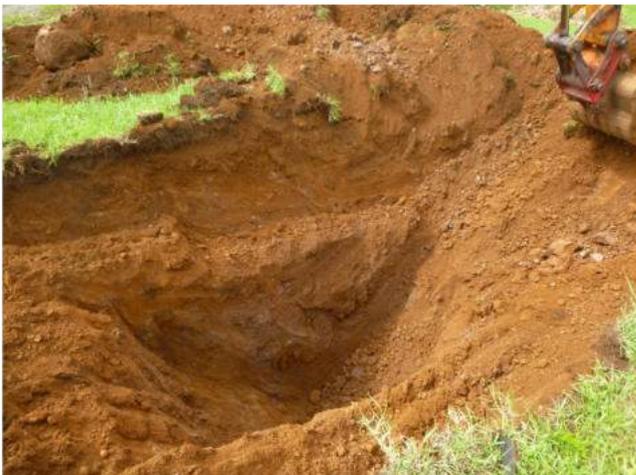
PHOTO / SKETCH

DEPTH (m)	SCALA (Blows / 100mm)	TESTS	GRAPHIC LOG	MATERIAL DESCRIPTION	WATER	DEPTH (m)
0.20				Clayey SILT TOPSOIL, dark brown, moist, highly plastic, rootlets.	Groundwater Not Encountered	
		SV = 174 / 25 kPa (GEO287)		Clayey SILT with gravels, dark brown, moist, highly plastic, MPS 180mm (completely weathered Andesite), floury.		
1		SV = 206 / 82 kPa (GEO287)				
		SV = 162 / 48 kPa (GEO287)				
2		SV = 127 / 63 kPa (GEO287)				
		SV = 159 / 79 kPa (GEO287)		2.5m: - becoming dark greyish brown		
3				3.00 EOH: 3.00m

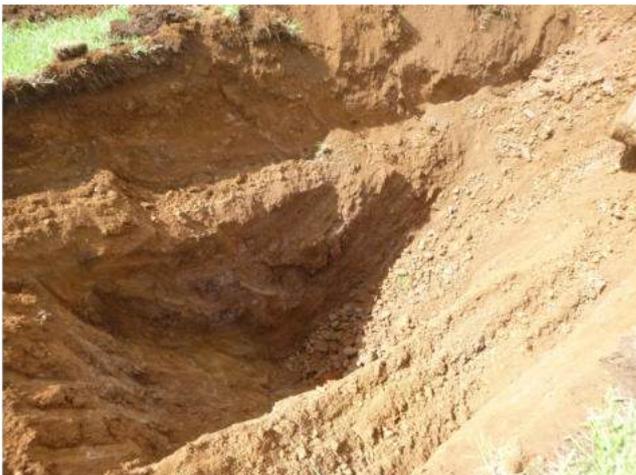
PHOTO / SKETCH

DEPTH (m)	SCALA (Blows / 100mm)	TESTS	GRAPHIC LOG	MATERIAL DESCRIPTION	WATER	DEPTH (m)
0.15			TS	Clayey SILT TOPSOIL, dark brown, moist, highly plastic, rootlets.	Groundwater Not Encountered	
		SV = 111 / 32 kPa (GEO287)		CLayey SILT (MH), brown, moist, highly plastic, very stiff, floury.		
1.0m				1.0m: - beginning to encounter trace boulders MPS 650mm, lots of smaller andesite boulders 50-100mm.		
3.00				EOH: 3.00m

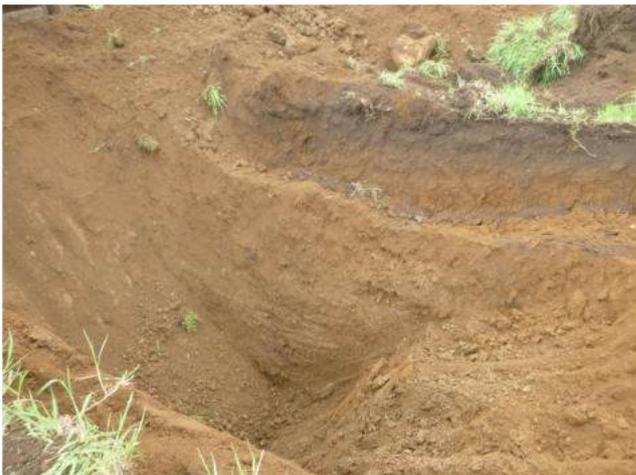
PHOTO / SKETCH

DEPTH (m)	SCALA (Blows / 100mm)	TESTS	GRAPHIC LOG	MATERIAL DESCRIPTION	WATER	DEPTH (m)
0.20			TS TS	Clayey SILT TOPSOIL, dark brown, moist, highly plastic, rootlets.	Groundwater Not Encountered	
		SV = 95 / 38 kPa (GEO287)		Clayey SILT (MH), brown, moist, highly plastic, very stiff, floury.		
1.0m				1.0m: -beginning to encounter gravels and few boulders, MPS 500mm.		
3.00				EOH: 3.00m

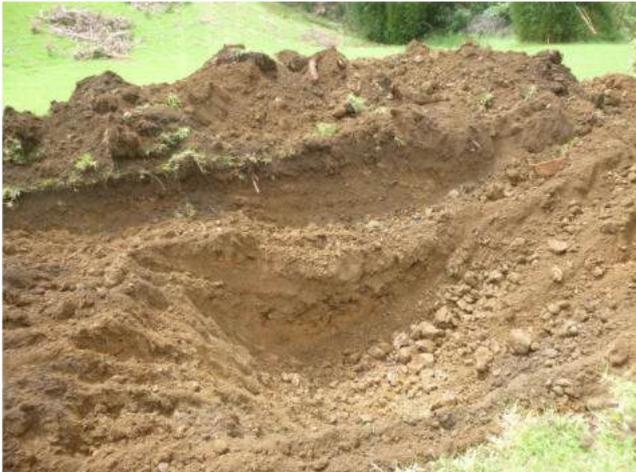
PHOTO / SKETCH

DEPTH (m)	SCALA (Blows / 100mm)	TESTS	GRAPHIC LOG	MATERIAL DESCRIPTION	WATER	DEPTH (m)
0			TS TS	0.20 Clayey SILT TOPSOIL, dark brown, moist, highly plastic, rootlets.		
				Clayey SILT (MH) brown, moist, highly plastic, very stiff, floury.		
1		SV = 111 / 32 kPa (GEO287)		0.5m: - beginning to encounter gravels and few boulders, MPS 500mm.	Groundwater Not Encountered	
2						
3				3.00 EOH: 3.00m		
4

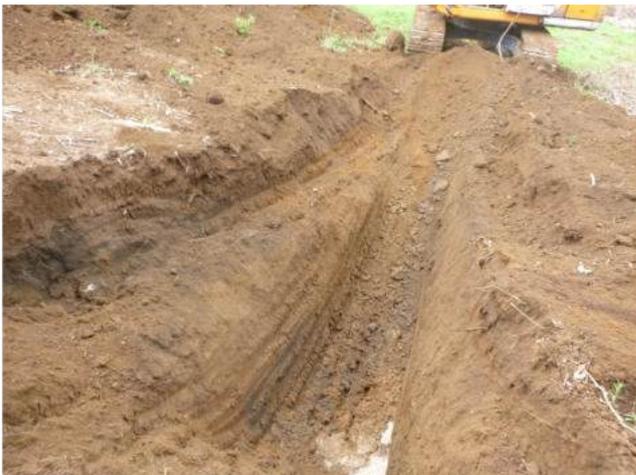
PHOTO / SKETCH

DEPTH (m)	SCALA (Blows / 100mm)	TESTS	GRAPHIC LOG	MATERIAL DESCRIPTION	WATER	DEPTH (m)
0 1 2 3 4				0.30 Clayey SILT FILL with gravel and coarse organics (roots and branches) 50-80mm, MPS 40mm.	Groundwater Not Encountered	
				0.40 Clayey SILT TOPSOIL, dark brown, moist, highly plastic, rootlets. Clayey SILT (MH) brown, moist, highly plastic, very stiff, floury.		
				0.9m: beginning to encounter gravels and few boulders, MPS 400mm.		
				2.50 Clayey SILT with gravels and few boulders, dark greyish brown, moist, highly plastic, very stiff.		
				3.00 EOH: 3.00m
