Application for resource consent or fast-track resource consent

Name/s:	Quail Ridge Country Club c/o Pete Lawrence	
Email:	[REDACTED]	
Phone number:	Work [REDACTED]	Home
Postal address: (or alternative method of service under section 352 of the act)	82 Rainbow Falls Road, Kerikeri	
	[REDACTED]	
	[REDACTED]	
	Postcode 247

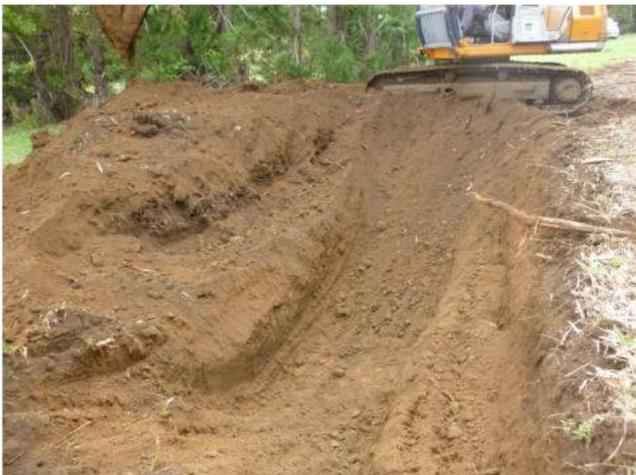
PHOTO / SKETCH

DEPTH (m)	SCALA (Blows / 100mm)	TESTS	GRAPHIC LOG	MATERIAL DESCRIPTION	WATER	DEPTH (m)
0.00			0.10	Clayey SILT TOPSOIL, dark brown, moist, highly plastic, rootlets.	Groundwater Not Encountered	0.00
0.10			0.1m	Clayey SILT (MH) brown, moist, highly plastic, very stiff, floury		0.10
0.50		SV = UTP (GEO287)	0.5m	- beginning to encounter boulders and completely weathered gravels MPS 300mm.		0.50
1.00		SV = UTP (GEO287)				1.00
2.00		SV = UTP (GEO287)			2.00	
3.00		SV = UTP (GEO287)	3.00	EOH: 3.00m	3.00	
4.00					4.00

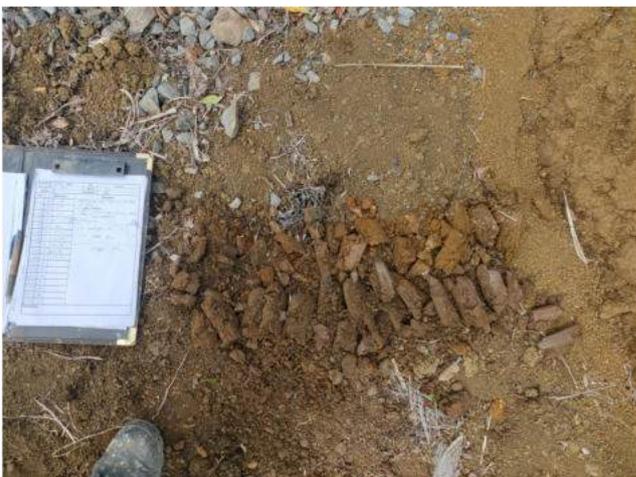
PHOTO / SKETCH

DEPTH (m)	SCALA (Blows / 100mm)	TESTS	GRAPHIC LOG	MATERIAL DESCRIPTION	WATER	DEPTH (m)	
0		SV = UTP (GEO287)		SILT, with minor clay and sand; dark orange brown. Hard; non-plastic; dry; sand, fine to medium; (Weathered Tuff) (logged observing the cut face).	Groundwater Not Encountered	0	
1		SV = UTP (0)		0.8m: reddish orange			1
1		SV = UTP (0)		1.2m: started drilling borehole			1
2		SV = UTP (0)				SILT, with minor clay and sand; reddish orange. Hard; non-plastic; moist; sand, fine to medium;	2
2		SV = 233+ kPa (0)					2
2		SV = 233+ kPa (0)					2
3		SV = 199 / 116 kPa (0)					3
3		SV = 233 / 130 kPa (0)		2.5m: dark grey brown			3
3		SV = 213 / 133 kPa (0)		2.7m: purple grey			3
4		SV = 203 / 125 kPa (0)					4
4		SV = 183 / 110 kPa (0)	3.50 EOH: 3.50m		4

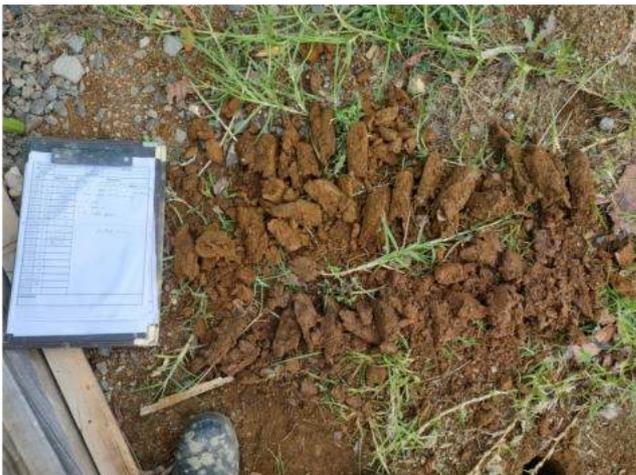
PHOTO / SKETCH

DEPTH (m)	SCALA (Blows / 100mm)	TESTS	GRAPHIC LOG	MATERIAL DESCRIPTION	WATER	DEPTH (m)
0 1 2 3 4		SV = 33 / 13 kPa (0)	[Cross-hatched pattern]	SILT, with minor clay and sand; dark orange. Firm; non-plastic; moist; sand, fine to medium; (Fill).	Groundwater Not Encountered	
		SV = 100 / 40 kPa (0)		0.80		
		SV = 233+ kPa (0)	[Dotted pattern]	SILT, with minor clay and sand; dark orange. Hard; non-plastic; moist; (Weathered Tuff).		
		SV = UTP (0)				
		SV = 216 / 106 kPa (0)		1.5m: Very stiff.		
		SV = 169 / 133 kPa (0)		2.0m: Grey orange.		
		SV = 183 / 125 kPa (0)				
		SV = 166 / 120 kPa (0)		2.5m: Purple grey, lack streaks.		
		SV = 179 / 123 kPa (0)				
		SV = 133 / 66 kPa (0)		3.00 EOH: 3.00m

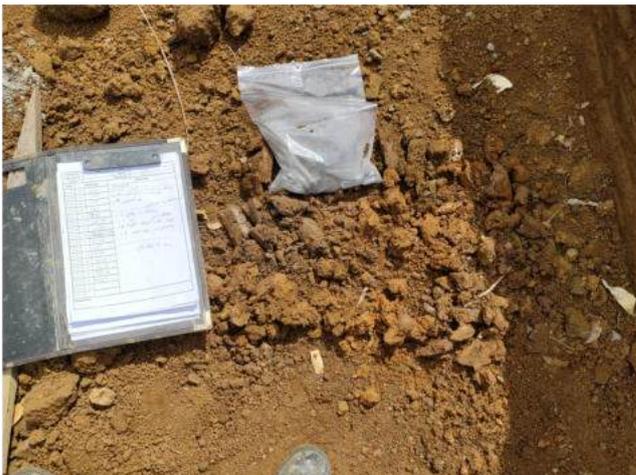
PHOTO / SKETCH

DEPTH (m)	SCALA (Blows / 100mm)	TESTS	GRAPHIC LOG	MATERIAL DESCRIPTION	WATER	DEPTH (m)
				Hardfill		
		SV = UTP (0)		SILT, with minor clay and sand; dark orange. Hard; non-plastic; moist; sand, fine to medium; (Weathered Tuff) (logged observing the cut face).		
		SV = UTP (0)		0.4m: reddish orange		
1		SV = UTP (0)		1.2m: started drilling borehole		
		SV = 233+ kPa (0)				
		SV = 199 / 95 kPa (0)		SILT, with minor clay and sand; dark orange. Hard; non-plastic; moist; sand, fine to medium;.		
2		SV = 213 / 130 kPa (0)			Groundwater Not Encountered	
		SV = 173 / 103 kPa (0)				
		SV = 169 / 113 kPa (0)		2.5m: grey, orange streaks		
		SV = 83 / 23 kPa (0)		2.7m: orange		
3		SV = UTP (0)				
		SV = 83 / 33 kPa (0)		3.2m: Purple grey, orange mottles. Stiff; wet.		
		SV = 116 / 33 kPa (0)				
4		SV = 120 / 30 kPa (0)		3.9m: dark grey, orange streaks		
		SV = 116 / 30 kPa (0)				
		SV = 83 / 40 kPa (0)		4.50 EOH: 4.50m

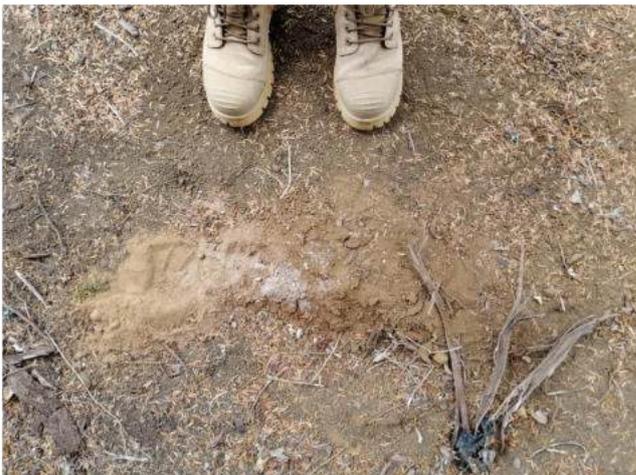
PHOTO / SKETCH

DEPTH (m)	SCALA (Blows / 100mm)	TESTS	GRAPHIC LOG	MATERIAL DESCRIPTION	WATER	DEPTH (m)
		SV = UTP (GEO952)		FILL: silty CLAY; gravel mix (MPS=40mm, sub-angular), brown, dry	Groundwater Not Encountered	
		SV = UTP (GEO952)				
		SV = UTP (GEO952)				
		SV = UTP (GEO952)				
		SV = UTP (GEO952)		0.90 EOH: 0.90m 0.9m: unable to penetrate		
1

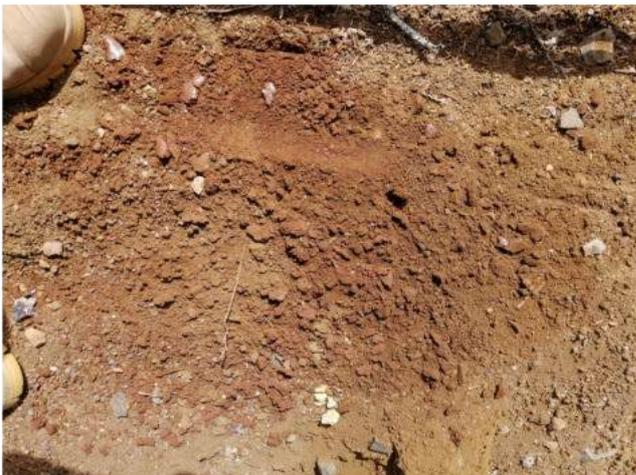
PHOTO / SKETCH

DEPTH (m)	SCALA (Blows / 100mm)	TESTS	GRAPHIC LOG	MATERIAL DESCRIPTION	WATER	DEPTH (m)
				FILL: silty CLAY; gravel mix (MPS= 40mm, well graded), brown, dry		
		SV = UTP (GEO287)				
		SV = UTP (GEO287)				
			0.50			
		SV = UTP (GEO287)		silty CLAY; reddish brown, dry, moderately plastic		
		SV = UTP (GEO287)				
1		SV = UTP (GEO287)		1.0m: some moisture		
		SV = UTP (GEO287)				
		SV = UTP (GEO287)		1.40 EOH: 1.40m		
				1.4m: unable to penetrate

Groundwater Not Encountered

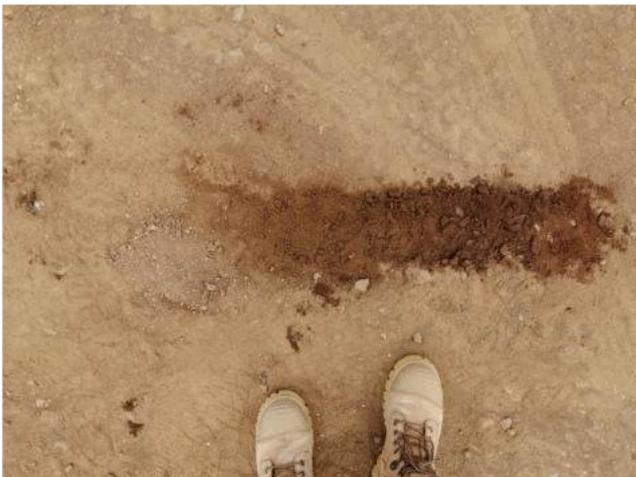
PHOTO / SKETCH

DEPTH (m)	SCALA (Blows / 100mm)	TESTS	GRAPHIC LOG	MATERIAL DESCRIPTION	WATER	DEPTH (m)
		SV = UTP (GEO952)		silty CLAY; some brown sub-angular gravel (MPS=40mm), reddish brown, dry, moderately plastic	Groundwater Not Encountered	
		SV = UTP (GEO952)				
		SV = UTP (GEO952)				
		SV = UTP (GEO952)				
1		SV = UTP (GEO952)				1.0m: unable to penetrate

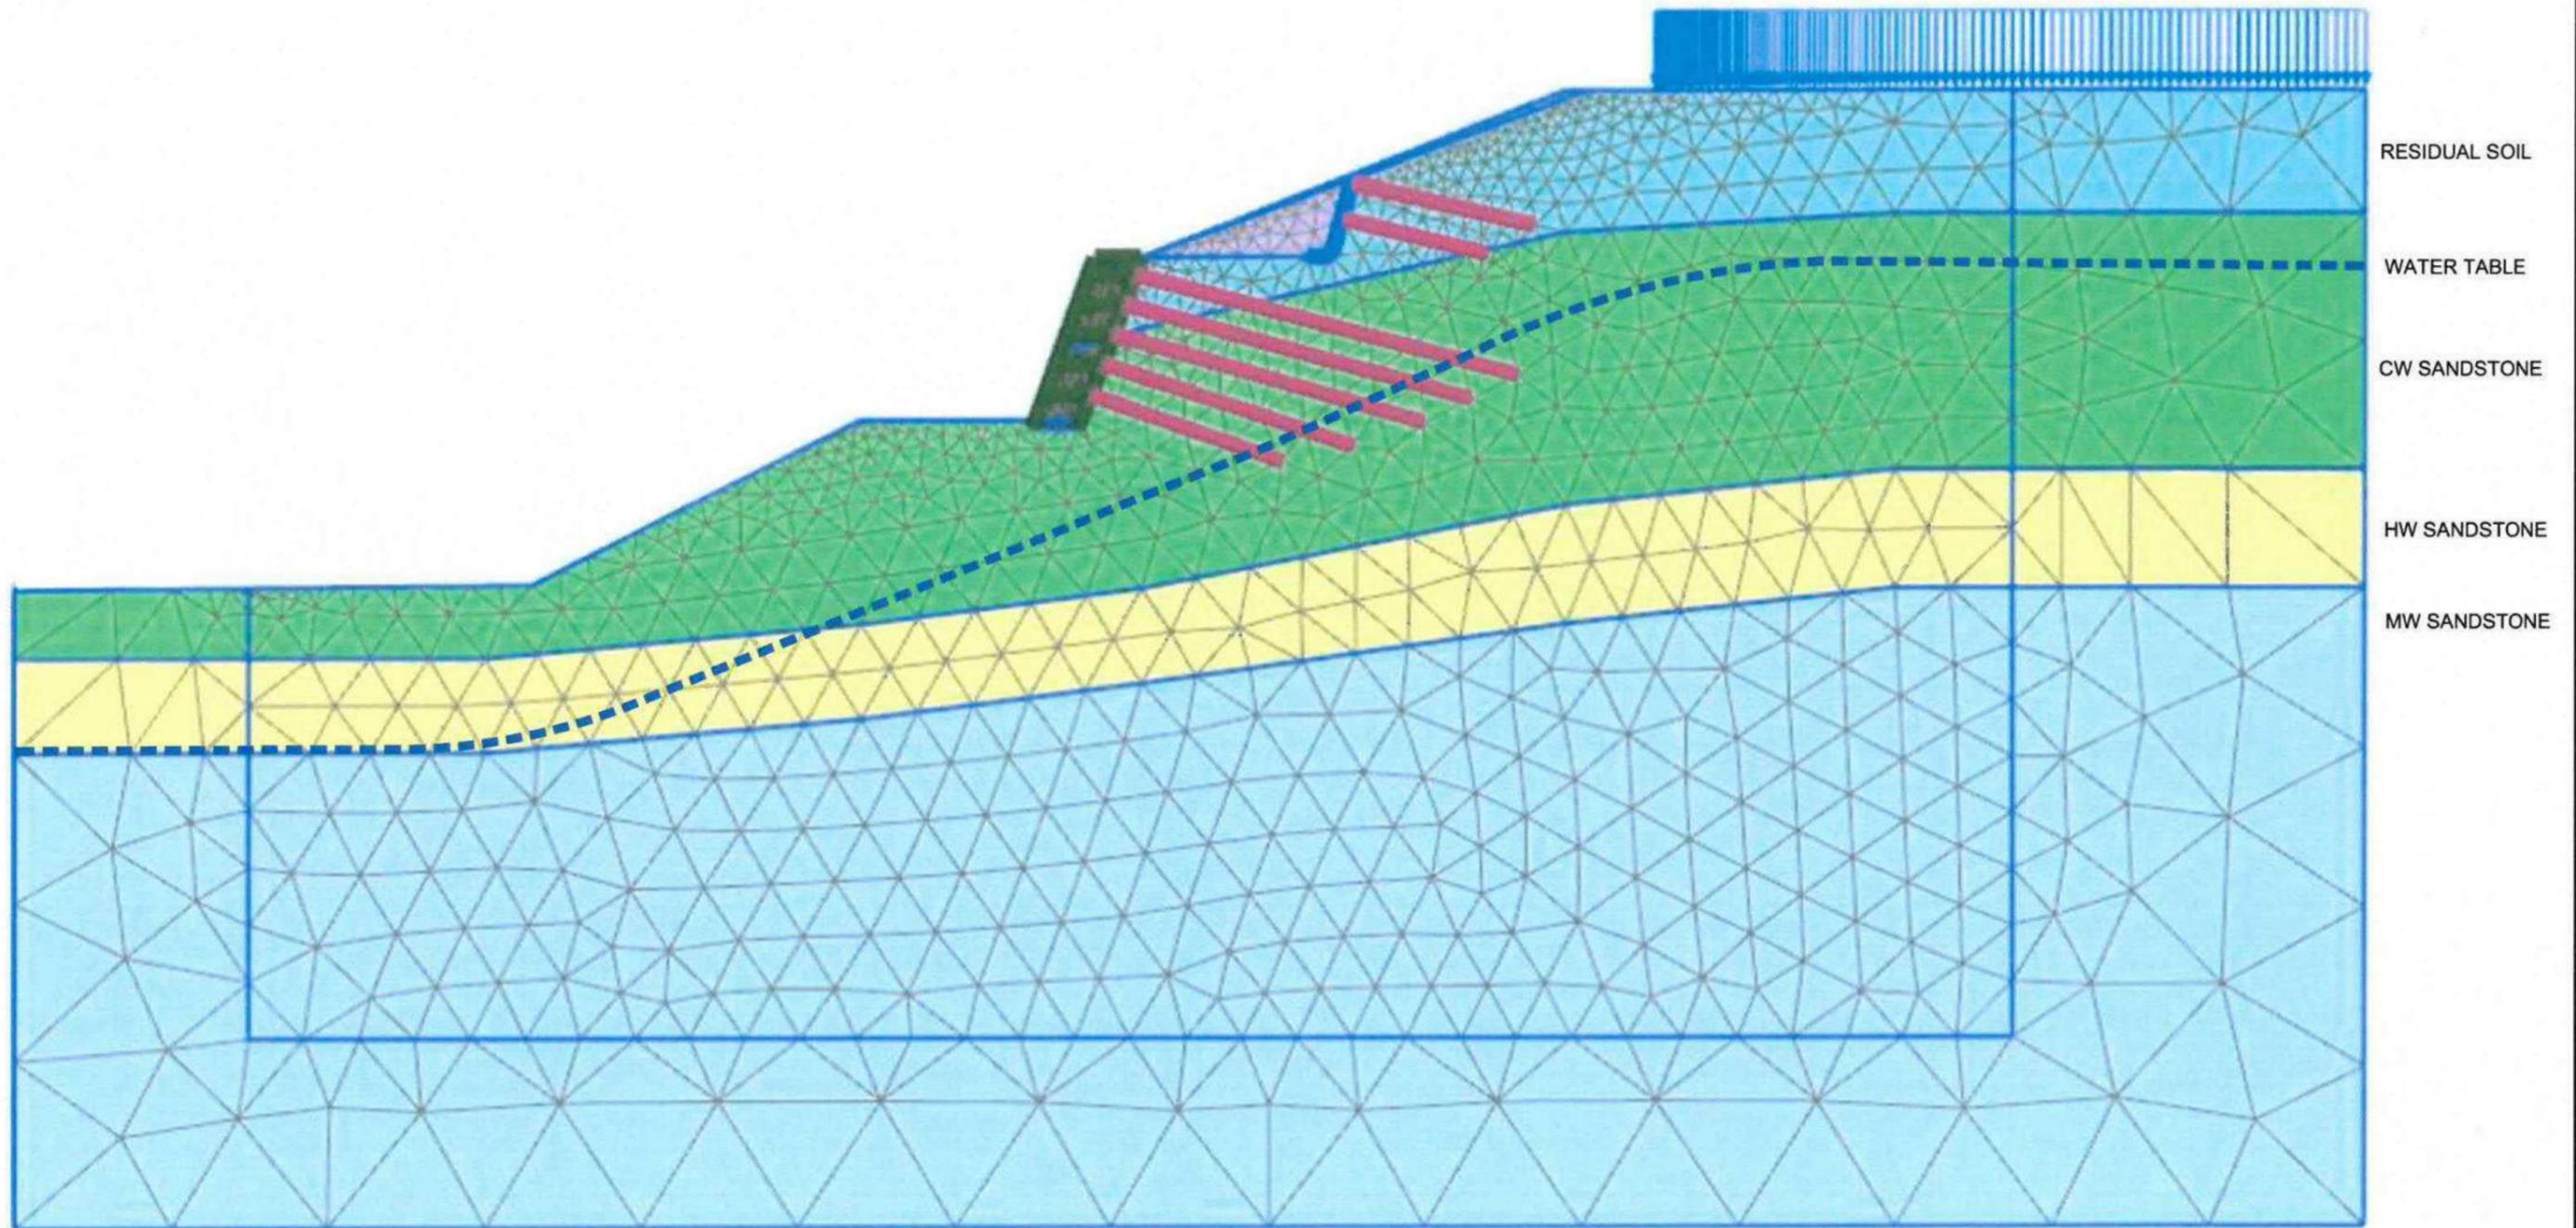
PLAXIS 2D MODEL - GLOBAL STABILITY INPUT FOR NAIL/CRIB COMPOSITE WALL ANALYSIS
 NOT TO SCALE

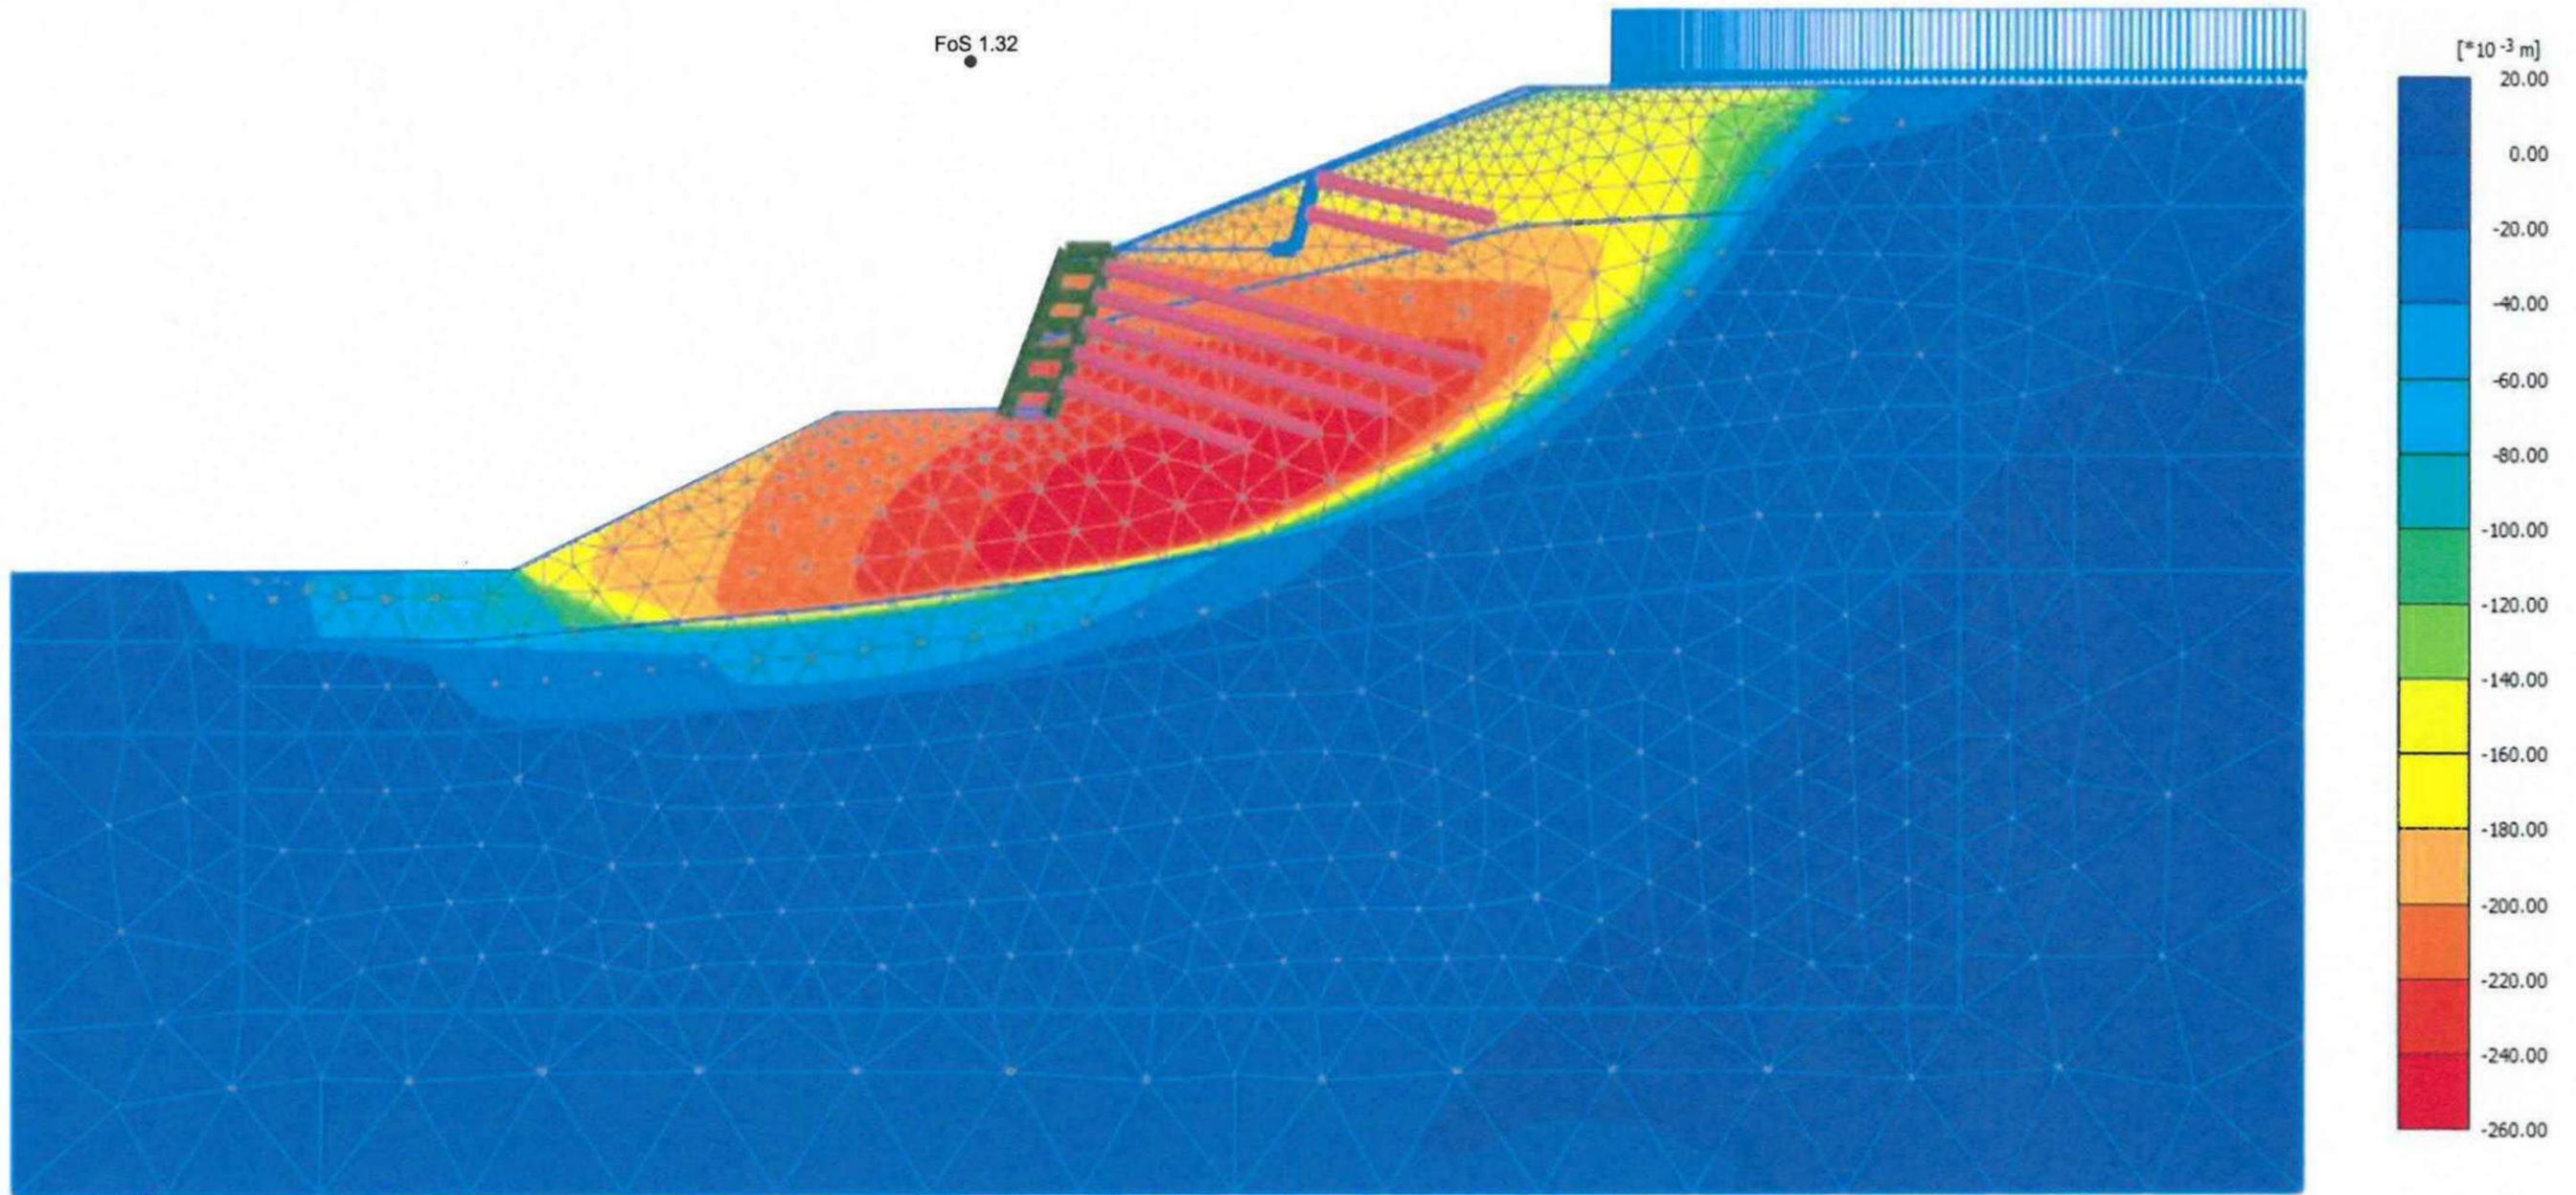
PLAXIS 2D MODEL - GLOBAL STABILITY OUTPUT FOR NAIL/CRIB COMPOSITE WALL ANALYSIS

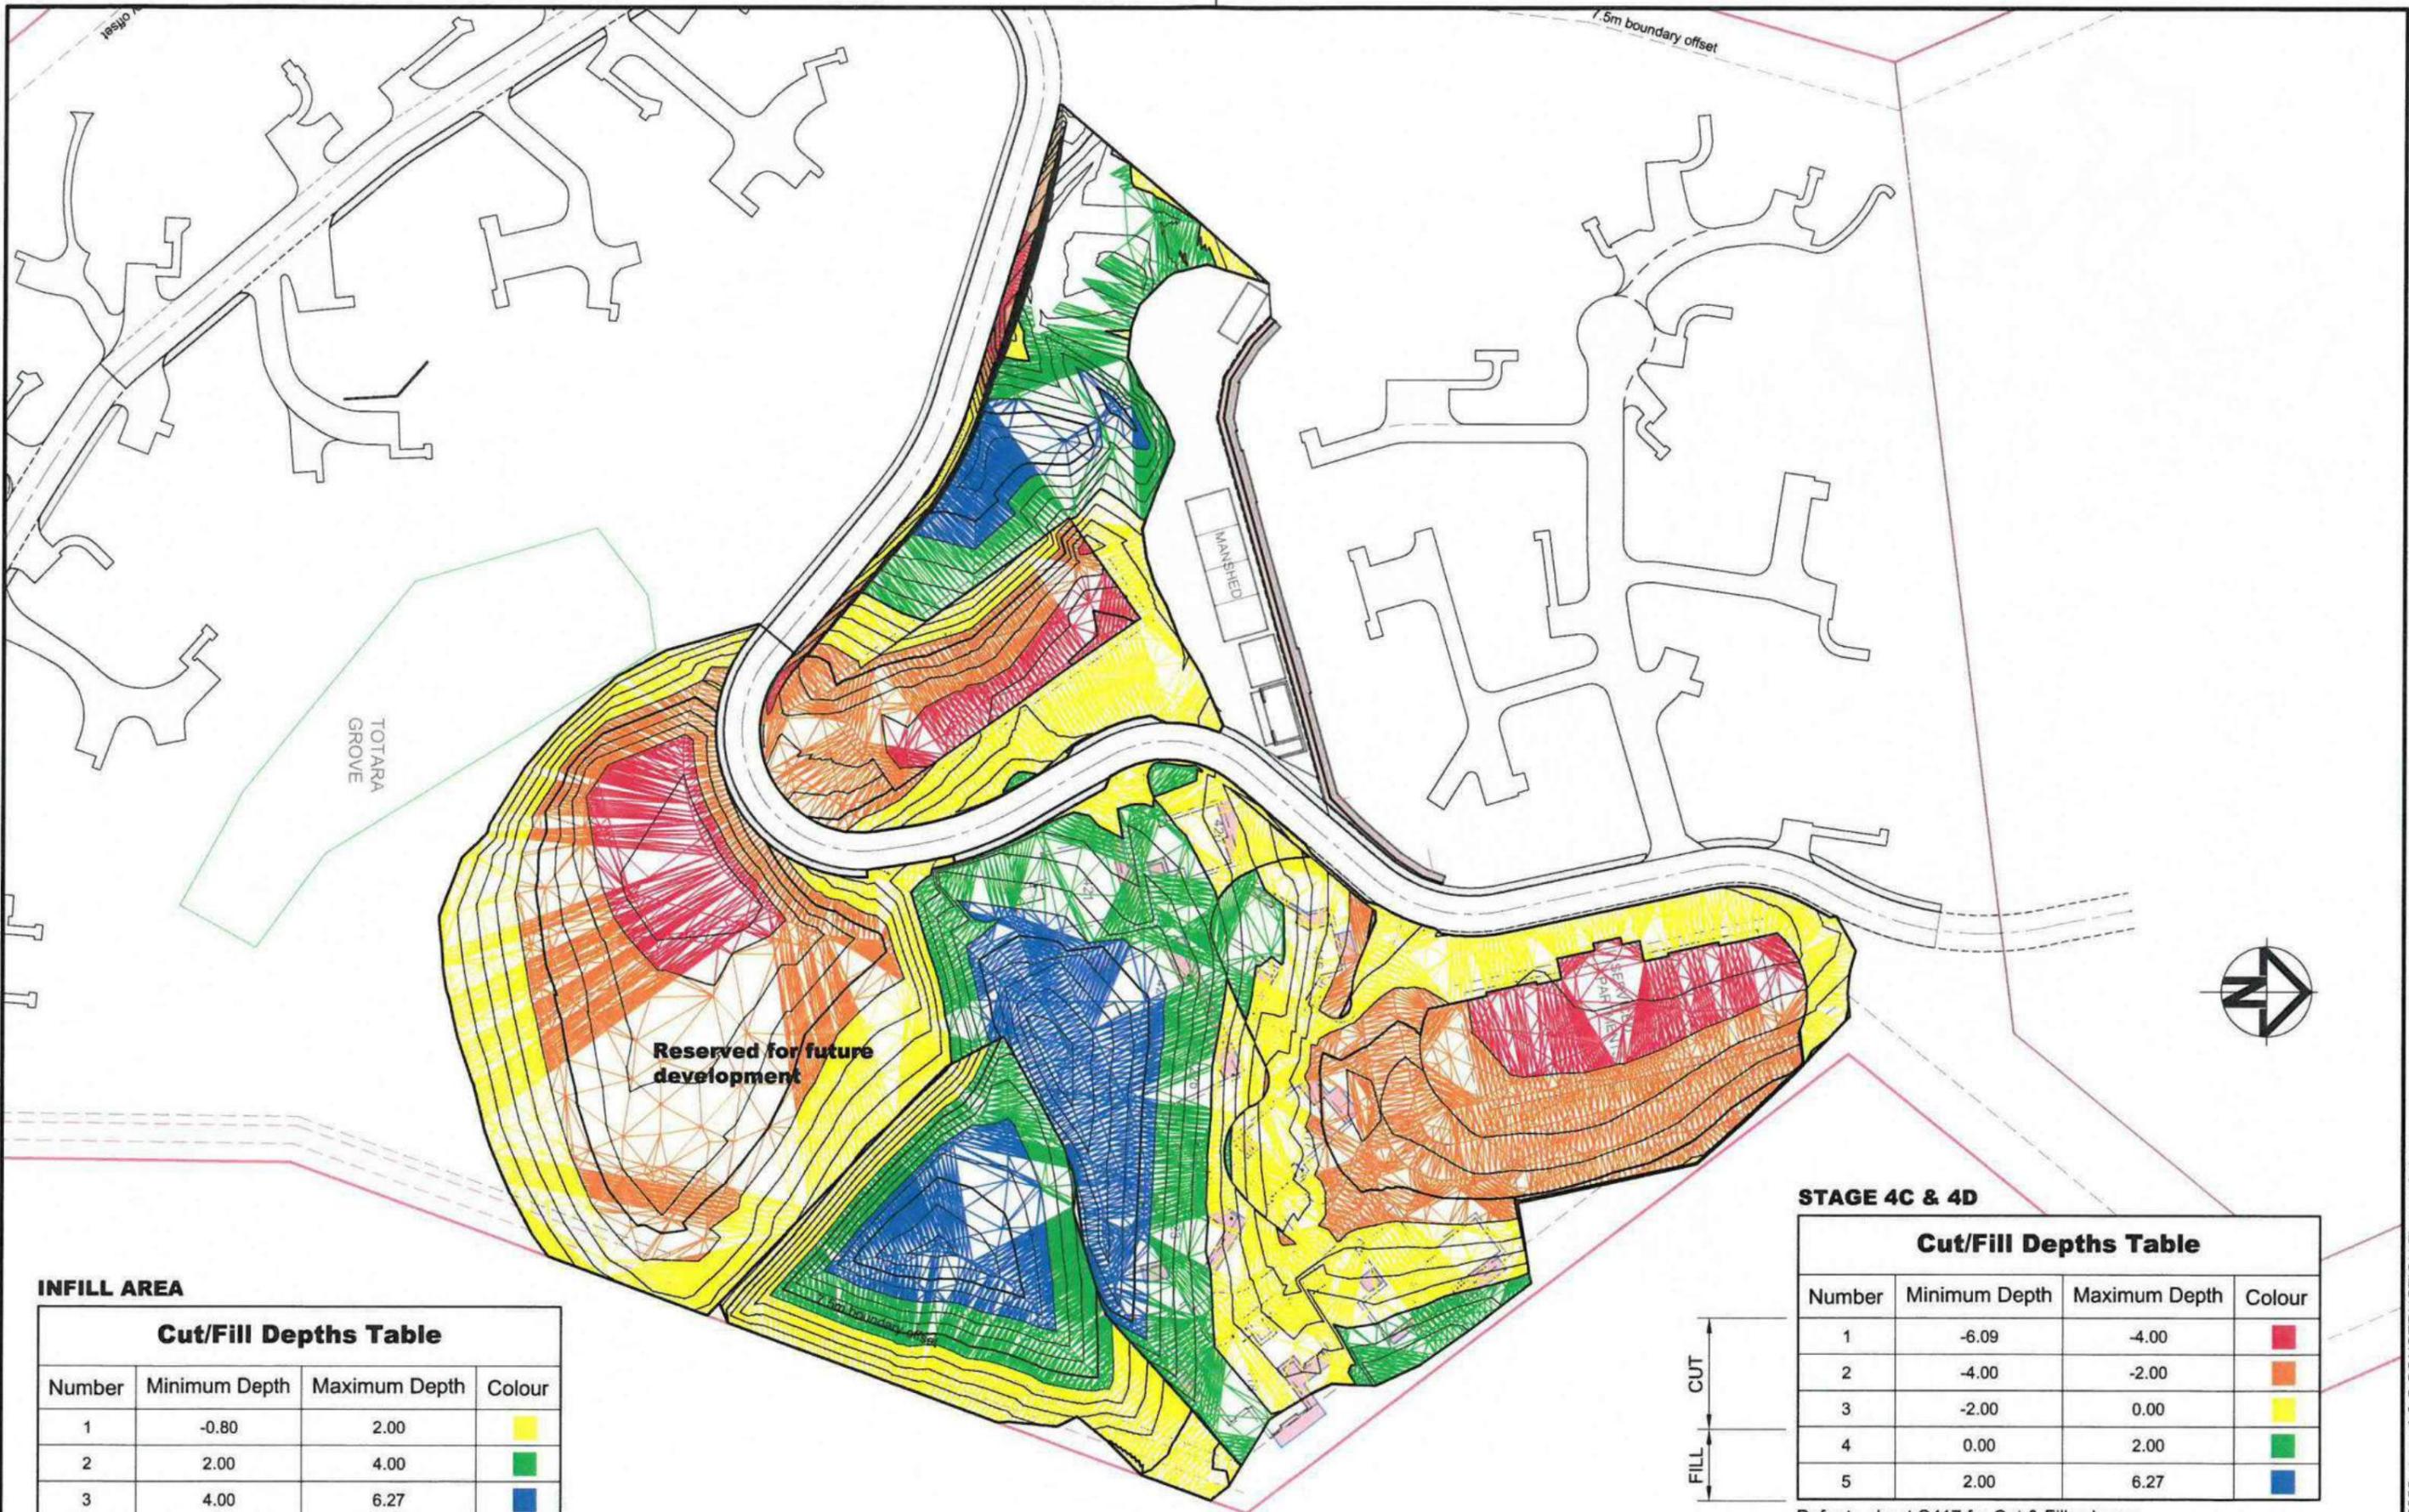
SCALE @ A3 1:500
 PROJECT No. **6062**
 FIGURE No. **13** REV. **R1**

INFILL AREA

Cut/Fill Depths Table			
Number	Minimum Depth	Maximum Depth	Colour
1	-0.80	2.00	Yellow
2	2.00	4.00	Green
3	4.00	6.27	Blue

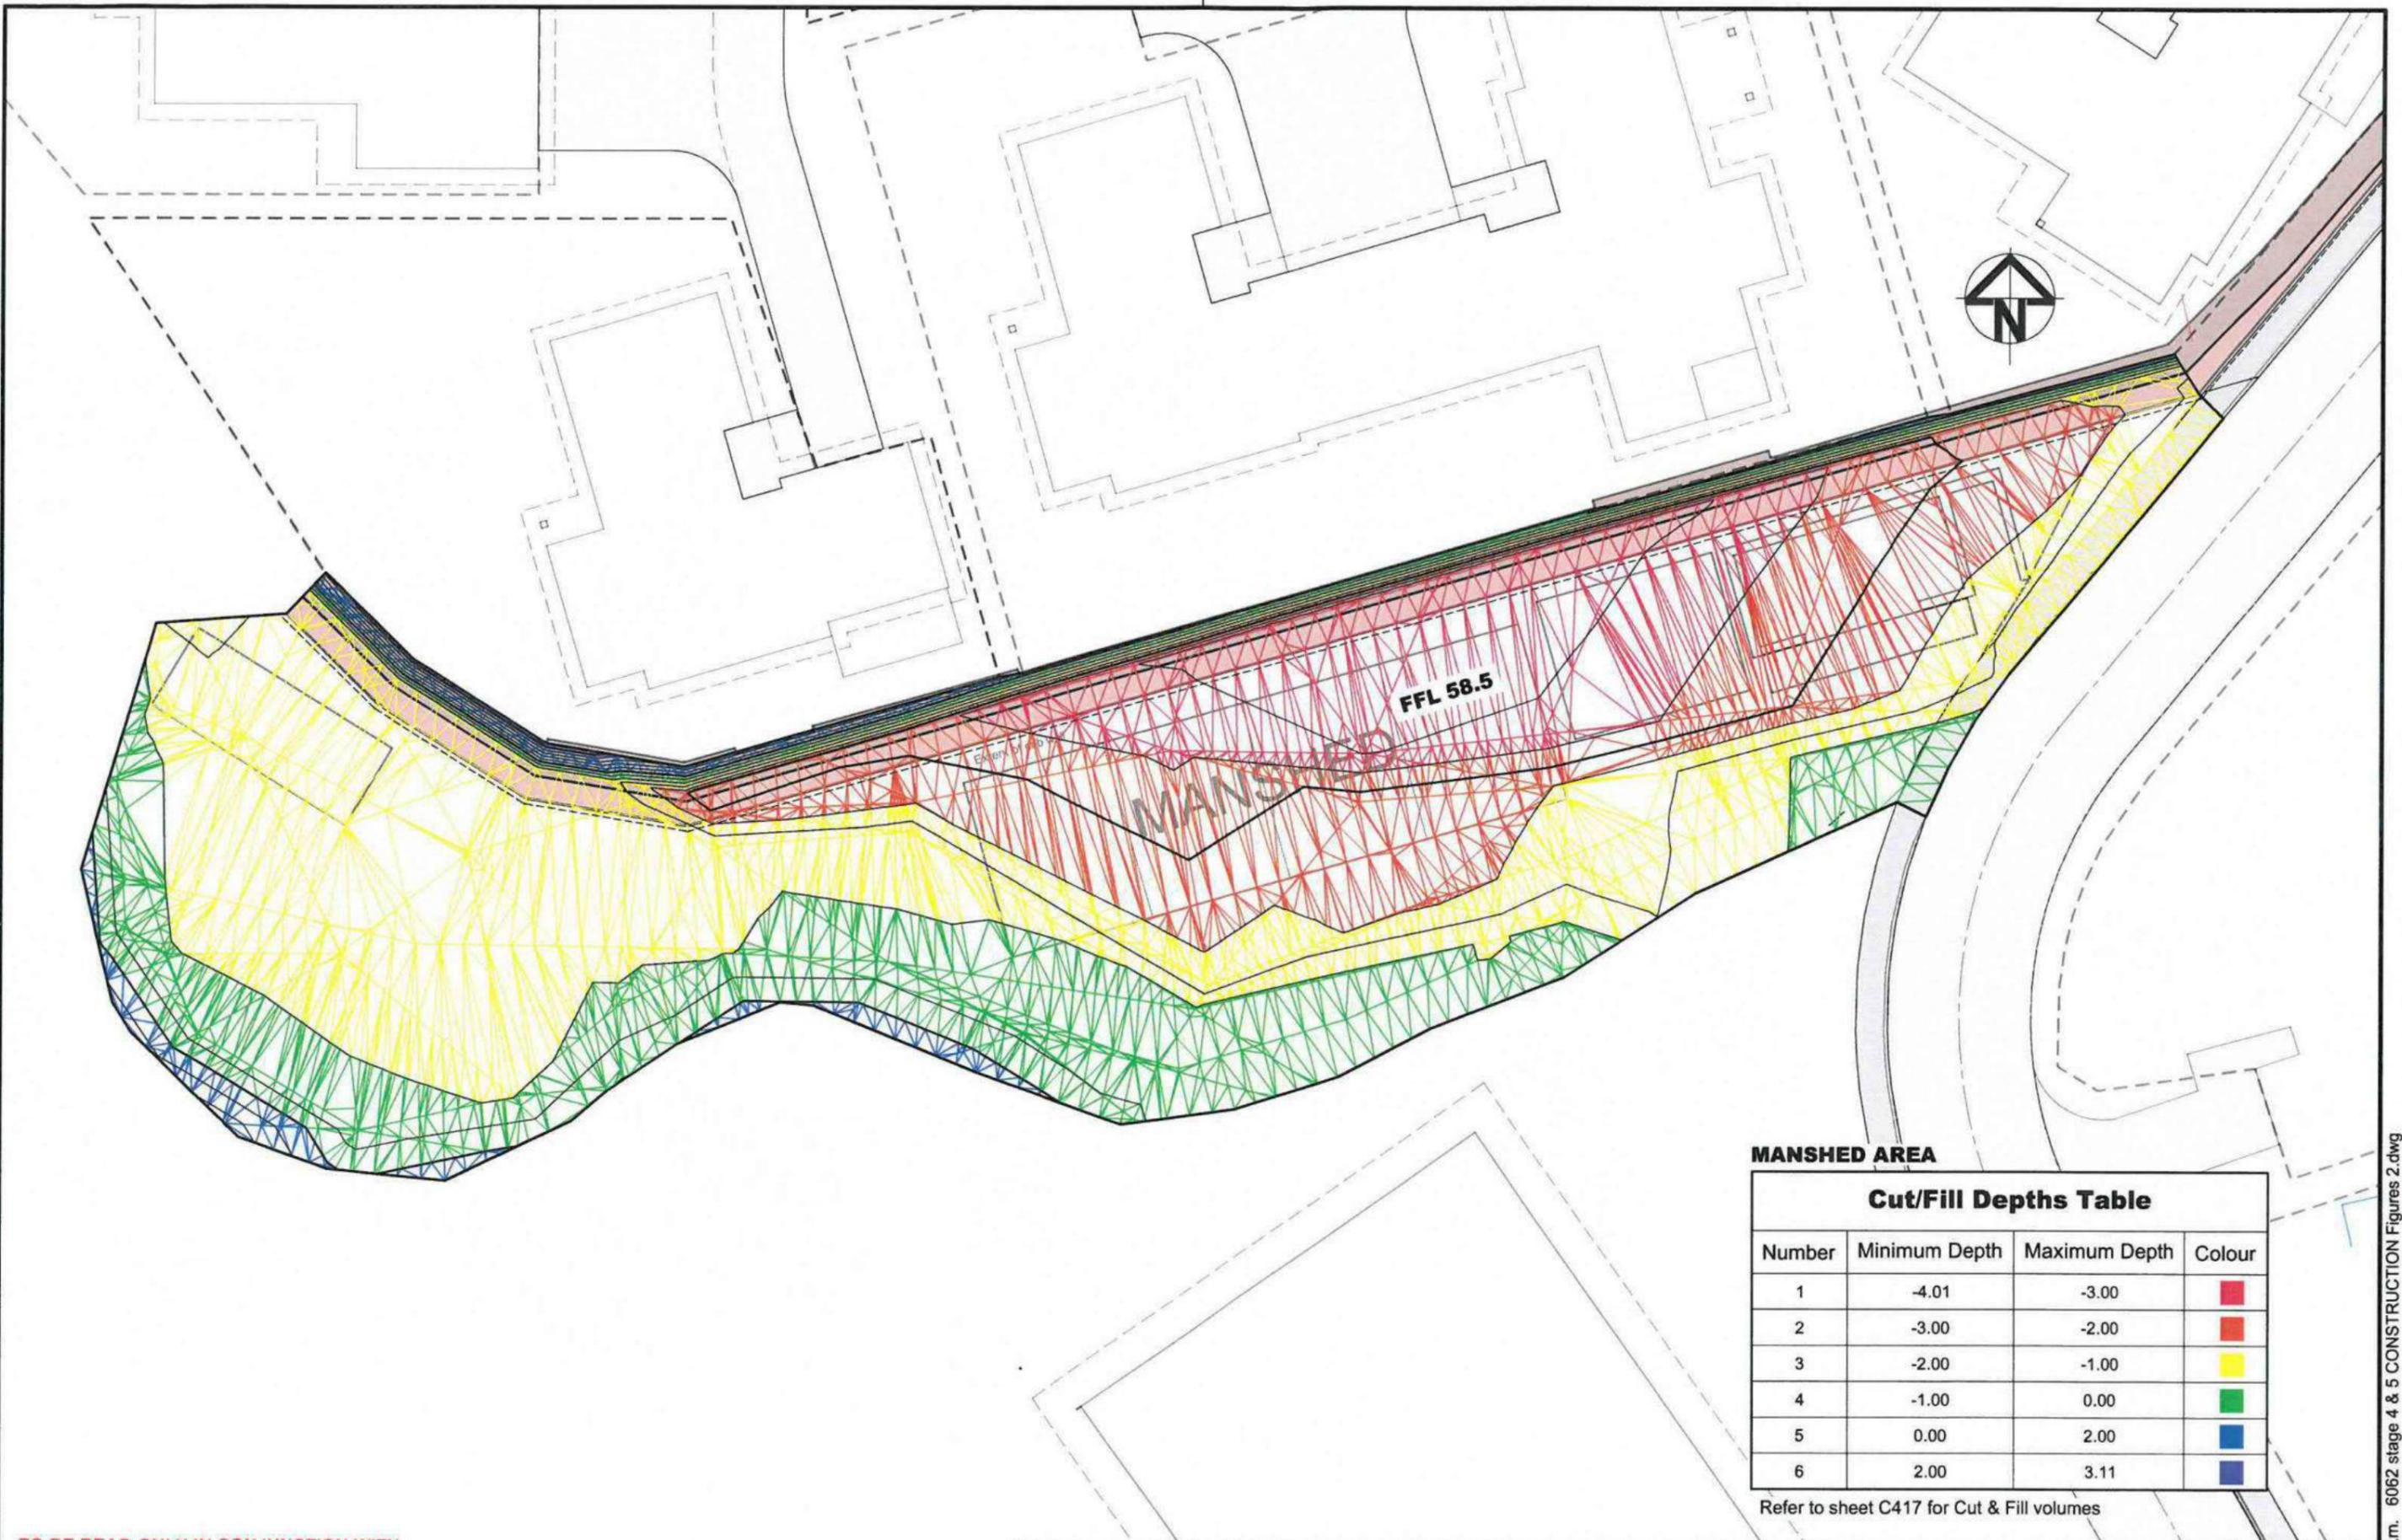
FIGURE No. **15**

MANSHED AREA

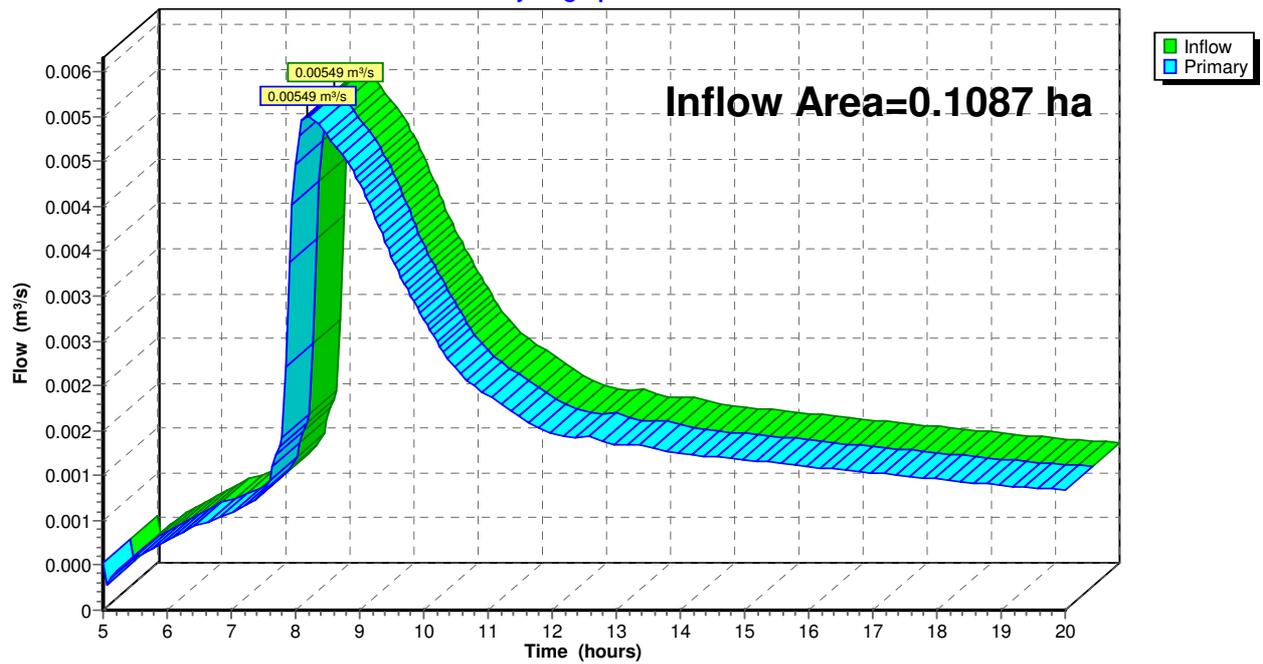
WATER OBSERVATIONS

Hydrograph
