### NOTICE OF WRITTEN APPROVAL

Description of the proposal (including why you need resource consent): IT IS PROPOSED TO ADJUST THE NORTHERN AND EASTERN BOUNDARY SETBACK FROM 10m TO 3m.

## 1. Introduction & Proposal Description

Project	J14599 - Proposed Lot 2, 201 Kerikeri Road, Kerikeri		
Group	Existing Ground Conditions	Scenario	NGWL
Drawn By	D.Simmonds	Company	VISION
Date	08/06/2021	File Name	14599 20210609 profile B.slmd

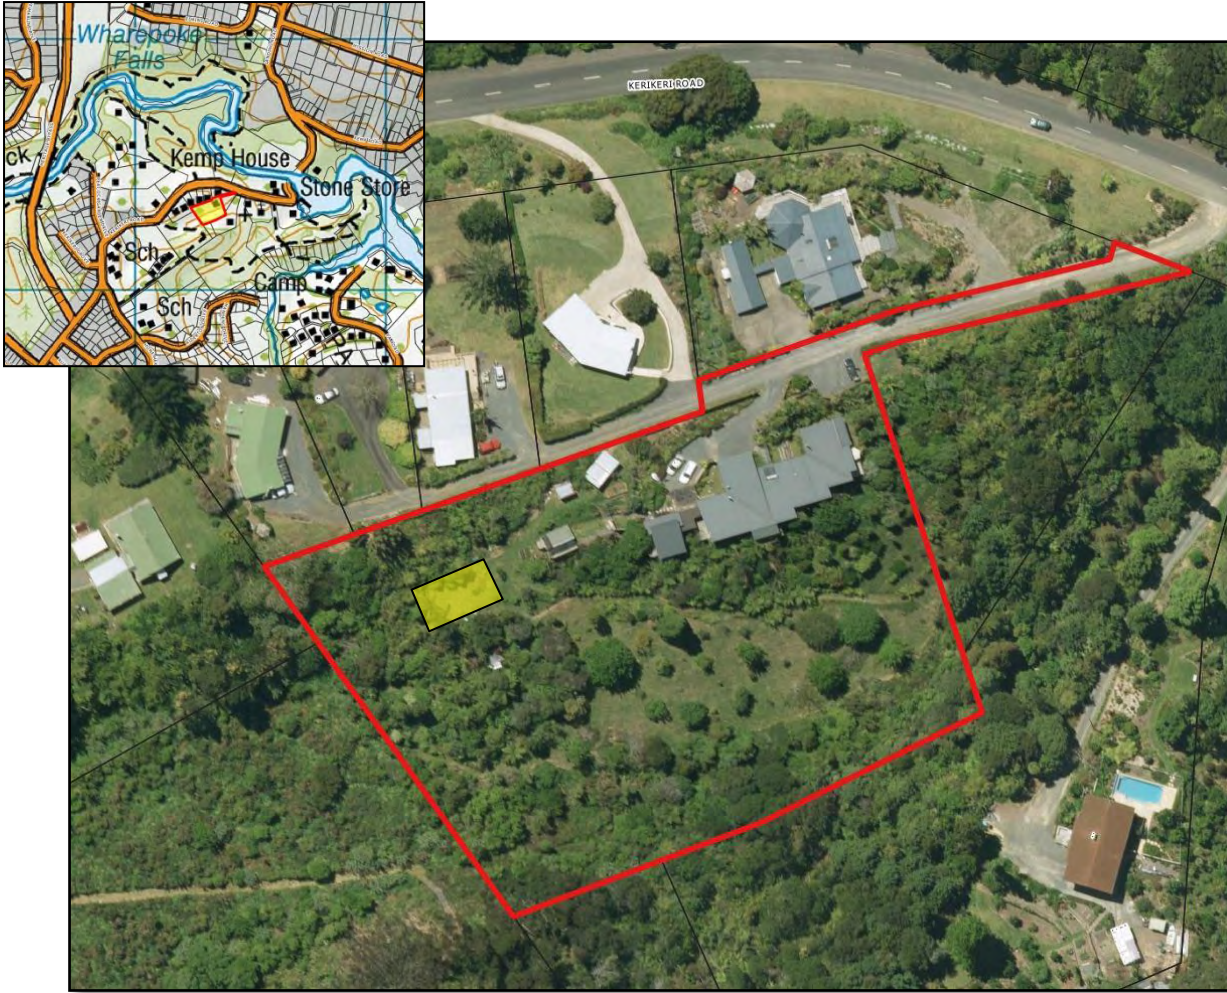
**Figure 1. Property Location**

*Property highlighted red, possible building site shown as yellow highlight, north at top, not to scale*

The possible building site ground profile varies but generally consists of a very steep slope to the north west of the site sloping at up to 41 degrees to the south east and gentle to steep slopes to the south of the site sloping between 3 to 30 degrees to the south and south east. There is a landscape timber retaining wall located to the south of the possible dwelling site, approximately 0.4m high. The site is generally covered in grass with one large boulder in the centre of the site. There are several fruit trees to the south east and two large palm trees in the south western corner of the site. The site is surrounded by dense bush on the western and southern boundaries. The very steep slope to the north west is covered by scrub and weeds with several small stand alone trees.

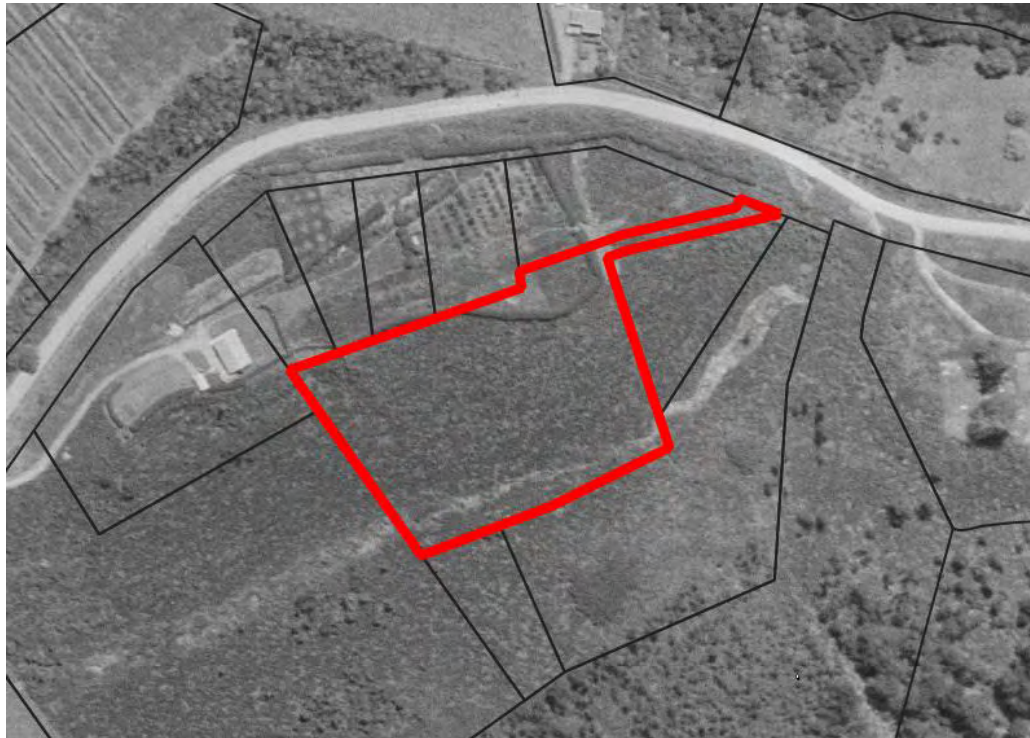
**Figure 2. Historic Aerial Image, 1953**

Historic aerial photographs from 1953 were reviewed as stereopairs. The review of the aerial photographs indicates that the western portion of the site and the land to the west has been affected by historic land instability.

*Property highlighted red, north at top, not to scale, image from VISION archives*

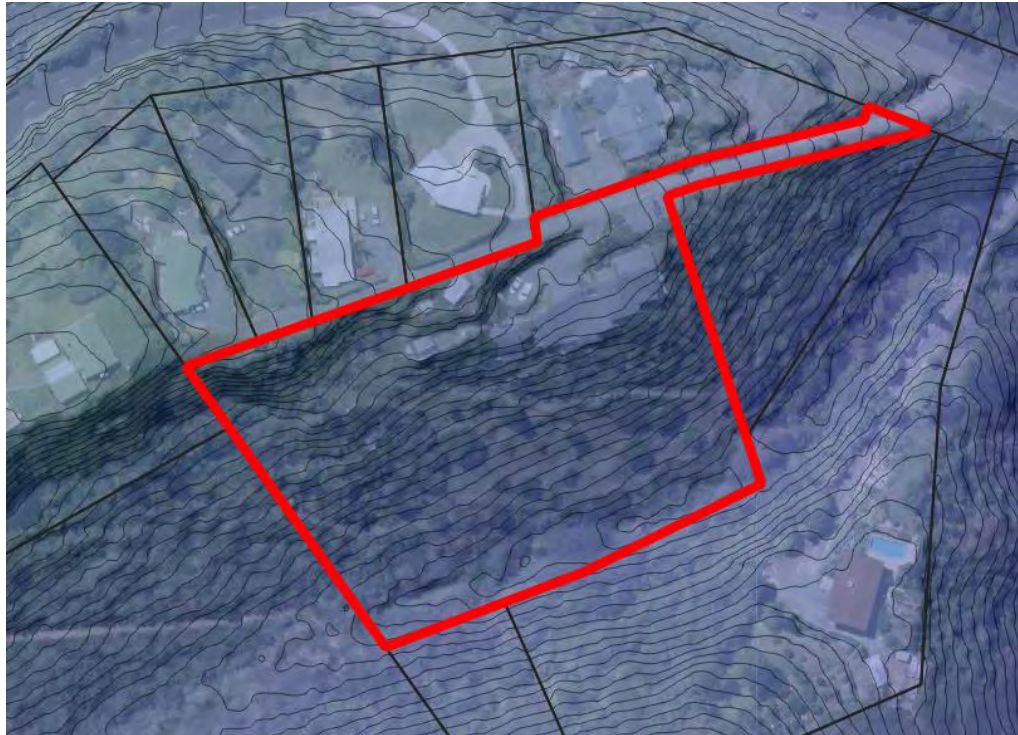
**Figure 3. Site Geomorphology**

The geomorphology of the area is shown in Figure 3 below using a digital elevation model derived from the 2018 Northland Regional Council (NRC) Light Detection and Ranging (LiDAR) dataset and 1m contours.

The property near the western boundary and the land to the west appears to have been affected by historic land instability. In addition the property is inferred to be located at the geological interface where the Kerikeri Volcanic Group overlies the Waipapa Group in the northern portion of the property, and the remainder of the site is underlain by the Waipapa Group.

*Site boundary indicative only(bold red), contours are shown at 1m intervals with blue shading lower elevations and green shading higher elevations, north is up the page. DEM courtesy of NRC*

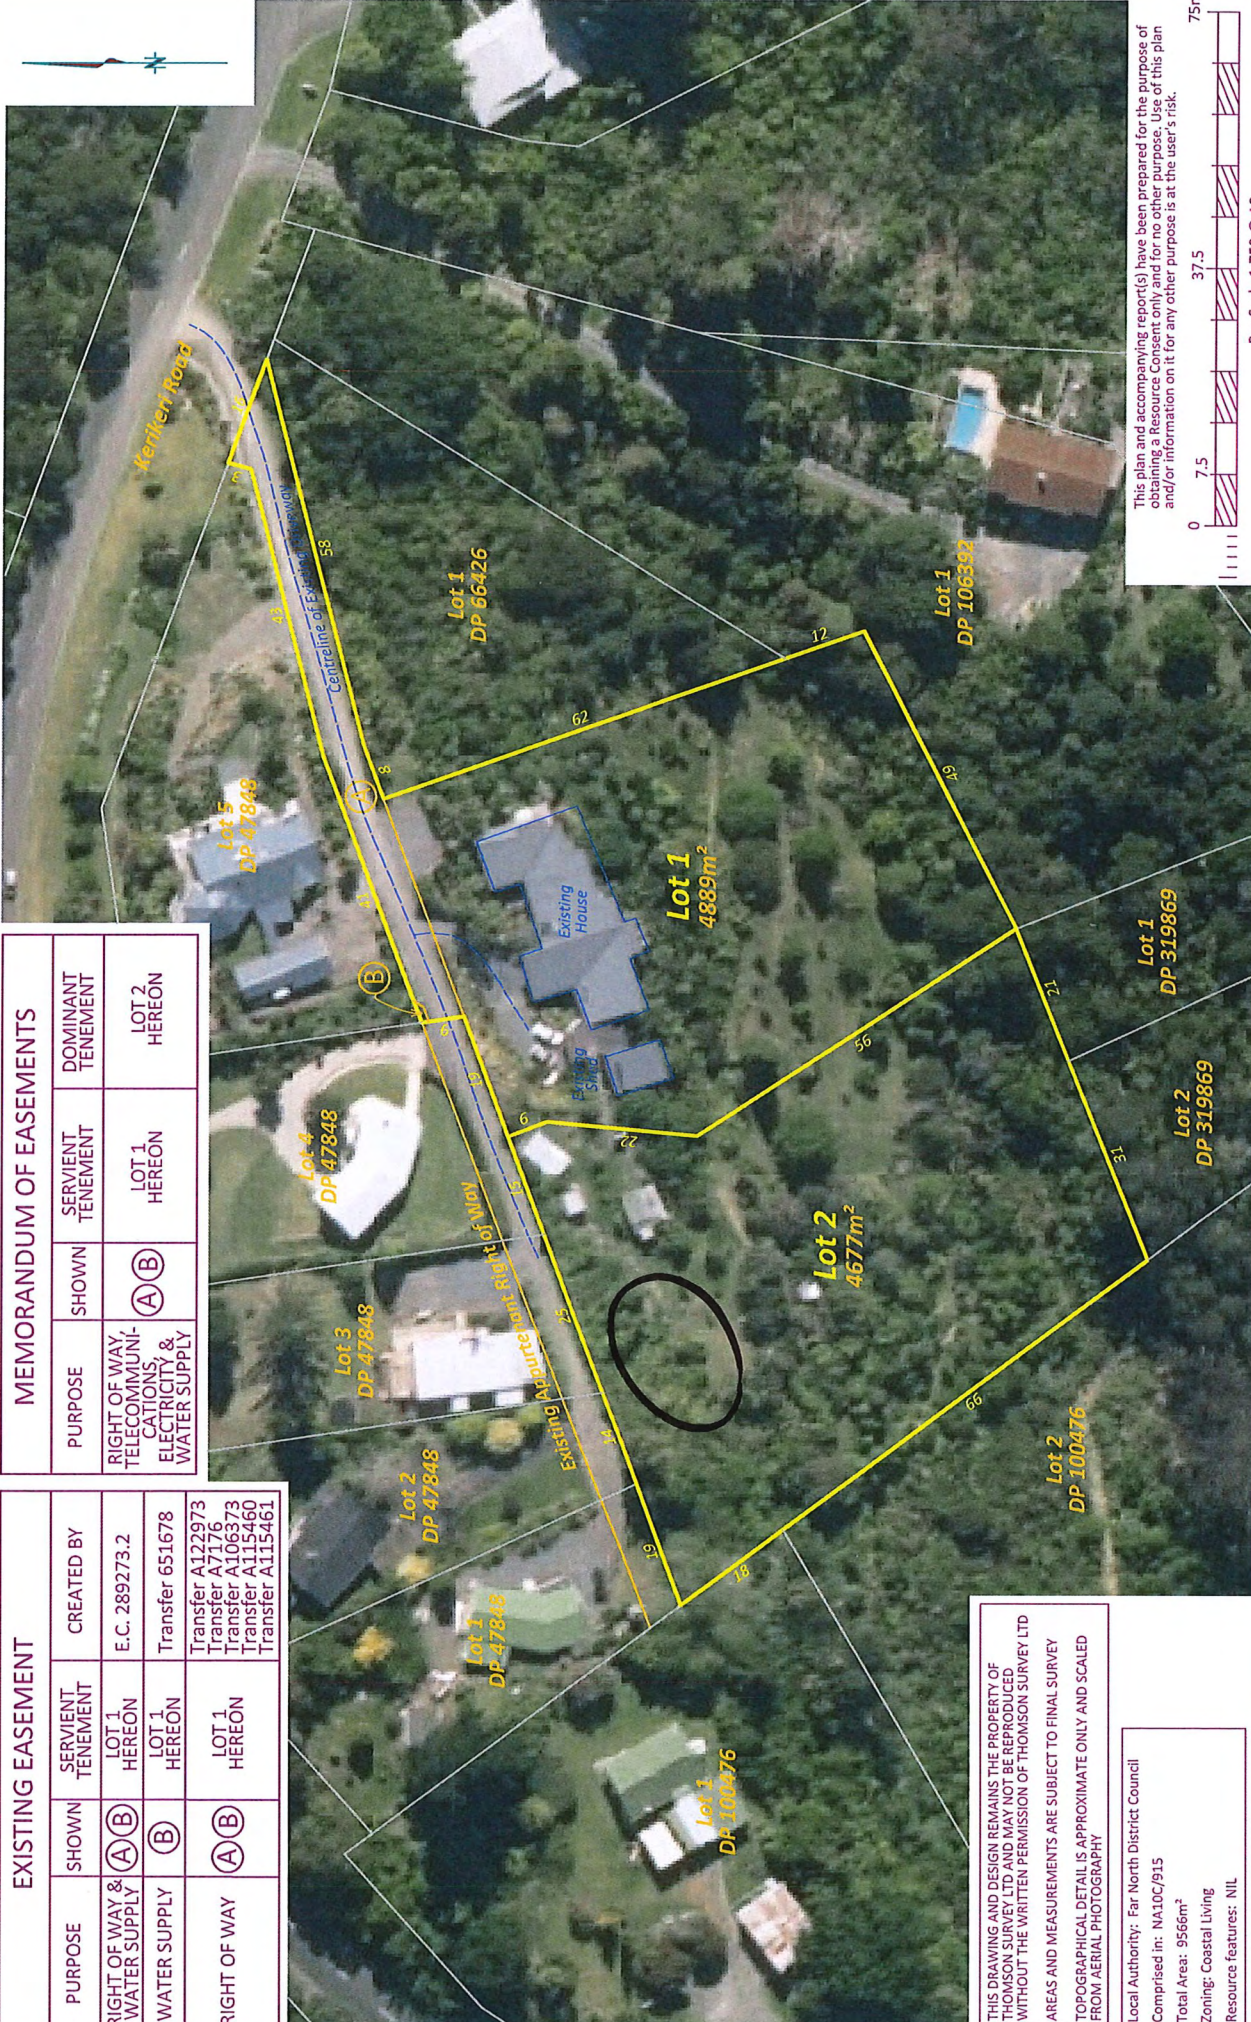
## Proposed Subdivision Scheme Plan

MEMORANDUM OF EASEMENTS			
PURPOSE	SHOWN	SERVIENT TENEMENT	DOMINANT TENEMENT
RIGHT OF WAY, TELECOMMUNICATIONS, ELECTRICITY & WATER SUPPLY	(A)(B)	LOT 1 HEREON	LOT 2 HEREON

The site is considered to be suitable for the proposed subdivision scheme plan depicted on the Thomson Survey drawing included in Appendix A provided that the following engineering recommendations are adopted.

The site is considered to be suitable for the proposed subdivision scheme plan depicted on the Thomson Survey subdivision scheme plan presented in Appendix A provided that the engineering recommendations outlined in this report are adopted for proposed Lot 2.

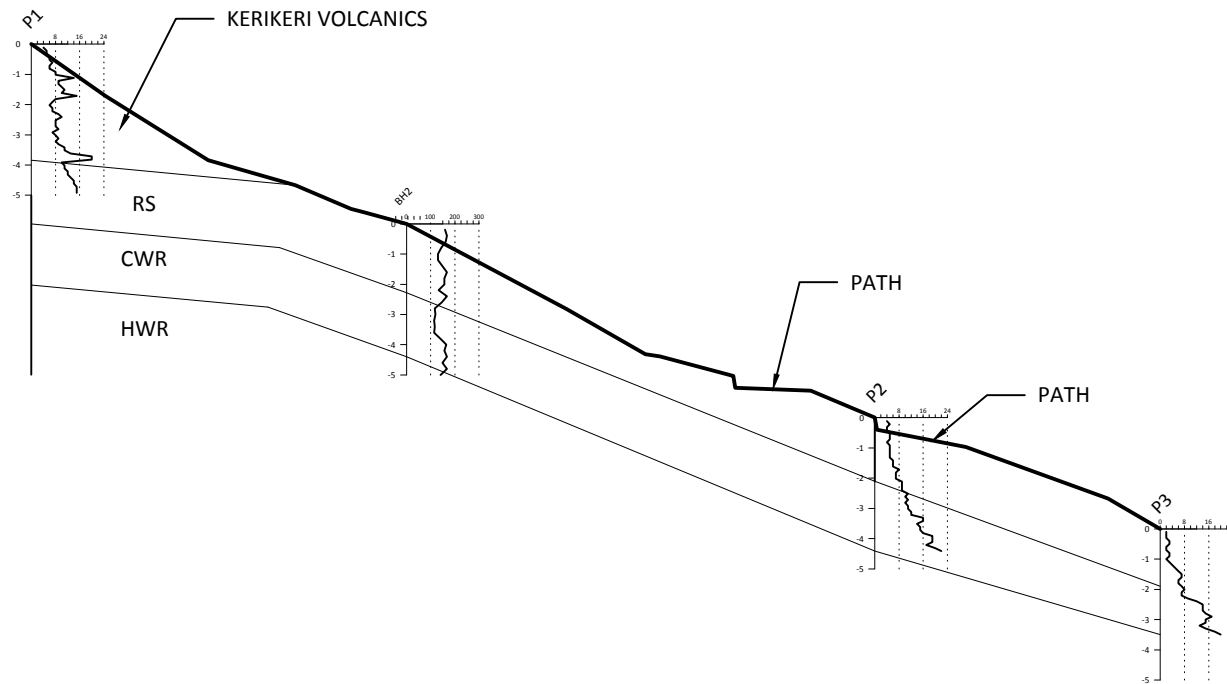
**SECTION A**

SCALE (A3) 1:250

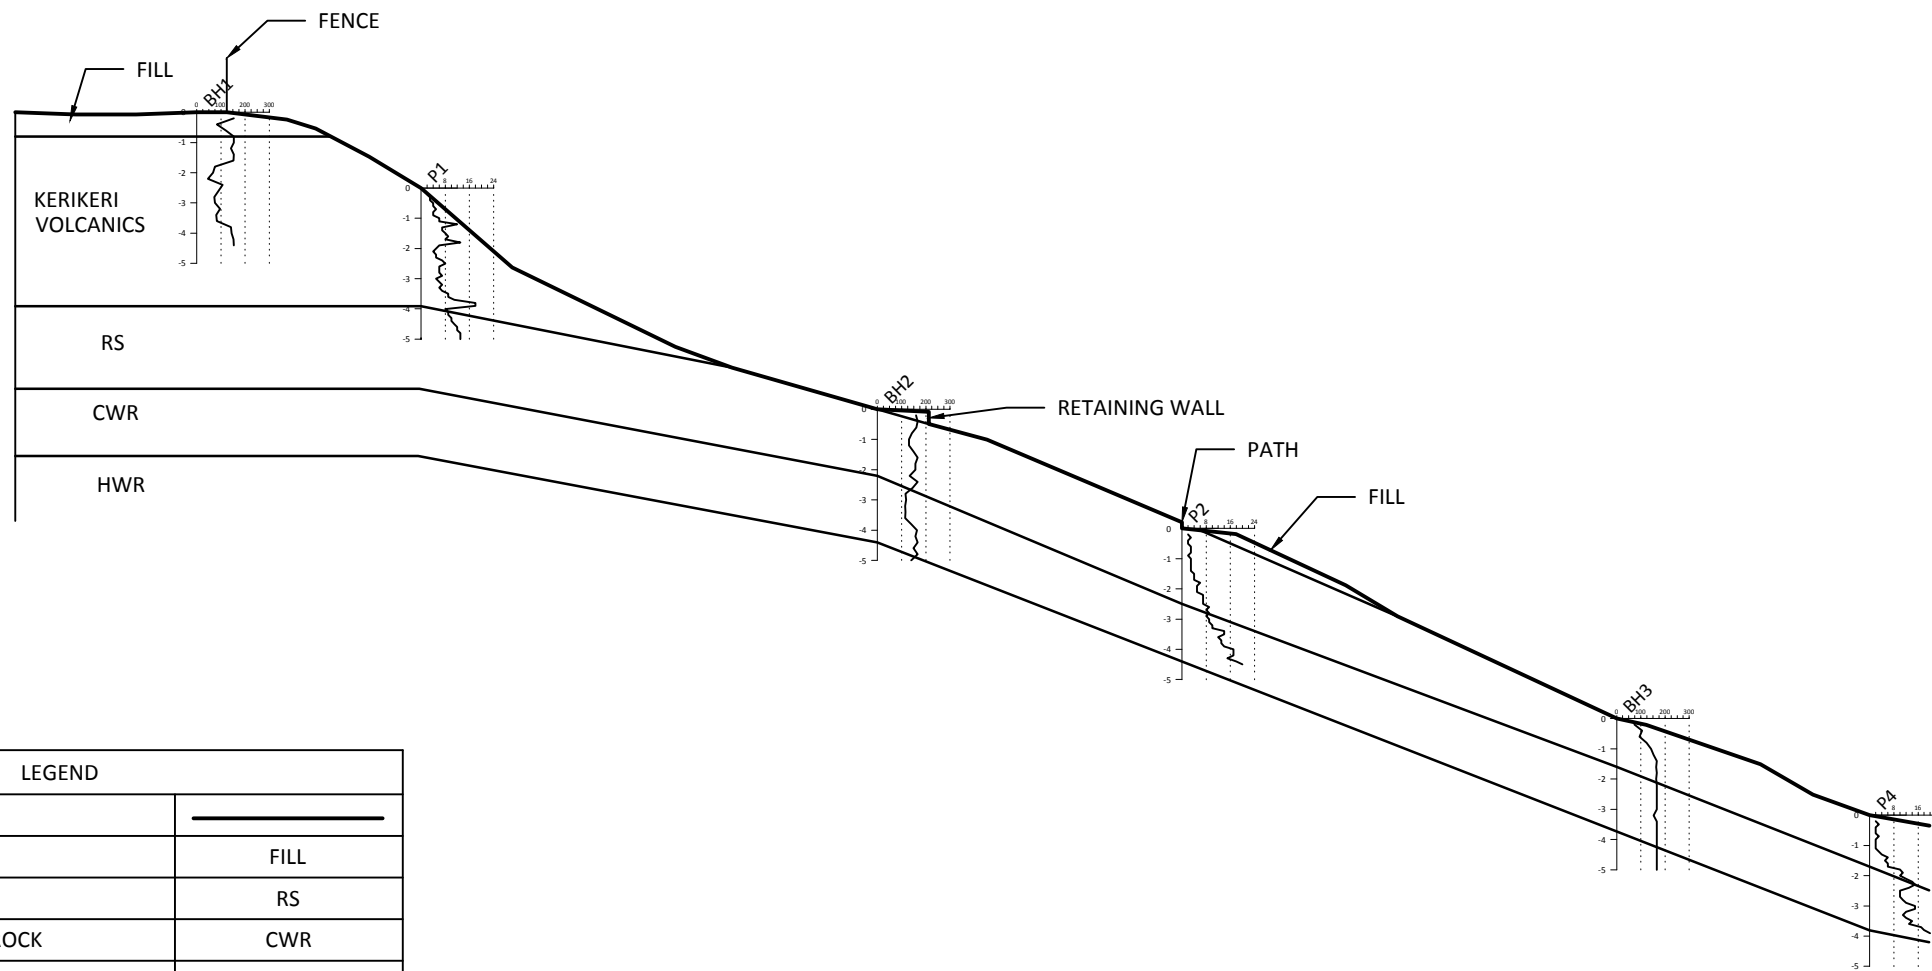
**SECTION B**

SCALE (A3) 1:250

LEGEND	
EXISTING GROUND	
FILL	FILL
RESIDUAL SOIL	RS
COMPLETELY WEATHERED ROCK	CWR
HIGHLY WEATHERED ROCK	HWR

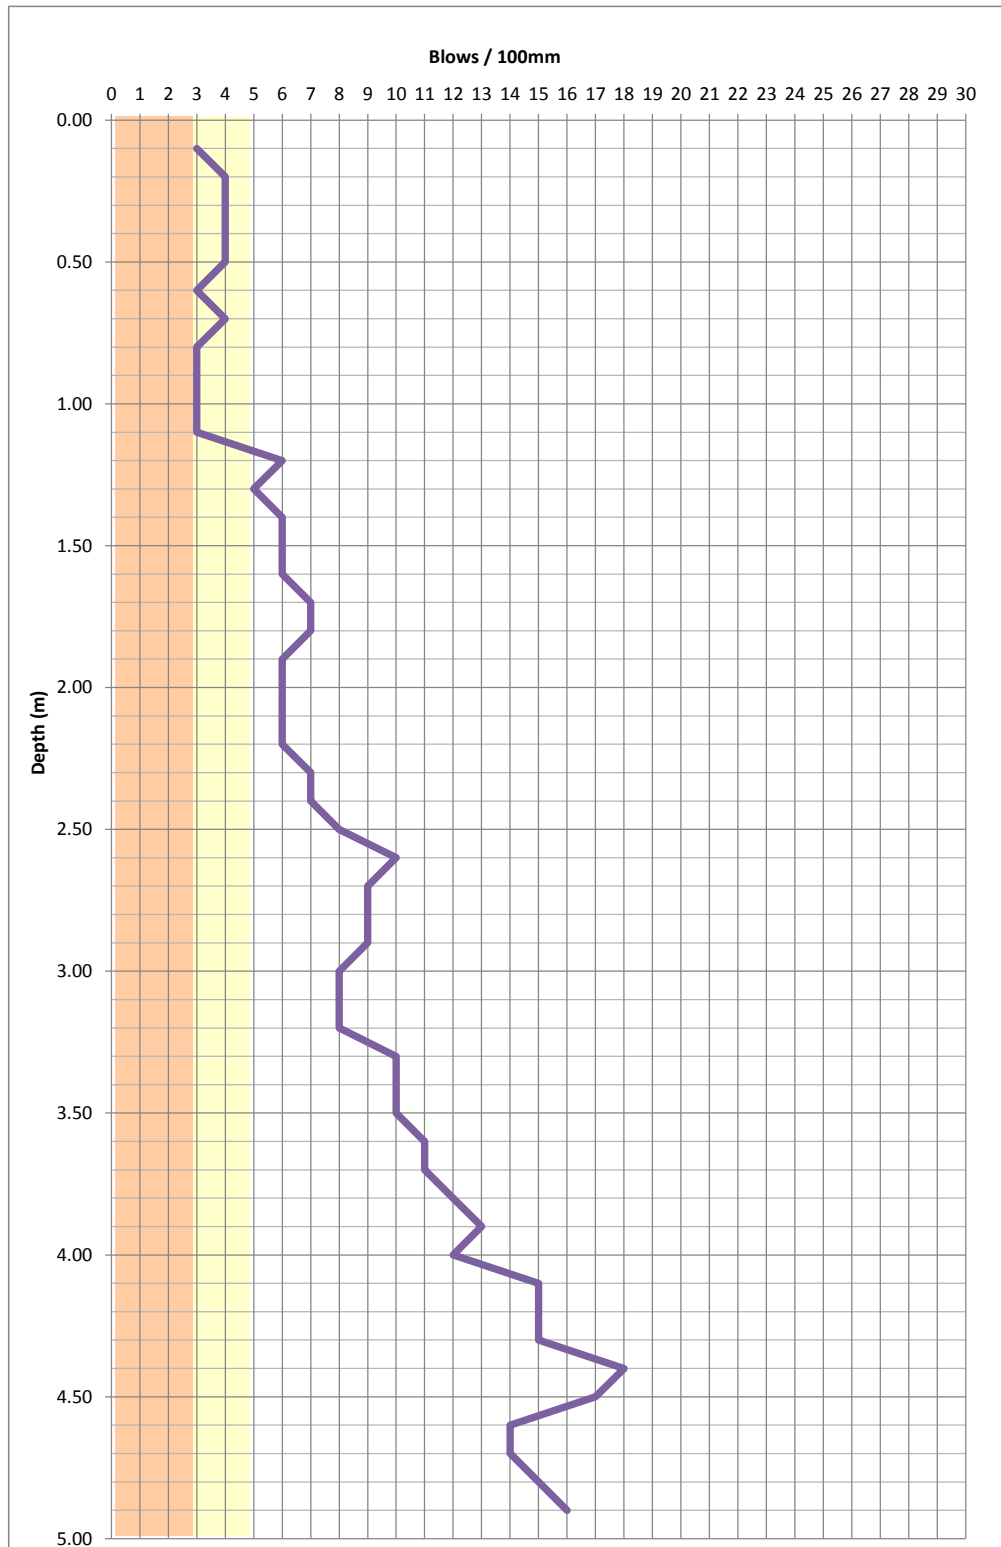
Depth (m)	Blows/100mm
0.10	3.0
0.20	4.0
0.30	4.0
0.40	4.0
0.50	4.0
0.60	3.0
0.70	4.0
0.80	3.0
0.90	3.0
1.00	3.0
1.10	3.0
1.20	6.0
1.30	5.0
1.40	6.0
1.50	6.0
1.60	6.0
1.70	7.0
1.80	7.0
1.90	6.0
2.00	6.0
2.10	6.0
2.20	6.0
2.30	7.0
2.40	7.0
2.50	8.0
2.60	10.0
2.70	9.0
2.80	9.0
2.90	9.0
3.00	8.0
3.10	8.0
3.20	8.0
3.30	10.0
3.40	10.0
3.50	10.0
3.60	11.0
3.70	11.0
3.80	12.0
3.90	13.0
4.00	12.0
4.10	15.0
4.20	15.0
4.30	15.0
4.40	18.0
4.50	17.0
4.60	14.0
4.70	14.0
4.80	15.0
4.90	16.0
5.00

\*Indicative only. Based on Stockwell (1977) correlation, bearing capacity factors excluded.

- Very low strength ground <2 blows per 100mm or less
- Low strength ground 2 to 4 blows per 100mm
- Ground with indicative ultimate bearing capacity of at least 300kPa\*

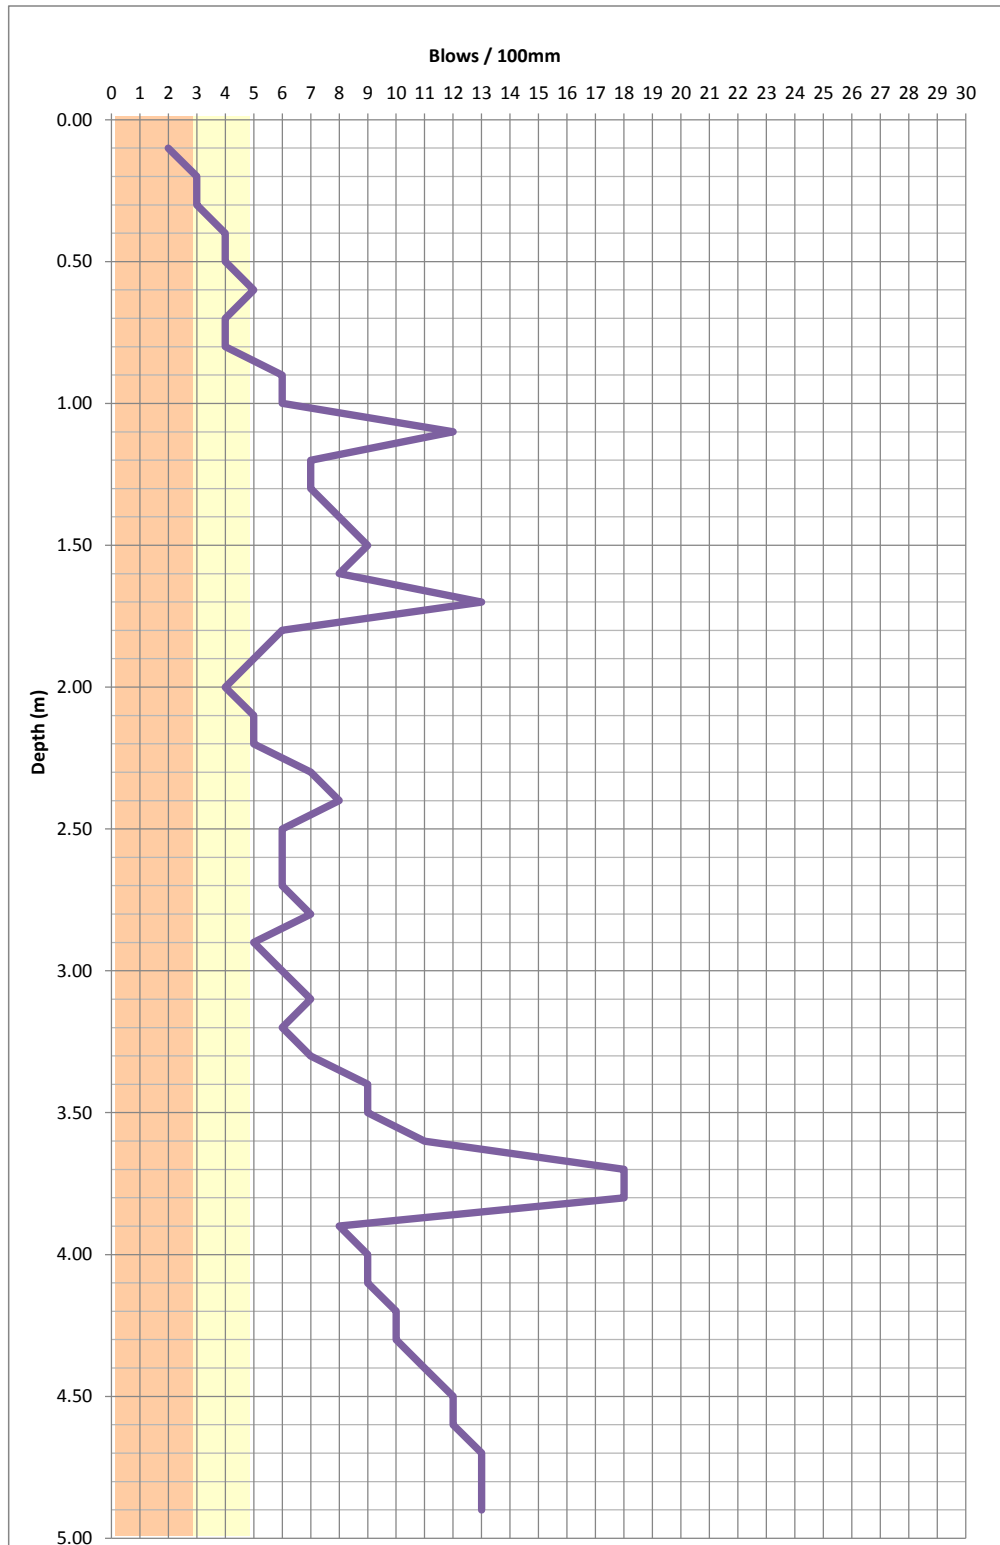
Depth (m)	Blows/100mm
0.10	2.0
0.20	3.0
0.30	3.0
0.40	4.0
0.50	4.0
0.60	5.0
0.70	4.0
0.80	4.0
0.90	6.0
1.00	6.0
1.10	12.0
1.20	7.0
1.30	7.0
1.40	8.0
1.50	9.0
1.60	8.0
1.70	13.0
1.80	6.0
1.90	5.0
2.00	4.0
2.10	5.0
2.20	5.0
2.30	7.0
2.40	8.0
2.50	6.0
2.60	6.0
2.70	6.0
2.80	7.0
2.90	5.0
3.00	6.0
3.10	7.0
3.20	6.0
3.30	7.0
3.40	9.0
3.50	9.0
3.60	11.0
3.70	18.0
3.80	18.0
3.90	8.0
4.00	9.0
4.10	9.0
4.20	10.0
4.30	10.0
4.40	11.0
4.50	12.0
4.60	12.0
4.70	13.0
4.80	13.0
4.90	13.0
5.00

\*Indicative only. Based on Stockwell (1977) correlation, bearing capacity factors excluded.

- Very low strength ground <2 blows per 100mm or less
- Low strength ground 2 to 4 blows per 100mm
- Ground with indicative ultimate bearing capacity of at least 300kPa\*

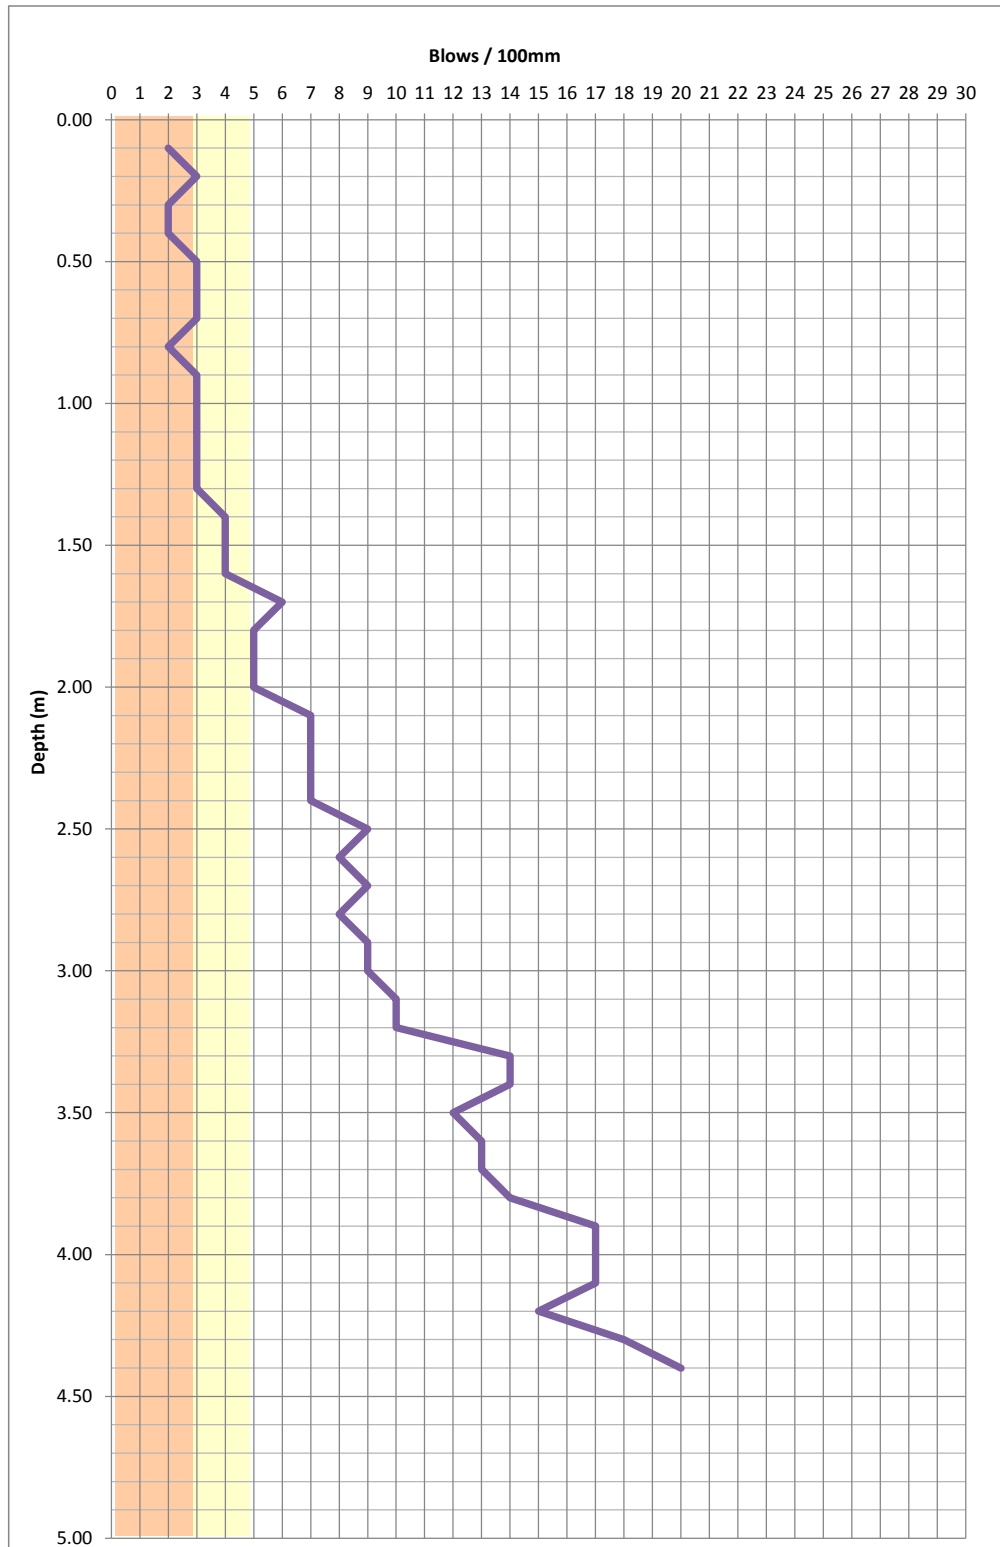
Depth (m)	Blows/100mm
0.10	2.0
0.20	3.0
0.30	2.0
0.40	2.0
0.50	3.0
0.60	3.0
0.70	3.0
0.80	2.0
0.90	3.0
1.00	3.0
1.10	3.0
1.20	3.0
1.30	3.0
1.40	4.0
1.50	4.0
1.60	4.0
1.70	6.0
1.80	5.0
1.90	5.0
2.00	5.0
2.10	7.0
2.20	7.0
2.30	7.0
2.40	7.0
2.50	9.0
2.60	8.0
2.70	9.0
2.80	8.0
2.90	9.0
3.00	9.0
3.10	10.0
3.20	10.0
3.30	14.0
3.40	14.0
3.50	12.0
3.60	13.0
3.70	13.0
3.80	14.0
3.90	17.0
4.00	17.0
4.10	17.0
4.20	15.0
4.30	18.0
4.40	20.0
4.50	
4.60	
4.70	
4.80	
4.90	
5.00

\*Indicative only. Based on Stockwell (1977) correlation, bearing capacity factors excluded.

- Very low strength ground <2 blows per 100mm or less
- Low strength ground 2 to 4 blows per 100mm
- Ground with indicative ultimate bearing capacity of at least 300kPa\*

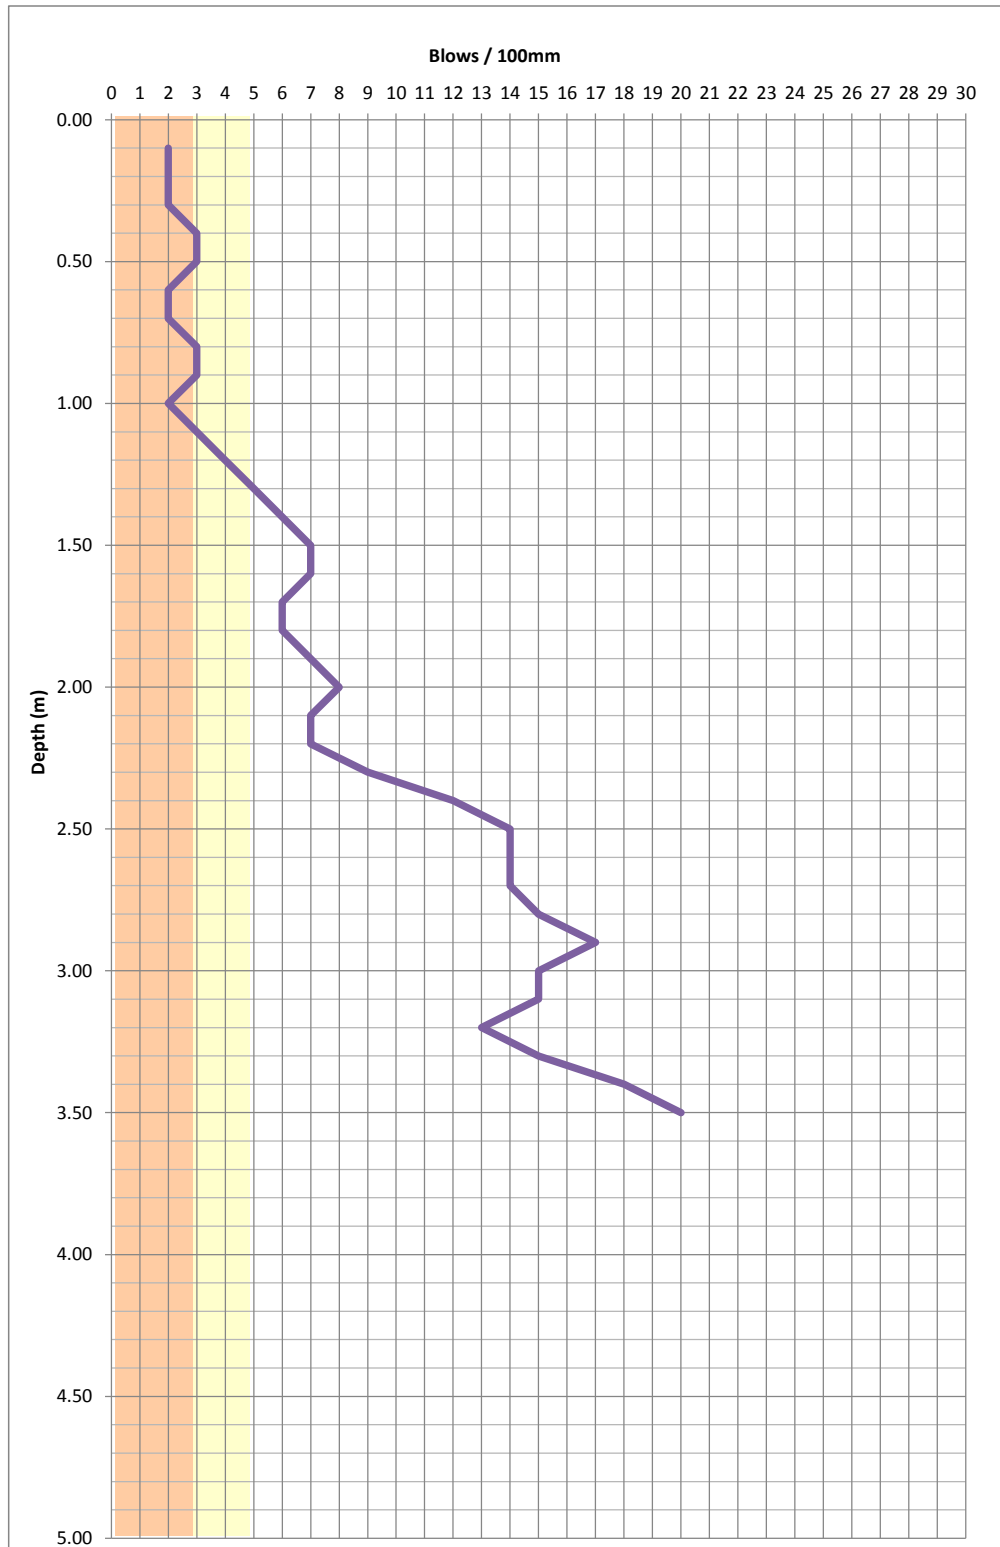
Depth (m)	Blows/100mm
0.10	2.0
0.20	2.0
0.30	2.0
0.40	3.0
0.50	3.0
0.60	2.0
0.70	2.0
0.80	3.0
0.90	3.0
1.00	2.0
1.10	3.0
1.20	4.0
1.30	5.0
1.40	6.0
1.50	7.0
1.60	7.0
1.70	6.0
1.80	6.0
1.90	7.0
2.00	8.0
2.10	7.0
2.20	7.0
2.30	9.0
2.40	12.0
2.50	14.0
2.60	14.0
2.70	14.0
2.80	15.0
2.90	17.0
3.00	15.0
3.10	15.0
3.20	13.0
3.30	15.0
3.40	18.0
3.50	20.0
3.60	
3.70	
3.80	
3.90	
4.00	
4.10	
4.20	
4.30	
4.40	
4.50	
4.60	
4.70	
4.80	
4.90	
5.00

\*Indicative only. Based on Stockwell (1977) correlation, bearing capacity factors excluded.

- Very low strength ground <2 blows per 100mm or less
- Low strength ground 2 to 4 blows per 100mm
- Ground with indicative ultimate bearing capacity of at least 300kPa\*

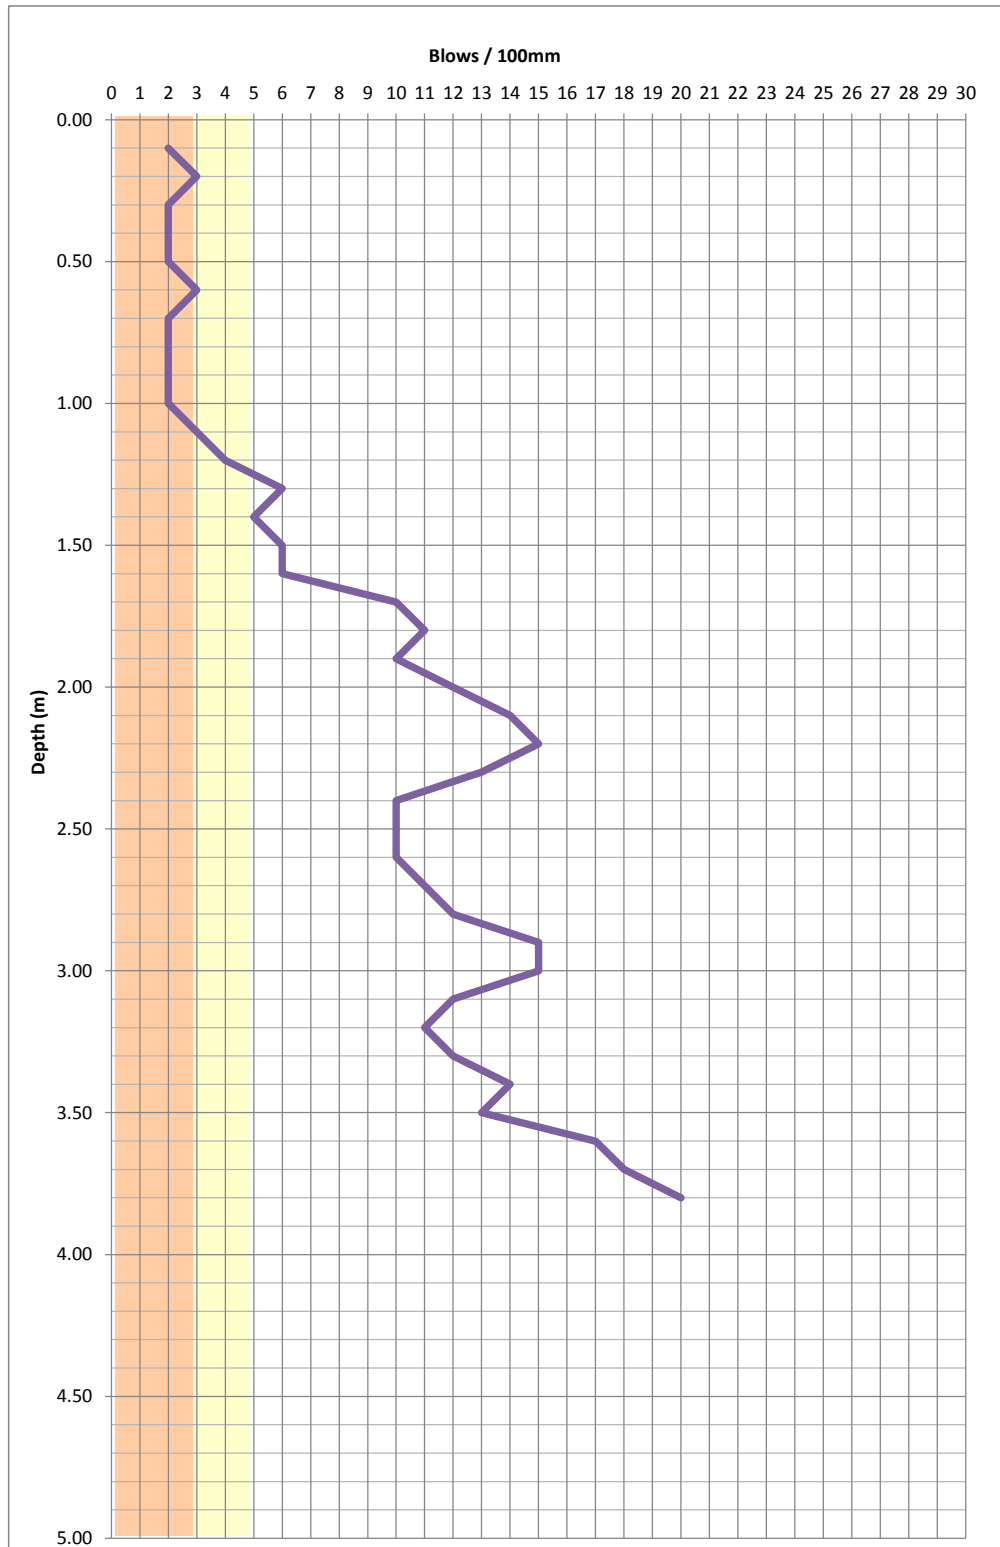
Depth (m)	Blows/100mm
0.10	2.0
0.20	3.0
0.30	2.0
0.40	2.0
0.50	2.0
0.60	3.0
0.70	2.0
0.80	2.0
0.90	2.0
1.00	2.0
1.10	3.0
1.20	4.0
1.30	6.0
1.40	5.0
1.50	6.0
1.60	6.0
1.70	10.0
1.80	11.0
1.90	10.0
2.00	12.0
2.10	14.0
2.20	15.0
2.30	13.0
2.40	10.0
2.50	10.0
2.60	10.0
2.70	11.0
2.80	12.0
2.90	15.0
3.00	15.0
3.10	12.0
3.20	11.0
3.30	12.0
3.40	14.0
3.50	13.0
3.60	17.0
3.70	18.0
3.80	20.0
3.90	
4.00	
4.10	
4.20	
4.30	
4.40	
4.50	
4.60	
4.70	
4.80	
4.90	
5.00

\*Indicative only. Based on Stockwell (1977) correlation, bearing capacity factors excluded.

- Very low strength ground <2 blows per 100mm or less
- Low strength ground 2 to 4 blows per 100mm
- Ground with indicative ultimate bearing capacity of at least 300kPa\*

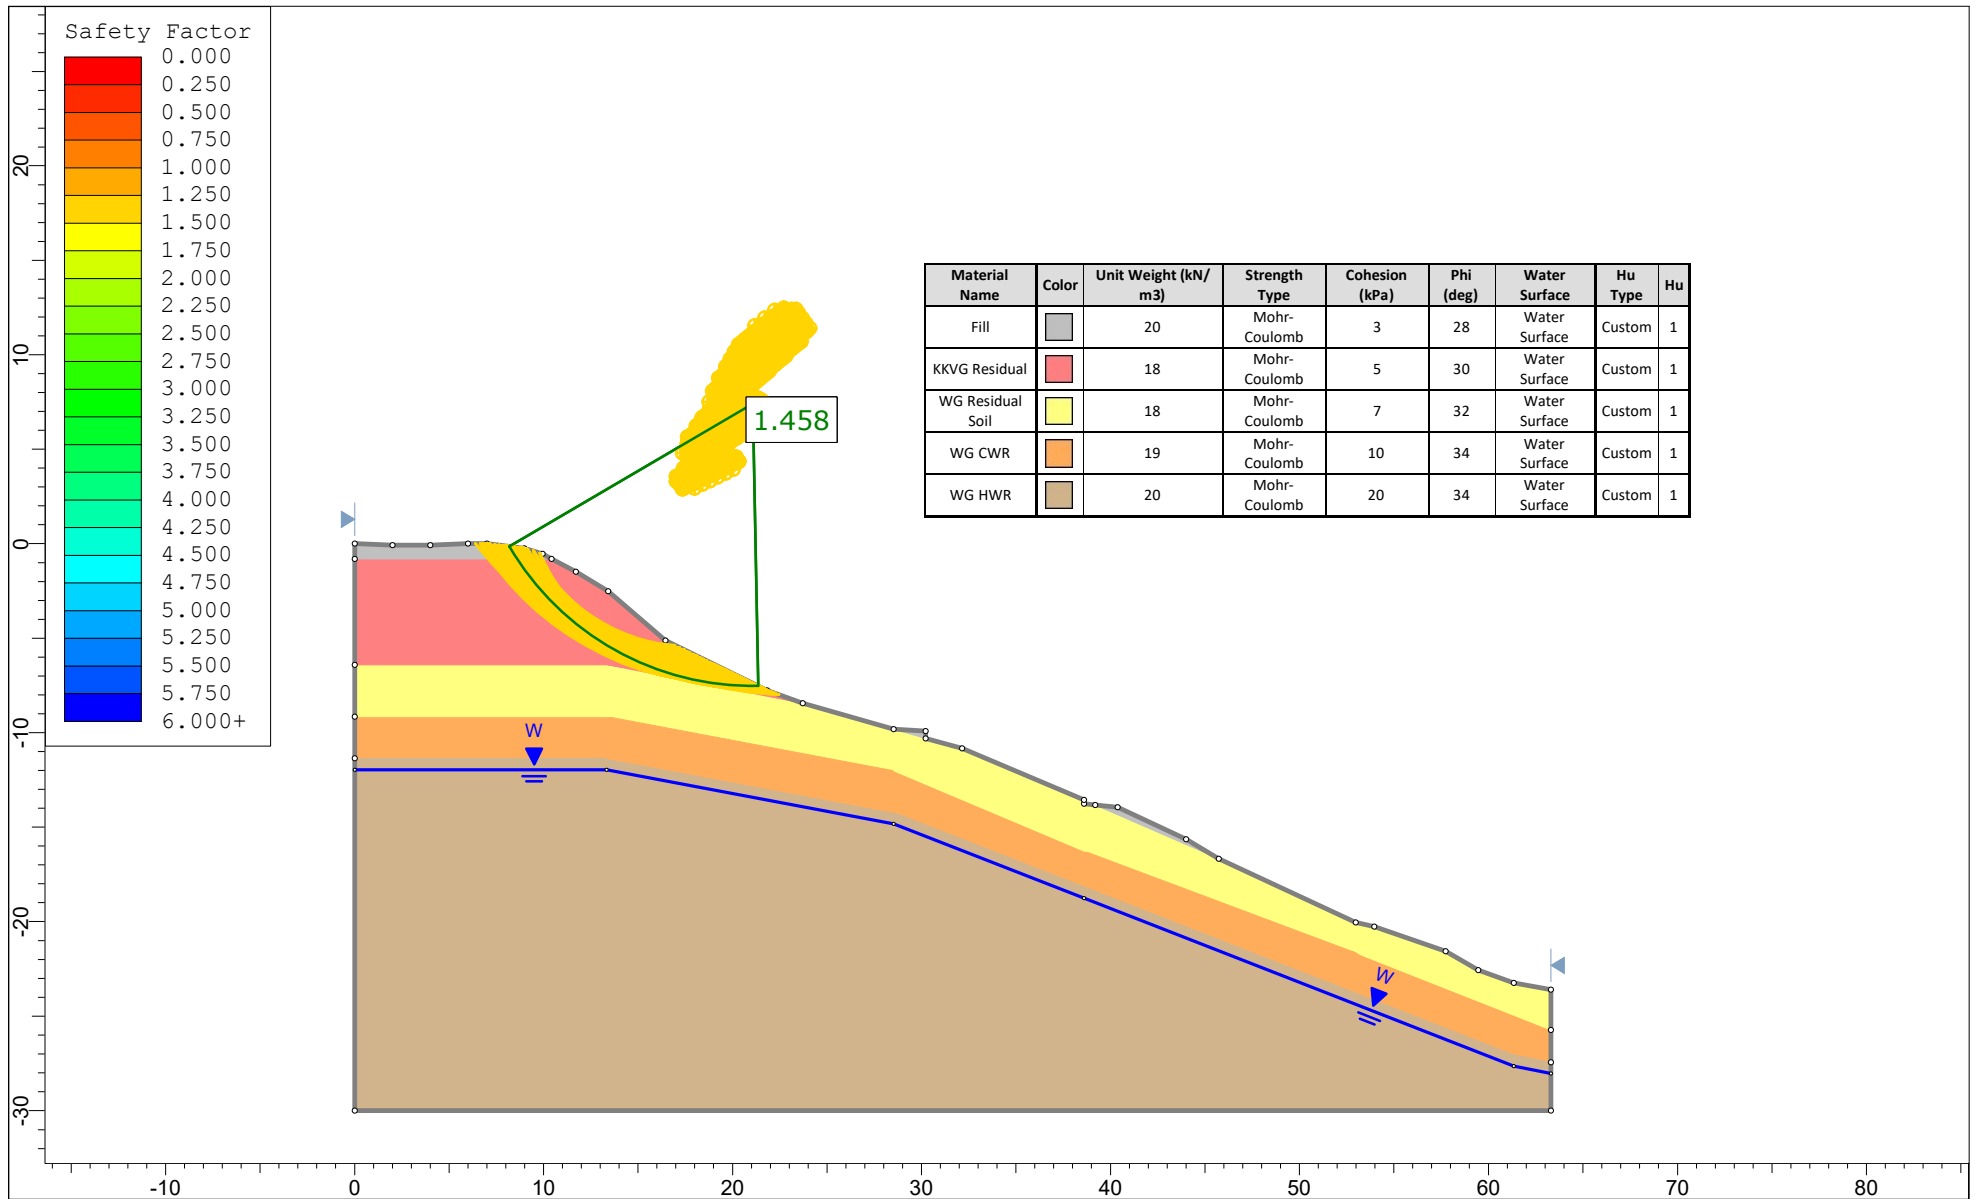
Material Name	Color	Unit Weight (kN/m <sup>3</sup> )	Strength Type	Cohesion (kPa)	Phi (deg)	Water Surface	Hu Type	Hu
Fill	Grey	20	Mohr-Coulomb	3	28	Water Surface	Custom	1
KKVG Residual	Red	18	Mohr-Coulomb	5	30	Water Surface	Custom	1
WG Residual Soil	Yellow	18	Mohr-Coulomb	7	32	Water Surface	Custom	1
WG CWR	Orange	19	Mohr-Coulomb	10	34	Water Surface	Custom	1
WG HWR	Brown	20	Mohr-Coulomb	20	34	Water Surface	Custom	1

The preliminary stability analysis carried out for the possible building area indicates the very steep slope in the northern portion of the property does not meet the minimum FoS under NGWL or EGWL conditions, with FoS of less than 1.5 and 1.2 respectively. This is consistent with historic aerial photographs that indicate historic ground movement has occurred in the vicinity of the property and shallow soil movement that was observed on the steep slope during the site walkover.

The results of the slope stability assessment indicate that the possible building area does not meet the stability criteria under normal ground water conditions or extreme groundwater conditions with FoS of less than 1.5 and 1.2 respectively.

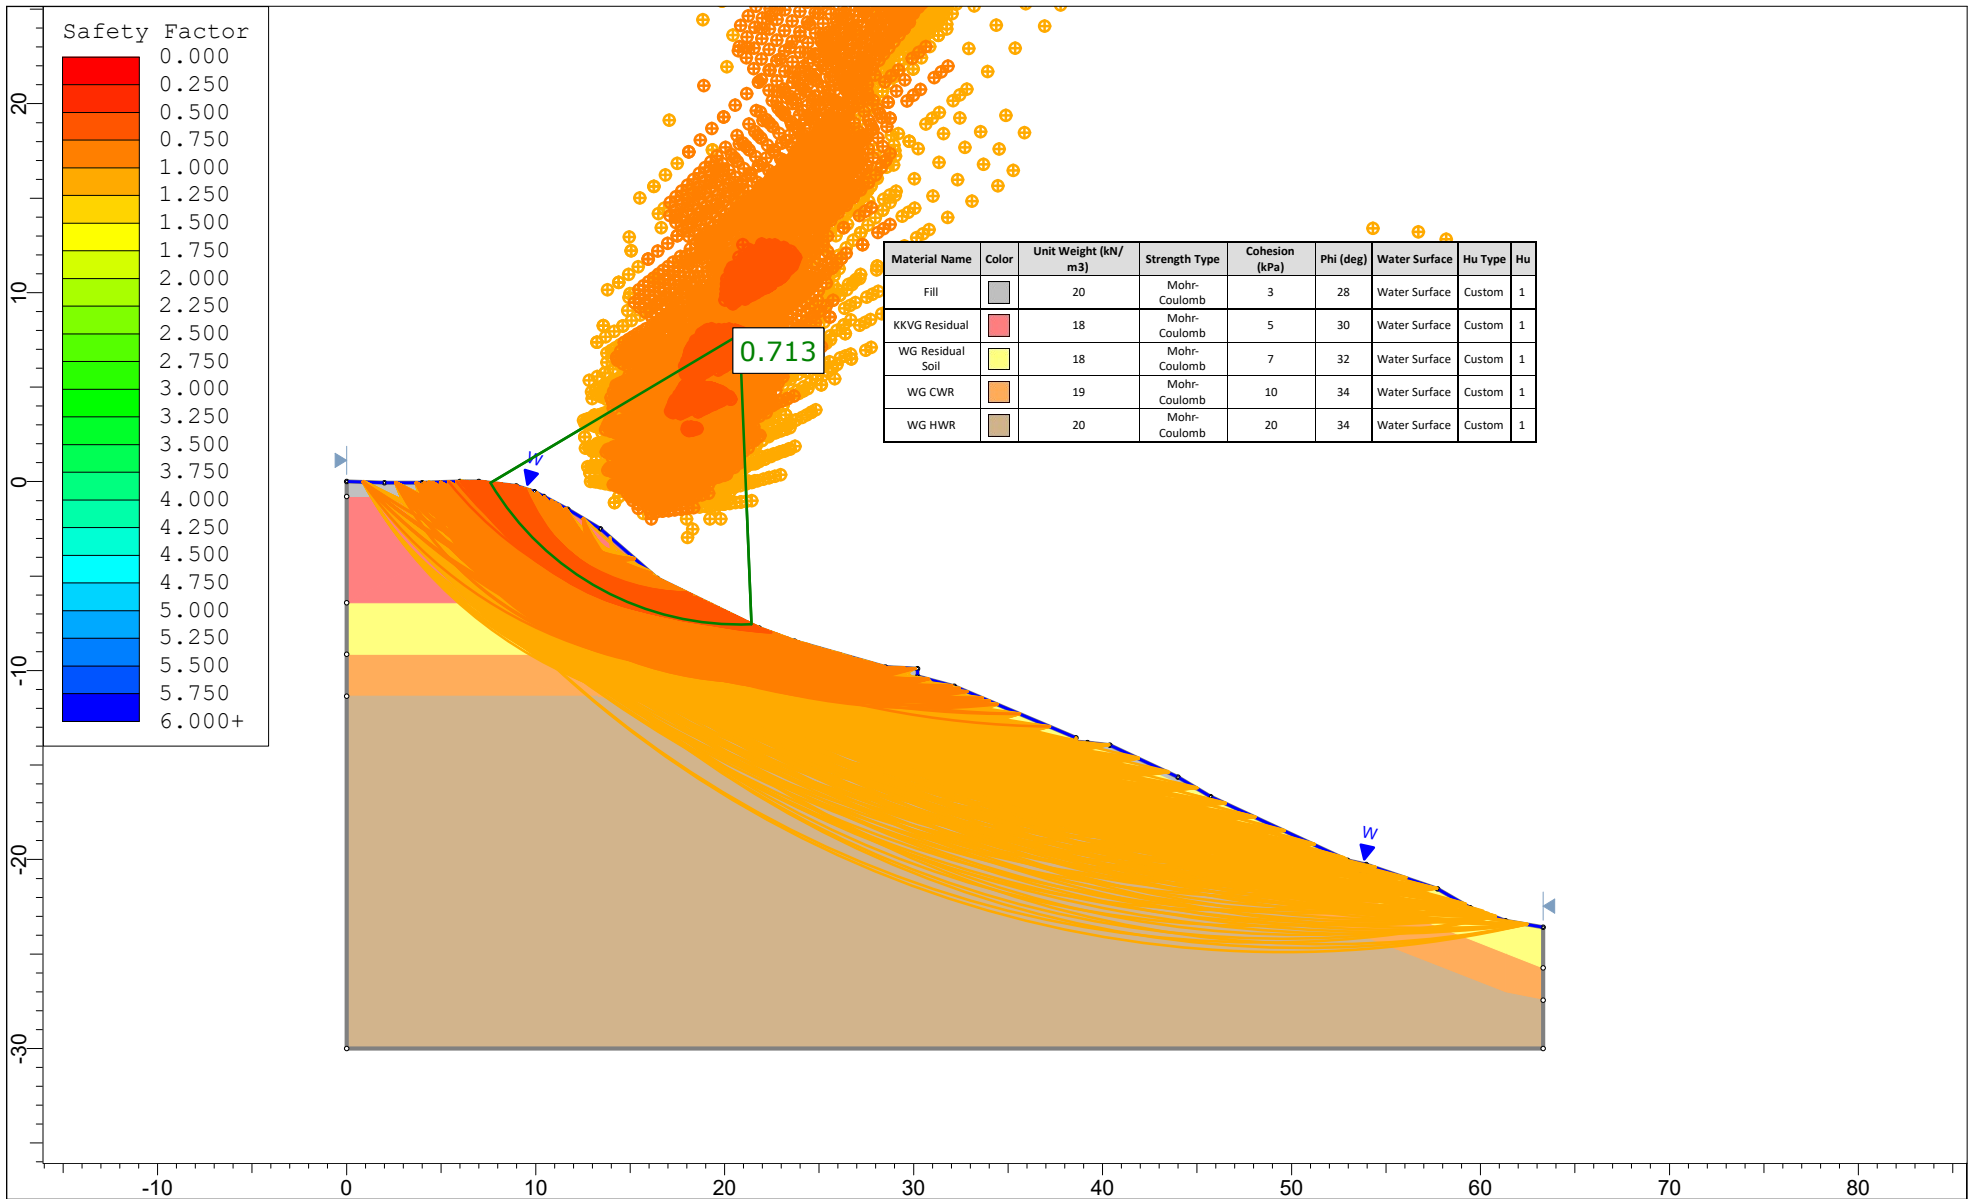
Project		J14599 - Proposed Lot 2, 201 Kerikeri Road, Kerikeri	
	Group		Existing Ground Conditions	Scenario
	Drawn By		D.Simmonds	Company
	Date		08/06/2021	File Name
				EGWL
				VISION
				14599 20210609 profile B.slmd
