### NOTICE OF WRITTEN APPROVAL

Description of the proposal (including why you need resource consent): IT IS PROPOSED TO ADJUST THE NORTHERN AND EASTERN BOUNDARY SETBACK FROM 10m TO 3m.

## 1. Introduction & Proposal Description

Project	J14599 - Proposed Lot 2, 201 Kerikeri Road, Kerikeri		
Group	Existing Ground Conditions	Scenario	NGWL
Drawn By	D.Simmonds	Company	VISION
Date	08/06/2021	File Name	14599 20210609 profile B.slmd

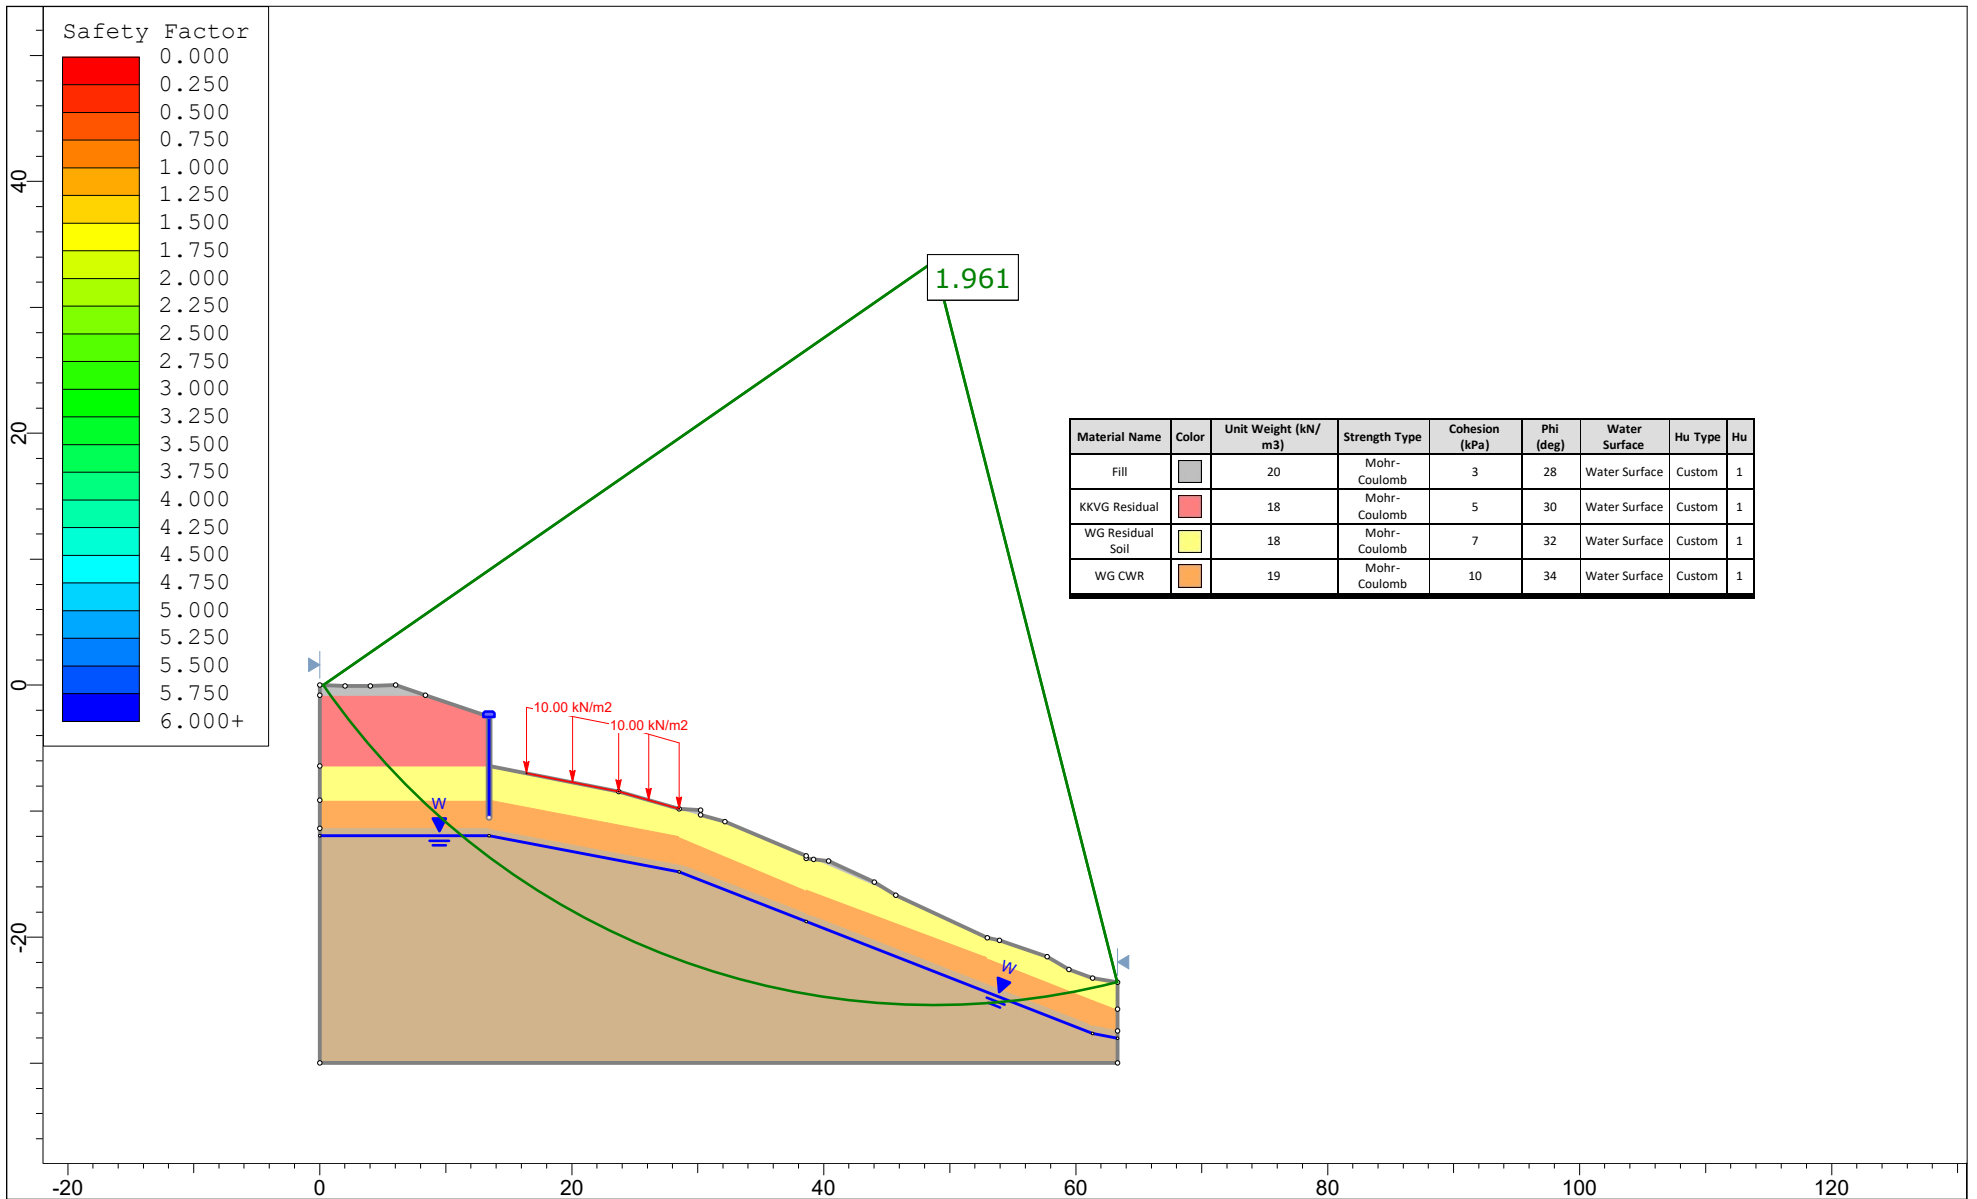
Project	J14599 - Proposed Lot 2, 201 Kerikeri Road, Kerikeri	
	Group	Possible Final Ground Conditions	Scenario NGWL
	Drawn By	D.Simmonds	Company VISION
	Date	08/06/2021	File Name 14599 20210609 profile B final.slm

In order to demonstrate that the minimum FoS can be achieved a retaining wall has been used to retain the very steep slope in the northern portion of the property and to provide a relatively level building area on which a dwelling could be constructed using timber pile foundations. Above the retaining wall, the ground has been regraded back to the property boundary (existing fence) to 1V:3H.

In order to demonstrate that the minimum FoS can be achieved under both NGWL and EGWL conditions, a retaining wall has been used to retain the steep slope in the northern portion of the property and to provide a relatively level building area on which a dwelling could be constructed using timber pile foundations. Above the retaining wall, the ground has been regraded back to the property boundary (existing fence) to 1V:3H.

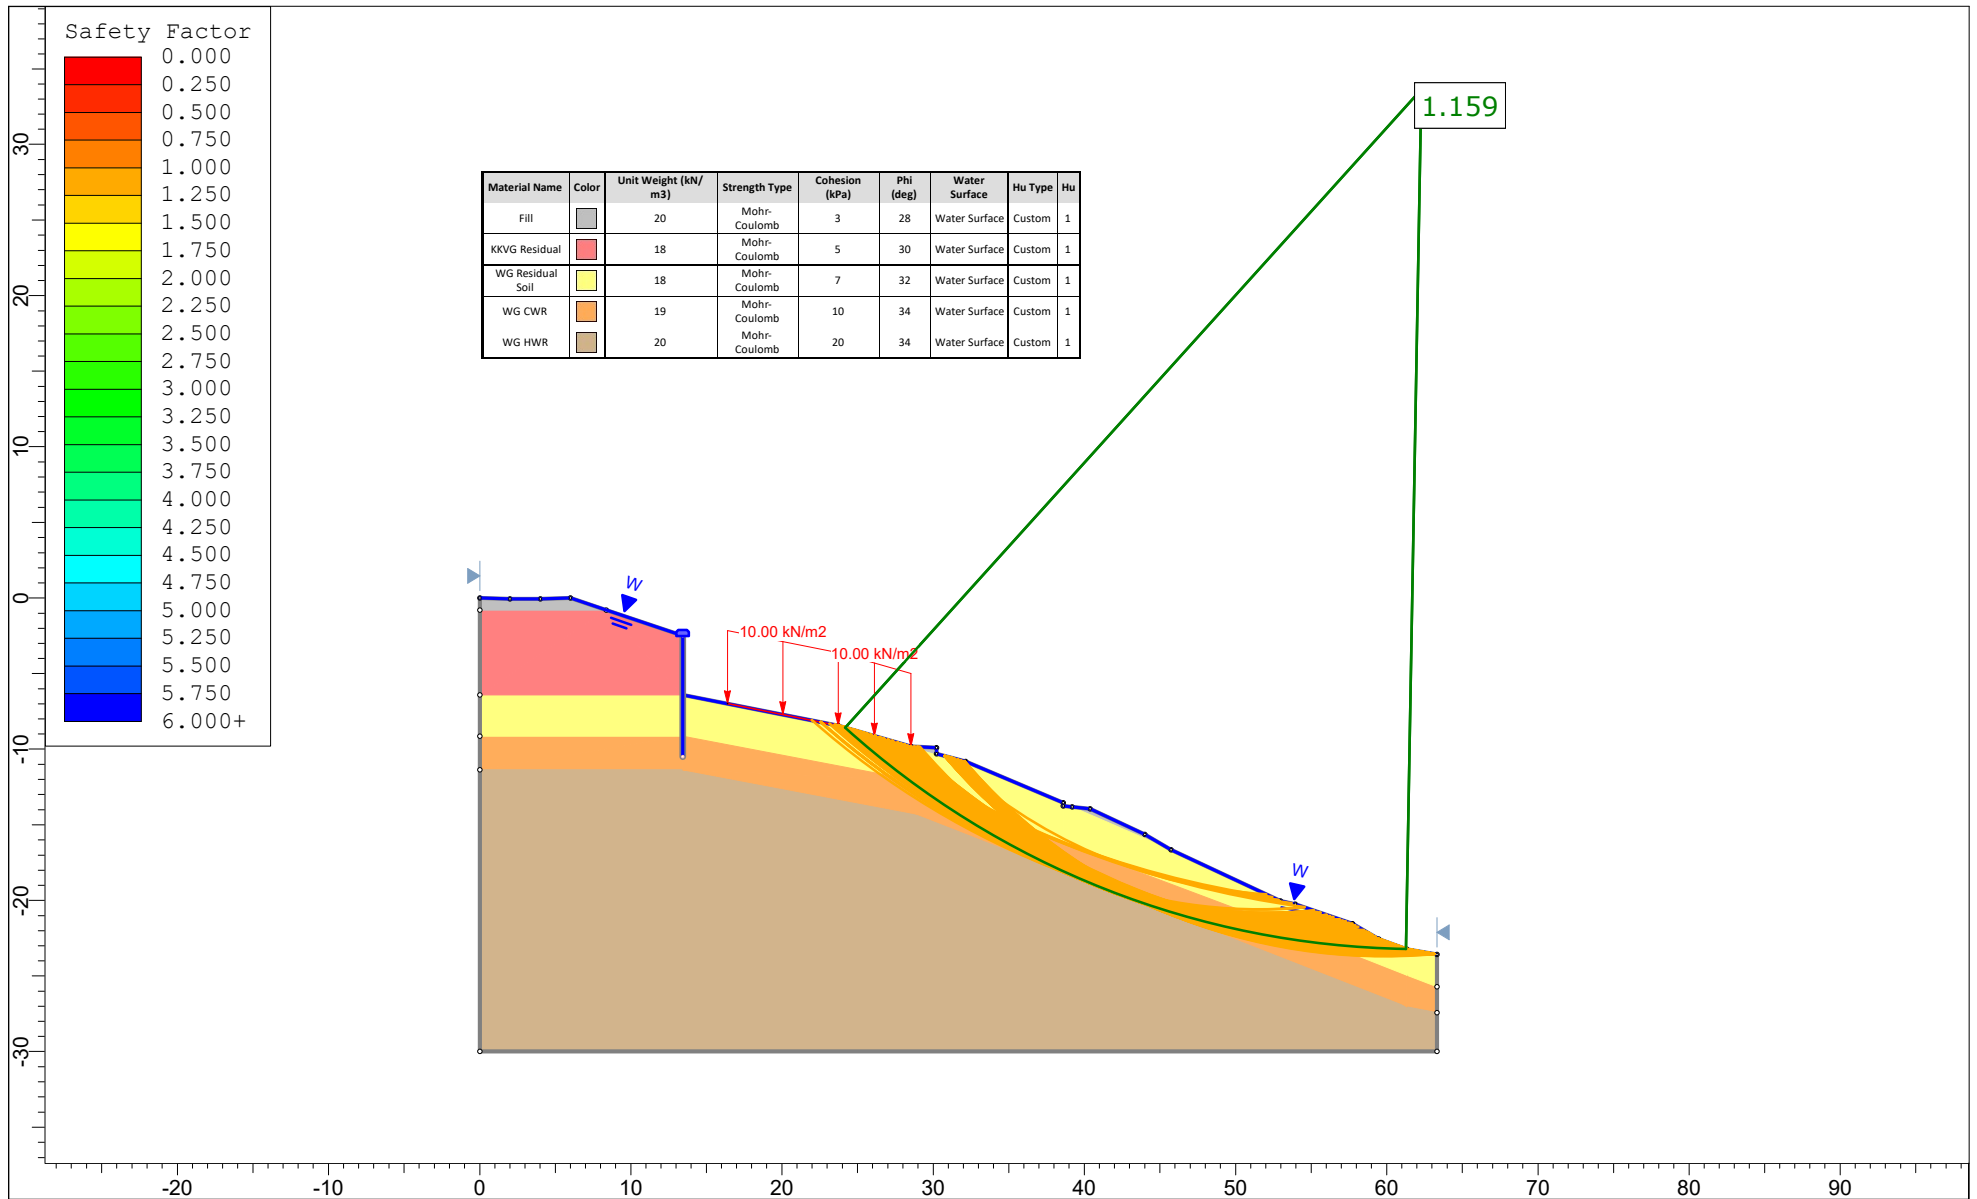
Project	J14599 - Proposed Lot 2, 201 Kerikeri Road, Kerikeri		
Group	Possible Final Ground Conditions	Scenario	EGWL
Drawn By	D.Simmonds	Company	VISION
Date	08/06/2021	File Name	14599 20210609 profile B final.sldm

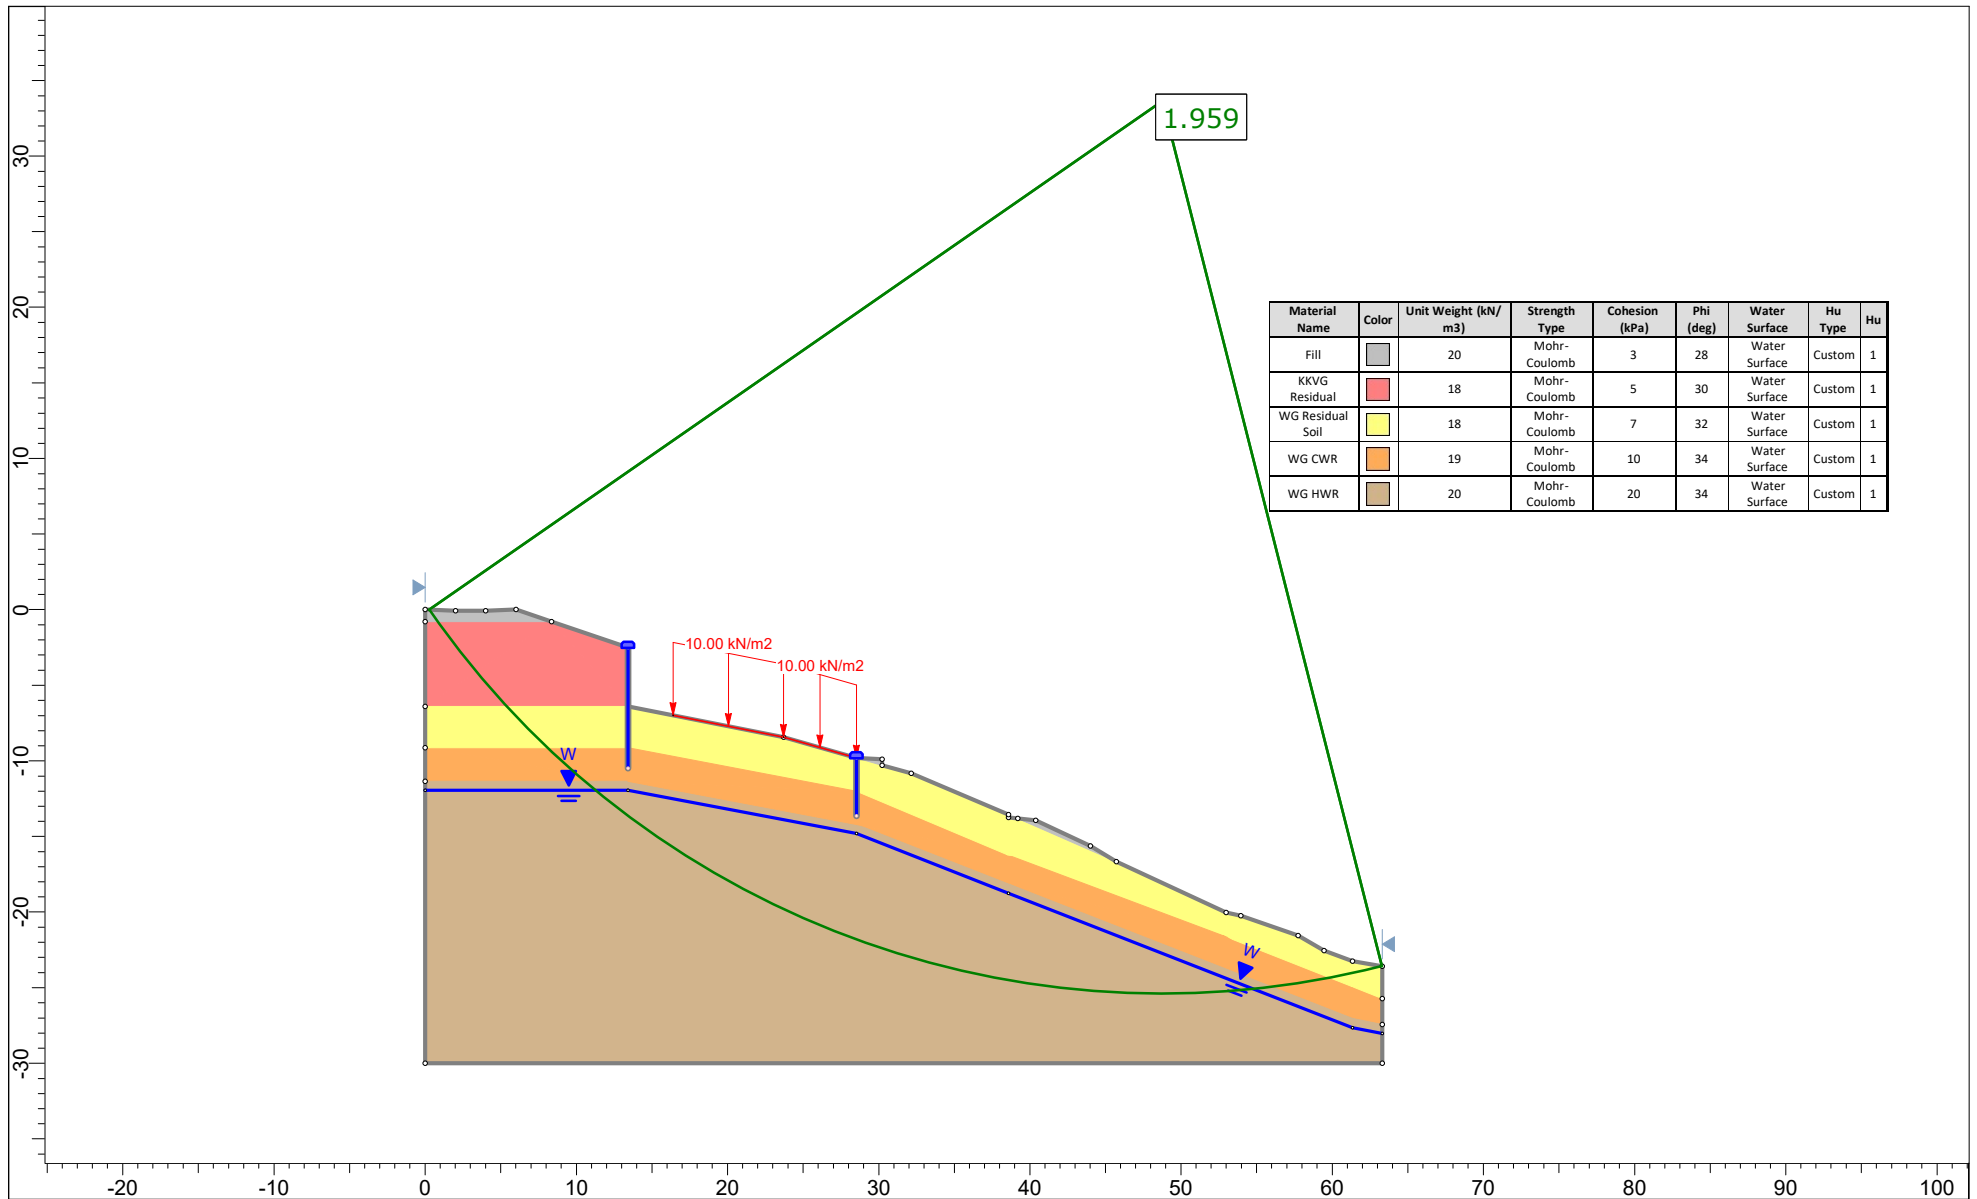
Project		J14599 - Proposed Lot 2, 201 Kerikeri Road, Kerikeri	
	Group		Possible Final Ground Conditions	Scenario
	Drawn By		D.Simmonds	Company
	Date		08/06/2021	File Name
			NGWL with leading edge piles	
			VISION	
			14599 20210609 profile B final.sldm

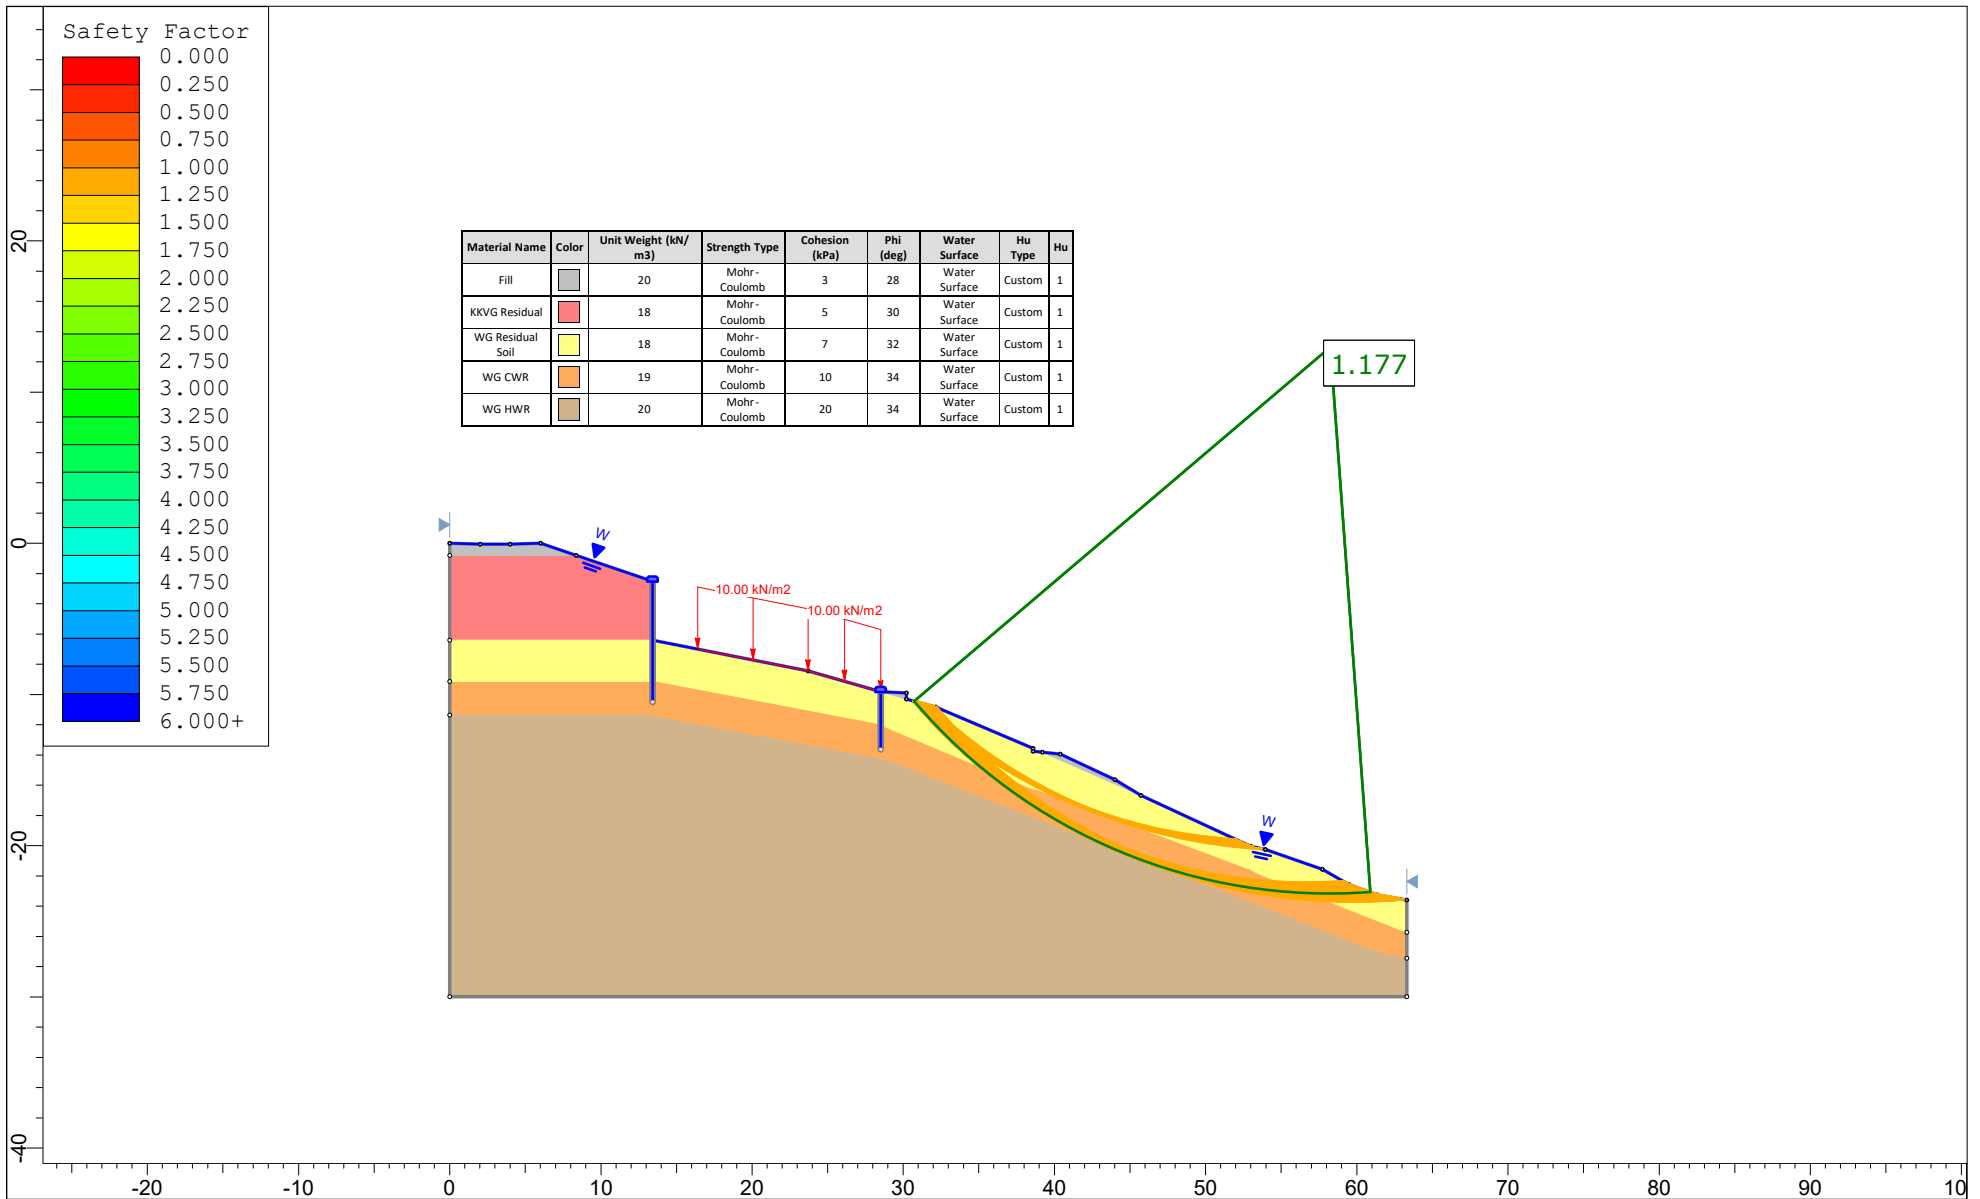
Material Name	Color	Unit Weight (kN/m <sup>3</sup> )	Strength Type	Cohesion (kPa)	Phi (deg)	Water Surface	Hu Type	Hu
Fill	Grey	20	Mohr-Coulomb	3	28	Water Surface	Custom	1
KKVG Residual	Red	18	Mohr-Coulomb	5	30	Water Surface	Custom	1
WG Residual Soil	Yellow	18	Mohr-Coulomb	7	32	Water Surface	Custom	1
WG CWR	Orange	19	Mohr-Coulomb	10	34	Water Surface	Custom	1
WG HWR	Brown	20	Mohr-Coulomb	20	34	Water Surface	Custom	1

1.177

Project	J14599 - Proposed Lot 2, 201 Kerikeri Road, Kerikeri		
Group	Possible Final Ground Conditions	Scenario	EGWL with leading edge piles
Drawn By	D.Simmonds	Company	VISION
Date	08/06/2021	File Name	14599 20210609 profile B final.sldm
