**PROPOSED RESIDENTIAL DEVELOPMENT  
TRANSPORT ASSESSMENT**

**LOT 1 DP53506  
PUKETONA ROAD (STATE HIGHWAY 11)  
HARURU, WAITANGI**

<b>Client</b>	Andre Galvin and Victoria Yorke
<b>Job Number</b>	240545
<b>Title</b>	Proposed Residential Development, Lot 1 DP53506, Puketona Road (SH11), Haruru, Waitangi
<b>Prepared By</b>	Peter Kelly
<b>Date</b>	October 2024
<b>Report Status</b>	Final

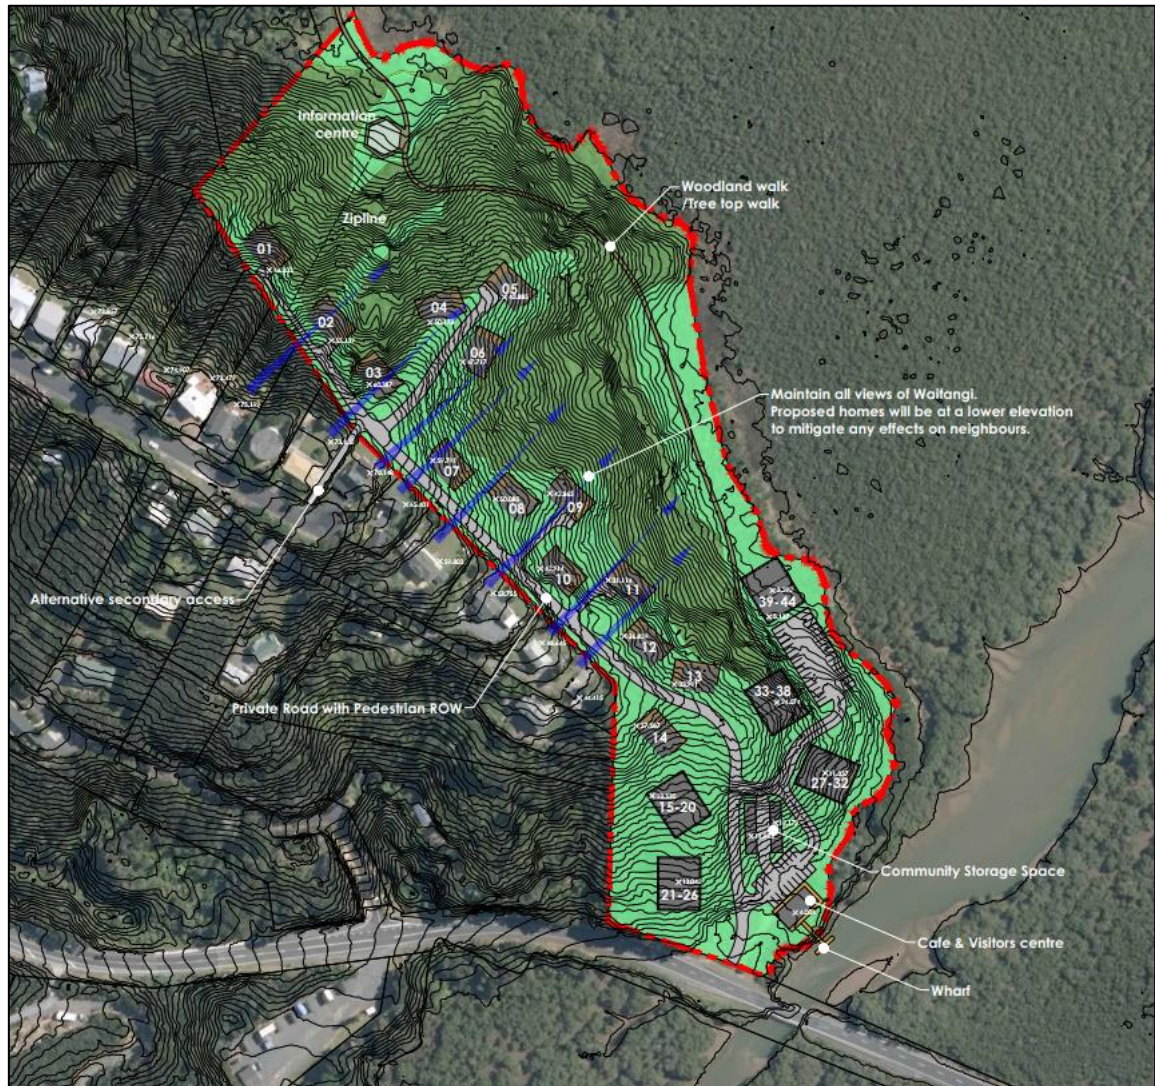
**Figure 4: Proposed Site Plan**

The proposal looks to establish up to 44 dwellings, with a supporting café and visitor's centre. The site will be accessed predominantly via Puketona Road, with the potential for a secondary supporting access via Goffe Drive. The general plan used for the basis of this assessment is shown in **Figure 4**.

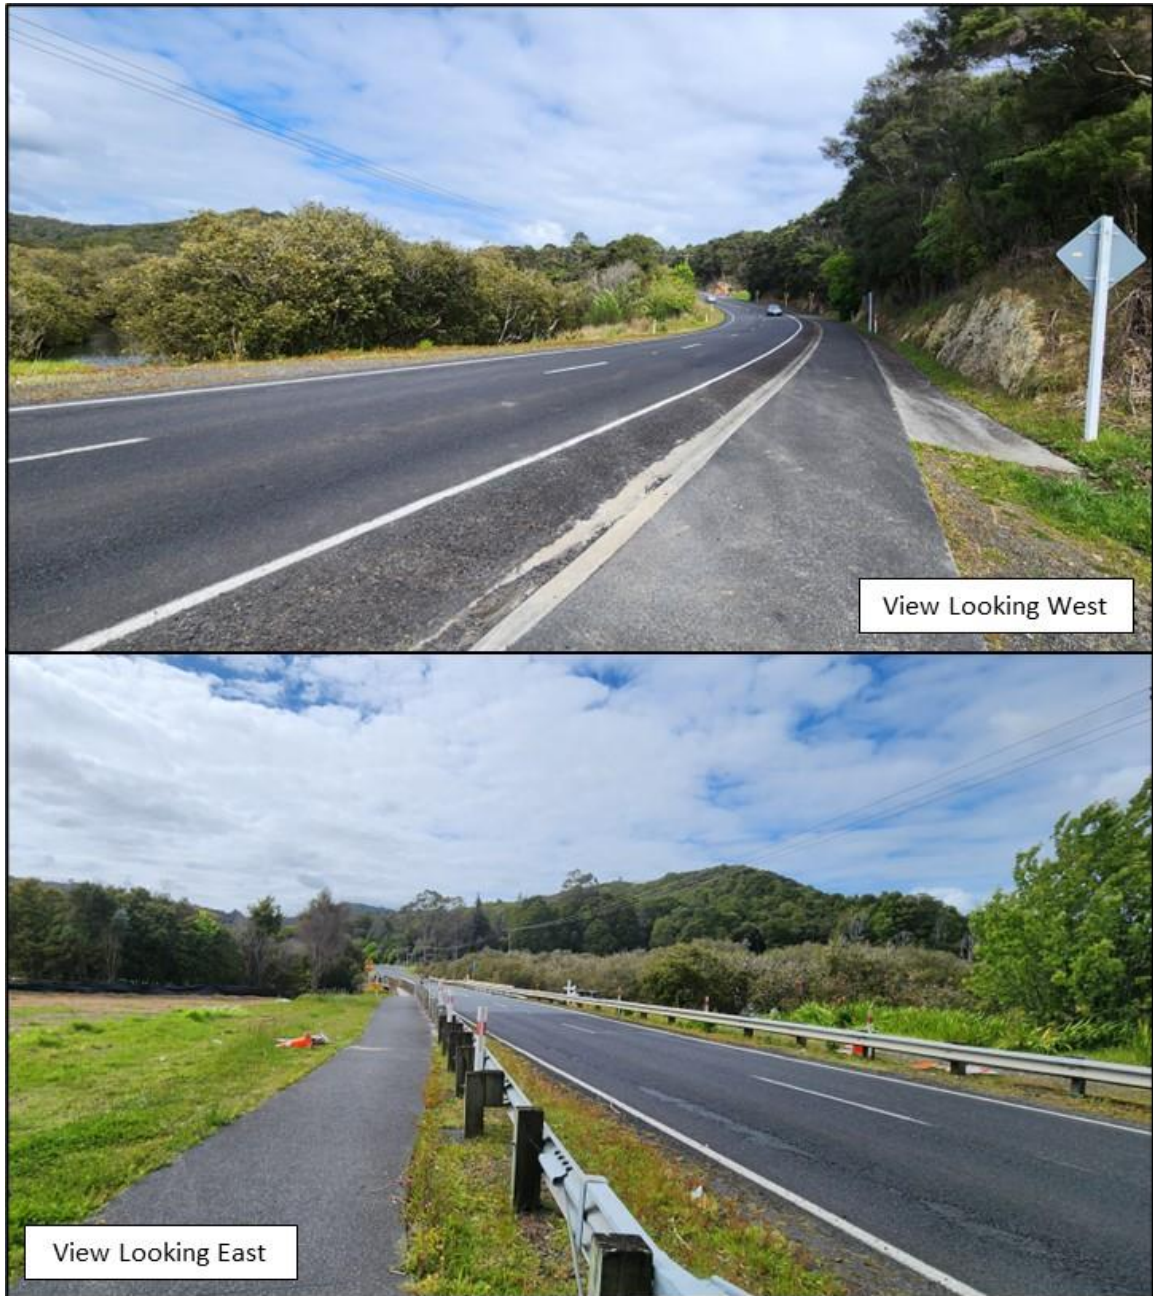
**Figure 5: Indicative Visibility from Proposed Road Connection**

Sightlines at the proposed intersection were reviewed from the indicative hold position along the new road in order to assess the available visibility. From the hold position, it was determined that more than 250 metres of sight distance is available between drivers on the side street and drivers approaching the intersection from the east. Additionally, it was determined that approximately 150 metres of sight distance is available between drivers on the side street and drivers approaching the intersection from the west, with this being able to be increased to approximately 165 metres, with the removal of relatively small amounts of vegetation on the south side of Puketona Road, or 185 metres, with more extensive vegetation removal. **Figure 5** displays the indicative sightlines from the new side road hold position.

Based on the identified operating speeds along SH11, for an 85<sup>th</sup> percentile speed of 82 km/h (eastbound traffic) a Safe Intersection Sight Distance (SISD) of 187 metres is required and for an 85<sup>th</sup> percentile speed of 83 km/h (westbound traffic) a SISD of 210 metres is required (with allowance for a 7% downhill gradient).

Based on this, the access provides suitable visibility to the east but is deficient from the SISD under typical conditions. When applying the Extended Design Domain (EDD), the observation time is permitted to be reduced from 3.0 seconds (typical) to 2.0 seconds, as the access will be a T-junction, and the main road (Puketona Road) will carry more than 5,000 vehicles per day. From this, the eastbound SISD requirement reduces to 185 metres. Reviewing the existing area and the vegetation on the south side of Puketona Road, sightlines could be increased to meet the 185-metre requirement through the removal of approximately 750 m<sup>2</sup> of roadside vegetation, depicted in **Figure 6**. Removal of this vegetation would also increase the visibility towards the intersection with Kaipatiki Rise, thereby increasing road safety overall.

- Sightlines at the proposed access point extend more than 250 metres to the east.
  - Sightlines at the proposed access point extend more than 145 metres to the west and can be increased to 185 metre through vegetation removal.

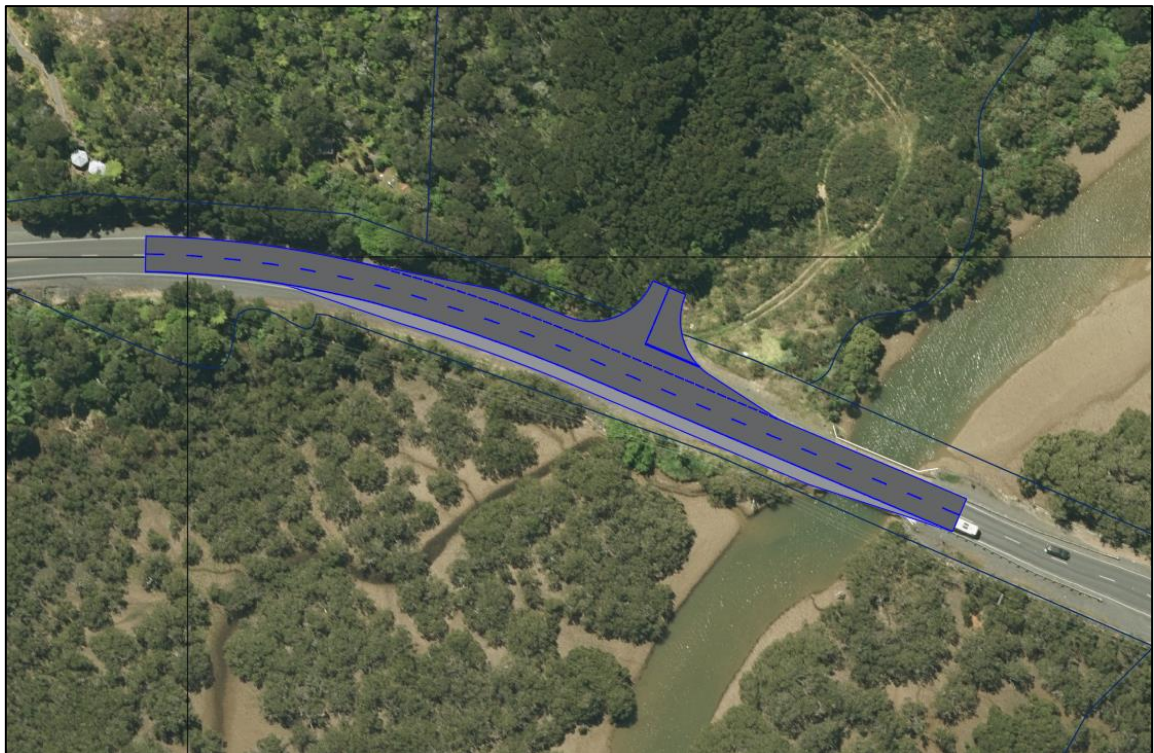
**Figure 7: Indicative Intersection Design**

With the site estimated to generate over 500 daily vehicle trips, the intersection should be formed to a standard consistent with the design parameters set out in Austroads Guide to Road Design Part 4A: Unsignalised and Signalised Intersections. From this, guidance was taken for a Rural basic left-turn treatment (BAL). Additionally, shoulder widening on the south side of Puketona Road was taken from Diagram E of NZTA's Appendix 5B – Accessway Standards and Guidelines. **Figure 7** displays the indicative intersection design. From this, there is sufficient space to accommodate the BAL treatment within the intersection, without impacting onto the formation of the existing bridge approximately 40 metres east of the potential road connection.

Alternatively, a departure from standards could be pursued to reduce the parallel shoulder length where near the intersection by approximately half (35 metres). As there is very good forward visibility for westbound vehicles (250 metres+), drivers approaching the site will be able to identify if there are any vehicles queued to turn right or approaching and signalling to turn right and thereby appropriately reduce their speed to avoid a collision.

As part of any intersection design, the existing guardrails protecting the bridge embankments will need to be realigned in response to the changes to the surrounding environment. There is sufficient space available for this realignment to occur.

- A BAL intersection treatment can be provided for the site, without impacting onto the physical formation of the bridge to the east.
  - Shoulder widening on the south side of the road, if reduced below the distance defined by the standard, can be safely accommodated due to the available forward visibility.

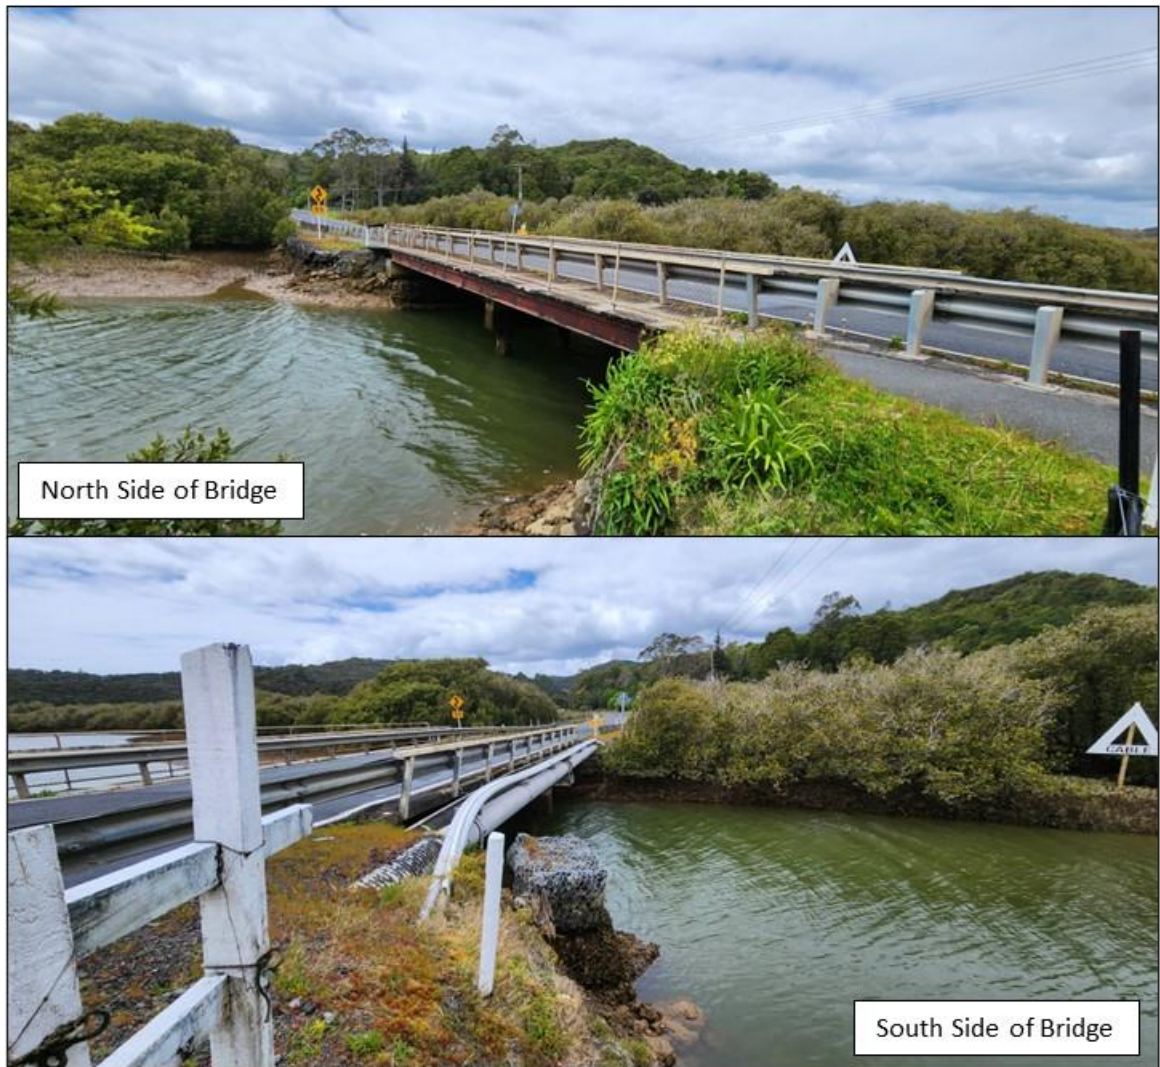
**Figure 8: Existing Bridge**

On the south side of Puketona Road, the Appendix 5B recommended shoulder widening would extend into the bridge, and if a compliant design was pursued the bridge would require widening. With a span of 20 metres, replacement of this bridge, which appeared to be approaching the end of its service life, is considered to be within the realm of feasible remedial measures. **Figure 8** displays the existing bridge.

- In the event that a reduced shoulder widening treatment is not acceptable, the bridge east of the site will be required to be widened. As this bridge has a span of approximately 20 metres, the replacement of the bridge is considered to be within the realm of realistic remedial measures.
