Application for resource consent or fast-track resource consent

New Zealand Transport Authority Waka Kotahi (NZTA)

On 19 August 2022, Te Tai Tokerau/ Northland was hit with a Severe Weather Event, including strong wind gusts and significant rainfall, which caused widespread damage and flooding across the Region, and resulted in several landslides through the Mangamuka Gorge, making it impassable. This damage resulted in the complete closure of SH1 through the Gorge, severing a vital link for the Far North/ Te Hiku-o-te-Ika to the remainder of the country.

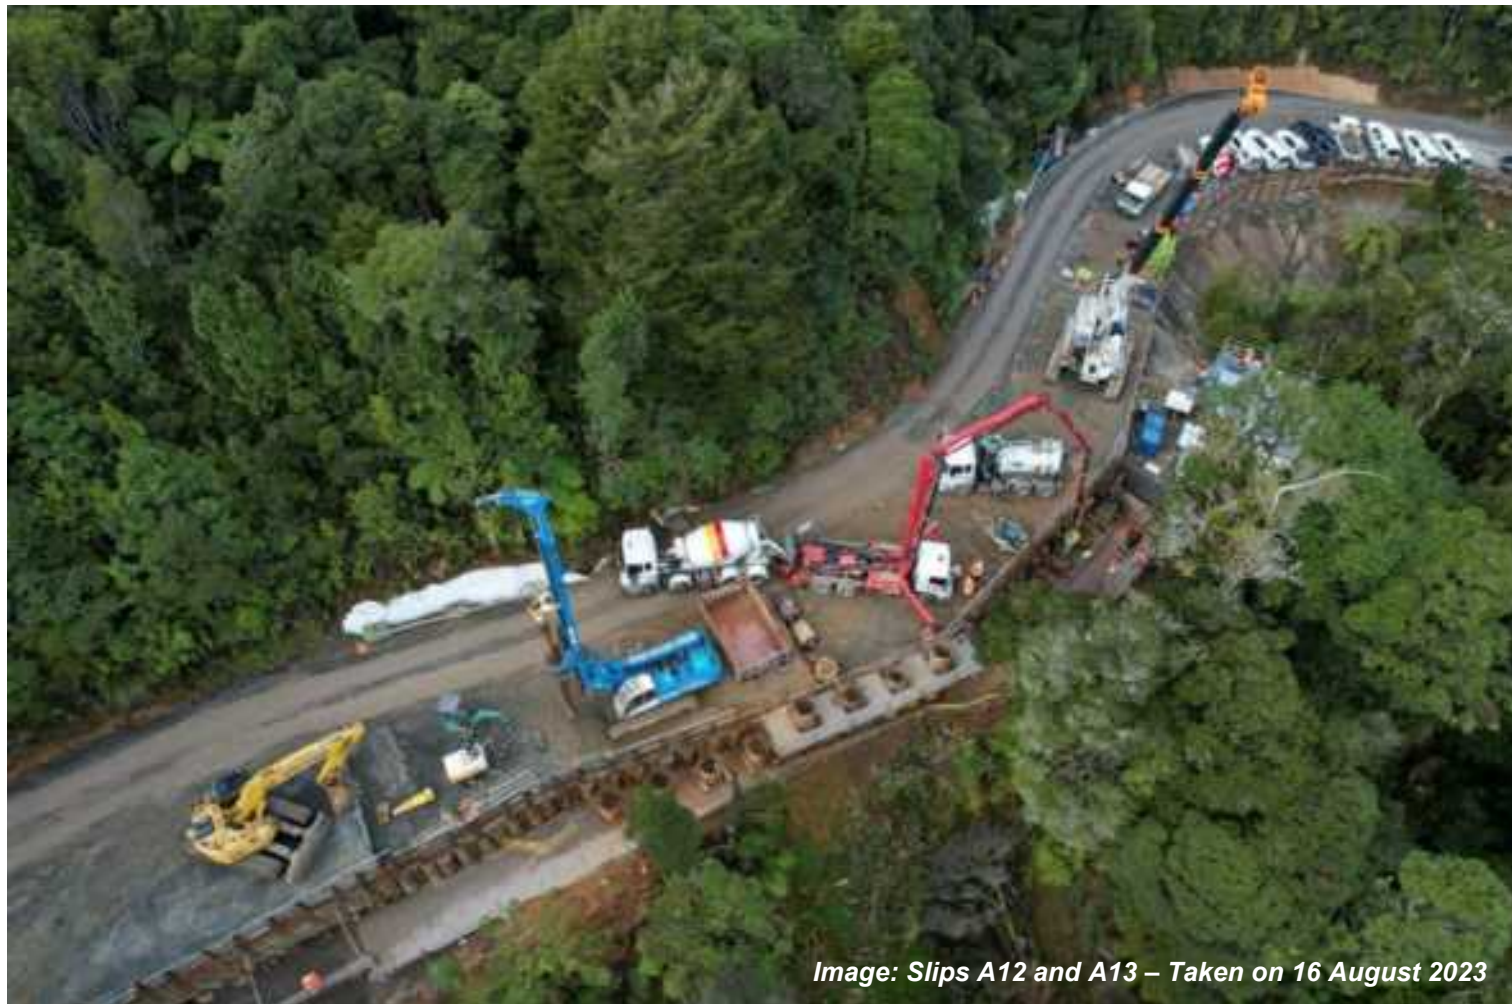
Image: Slips A12 and A13 – Taken on 16 August 2023

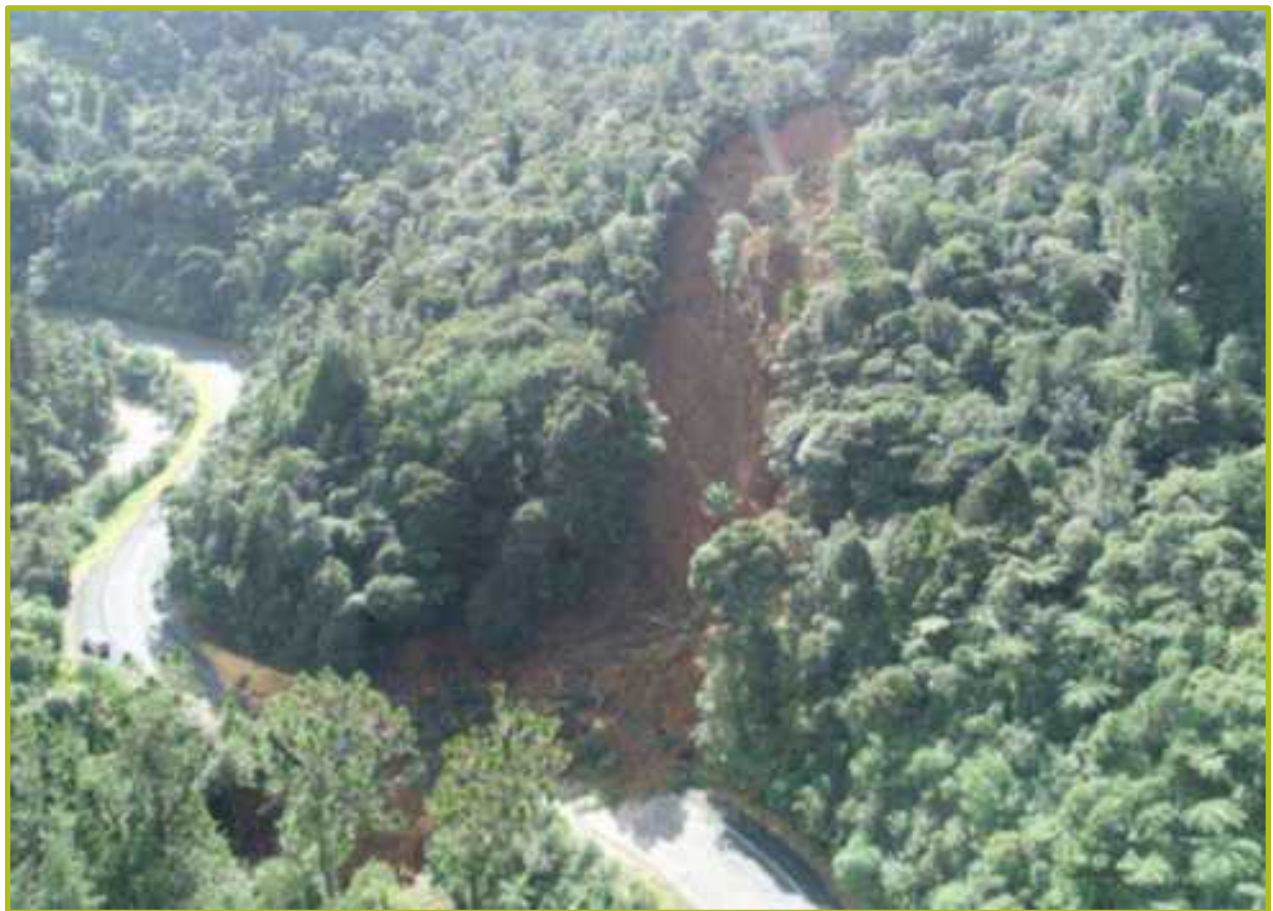
Figure 2: A large slip at the southern end of the Gorge in the immediate aftermath of 19 August 2022 Weather Event
(Source: NZTA Media Release - 24 August 2022)

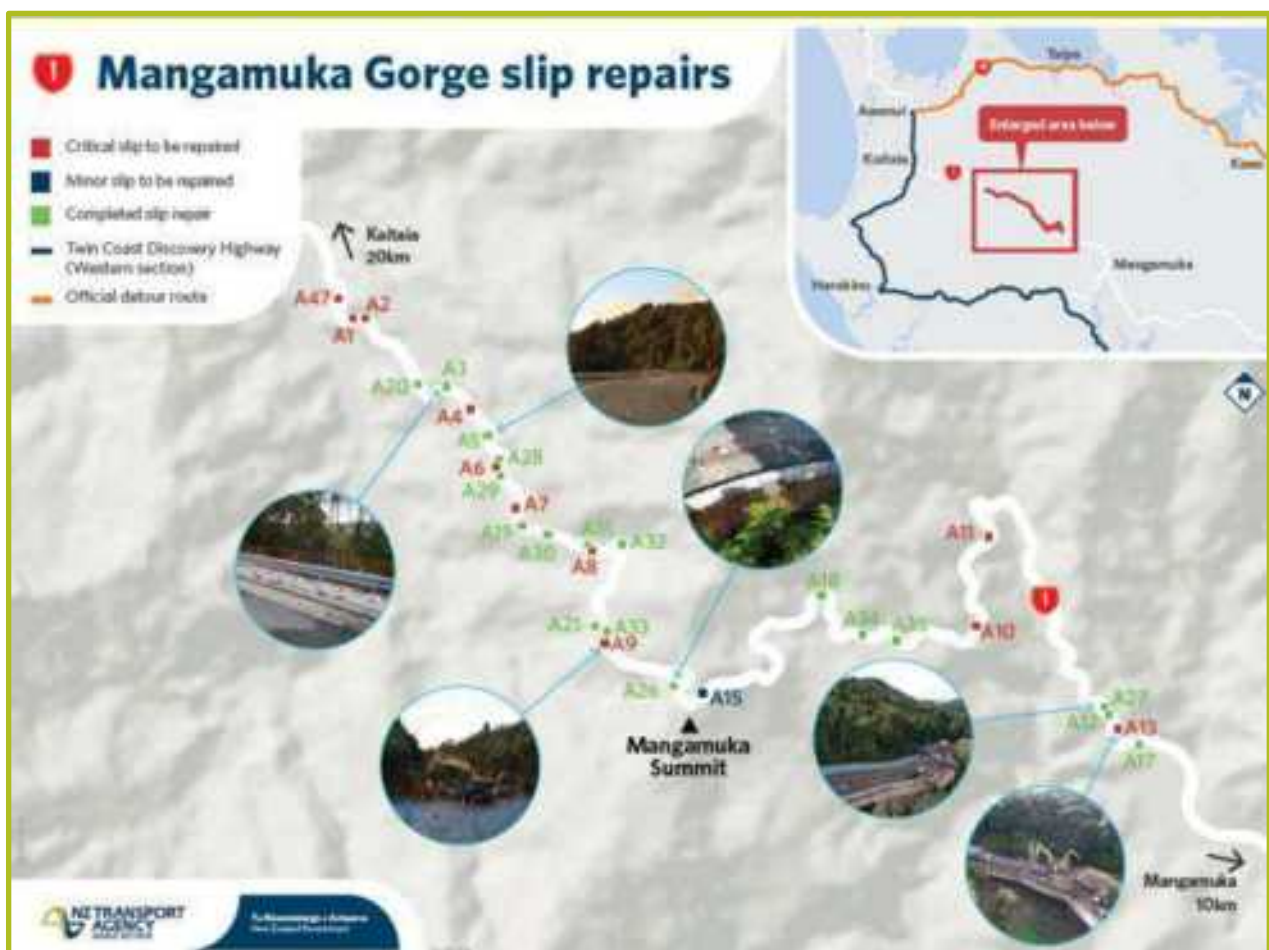
In total there are 24 “critical” slip sites, being slips posing an imminent risk of complete evacuation of the road, across the entire Gorge (refer **Figure 5**), mostly comprising underslips and several “minor” slips. Remediation works were undertaken across all the slips, including replacement and upgrade of stormwater infrastructure such as culverts.

Figure 5: Critical Slip Sites - Mangamuka Gorge

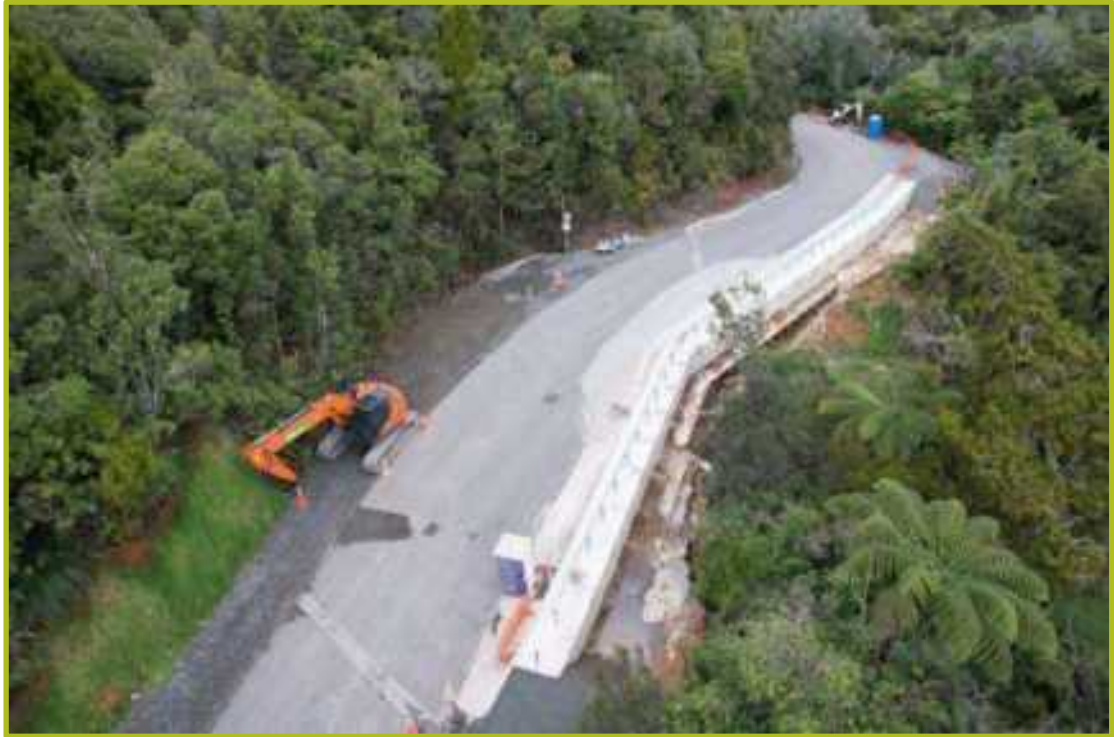
Figure 6: Example of Typical Slip Site (Slip A5 Near Completion of Remediation Works (Image Taken: 6 August 2024))

- c. sealing road cracks to reduce ground soakage.
3. Following the initial slip mitigation works, the majority of slips have been stabilised with the construction of a concrete pile wall on the outer edge of the road. This was a 2-stage process, whereby '*temporary*' shallow piles needed to be installed first to support a larger drilling rig which constructed the larger, permanent piles.

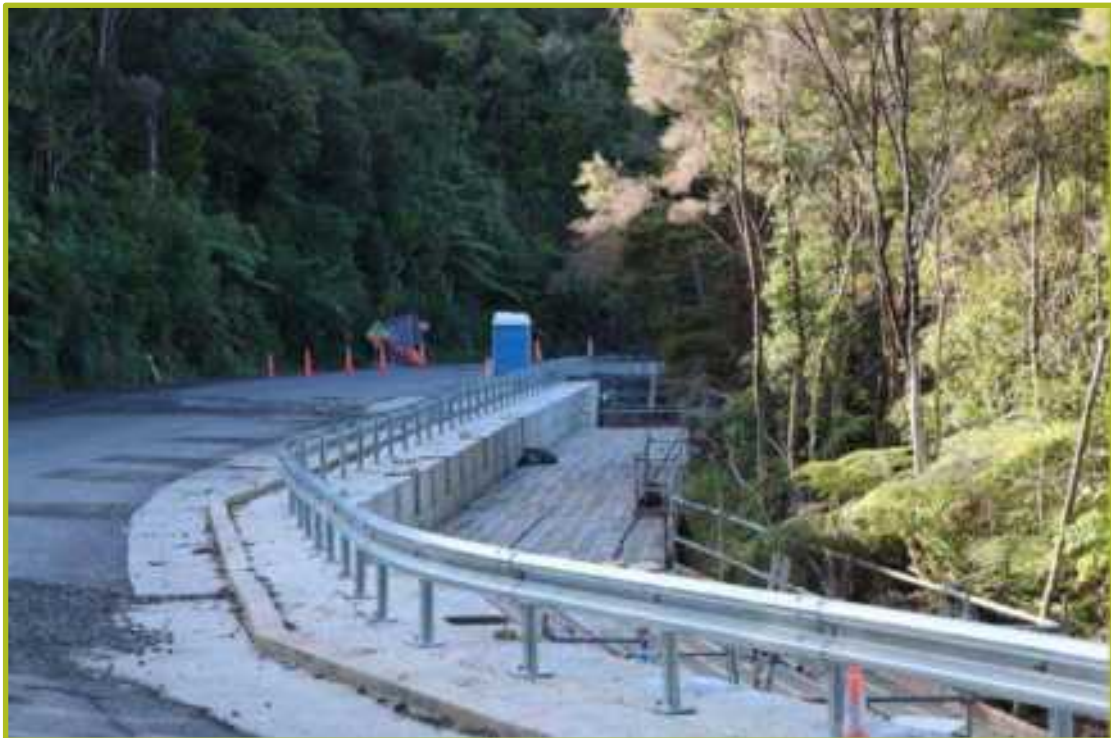
Figure 7: Example of Typical Slip Site (Slip A3 Near Completion of Remediation Works (Image Taken: 14 August 2024))

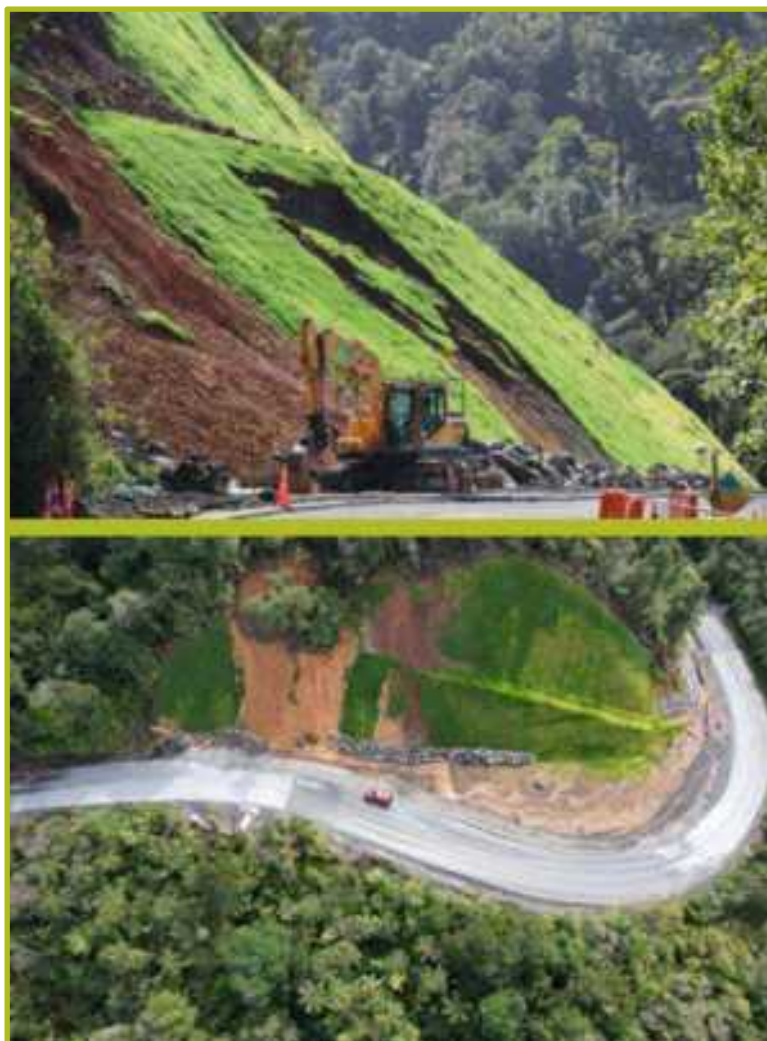
Slip A11 is a historic slip first reported in 1988 during Cyclone Bola and is known as a “*Whole Road Slip*”. The slip was 50m wide and very deep-seated and extensive with a 20m depth failure surface under the downslope shoulder of the highway.

Figure 8: Slip A11 (Images taken: August 2024)

NZTA have also installed a monitoring system to monitor any future movement where the road has been reinstated. The option to build the new alignment if required in the future is still retained.

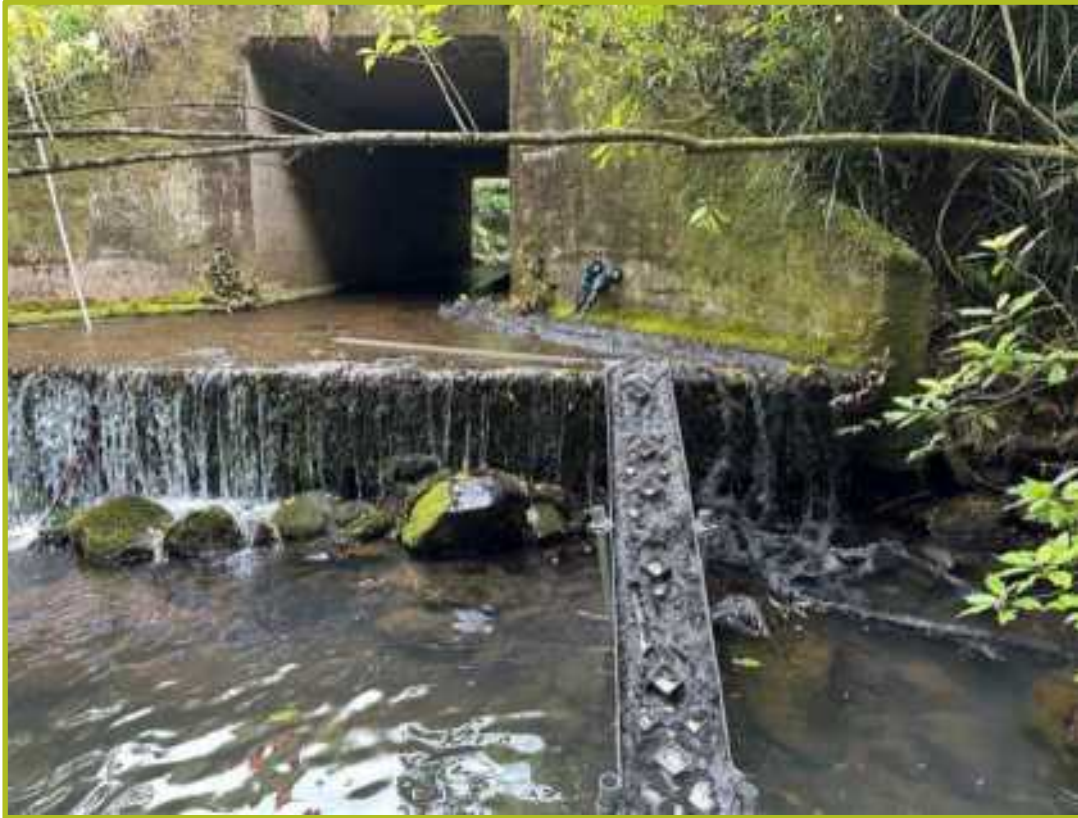
Fish passage structures were installed in several culverts based on a priority approach, which saw fish passage improved and/or restored to the four main permanent streams throughout the Gorge.

Figure 9: Fish Ladder installed as part of the Fish Passage Betterment across the Gorge (Image taken 5 December 2024)

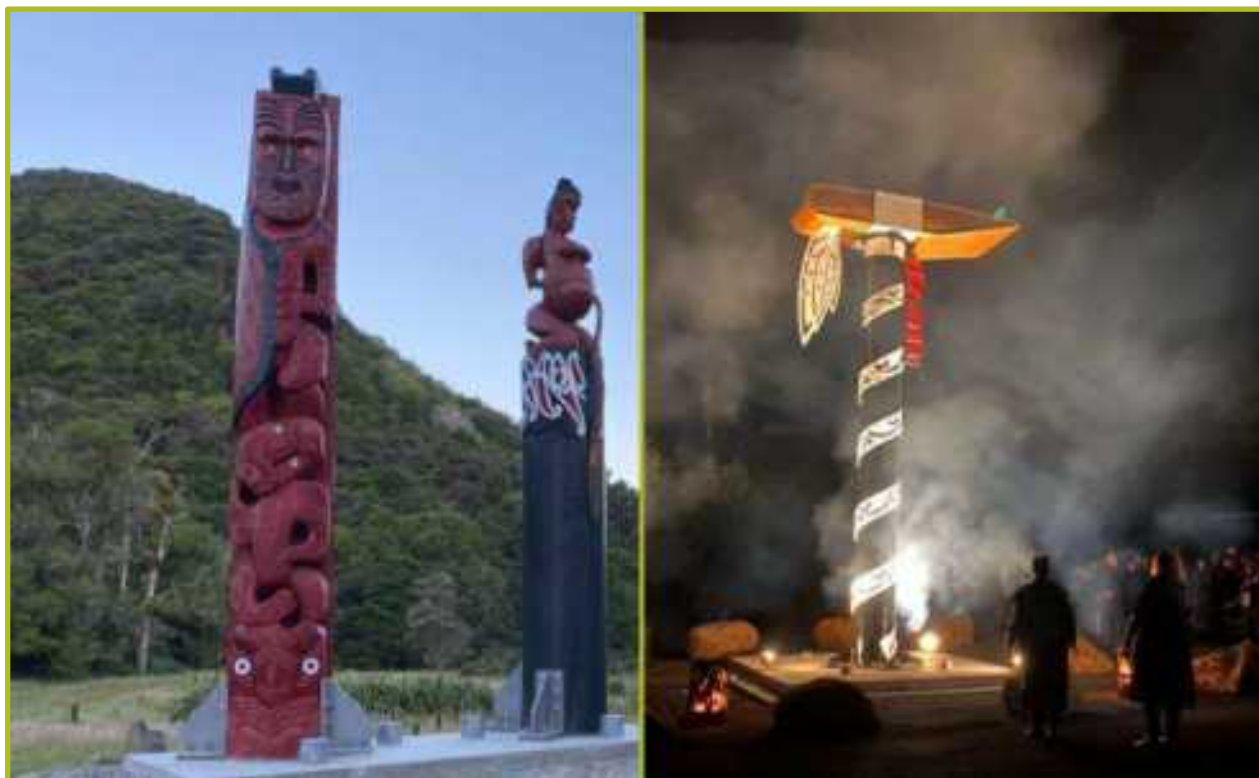
The Northern Pou (refer **Figure 10**) is carved from timber and is approximately 3.5m high with a 0.6m diameter.

The Southern Pou (refer **Figure 10**) is constructed out of steel is similarly approximately 3.5m high with a 0.6m diameter.

Figure 10: (Left) Northern Pouwhenua; (Right) Southern Pouwhenua

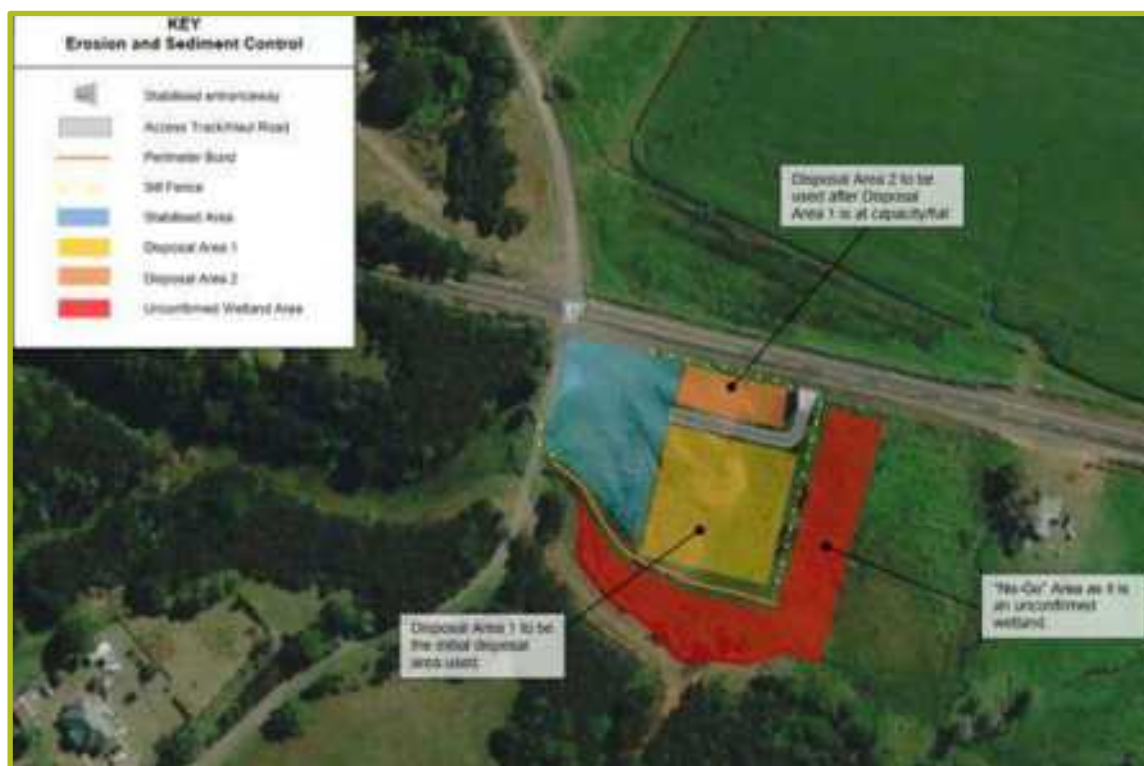
The southern edge of the laydown yard is demarcated with a grassed bund which is set back approximately 5m from a stream, and the eastern edge has a silt fence beyond which is a natural inland wetland. A “no go” zone was established (refer **Figure 12**) that ensured the works and utilisation of the Southern laydown site did not encroach within the natural inland wetland area, and the utilisation of the site was confined to the areas that were already established as a laydown area, prior to its use as one for the Slip Response.

Figure 12: Excerpt from CLL Erosion & Sediment Control Plan, which also indicates “no go” zone in and around a natural inland wetland. *Note that fill was not disposed on the site despite the notations on the plan.* (Source: CLL Contractors)

The Site was purely used as a Laydown Yard; no fill activities were undertaken on the Site, and no cleanfill was deposited at the Site.

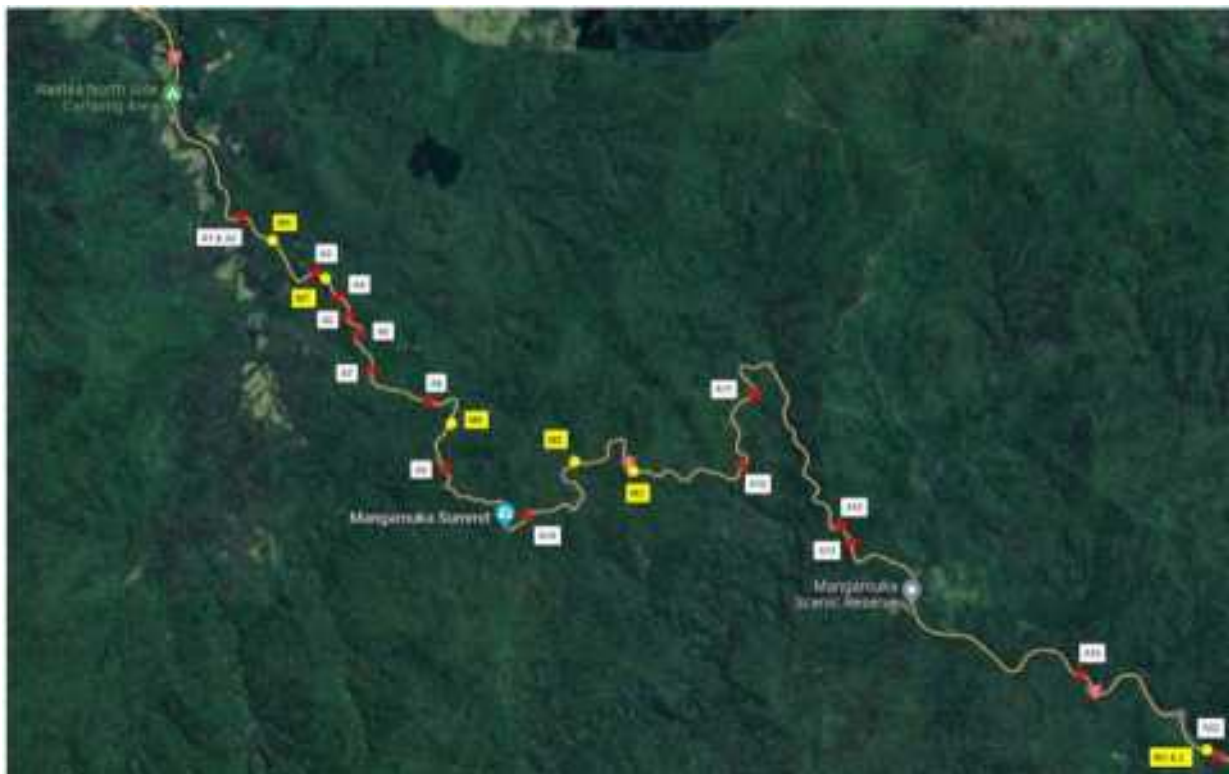
Figure 1: Slips on State Highway 1, Mangamuka

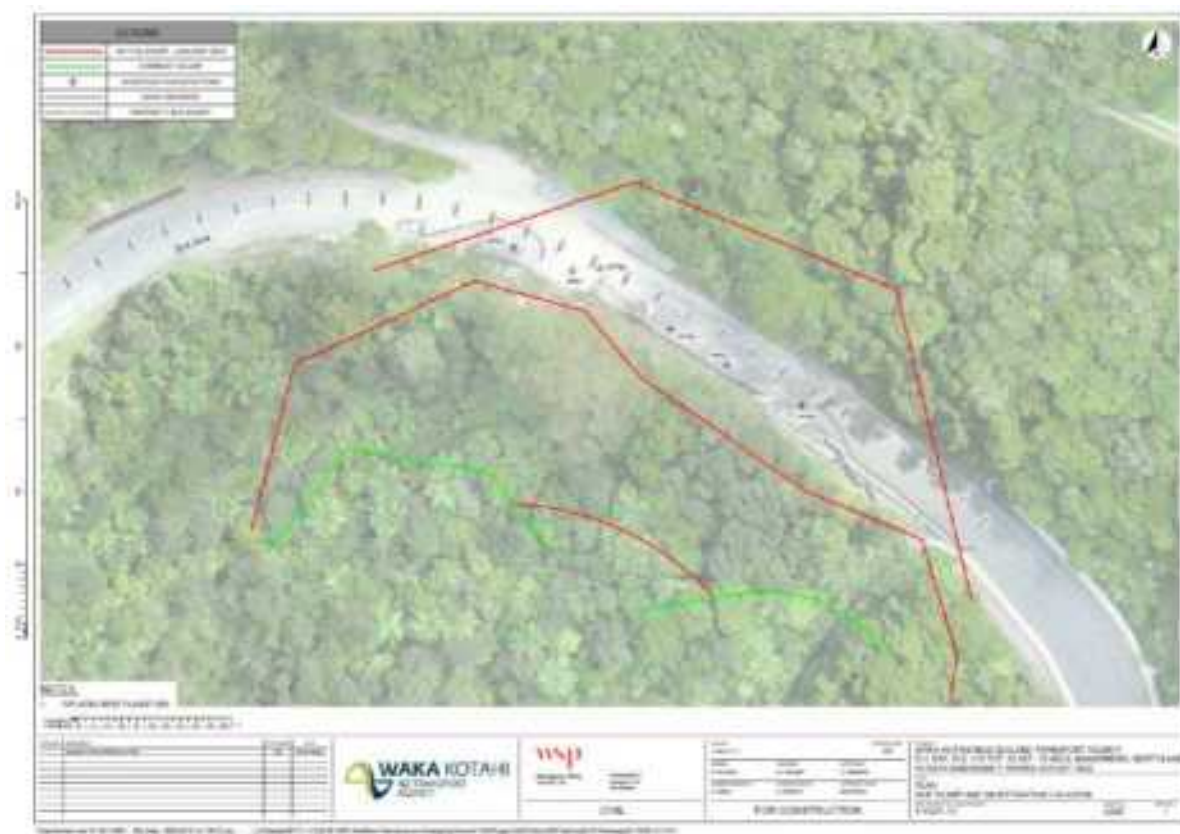
Figure 2: Slip A3.

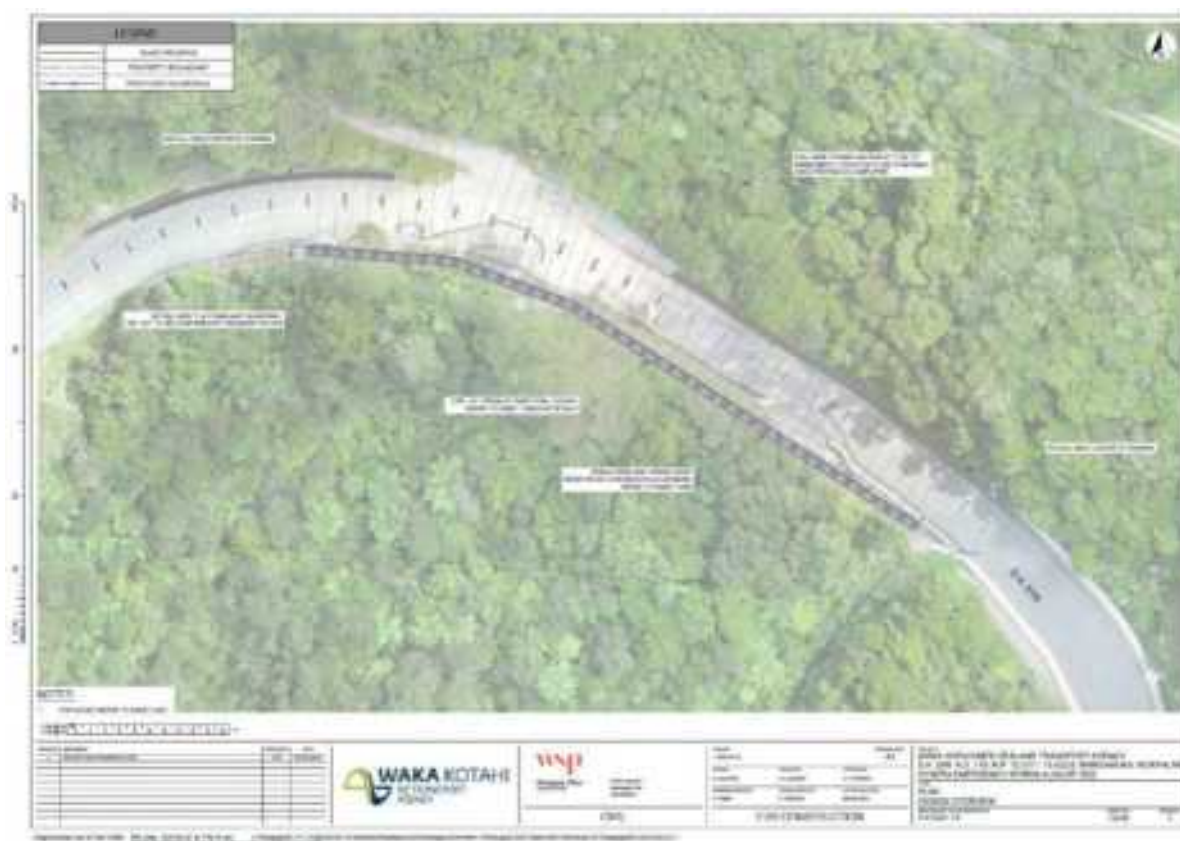
Figure 3: Slip A3, plan of concrete cap and pile retaining and new channelling.

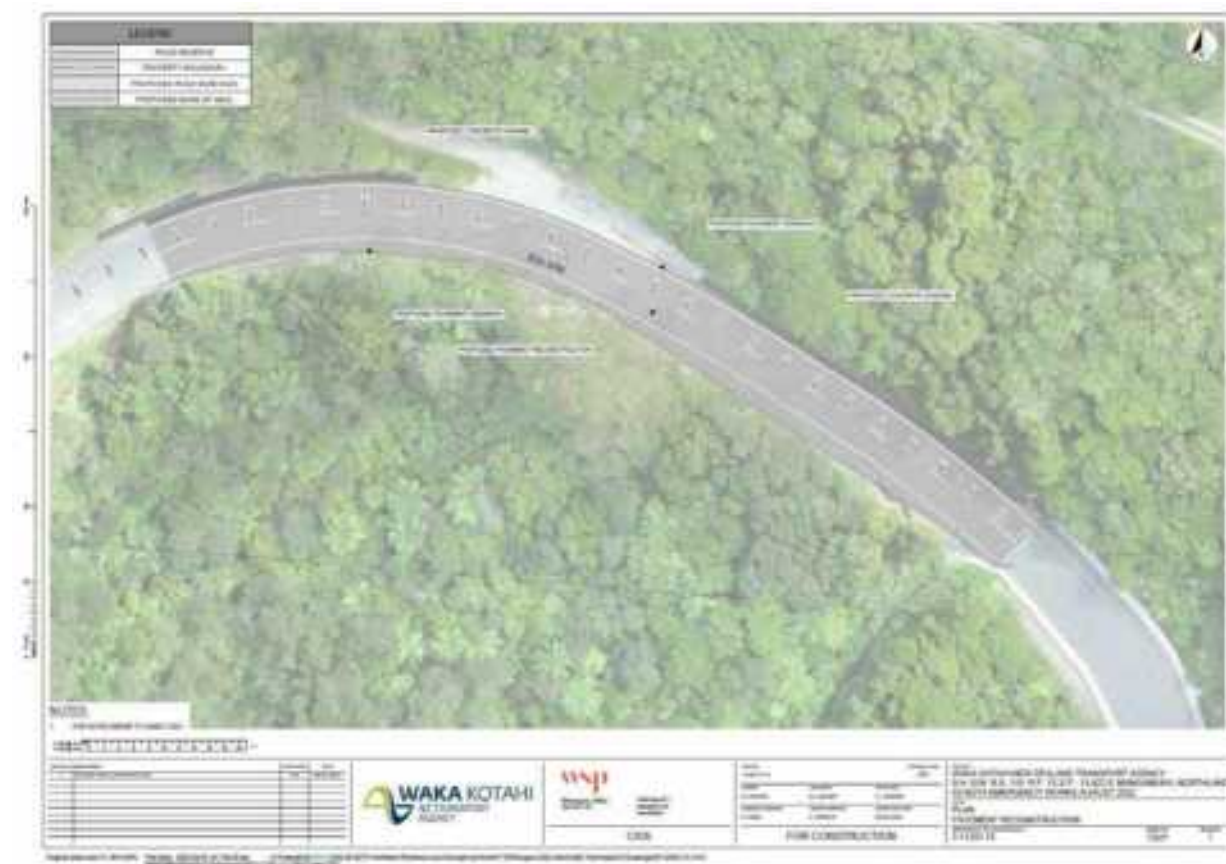
Figure 4: Slip A3, plan of pavement reconstruction.

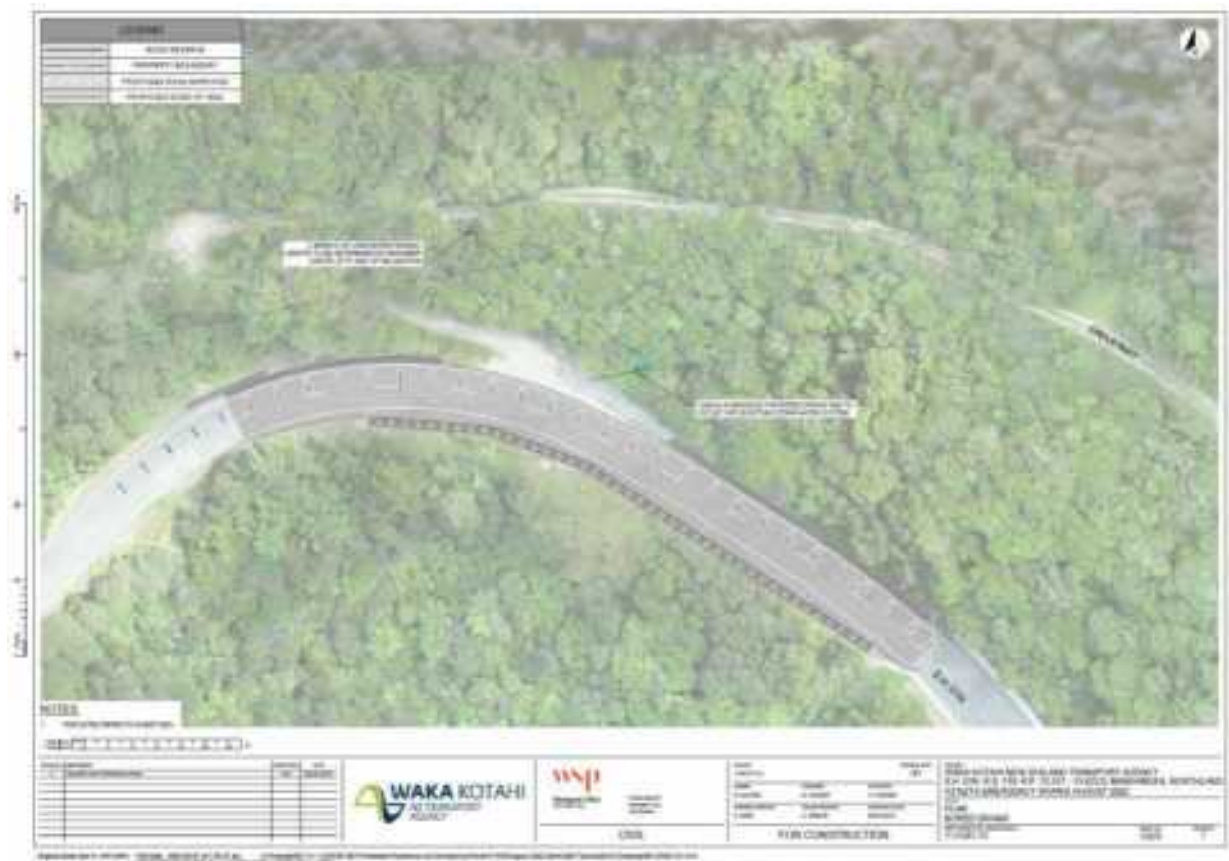
Figure 5: Slip A3, plan of bored drains.

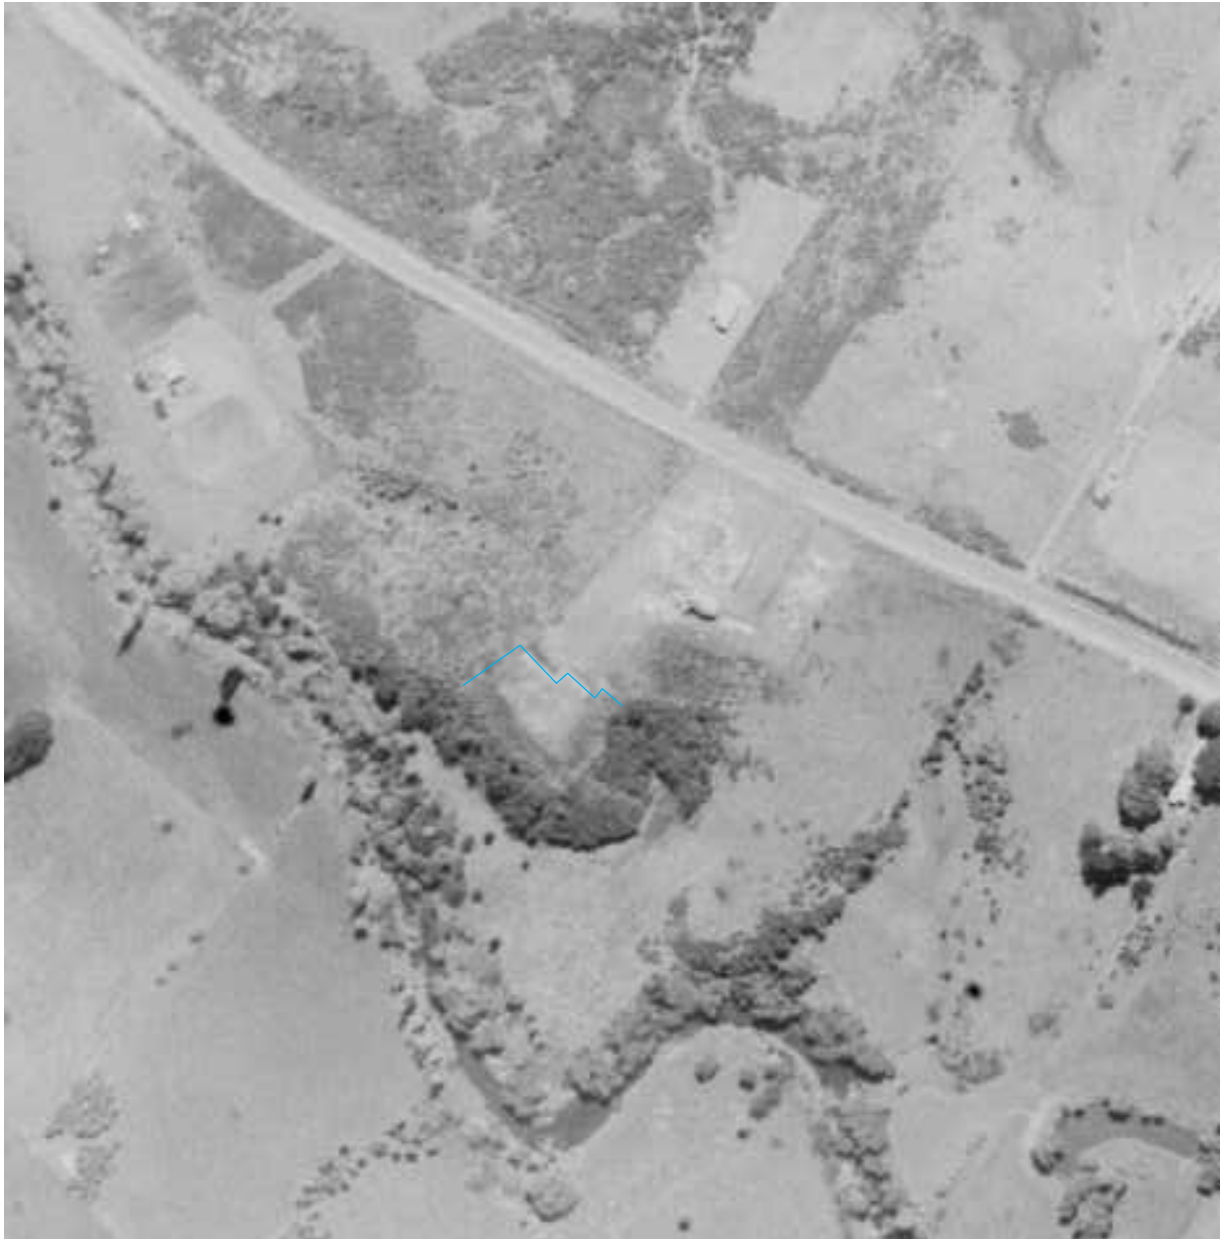
Figure 77: Detail from aerial image SN 350 1365/16 (1950) showing clearest image of possible defensive ditch with gun-fighting flanking angles at rear of urupa (in blue).

Both modern and historic aerial imagery (Figure 77 - Figure 80) show the remains of what appears to be a defensive earthwork with multiple flanking angles suggestive of gun-fighting adaptation on the northern face, most obvious in the 1950 aerial. A western return of the ditch back towards the river is most visible in the 1973 aerial.

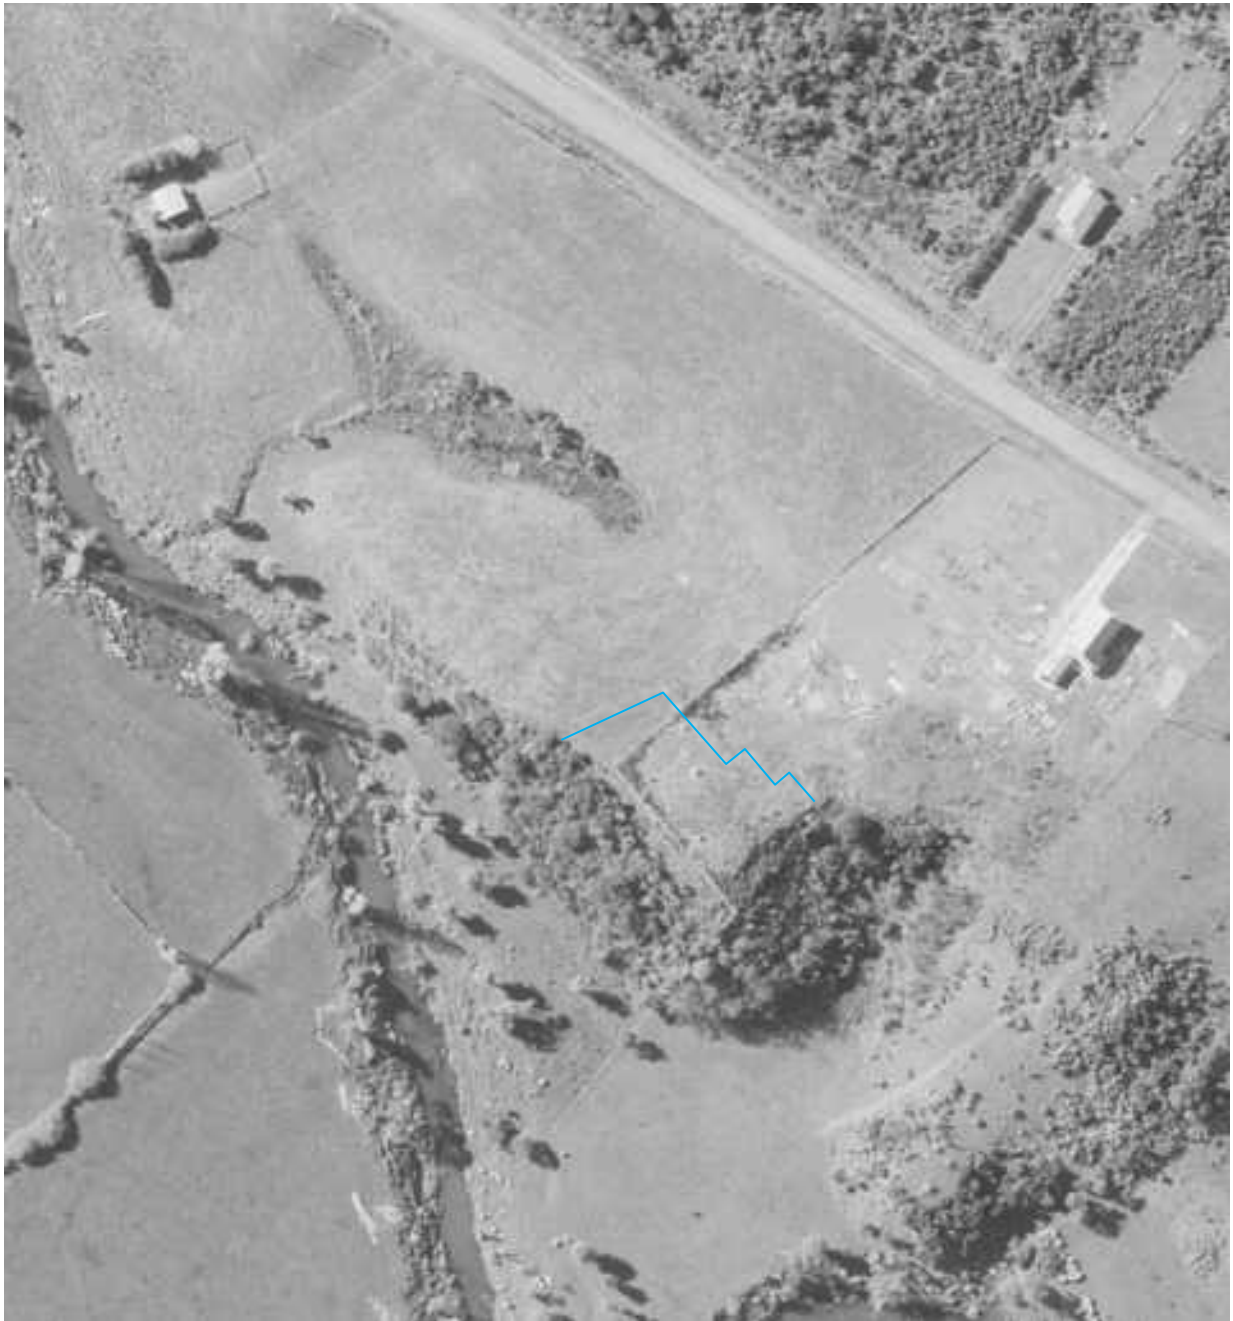
Figure 78: Detail from SN 1417 B/12 (1961) showing possible defensive ditch with gun-fighting features at rear of urupa.

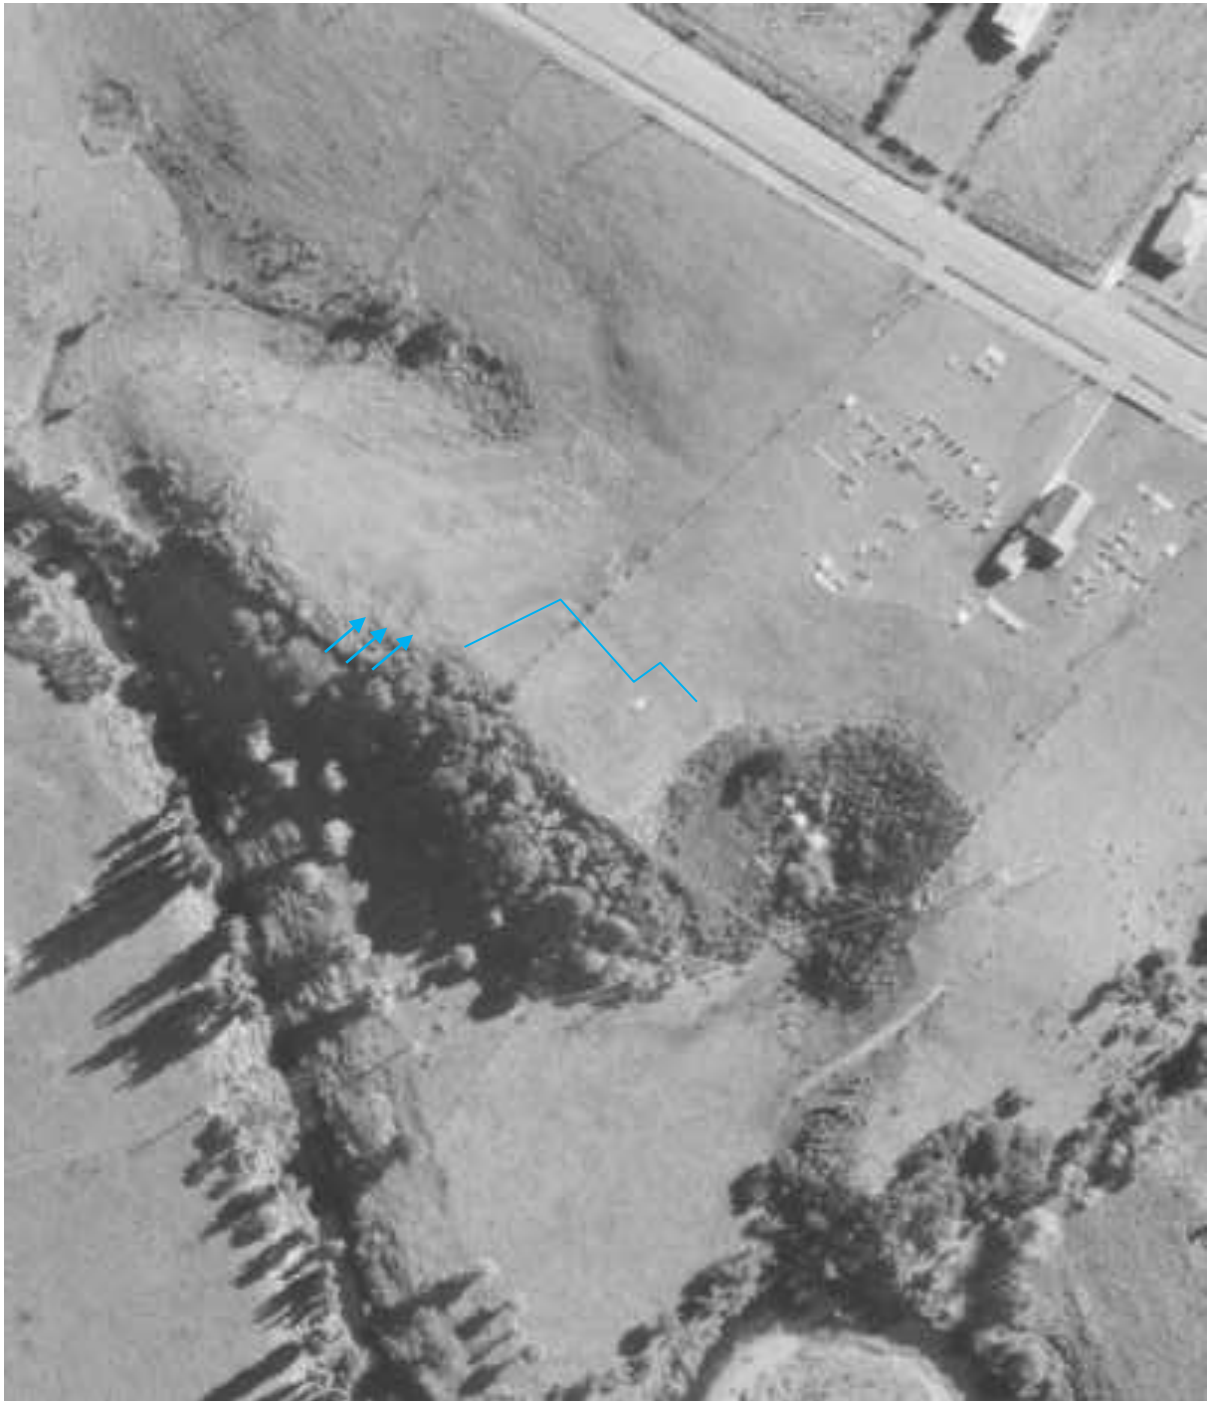
Figure 79: Detail from aerial image SN 3675 C/3 (1973) with defensive ditch and possible terraces.

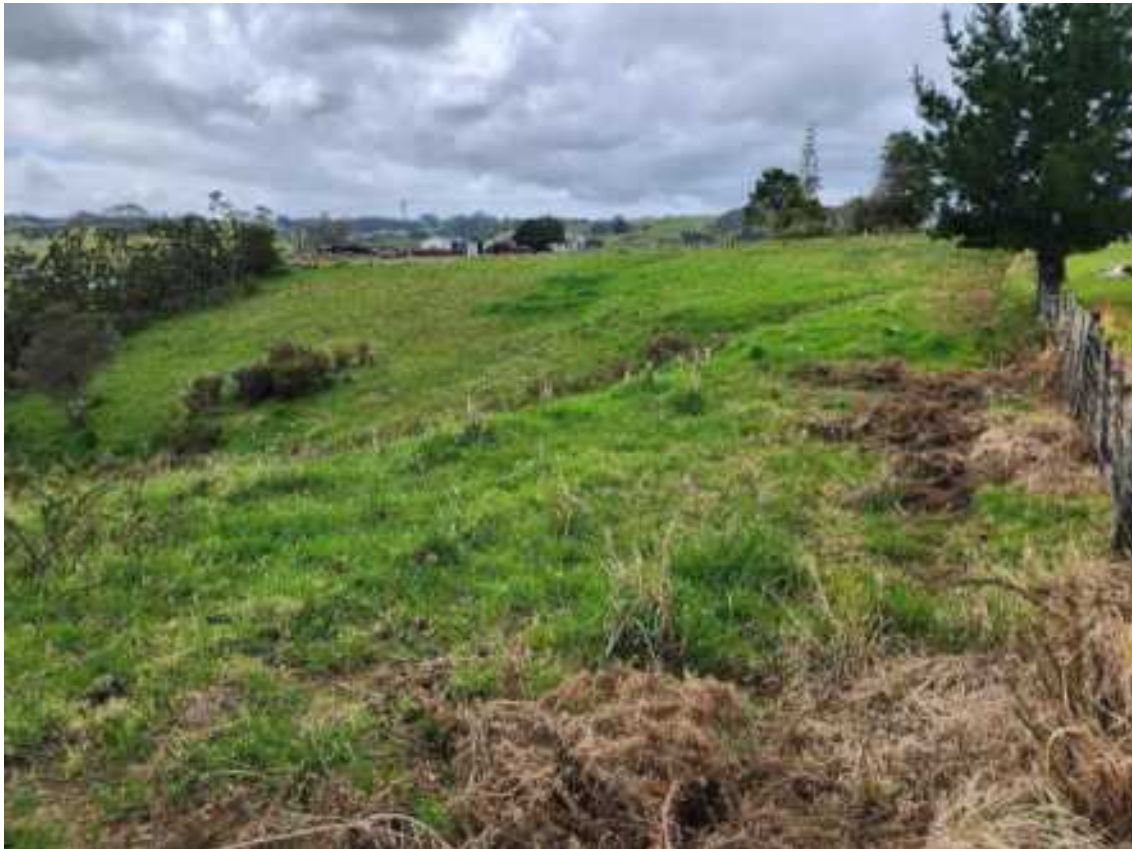
Figure 86: Looking north towards proposed spoil dump site.

The proposed spoil dump site (Figure 86) was visited for an hour on 9 September 2023, in the company of T. Latimer, R. Gabel, and G. Latimer. The possible infilled defensive ditch in the urupa was visible as a slightly darker line of vegetation and shallow swale running across the rear of the urupa under closely mowed grass, but was not visible beneath the rank grass on the western side of the internal fence (Figure 87).

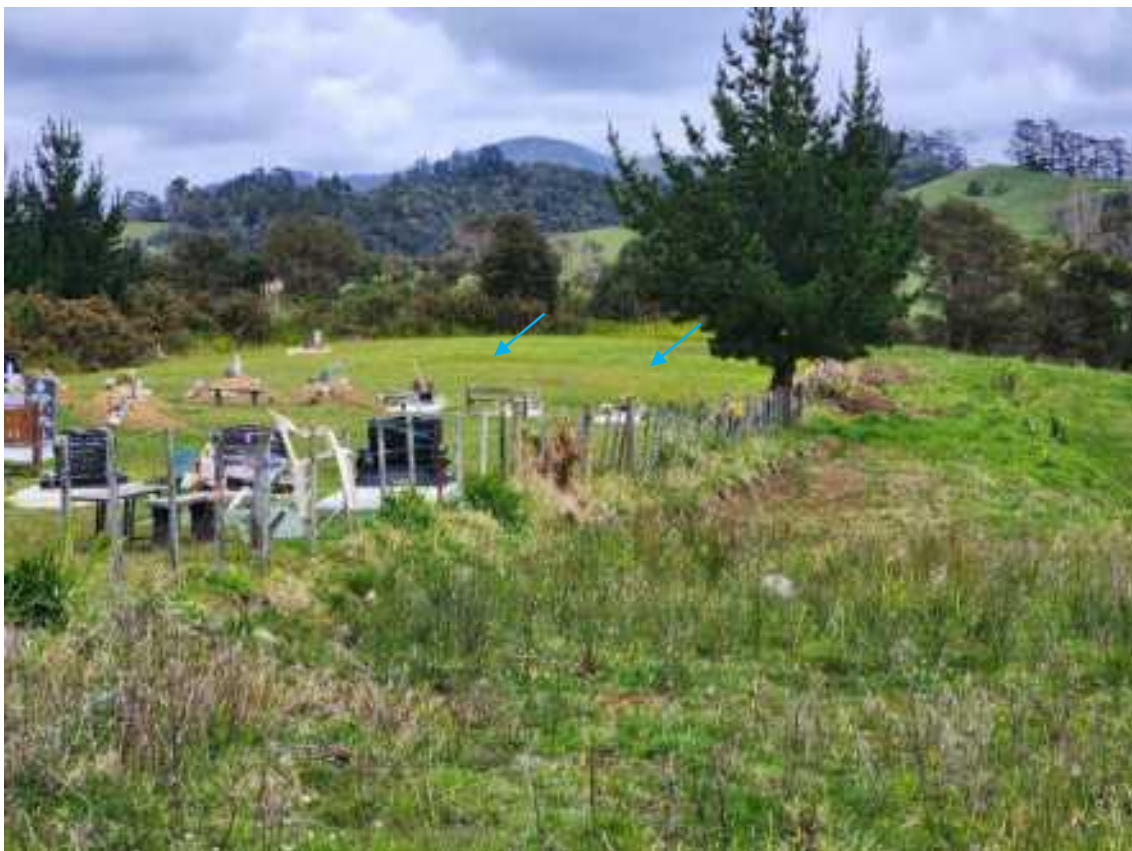
Figure 87: Looking south over rear of urupa with possible infilled ditch.
