Application for resource consent or fast-track resource consent

New Zealand Transport Authority Waka Kotahi (NZTA)

On 19 August 2022, Te Tai Tokerau/ Northland was hit with a Severe Weather Event, including strong wind gusts and significant rainfall, which caused widespread damage and flooding across the Region, and resulted in several landslides through the Mangamuka Gorge, making it impassable. This damage resulted in the complete closure of SH1 through the Gorge, severing a vital link for the Far North/ Te Hiku-o-te-Ika to the remainder of the country.

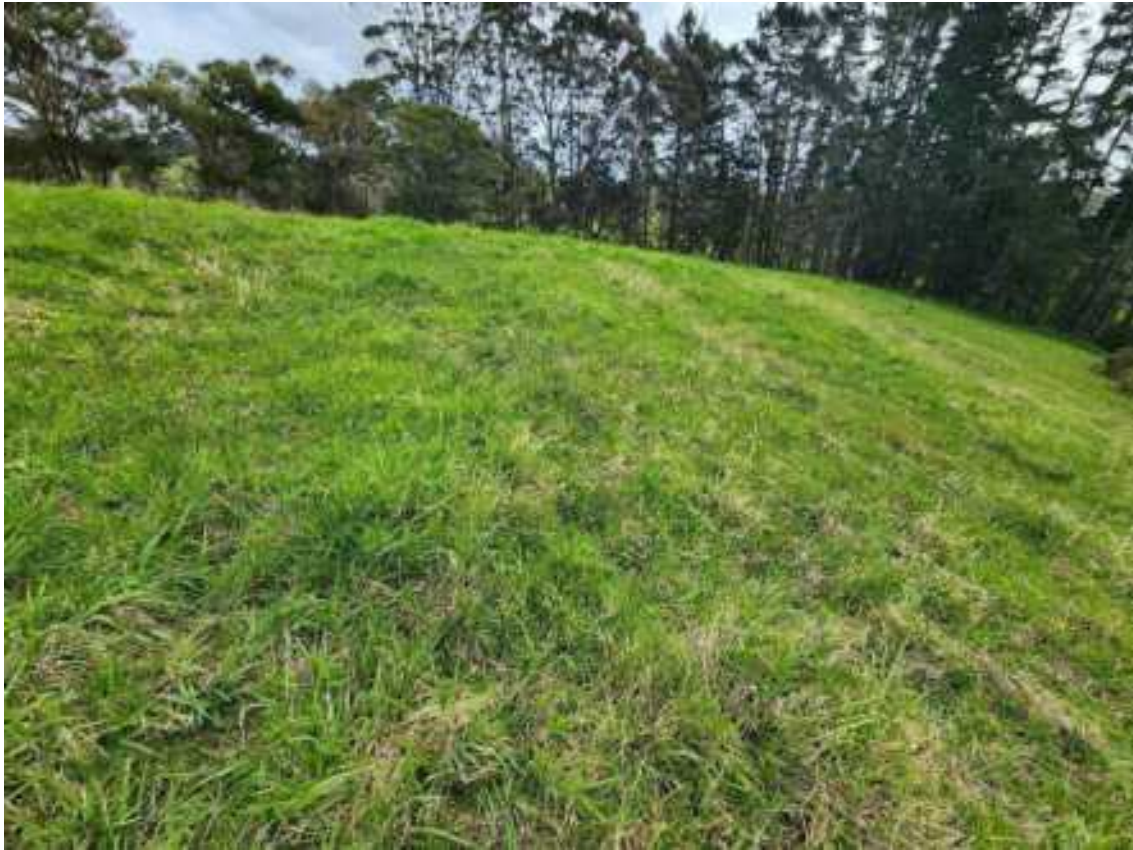
Figure 88: Possible terraces down western ridgeline.

A number of possible terraces were observed on the southern descending spur to the west of the fence. There were larger transverse terraces on the spur which were 10-15 x 10 x 0.3m in size, and smaller lateral terraces around the head of the gully which are more likely to be erosional features. However they were all relatively indistinct and while they looked like they started as erosion features, have probably been modified by occupation and/or gardening (Figure 88).

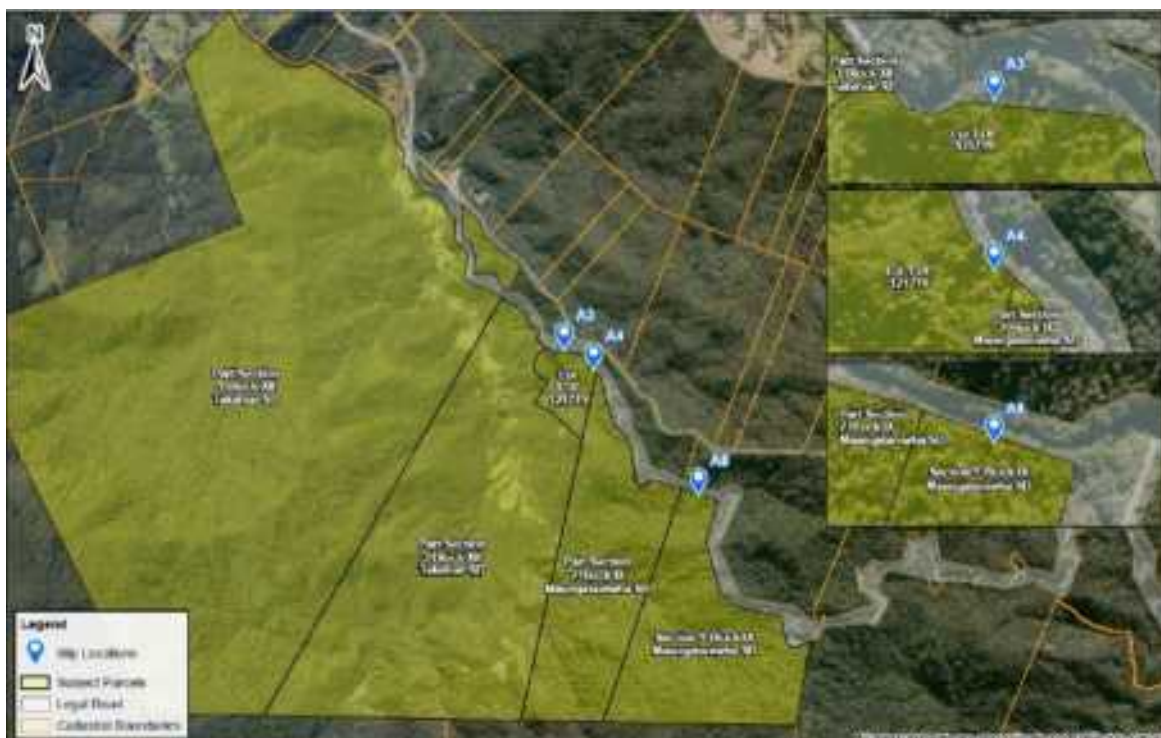
The Department of Conservation (DOC) and NZ Transport Agency (NZTA) agreed to commence the concession on 1 May 2024 in three separate locations within Mangamuka Gorge Scenic Reserve; locations, A3, A4 and A8 shown on the plan below.

The subject land for A8 is vested in the Crown, surveyed on SO 46561 as Sec 9 Block IX Maungataniwha Survey District, and set apart as a reserve for scenic purposes subject to the Reserves Act 1977. The subject land for A3 and A4 is private land, held in Record of Title NA70C/847, owned by Bruce Alexander Shine. The concession with DOC is, therefore, not the appropriate agreement for the infrastructure located at A3 and A4 with DOC not being the owner of the land.

A concession should remain for the infrastructure located at A8, however, pursuant to section 17ZC subpart 3(c) of the Conservation Act 1987, a variation of the existing concession is necessary to exclude locations A3 and A4. NZTA will be removing the flumes from private land at locations A3 and A4.

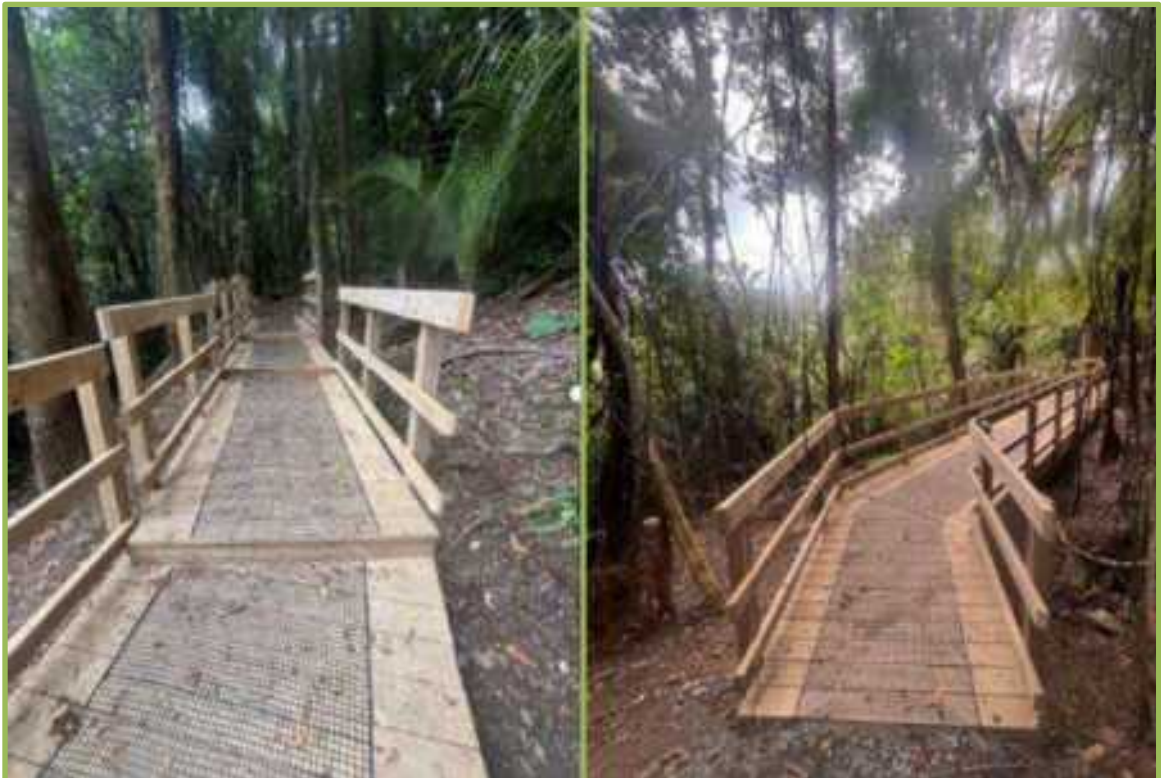
Therefore, a raised timber boardwalk, with handrails was constructed (refer **Attachment 2** for Site Plan). The boardwalk is 240m -1065m off the ground, with the height at the top of the handrail being 1.050m from boardwalk walkway. The boardwalk is 28.45m long by 1.570m wide (refer **Figure 1**).

Figure 1: Timber Boardwalk (Image taken 4 March 2024)

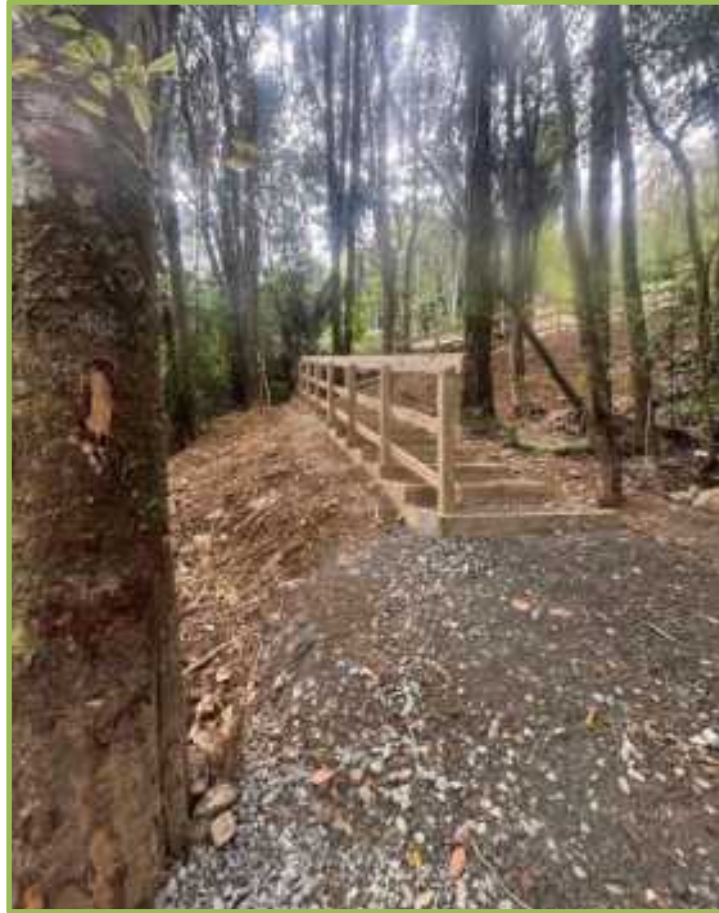
Figure 2: Stairs at North End of Access Track (Image taken 4 March 2025)

In addition, timber stairs are to be erected at each entrance to the access track (refer **Figure 2**). Most of the stairs (as evident on the Site Plan at **Attachment 2**) will be located outside of the DOC reserve and within the road corridor and the NZTA held designation for State Highway

1, however a small portion may extend into the DOC reserve. Therefore, for completeness and as a conservative approach, it is requested the stairs, where they may cross into the DOC reserve are included in the concession.

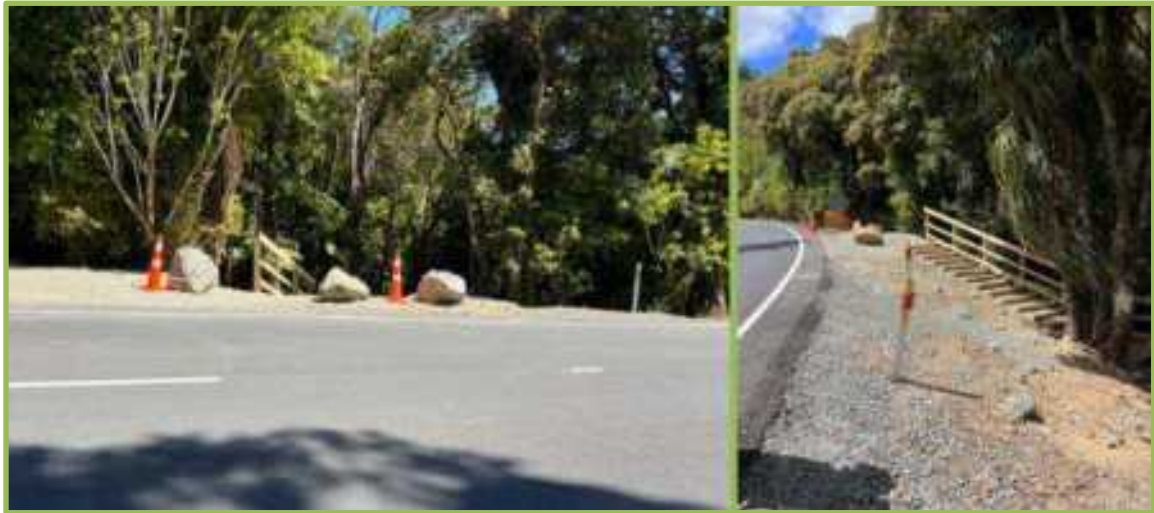
Figure 3: (Left) North Stairs as Visible from Roadway (Right) South Stairs as Visible from Roadway (Images taken: 10 March 2025)

The stairs will be hidden from public view as much as is possible and reasonably practicable, with large boulders placed along the roadside to prevent vehicles in particular from being able to access the boardwalk.

The roadway at the site (Slip A8) does not provide sufficient room for a vehicle to safely stop (such as a long visible approach or wide berm or layby area) reducing the likelihood that a member of the public would come across the stairs and access to the boardwalk. If a member of the public, whilst driving past happened to notice the stairs, they would need to drive a few hundred metres further down the road, and walk back along the road, where there is limited availability to do so. Generally speaking, it is not considered likely, due to the number of obstacles, a member of the public would access the stairs and/or boardwalk.

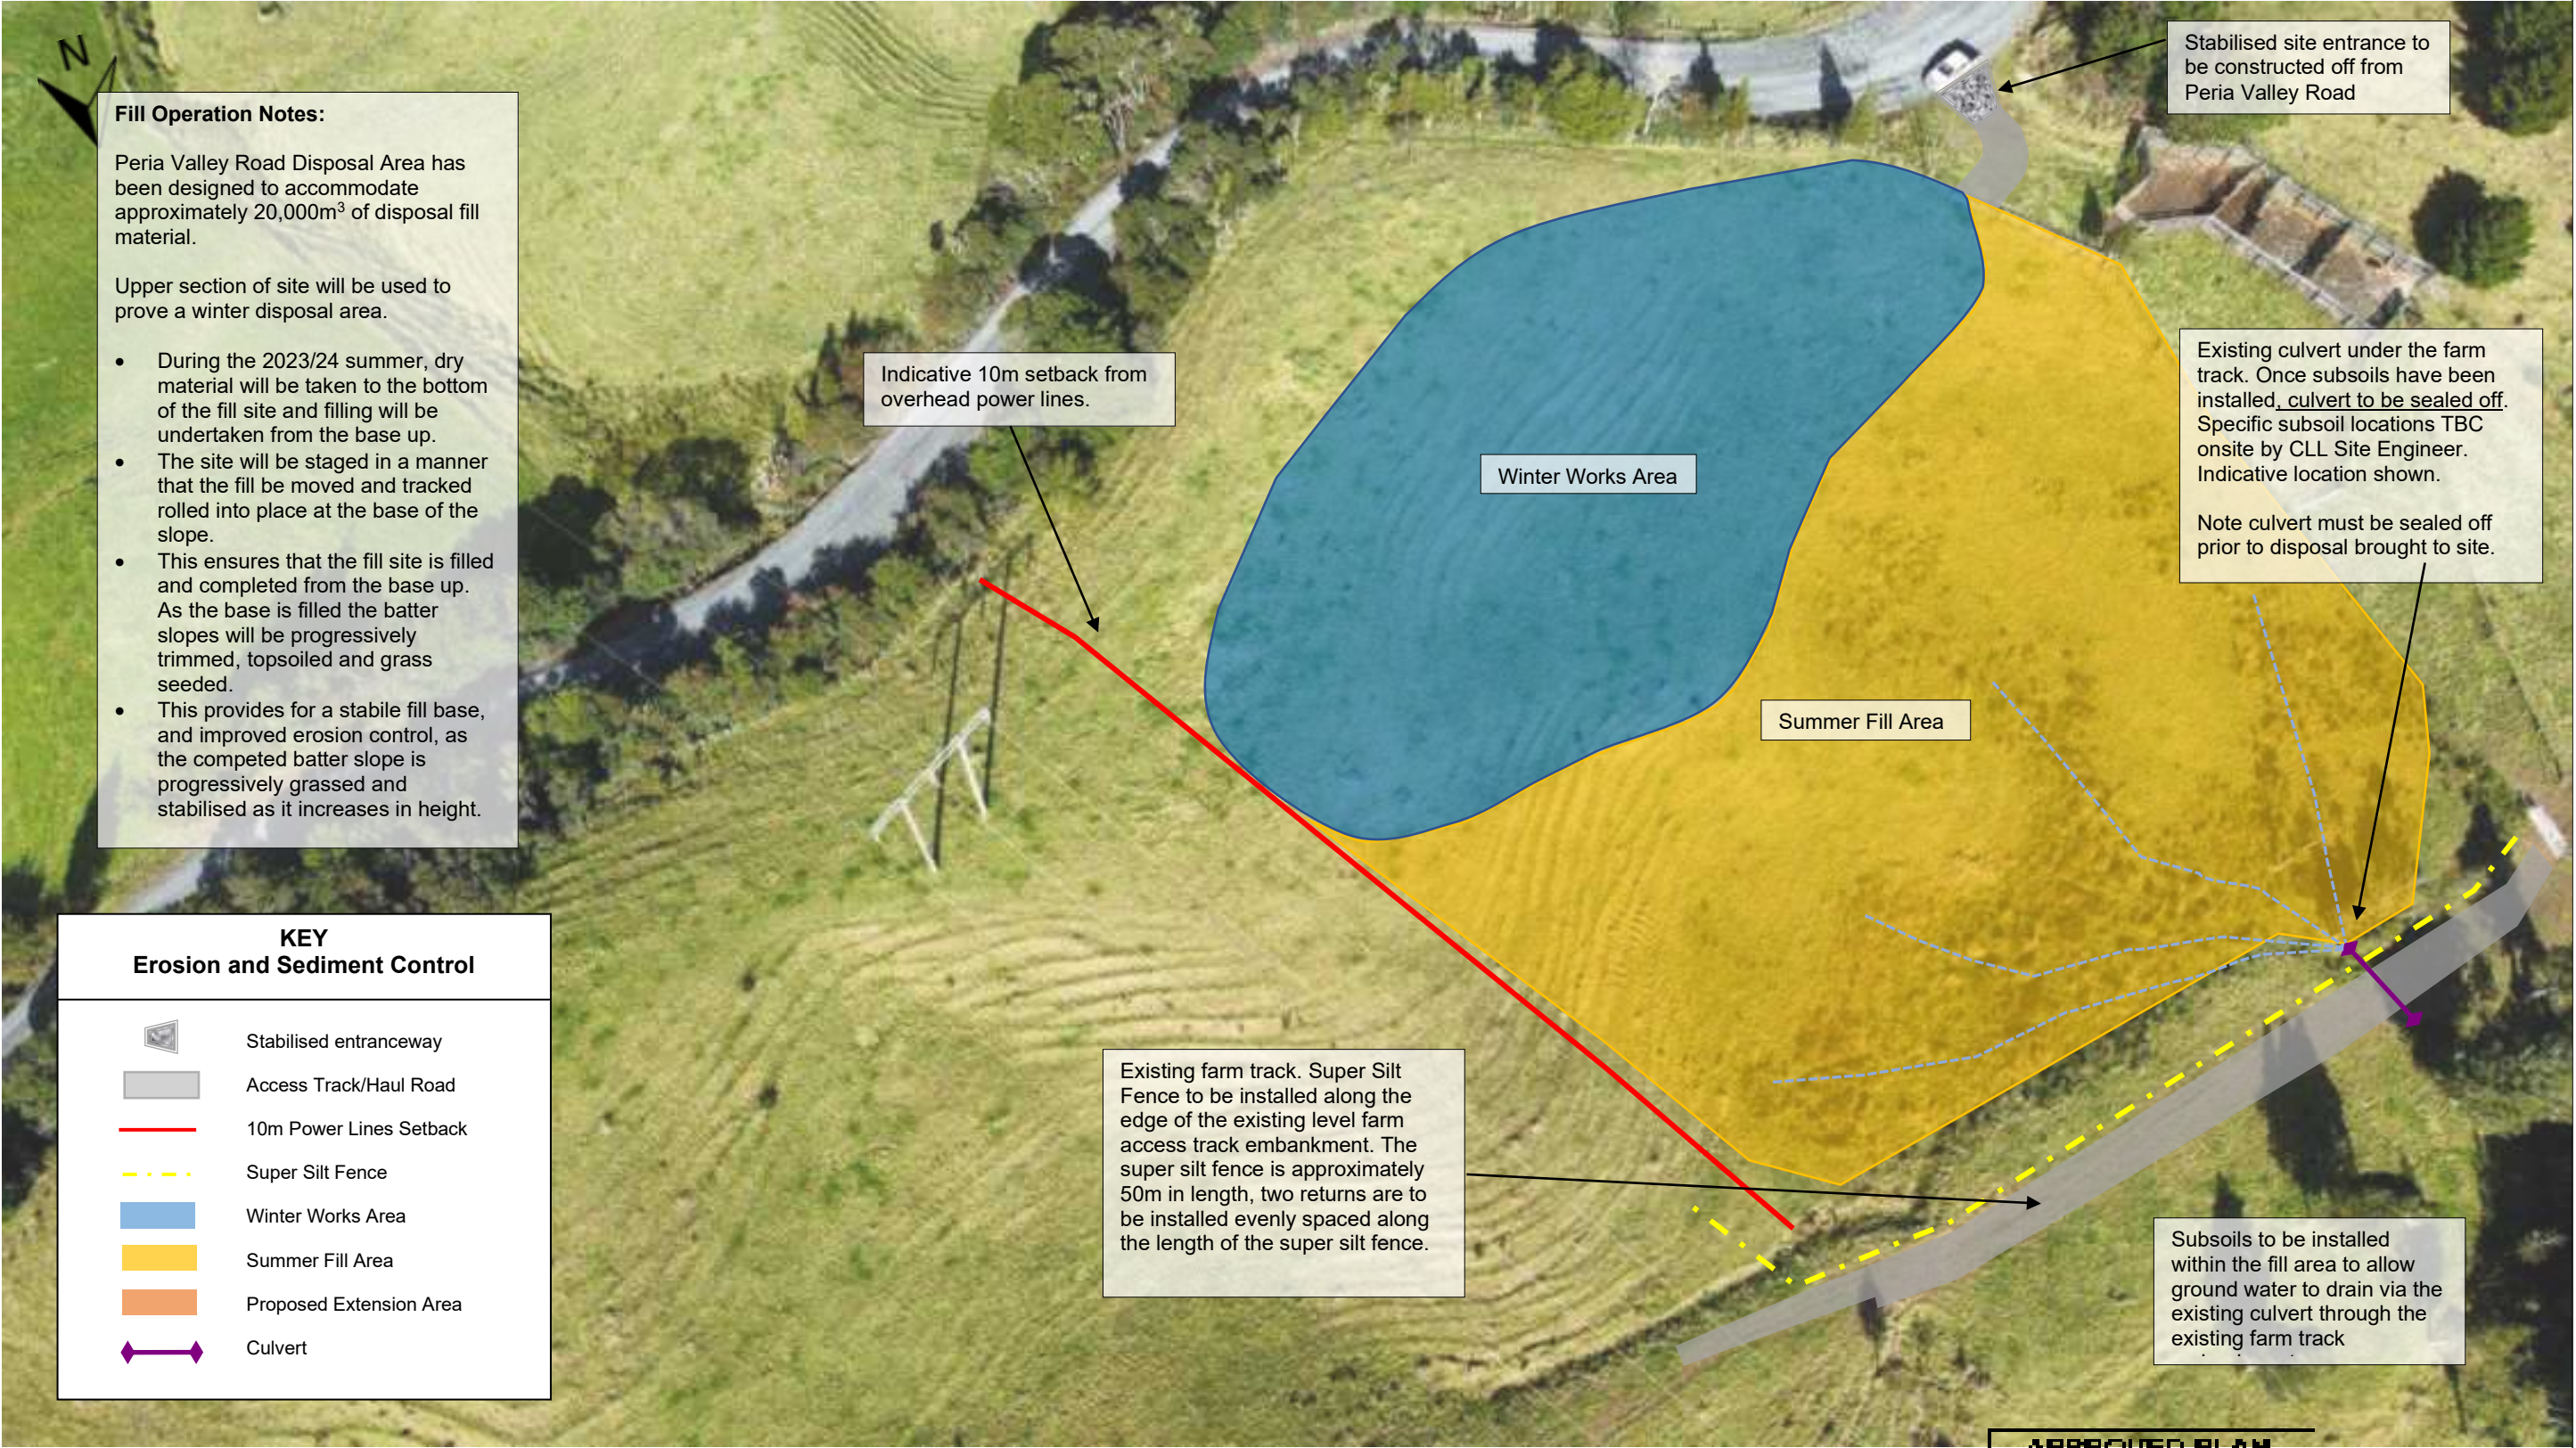
- All erosion and sediment controls will be installed and maintained in accordance with Auckland Council Guideline Document 2016/005 'Erosion and Sediment Control Guide for Land Disturbing Activities' (GD05).
- Earthworks are to be programmed to ensure rapid stabilisation.
- All erosion and sediment control measures will be inspected on a daily basis by the site foreman.
- Site monitoring will be undertaken before and immediately after rain as well as during heavy rainfall events. Any required maintenance or improvements to control measures will be undertaken immediately.

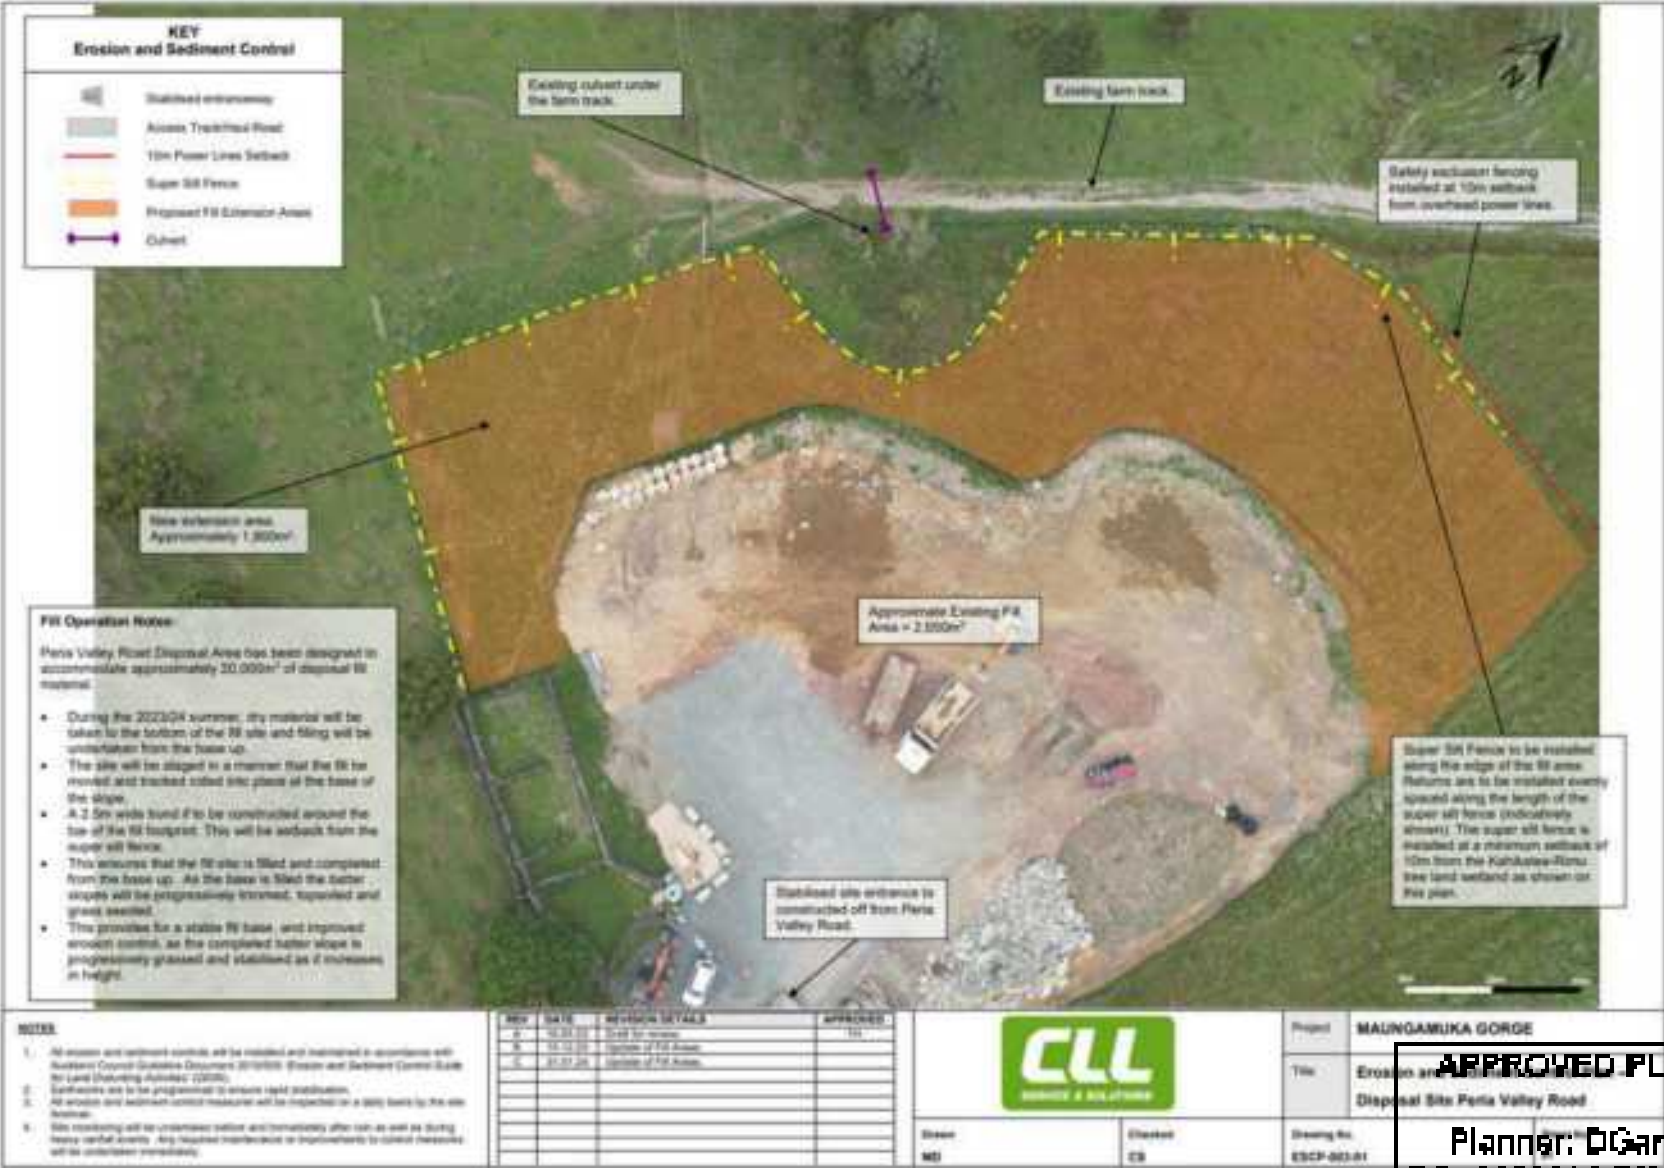
Figure 1-1: Map and scheme plan of the existing and proposed soil disposal site at 184 Peria Valley Road, Northland.

Near the northwest edge of the hillslope seepage wetland is a small area of kahikatea-rimu treeland. This treeland comprises seven kahikatea and two rimu (*Dacrydium cupressinum*) (Summer Fill Area, Figure 1-1). Many of these trees exhibited late-stage symptoms of disease and/or overall stunted growth and ill-health (Plate 4-3). Whilst small, this treeland meets the definition of an indigenous wetland in the Far North District Plan (Appendix I).

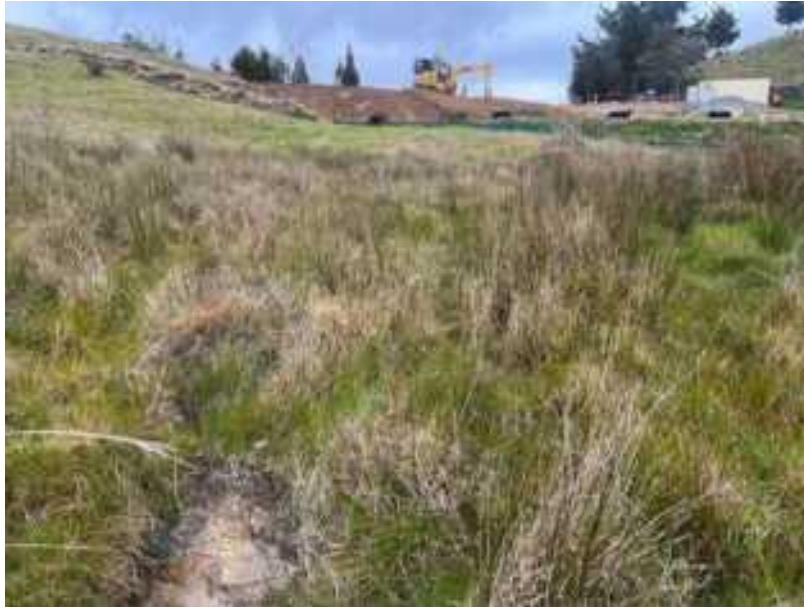
The lower hillslope within the spoil disposal site is a hillslope seepage wetland (Plate 4-2). This area meets the definition of a wetland provided in the Resource Management Act 1991, as it comprises “permanently or intermittently wet areas... that support a natural ecosystem of plants and animals that are adapted to wet conditions”. This wetland type occurs on sloping ground where the groundwater levels are close to or at the ground surface, resulting in permanently wet soils (Wildland Consultants, 2012). The hydrophytic vegetation in this seepage (Figure 4-1) meets the tests and definitions of a natural inland wetland in the NPS-FM and NES-FW. Whilst the lower edge of the wetland may have higher water levels due to the construction of an adjacent farm race, the wetland is on a sloping surface, and most of the wetland lies at a higher elevation than this race and is not there due to this artificial impoundment. Additionally, the water source does not exclude this wetland as a natural inland wetland as the site has a permanently high water table that interacts with the ground surface (vs. the alternative of only being subject to temporary rain-derived water pooling). The wetland is dominated by two indigenous species wīwī (*Juncus edgariae* – facultative wetland species) and spike sedge (*Eleocharis acuta* – obligate wetland species) (Plate 4-2). Mercer grass (*Paspalum distichum*), and soft rush (*Juncus effusus*) are also present, and exotic grasses increase in abundance towards the drier top edge of the wetland.

Plate 4-2: Hillslope seepage wetland within the spoil disposal area. The vegetation is dominated by wīwī (*Juncus edgariae*), and spike sedge (*Eleocharis acuta*) is common.

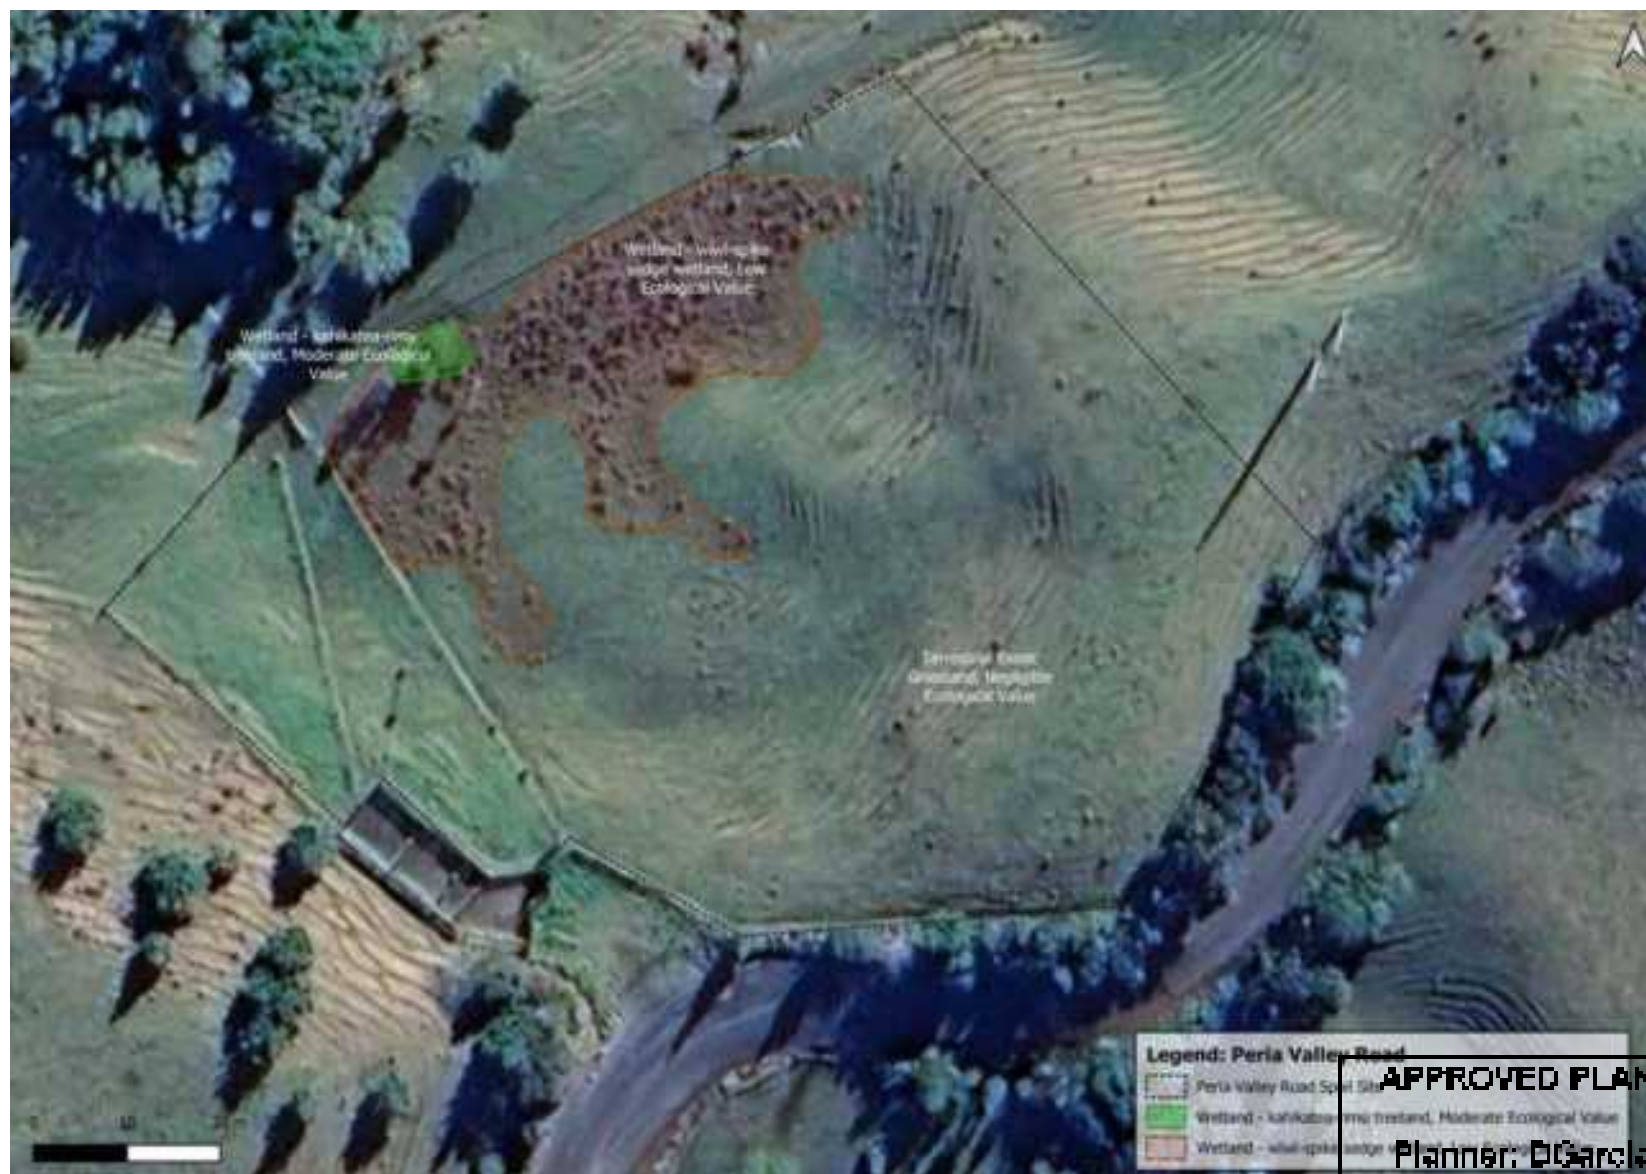
Figure 4-1: Map of vegetation and habitats at the proposed soil disposal site at 184 Peria Valley Road, Northland.

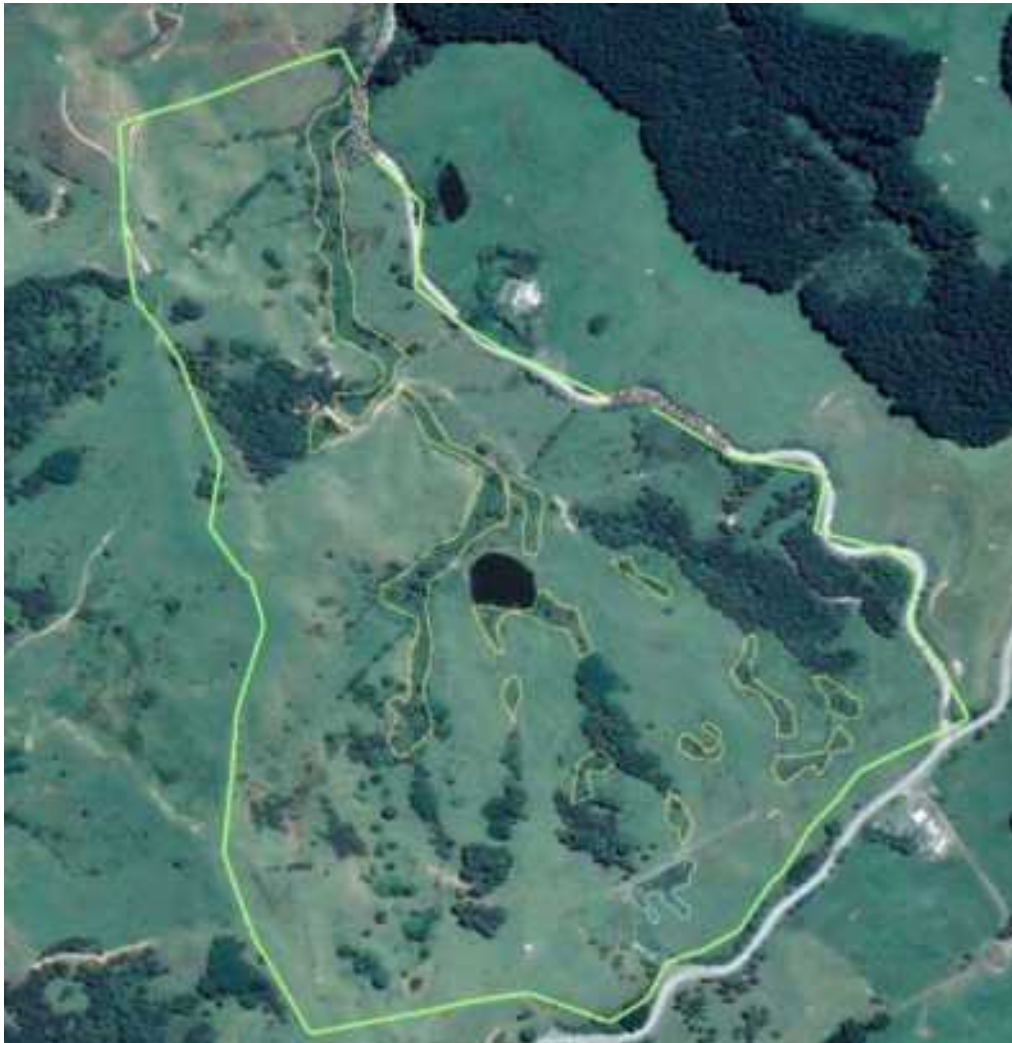
Figure 4 1: Desktop map of wetland habitats in the catchment of the spoil site. The wetland within the spoil site is shown in blue. Additional wetland areas are likely present but concealed from view by tree canopy.

A desktop map was produced of wetland areas in the wider catchment area, using Google Earth imagery.

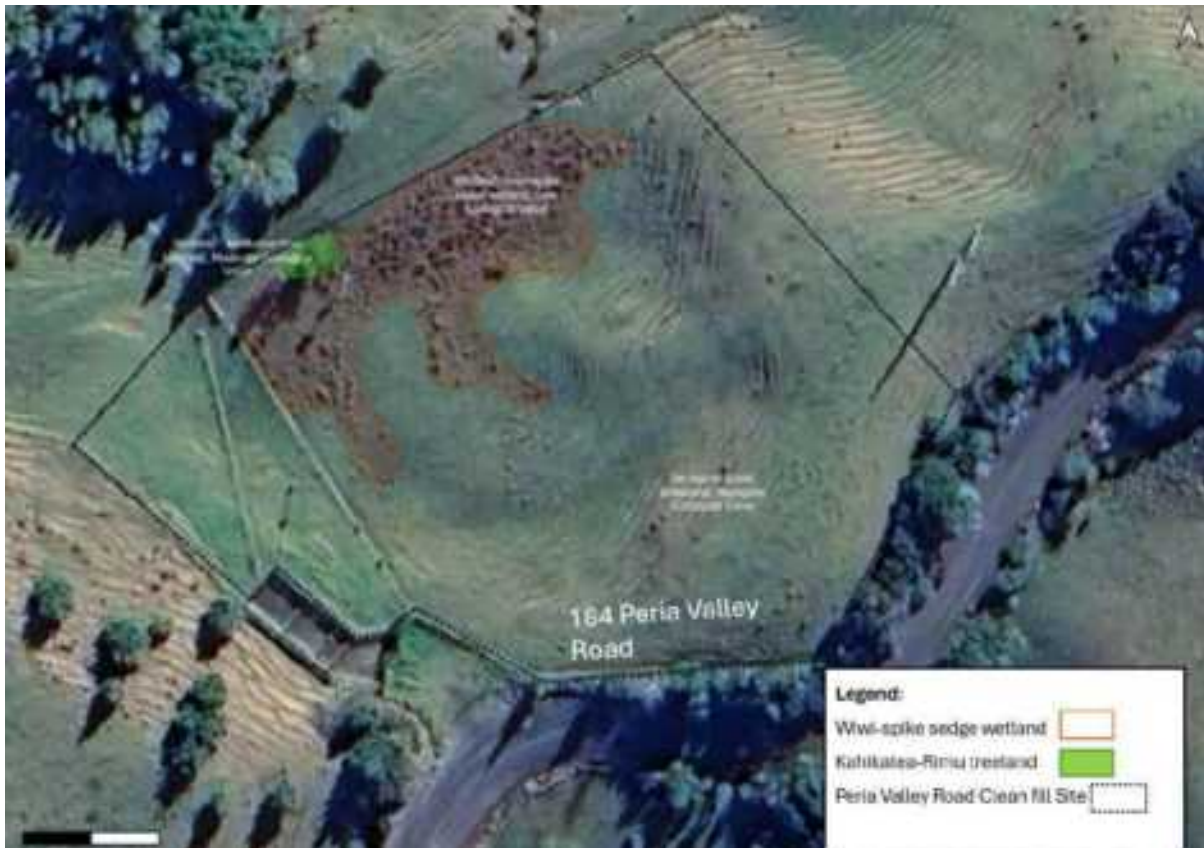
Figure 1 Wetland habitats present at the application site as identified by NZEM, 2024. Image adapted from NZEM EIA Report (p. 4-7, 2024).

The operation of the clean fill site resulted in the removal of vegetation, earthworks and diversion / drainage of water within, and within 10m of a natural inland wetland. The activities completed to date have resulted in a loss of 1,365 square meters (m²) of natural inland wetland extent classified as 'wīwī-spike sedge rushland'. The wetland was not considered a 'significant wetland' as it did not meet all of the significance criteria under the relevant planning provisions and criteria. A portion of wetland classified as 'kahikatea-rimu treeland' habitat to the northwest of the fill site comprising of 35m² in area has been retained due to its moderate ecological value. Erosion and sedimentation controls were designed in accordance with Auckland Council Guideline Document 2016/005 (GD05), installed and maintained around the extent of this habitat and the extent of the clean fill operation during works at the site.

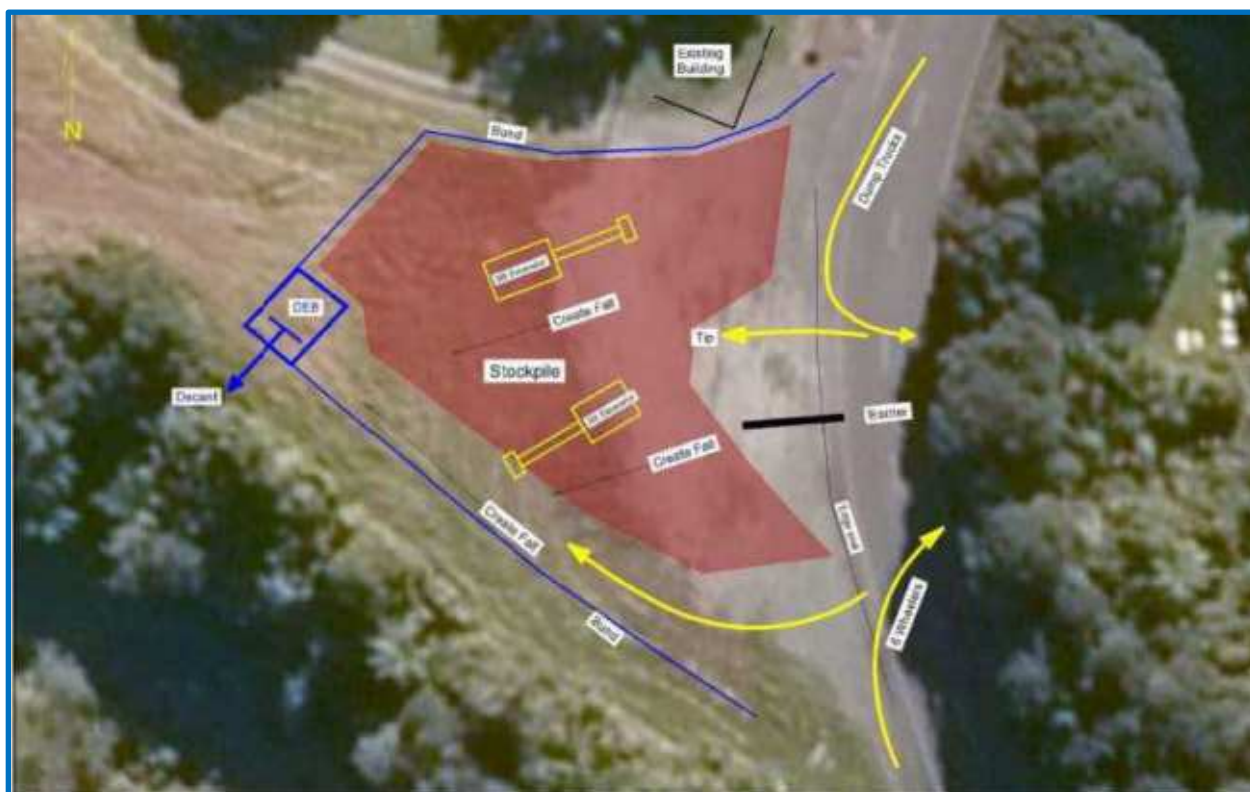
Figure 2: Proposed Layout of Facility

This planning assessment has been undertaken prior to the preparation of a detailed erosion and sediment control plan (ESCP). The only available documentation to assess the proposal is a high level concept layout plan (refer **Figure 2**). The concept layout shows that an earth bund will be installed around the perimeter of the facility, and stormwater diverted to a DEB (decanting earth bund), with an outflow, located at the road reserve boundary, into the scenic reserve above the stream.

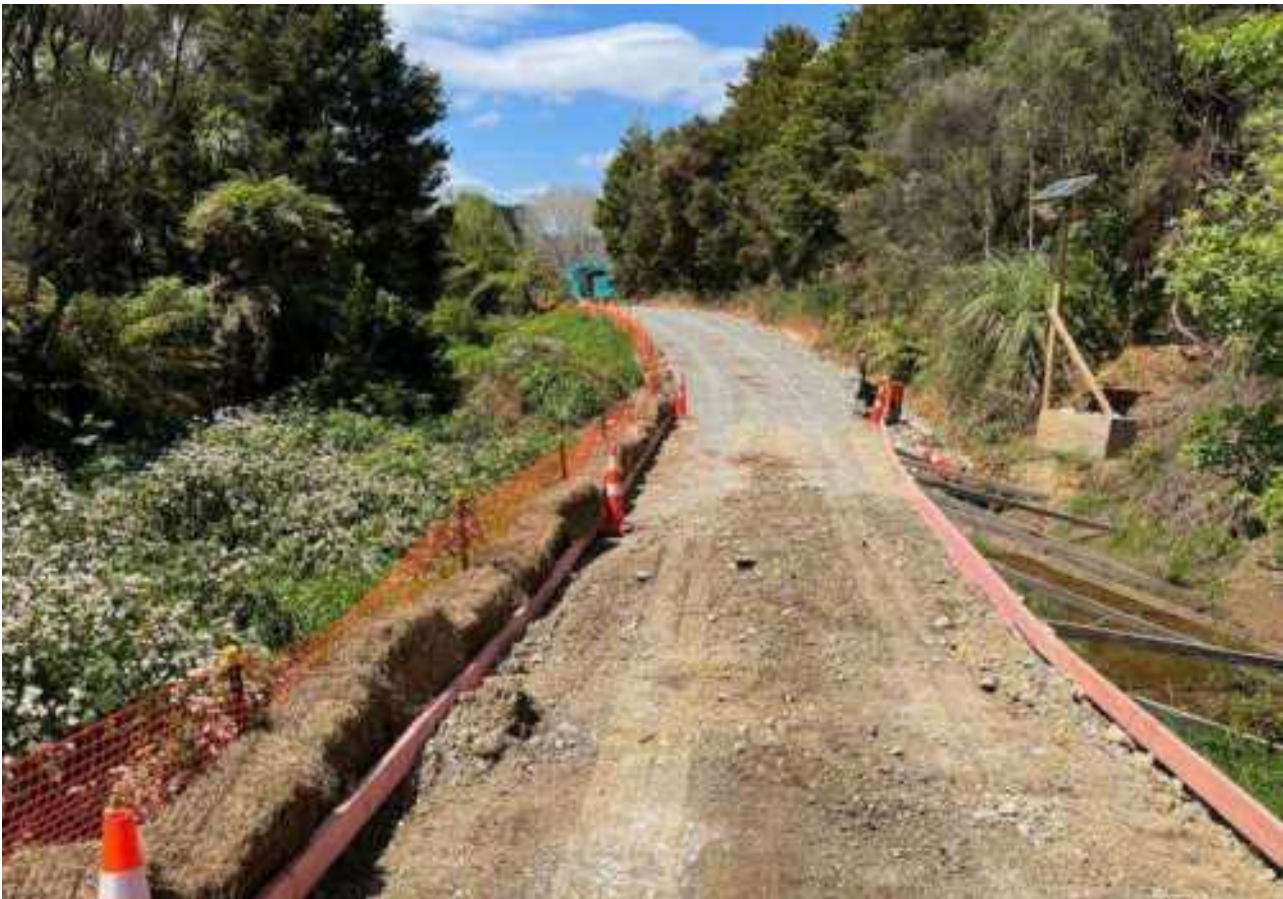
Figure 5: Photograph of culvert crossing being upgraded to concrete finish

The accessway within the ROW is a one-way gravel driveway of variable width, which has recently been resurfaced and widened by up to approximately 2m in places to prepare for the fill operation (this can be seen in Figure 9). A short section of the driveway that passes over an old culvert crossing has been upgraded to concrete to avoid the weight of trucks damaging the culvert (refer Figure 5). The driveway meets the relevant minimum standards for a private accessway in the Rural Production zone, being 1:5 Maximum gradient and 3.0m minimum width.

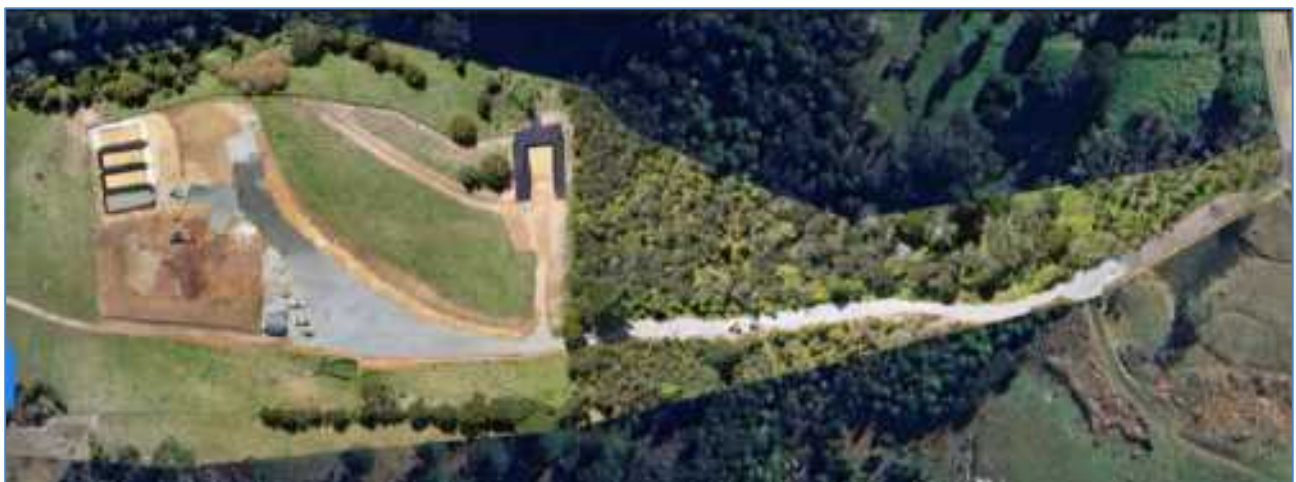
Figure 7: Aerial drone survey showing the construction of the Stage 1 fill site

Ancillary works associated with Stage 1 fill area include an approximately 1,000m² aggregate area above the fill site to provide for truck manoeuvring (visible in Figure 7) and a site office.

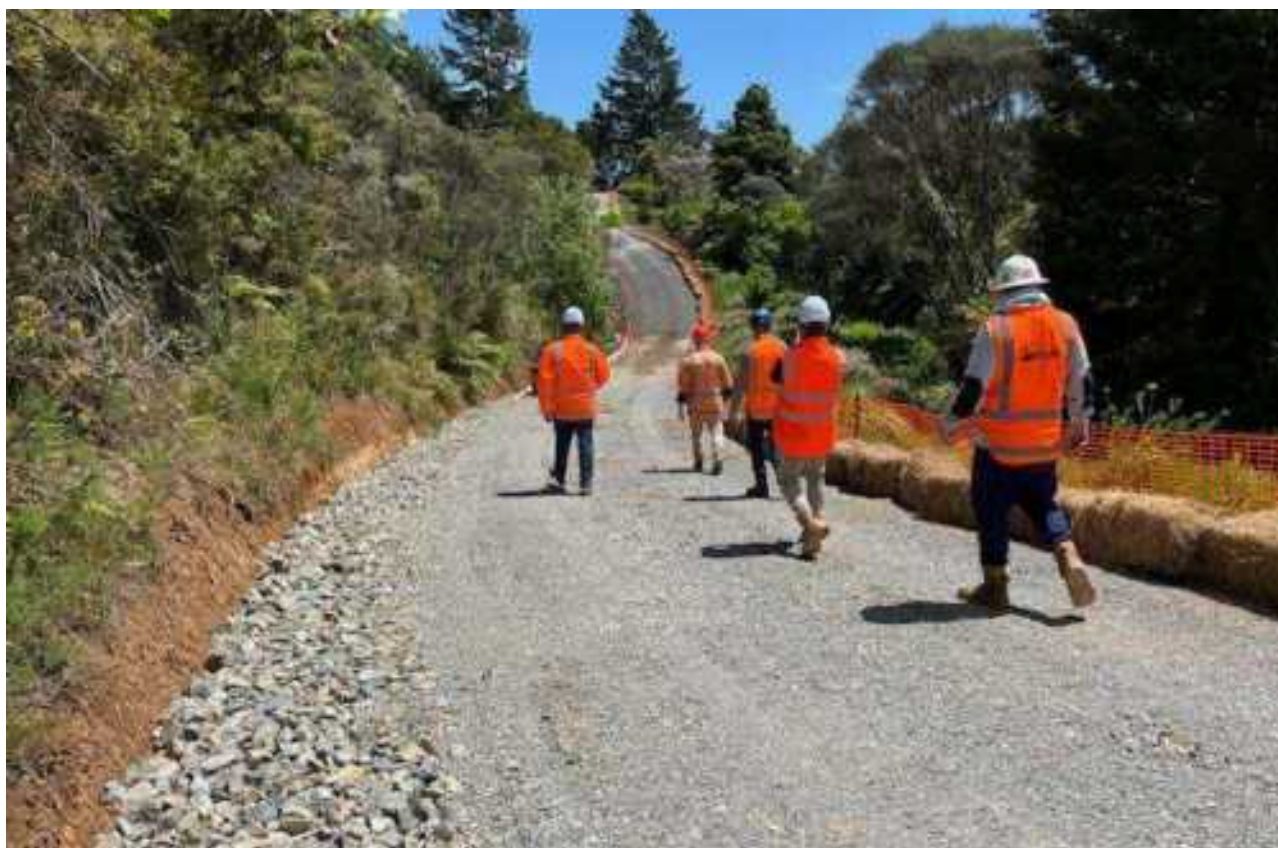
Figure 9: Photograph of upgraded driveway, looking west

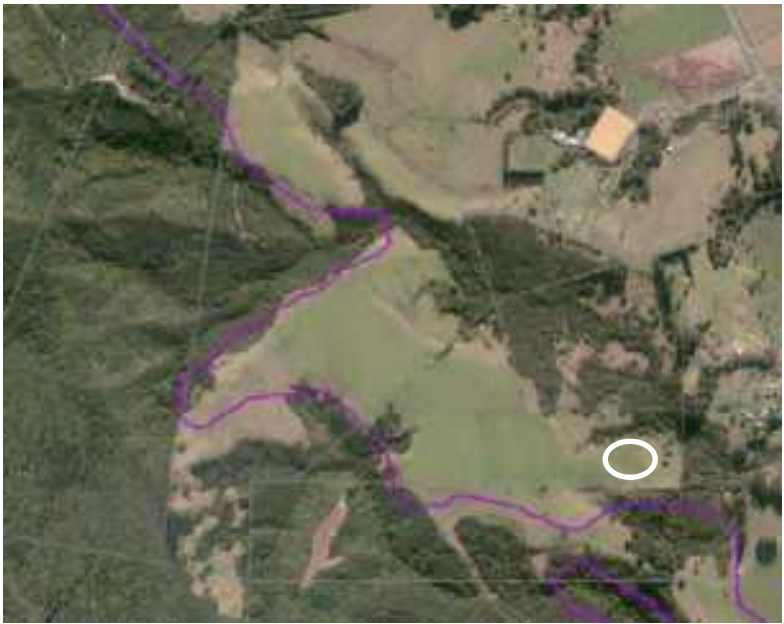
Soil classification:	The property contains LUC 2 however the fill locations 1- 3 are LUC 4 – Arable. As such NPS-HPL does not apply to this site.
Northland brown kiwi & mudfish distribution:	N/A
Significant indigenous vegetation & significant habitats of indigenous fauna:	<p>The property contains a PNAP area (in purple) being the Mangamuka-Mangataipa Mosaic however the proposed fill locations 1- 3 (white circles) are outside this area</p>

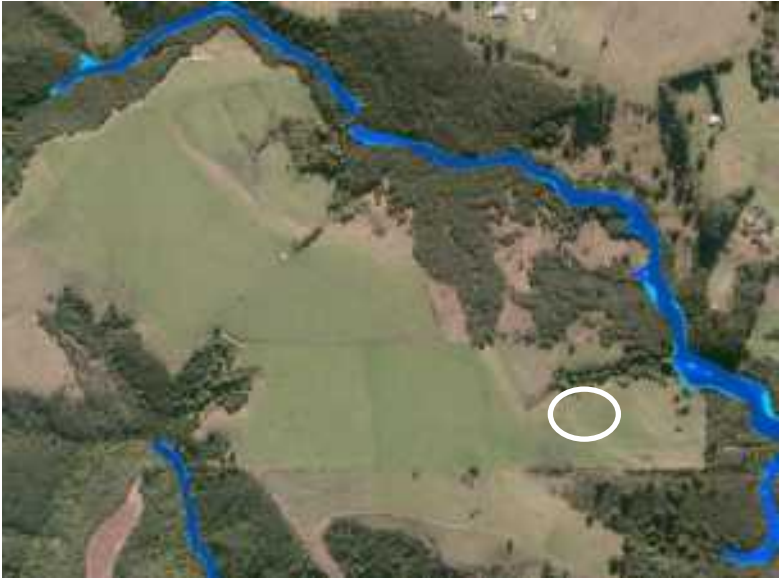
NRC Natural Hazards:	<p>River Flood Hazard zone (10, 50 & 1—year) on site but outside proposed fill locations 1- 3 (white circles)</p>

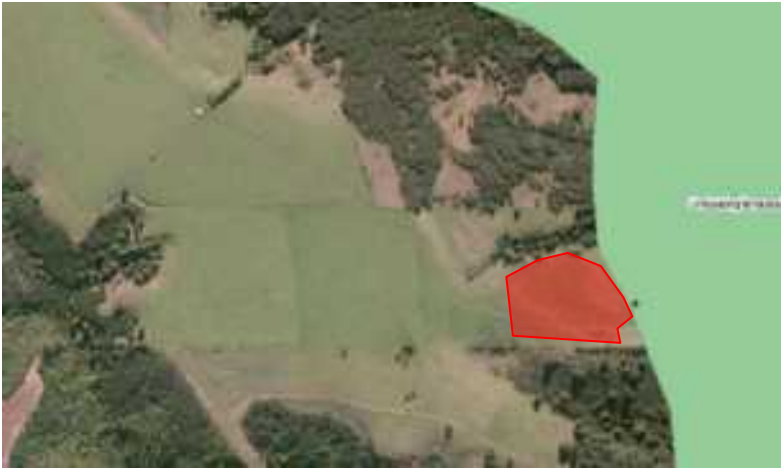
<p>Land hazard: Flood susceptible site - Undulating Terraces on site (shown in green below), appears to be on the boundary of proposed fill site 1 (shown in red)</p>

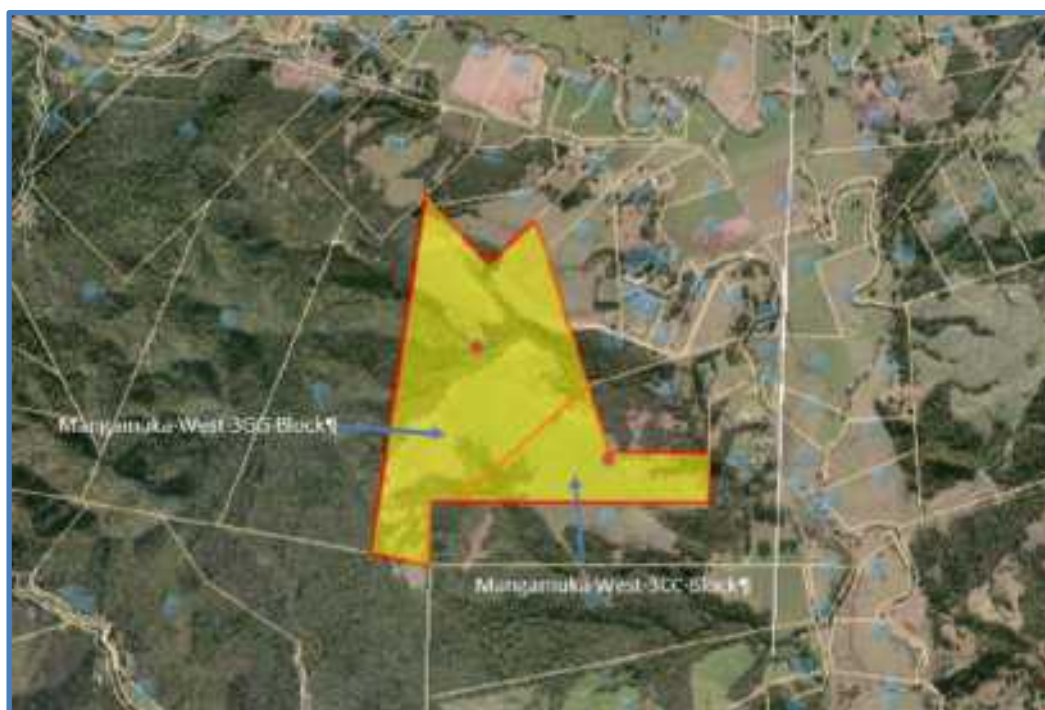
Figure 1: 4321 State Highway 1 site locality aerial photograph

As noted above, the site comprises 70ha of land in two titles (refer **Figure 1**) which is predominantly used for pastoral farming. The proposed fill site is to be wholly located on the Mangamuka West 3GG block, with a stabilised access track to be constructed, which will extend across both titles.
