Application for resource consent or fast-track resource consent

New Zealand Transport Authority Waka Kotahi (NZTA)

On 19 August 2022, Te Tai Tokerau/ Northland was hit with a Severe Weather Event, including strong wind gusts and significant rainfall, which caused widespread damage and flooding across the Region, and resulted in several landslides through the Mangamuka Gorge, making it impassable. This damage resulted in the complete closure of SH1 through the Gorge, severing a vital link for the Far North/ Te Hiku-o-te-Ika to the remainder of the country.

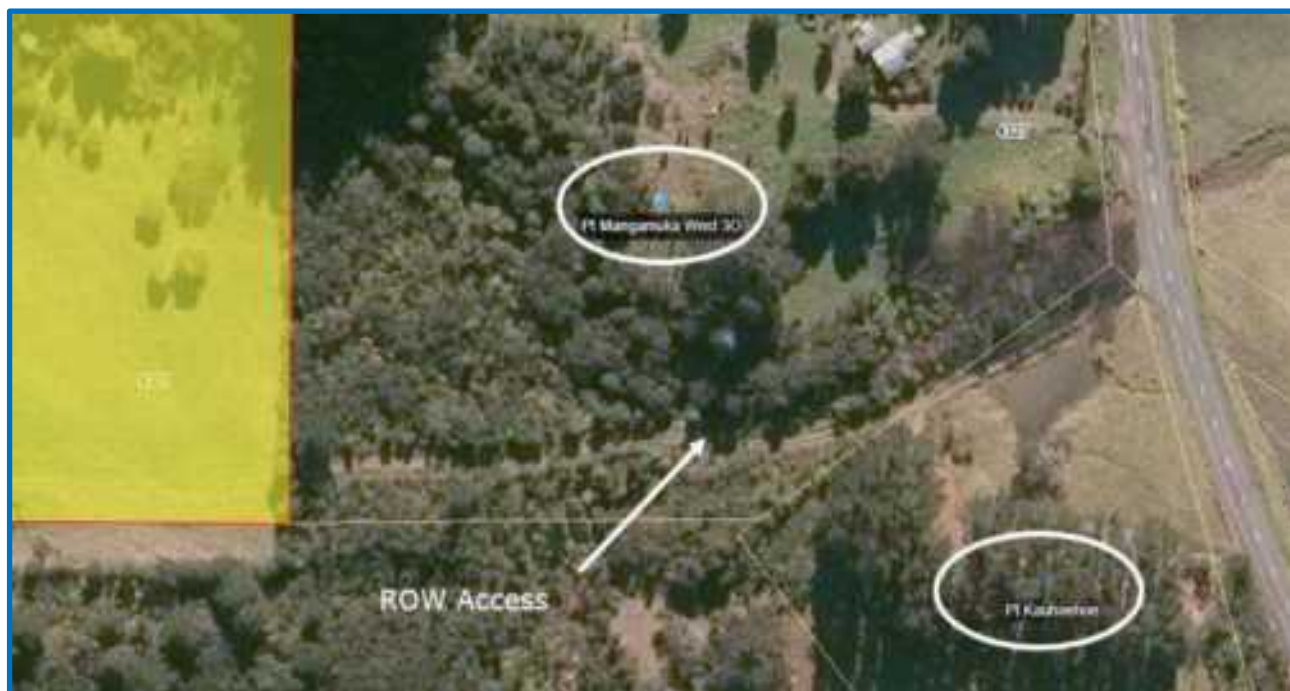
Figure 2: Aerial photograph of the two adjoining properties where ROW access is provided to the site.

Access to the site from SH1 is via a 10m wide right of way easement (ROW) over two adjacent properties: a 4.97ha property legally described as Part Mangamuka West No.3

O Block, and 1.68ha property legally described as Part Kauhoehoe Block (refer **Figure 2**).

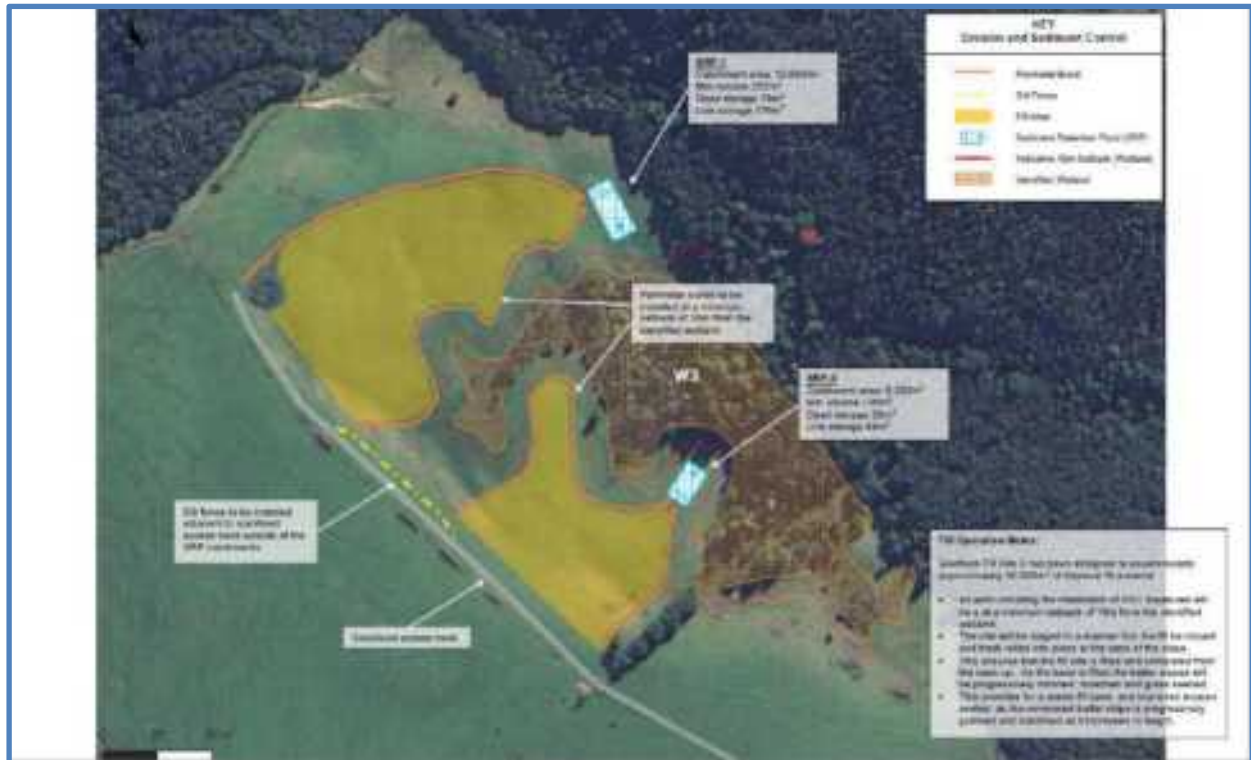
The proposal, as detailed in the Erosion and Sediment Control Plan (ESCP) prepared by CLL (refer **Appendix 1**) seeks to establish two separate fill site areas adjacent to each other in the northeastern portion of the site (refer **Figure 3**). The northern most fill area (**Fill Site 3**) will be established first, with the other area being established as required due to the capacity of the other fill site (**Fill Site 2**).

The fill area will contain a disposal area of 12,600m² (Fill Site 3) and 6,300 m² (Fill Site 2) resulting in a combined disposal area of 18,900 m², and is designed to accommodate 30,000m³ fill combined total. The fill sites are divided into two separate catchments by a ridgeline feature.

A natural inland wetland has been identified on the ESCP (W3) (refer **Figure 3**) between and below the fill areas. A 10m setback has been identified, and no fill or earthworks

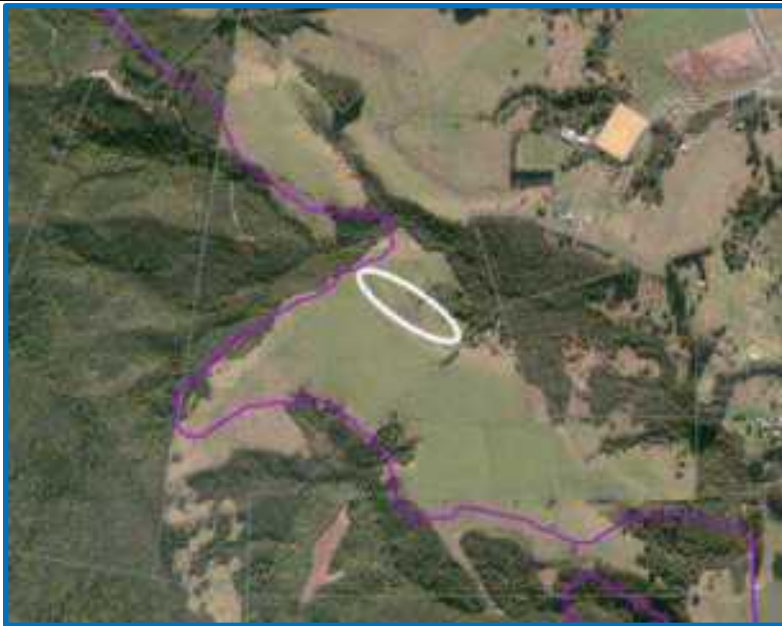
Soil classification:	The property contains LUC 2 however the fill locations 1- 3 are LUC 4 – Arable. As such NPS-HPL does not apply to this site.
Northland brown kiwi & mudfish distribution:	N/A
Significant indigenous vegetation & significant habitats of indigenous fauna:	The property contains a Protected Natural Areas Programme (PNAP) area (in purple) being the Mangamuka-Mangataipa Mosaic however the proposed fill locations (white circle) are outside this area. The area of native vegetation below the proposed fill sites is not identified as a PNAP

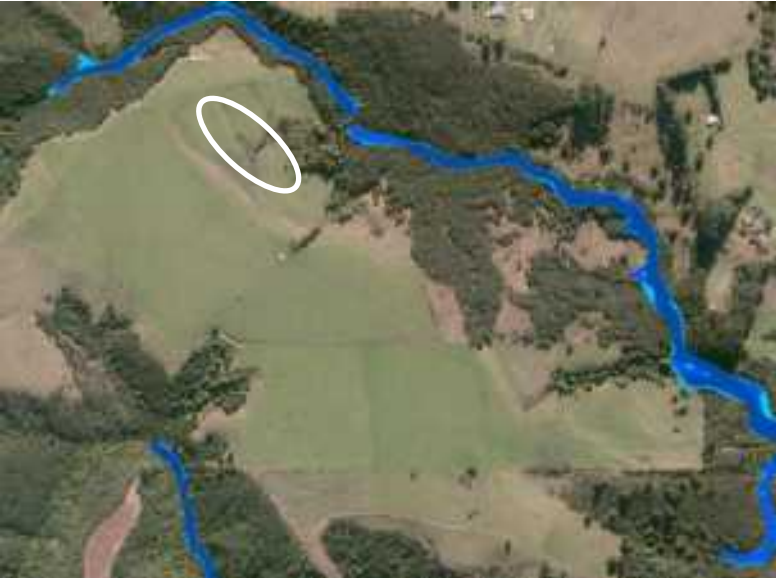
Surface Water Protection zone:	N/A
NRC Natural Hazards:	<p>River Flood Hazard zone (10, 50 & 1—year) on site but outside proposed fill locations 1- 3 (white circles)</p>

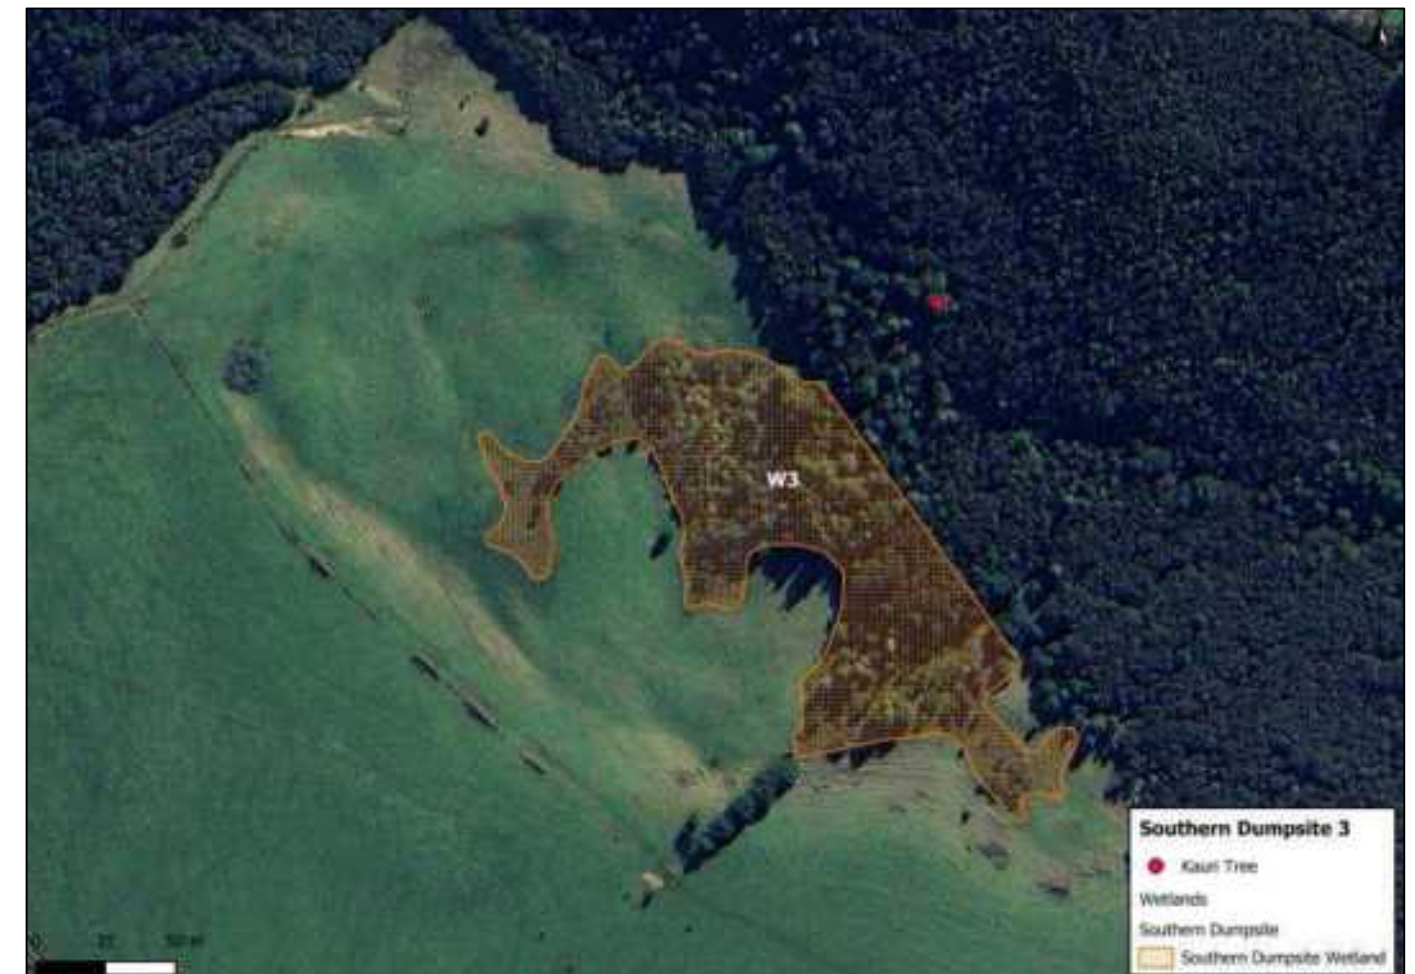
A wetland has been identified in the vicinity of the disposal area (refer to figure 1). A minimum 10m setback will be observed for the establishment of the perimeter controls (perimeter bunds). All works, plant and operations are to stay clear of the wetlands.

Figure 1: Identified Wetland 3

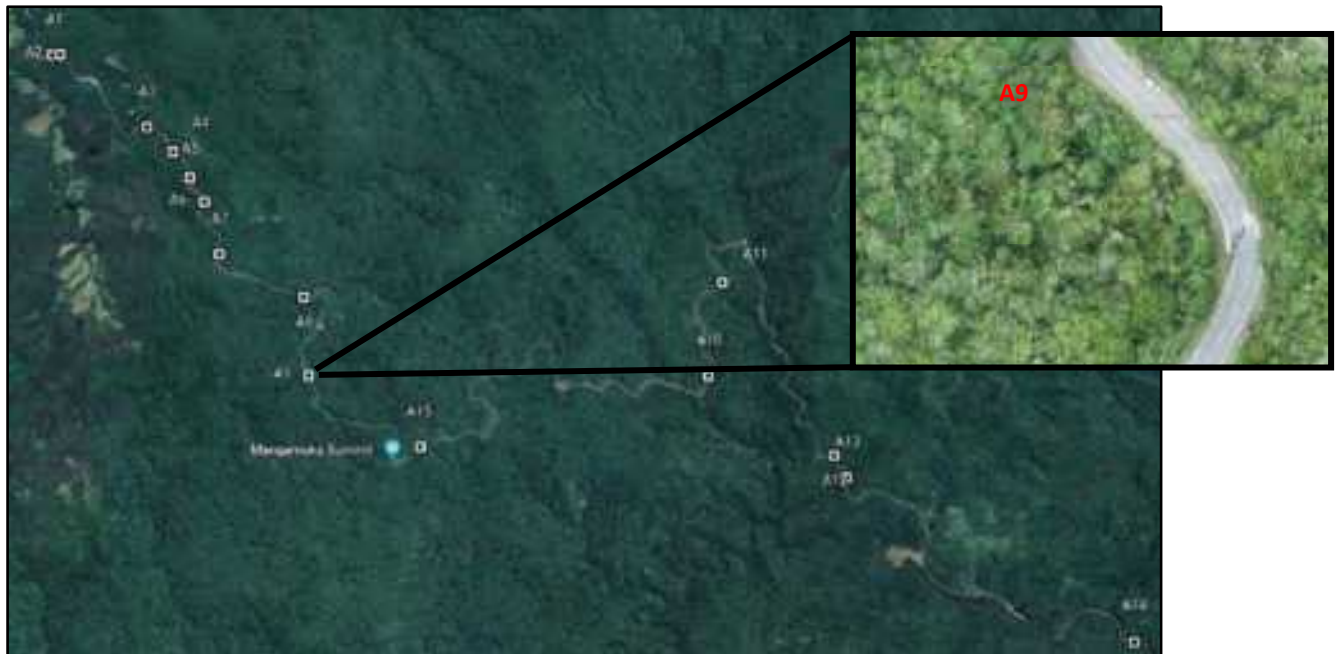
Site A9 is located at RP15.139 along SH1, approximately 21km southeast Kaitiaki. The landslide is an under slip likely caused by a material saturation resulting from the recent storm events. The site location is shown below in Figure 1-1 together with the other slip sites.

Figure 1-1: 10174/22A9 Site location Plan

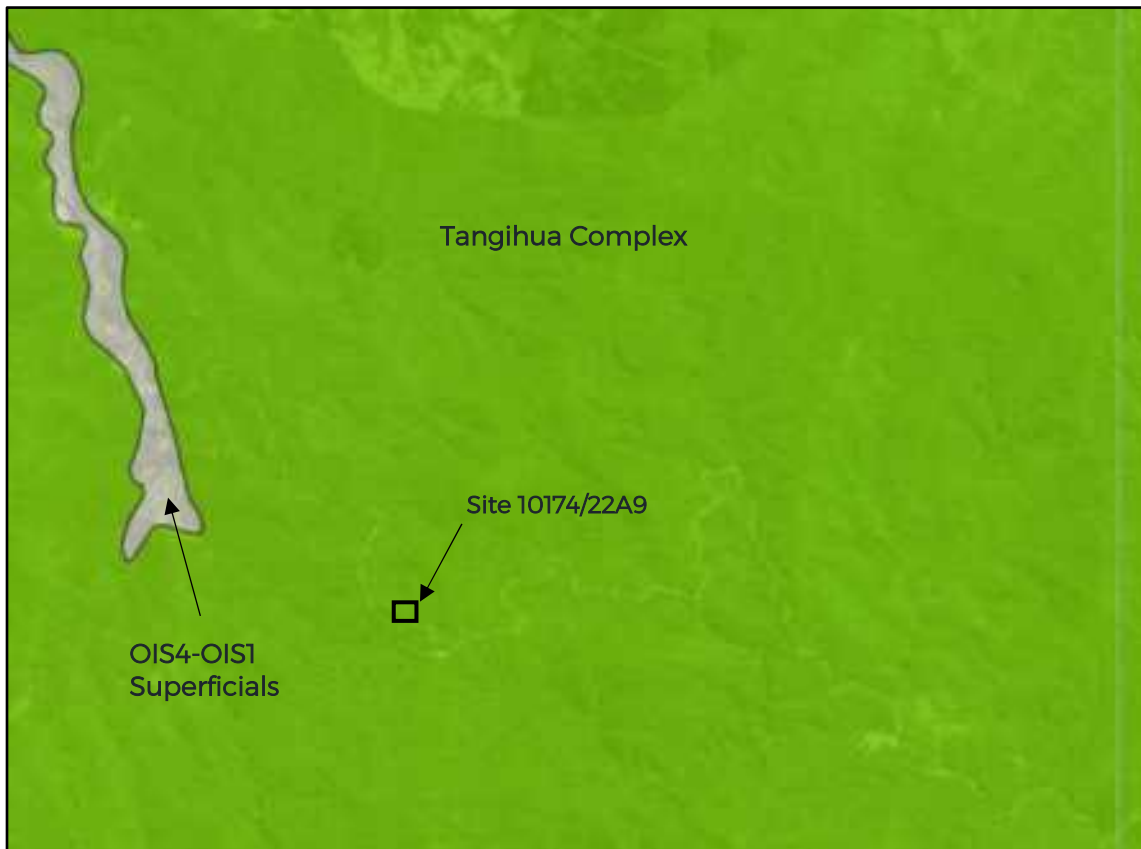
The 1:250 000 scale QMAP seamless digital data (GNS, 2013) indicates the site area to be underlain by the Undifferentiated Tangihua Complex in Northland Allochthon comprising basalt pillow lava, with subvolcanic intrusives of basalt, dolerite and gabbro; locally incorporating siliceous mudstone. (Figure 2-1). The Tangihua Complex has been emplaced onto New Zealand through convergent plate tectonics and sea floor sliding. As a result, the material has been historically sheared with the rock underlying the site expected to be highly fractured and degraded through original emplacement processes and further modified by weathering.

Figure 2-1: Regional geology

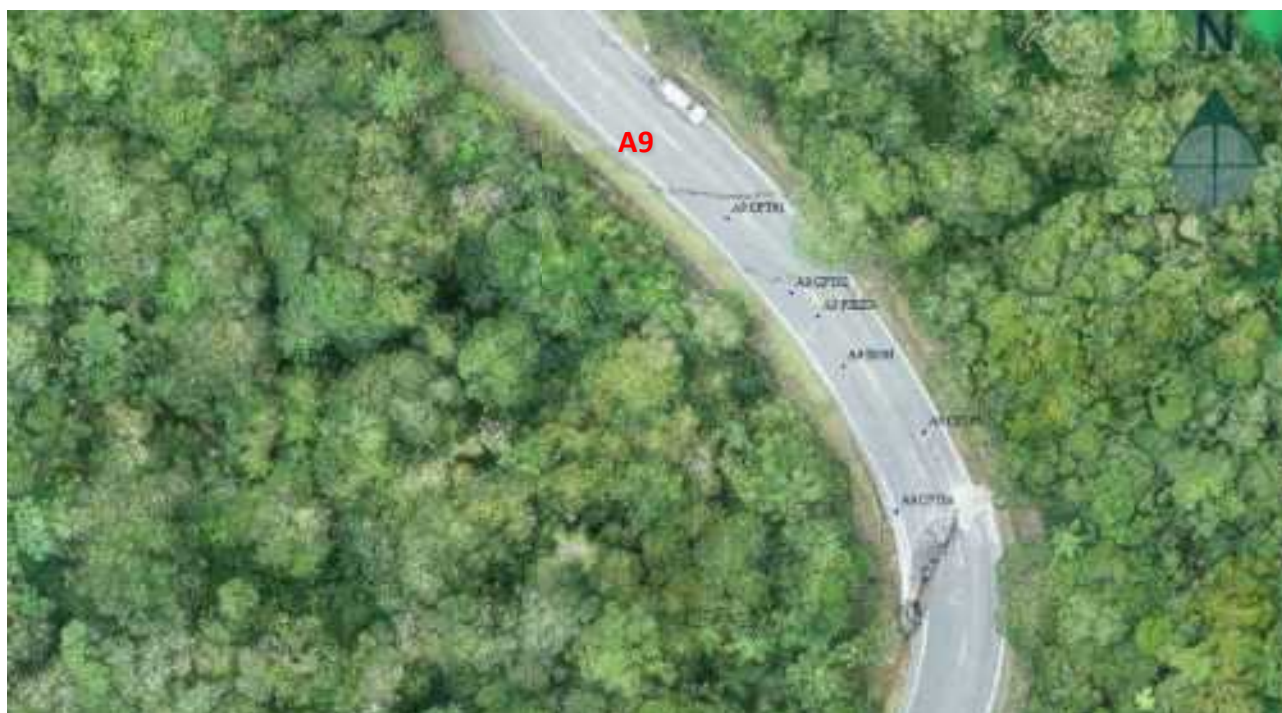
Figure 3-1: Exploratory hole location plan

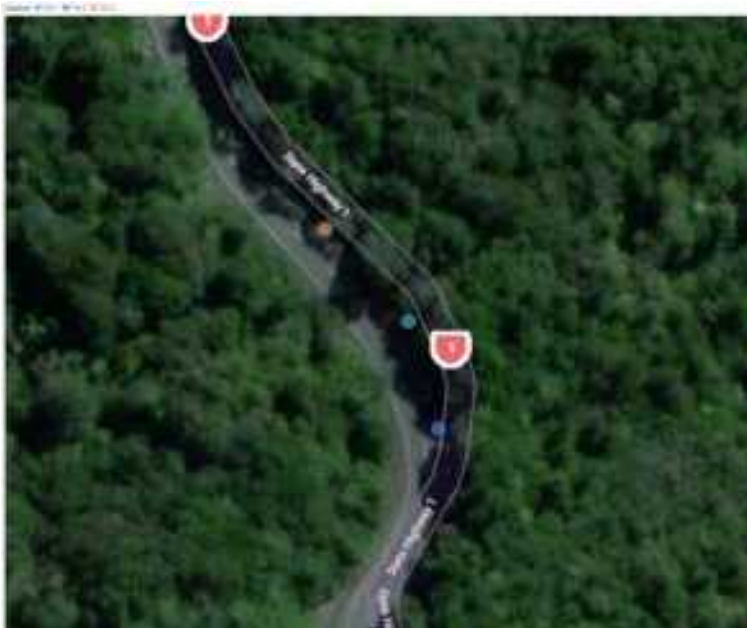
Figure 5-1: Tilt sensor positioning site A9

Tilt sensors data and rainfall sensors data is presented within Appendix C, collected from 14th September 2022. Tilt sensor positions shown below on Figure 5-1.

No significant tilt sensor movements have been identified to date at site A9 with peaks and troughs typically displaying cyclic changes in temperature affecting both the ground and monitoring equipment. MA Tilt 1,2 and 3 all displayed X, Y, Z movements up to 0.30° between 17th September and 20th September 2022.

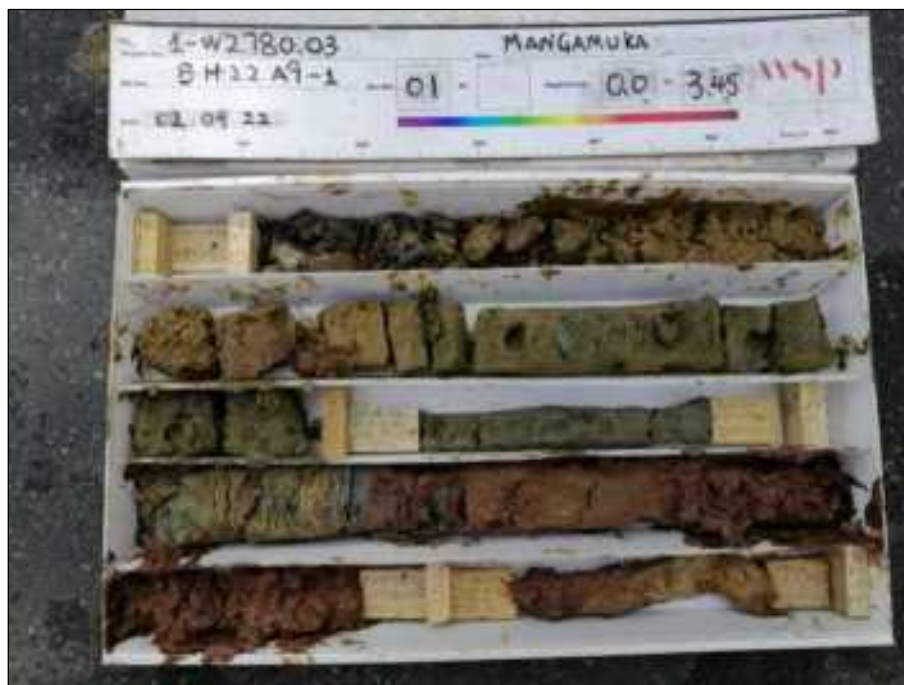
Photo BHA9-1.1
 BOX01: 0.00 - 3.45m.

Coordinates: 280495 E 987052 N
 Ref. Grid: NZTM
 R.L.: 328.8 m
 Datum: NZ Geodetic Datum 2000
 Depth: 19.5 m
 Inclination: Vertical

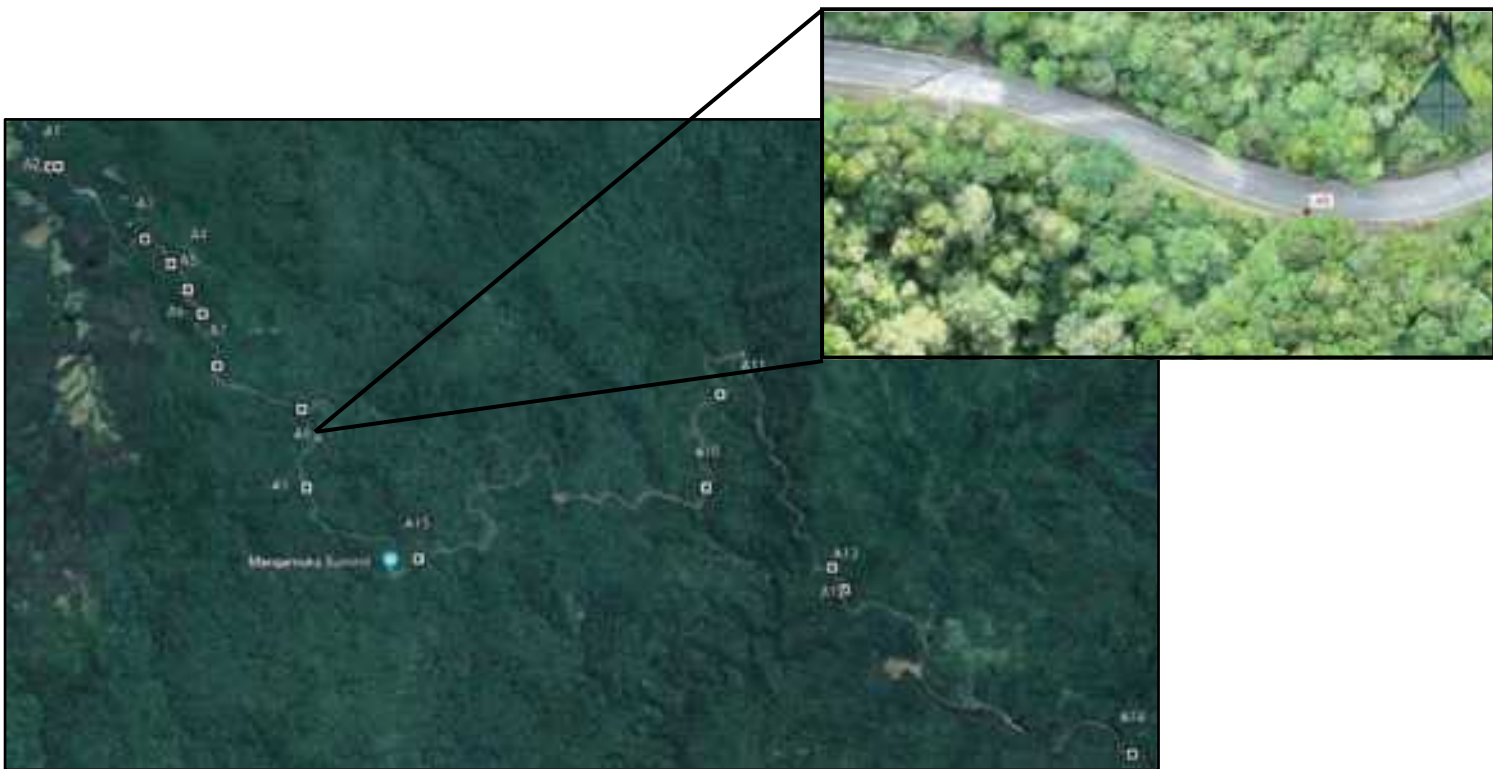
Figure 1-1: 10176/22A8 Site location Plan

This report covers the investigation and assessment at 10176/22A8 (henceforth referred to as A8) and provides a recommended solution. Site A8 is located at RP14.580 along SH1, approximately 2km north of Mangamuka Summit and 21km southeast Kaitiaki. The feature is an historical underslip with movement activated as a result of the recent storm events with heavy rainfall.

The site location is shown below in Figure 1-1 together with the other slip sites.

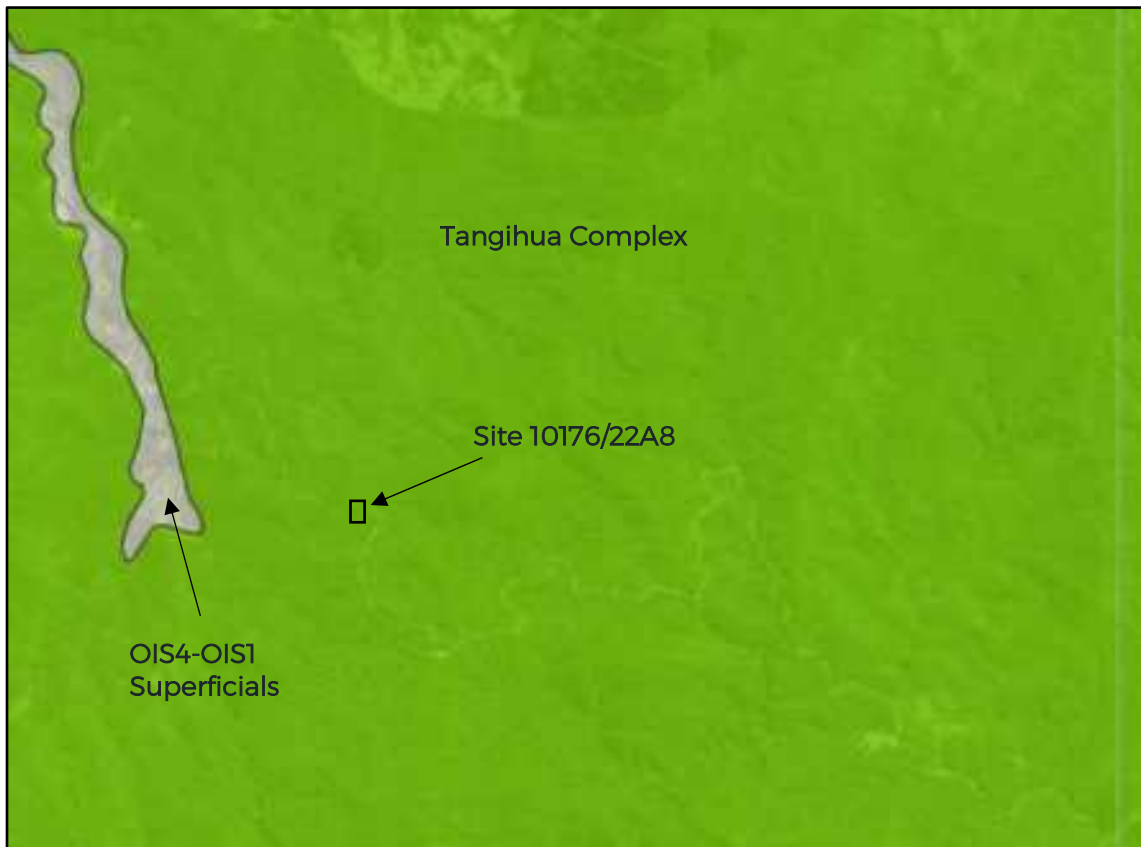
The Tangihua Complex has been emplaced onto New Zealand through convergent plate tectonics and sea floor sliding. As a result, the material has been historically sheared with the rock underlying the site expected to be highly fractured and degraded through original emplacement processes and further modified by weathering.

Figure 2-1: Regional geology

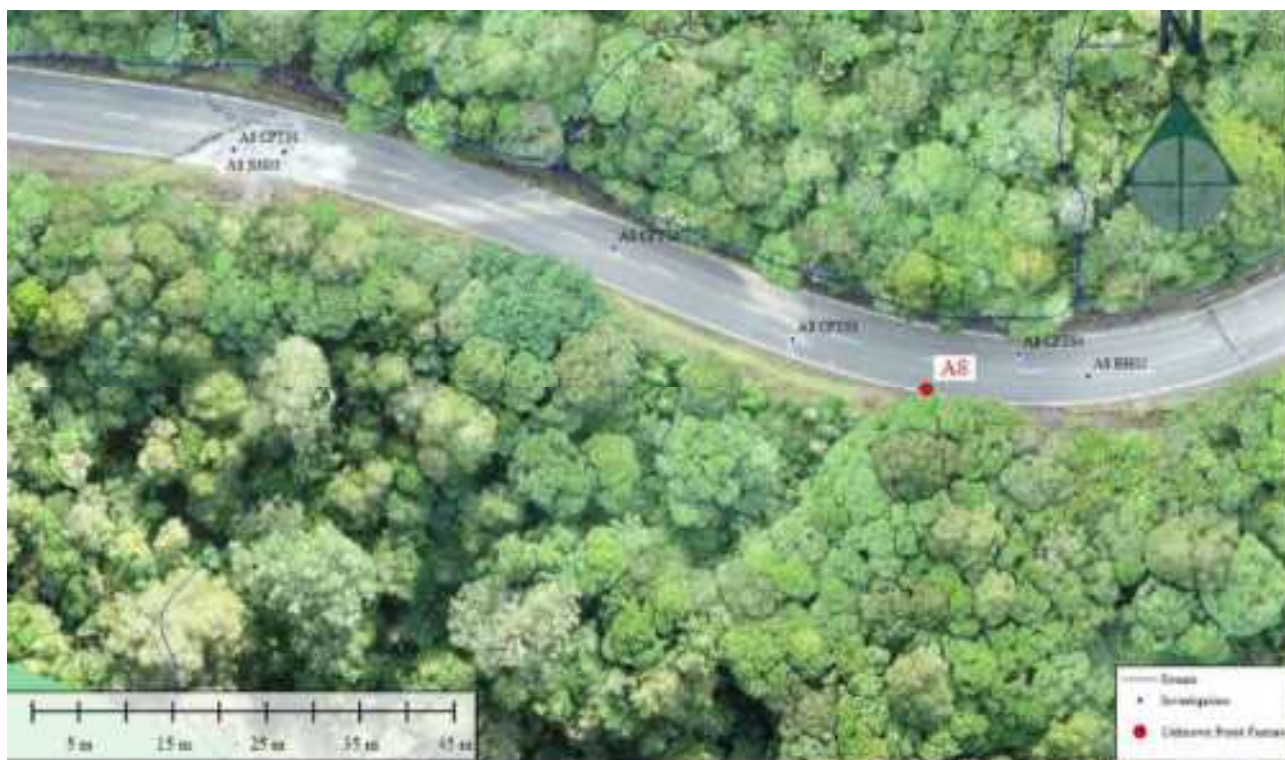
Figure 3-1: Exploratory hole location plan

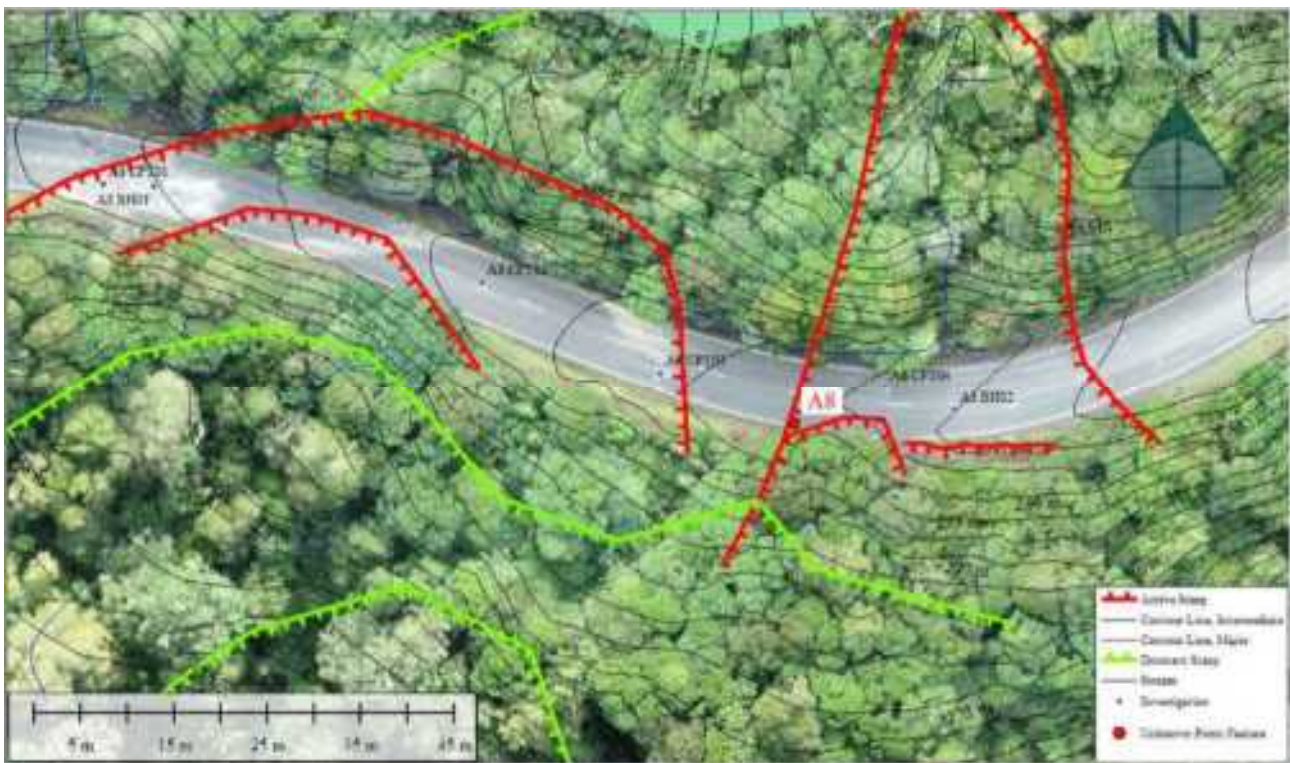
A terrain evaluation is presented below in Figure 4-1. Geomorphological mapping undertaken from both Lidar and aerial photography as well as site observations.

Figure 4-1: Geomorphological map

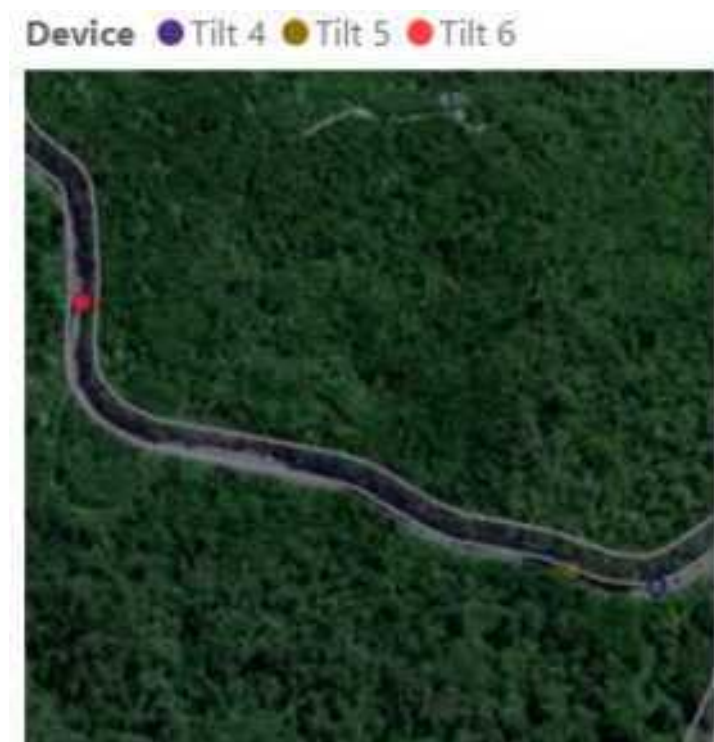
Figure 5-1: Tilt sensor position A8

Tilt sensors data and rainfall sensors data is presented within Appendix C, collected from 14th September 2022. Tilt sensor positions shown below on Figure 5-1.

Mangamuka gorge experienced 16mm of rain at 11pm on the 29th October 2022, resulting in the following movements at MA tilt sensor:

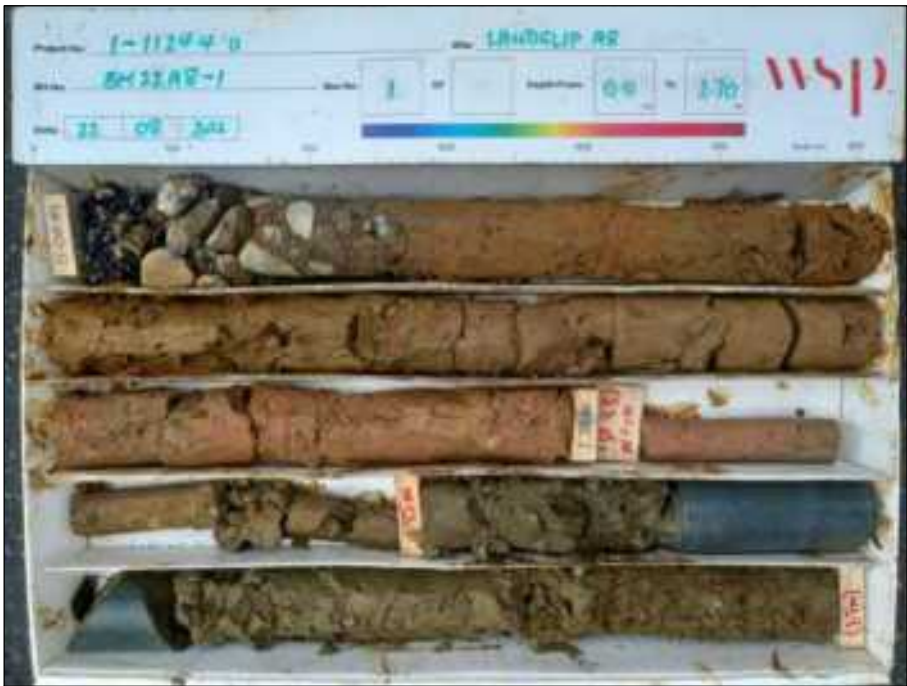
Photo BH22A8-1.1
BOX01: 0.00m - 2.70m

Project:	Waka Kotahi Northland Emergency Resilience	Coordinates:	280352 E 987494 N
Client:	Waka Kotahi	Ref. Grid:	NZTM
Project No.:	1-11244.00	Depth:	30 m
Location:	Slip 22A8 Mangamuka Range	R.L.:	276.946 m
		Inclination:	-90°
		Datum:	NZ Vertical Datum 2016 Azimuth: 0°

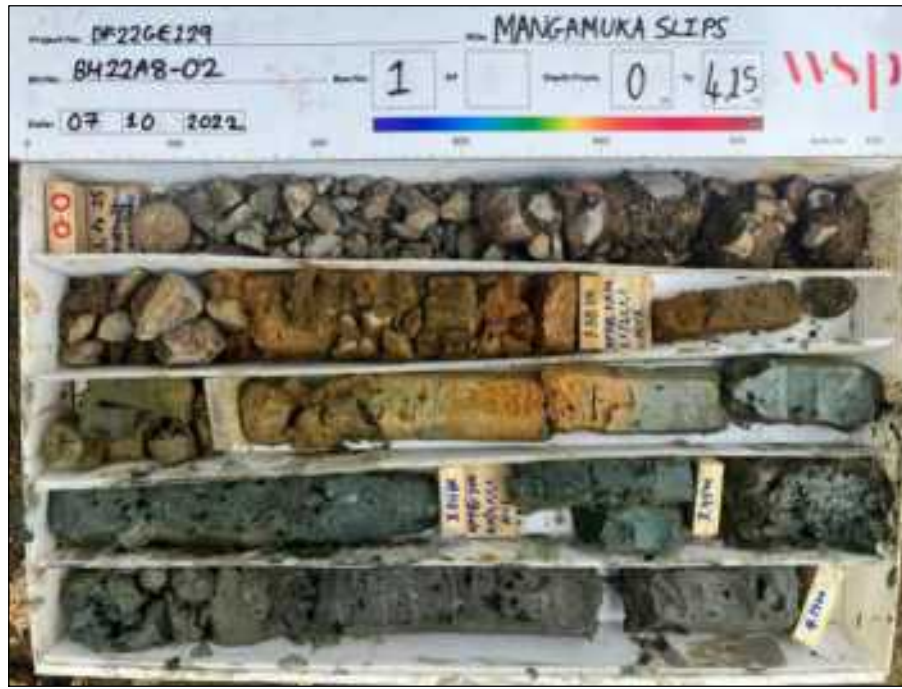
Photo BH22A8-2.1
 BOX 01 - 0.00 - 4.15m

Coordinates: 280438 E 987470 N
 Ref. Grid: NZTM
 R.L.: 282 m
 Datum: NZ Geodetic Datum 2000
 Depth: 25.5 m
 Inclination: Vertical

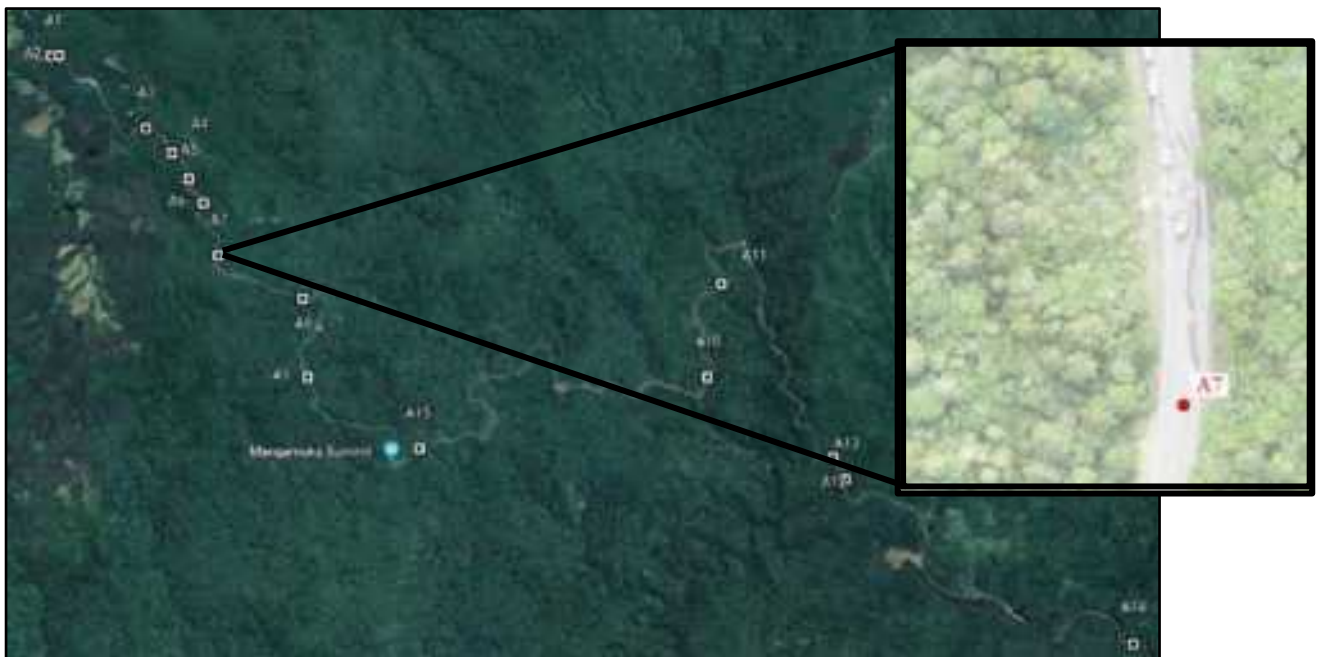
Figure 1-1: 10037/22A7 Site location Plan

Site A7 is located at RP14100 along SH1, approximately 20km southeast Kaitiaki. The landslide is an underslip likely caused by a material saturation resulting from the recent storm events. The site location is shown below in together with the other slip sites.

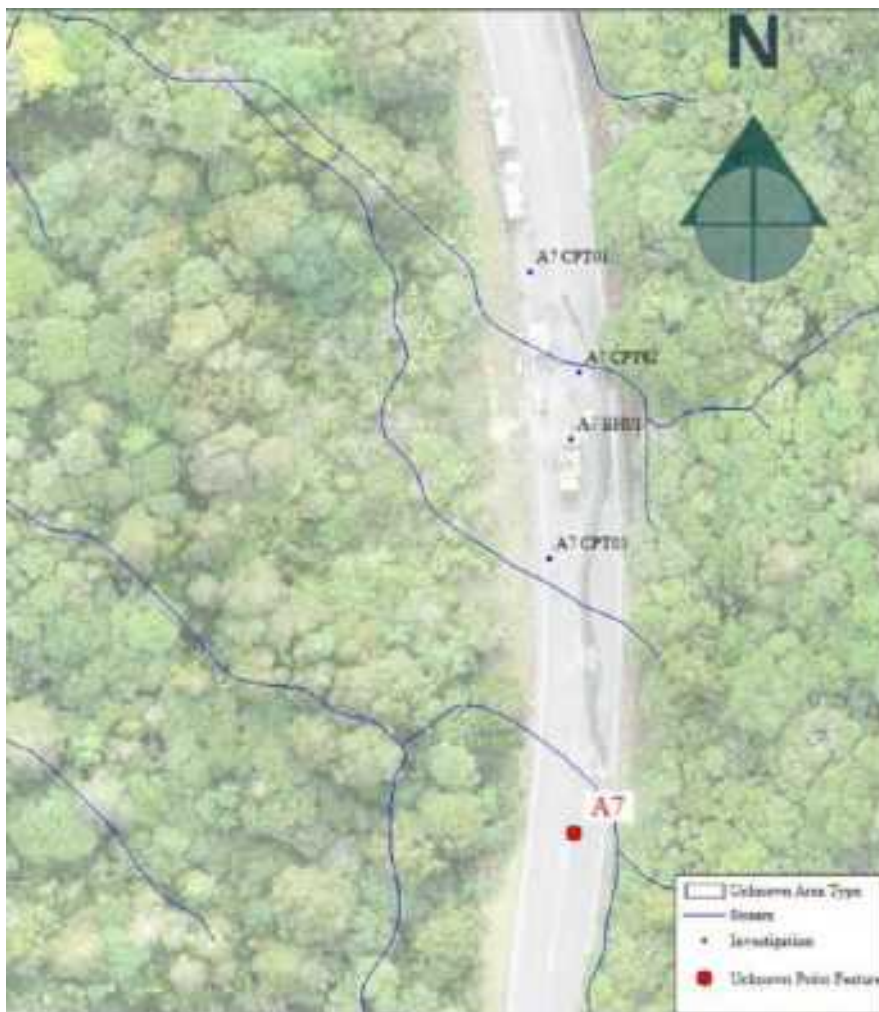
Figure 3-1: Exploratory hole location plan

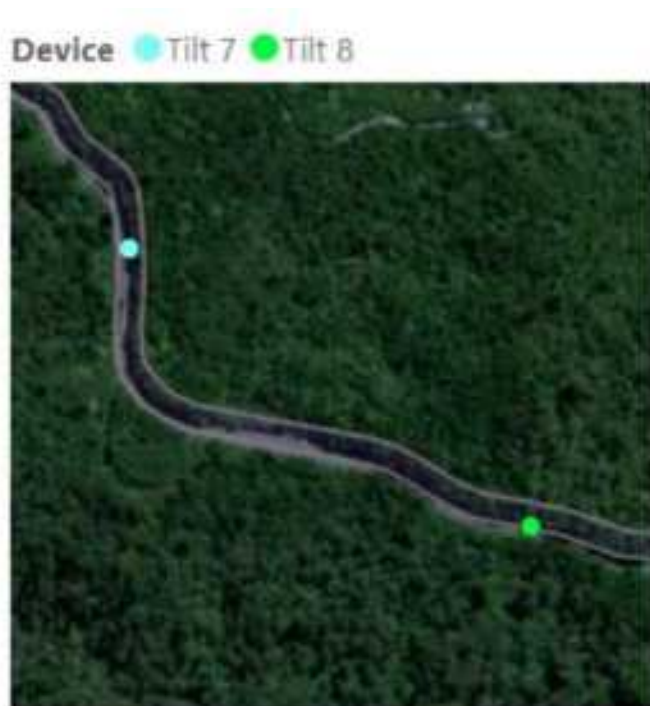
Figure 5-1: Tilt sensor position A7

Tilt sensors data and rainfall sensors data is presented within Appendix C, collected from 14th September 2022. Tilt sensor positions shown below on Figure 5-1.

No significant tilt sensor movements have been identified to date at site A7 with peaks and troughs typically displaying cyclic changes in temperature.

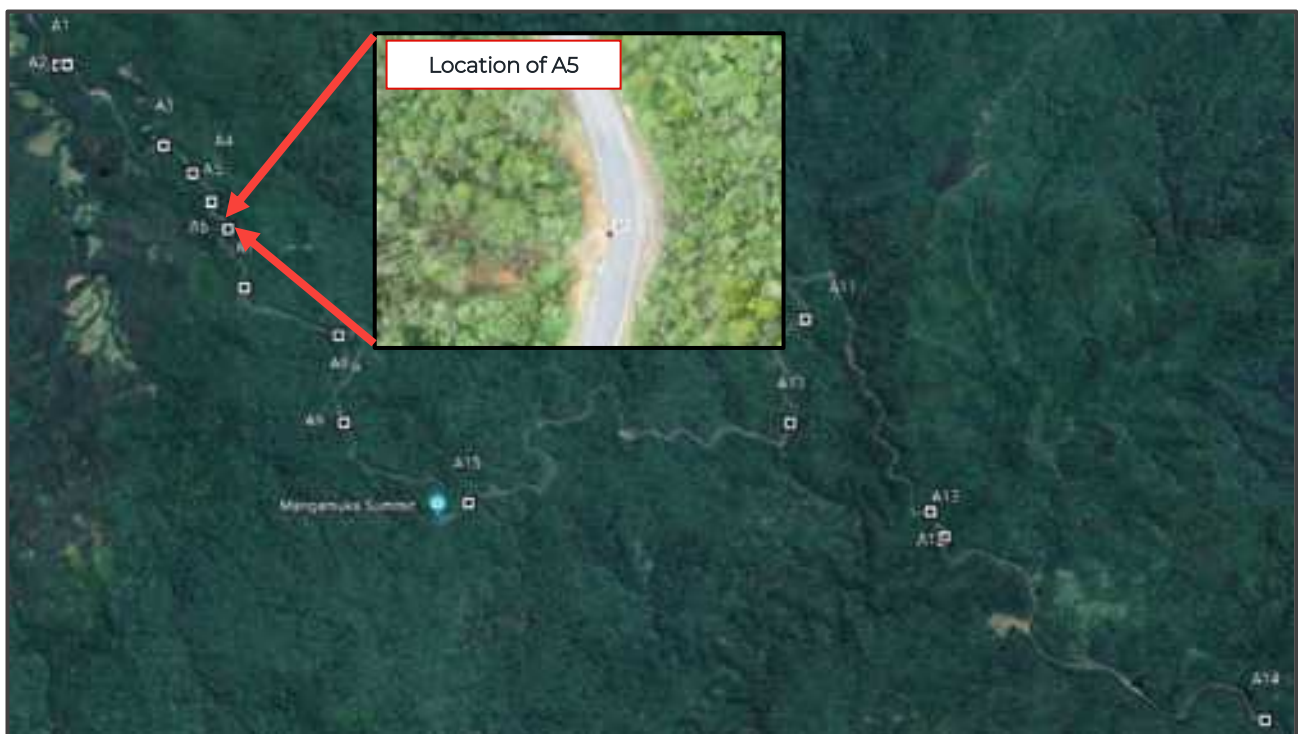
Figure 1-1: 10012/22A5 Site location Plan

This report covers the investigation and assessment at site 10012/22A5 (henceforth referred to as A5) and provides a recommended solution. The Site A5 is located at approximately 22 km south of the northern extent of the study area at RS119 PR13.507, approximately 20 km southeast Kaitiaki.

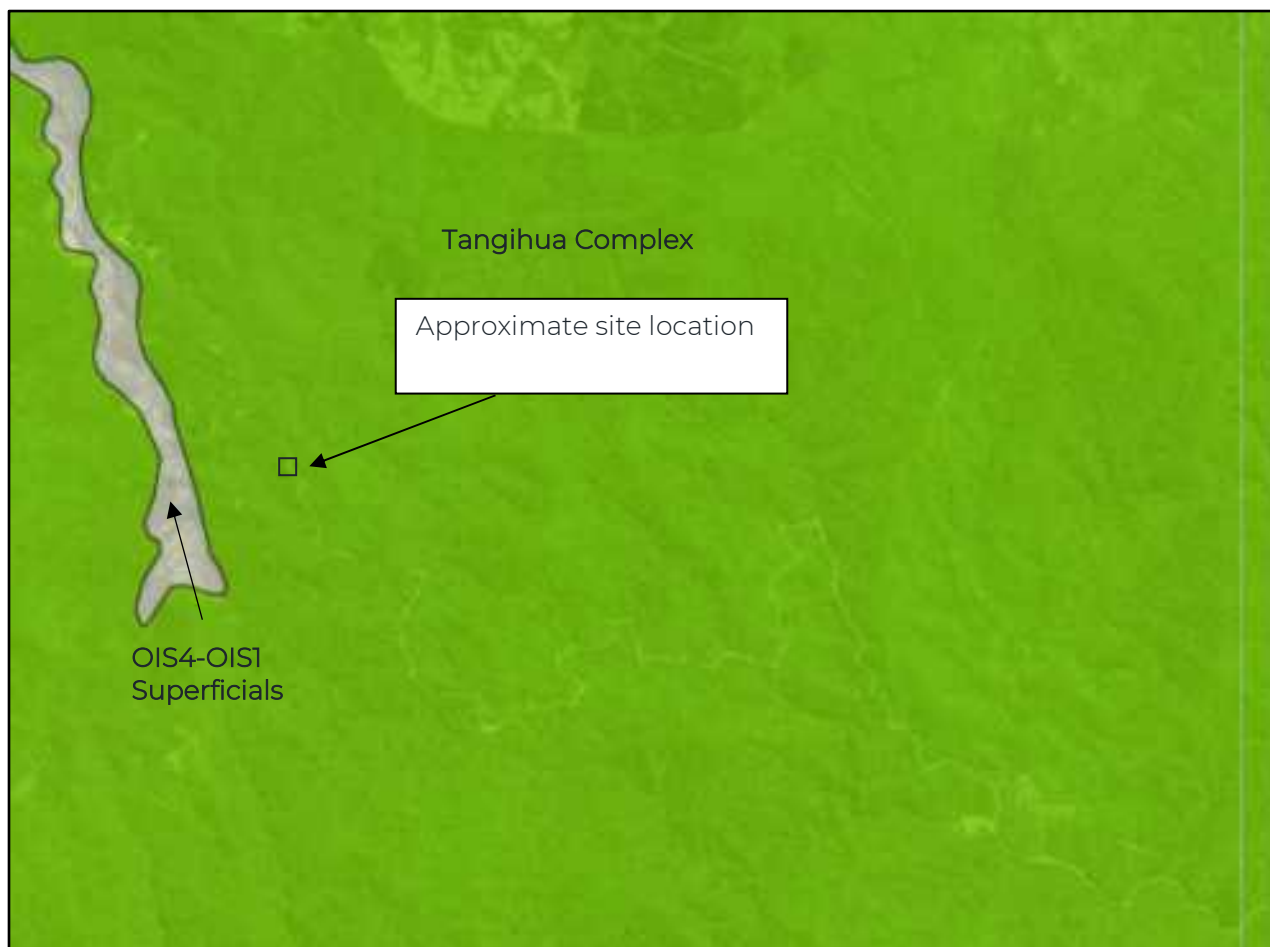
The 1:250 000 scale QMAP seamless digital data (GNS, 2013) indicates the site area to be underlain by the Undifferentiated Tangihua Complex in Northland Allochthon comprising basalt pillow lava, with subvolcanic intrusives of basalt, dolerite and gabbro; locally incorporating siliceous mudstone (Figure 2-1). The Tangihua Complex has been emplaced onto New Zealand through convergent plate tectonics and sea floor sliding. As a result, the material has been historically sheared with the rock underlying the site expected to be highly fractured and degraded through original emplacement processes and further modified by weathering.

Figure 2-1: Regional geology

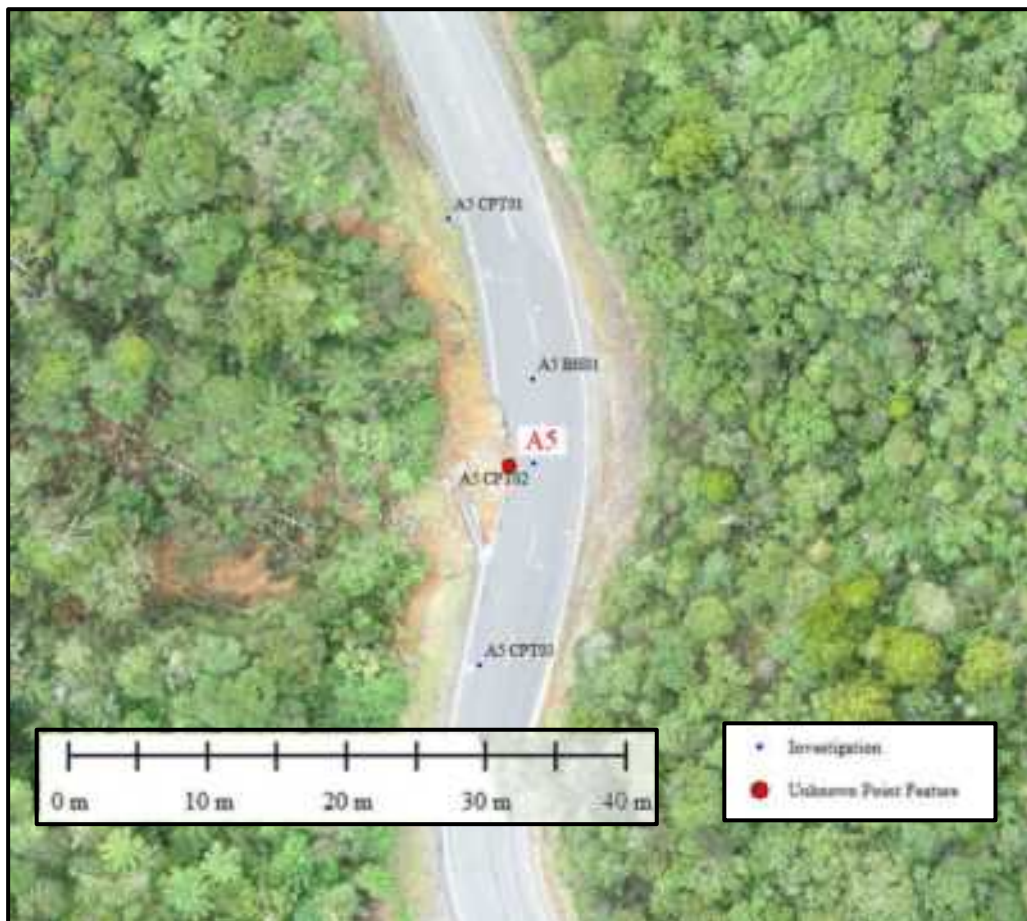
Figure 3-1: Exploratory hole location plan

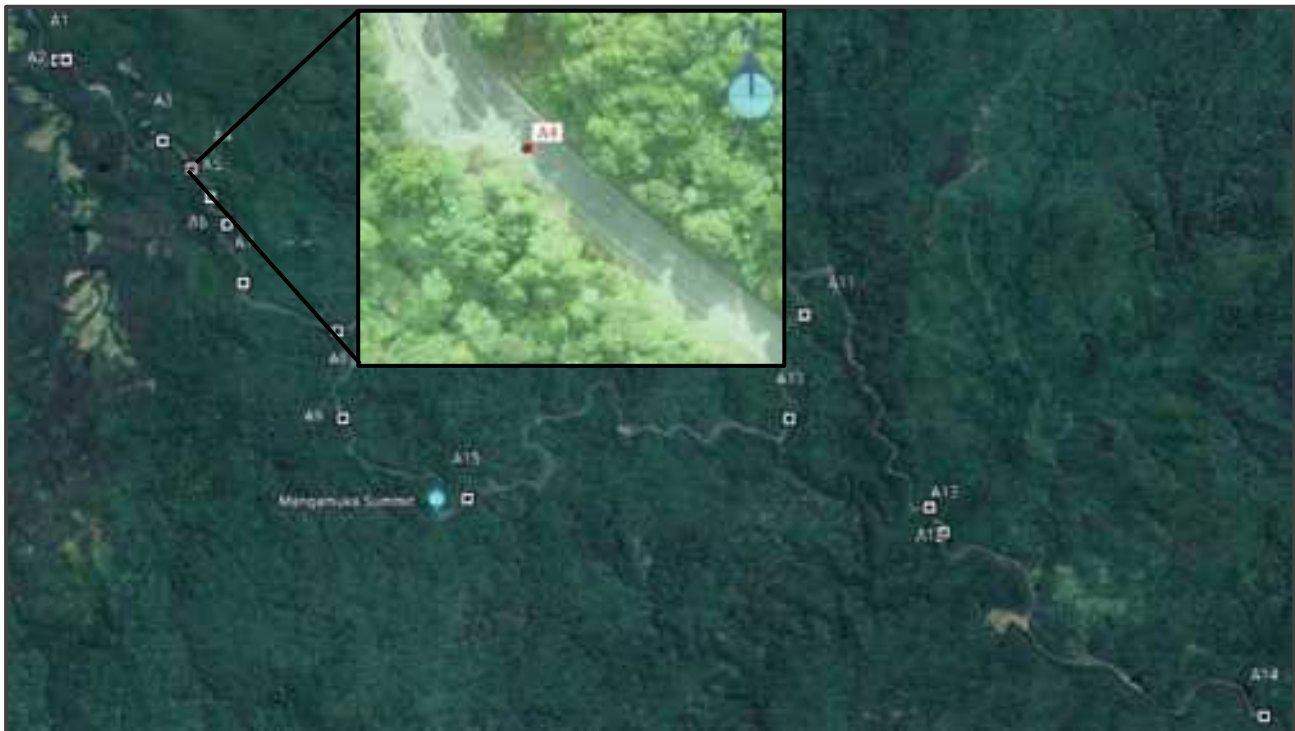
Figure 1-1: 10081/22A4 Site location Plan.

Slumping of the northbound lane has occurred with minor deformation and cracking extending into the southbound lane and along the centreline. The landslide is an underslip likely caused by a material saturation resulting from the recent storm events and long-term undercutting by Victoria River near the base of the slope reducing the global stability of the hillside. The cracking was first observed in July (refer to July 2022 Storm Event Initial Advice – Memo no.1)
