Application for resource consent or fast-track resource consent

New Zealand Transport Authority Waka Kotahi (NZTA)

On 19 August 2022, Te Tai Tokerau/ Northland was hit with a Severe Weather Event, including strong wind gusts and significant rainfall, which caused widespread damage and flooding across the Region, and resulted in several landslides through the Mangamuka Gorge, making it impassable. This damage resulted in the complete closure of SH1 through the Gorge, severing a vital link for the Far North/ Te Hiku-o-te-Ika to the remainder of the country.

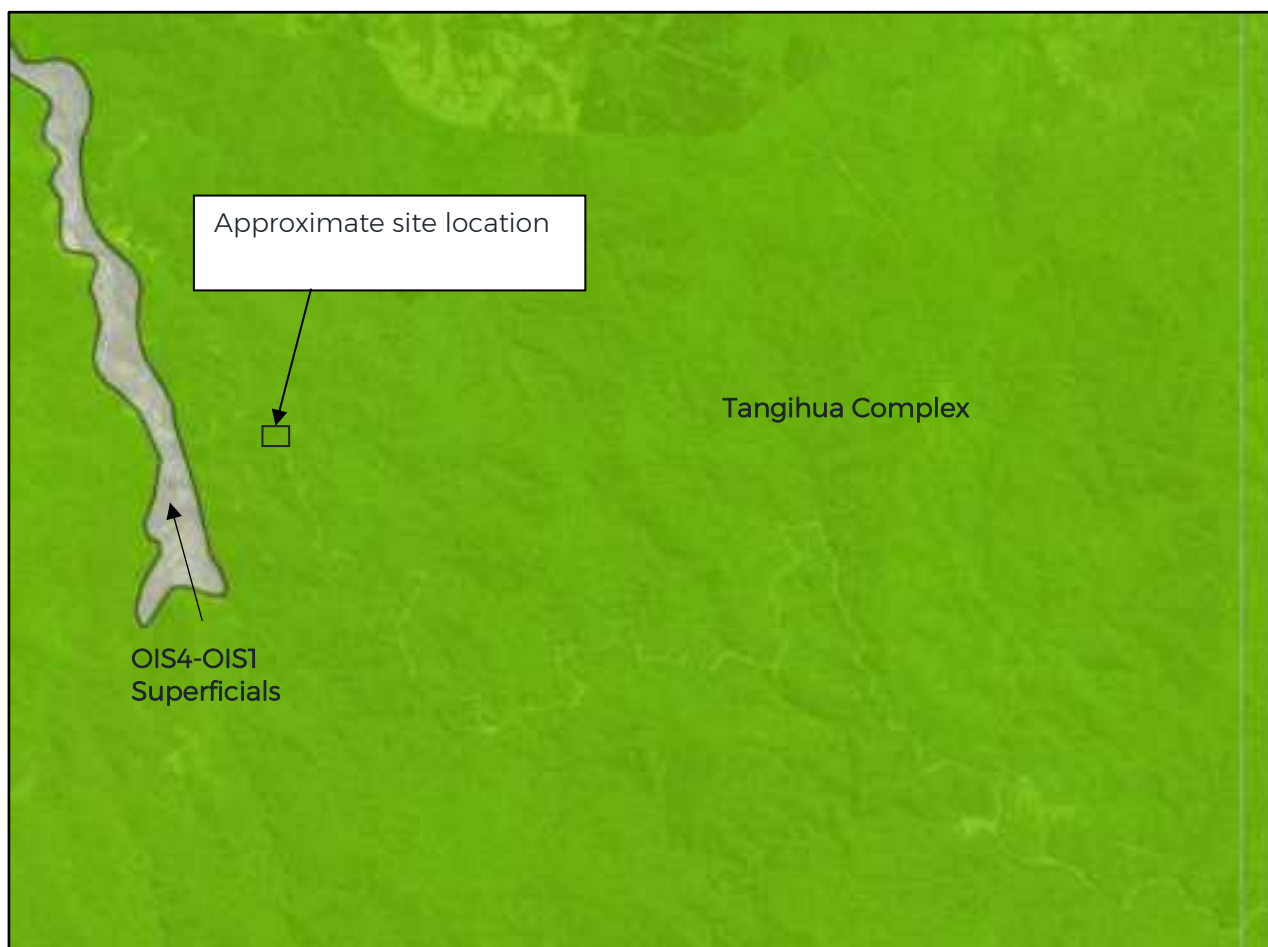
The Tangihua Complex has been emplaced onto New Zealand through convergent plate tectonics and sea floor sliding. As a result, the material has been historically sheared with the rock underlying the site expected to be highly fractured and degraded through original emplacement processes and further modified by weathering.

Figure 2-1: Regional geology

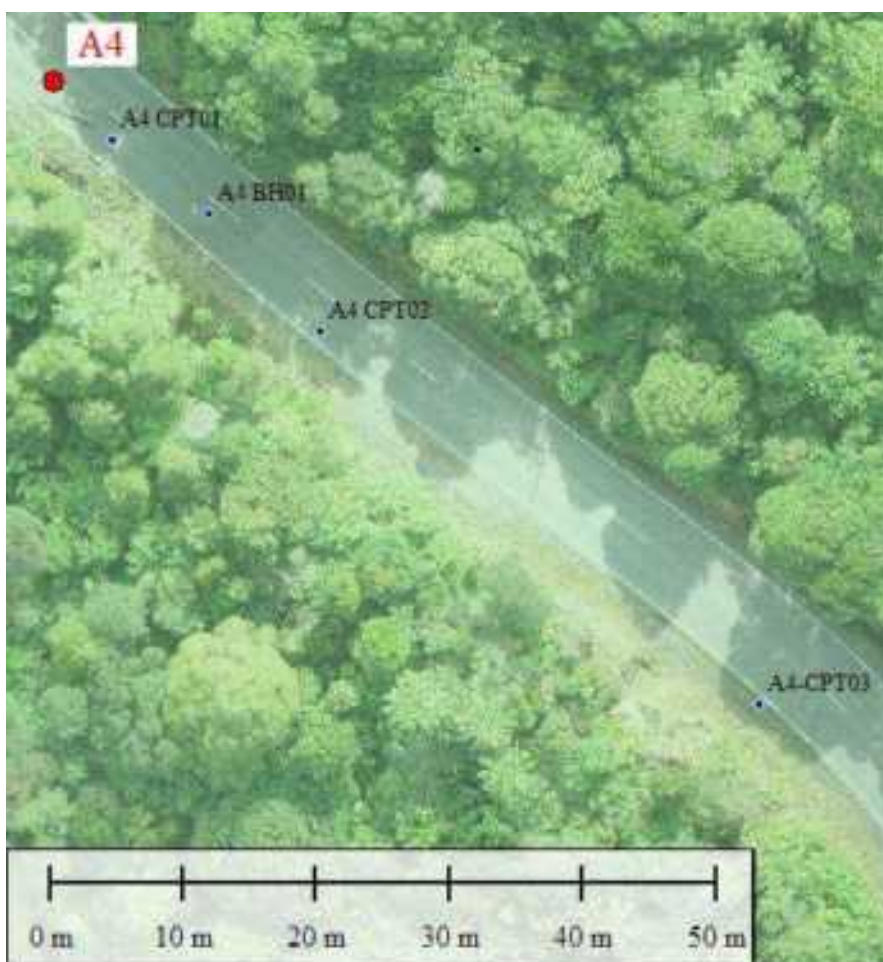
Figure 3-1: Exploratory hole location plan

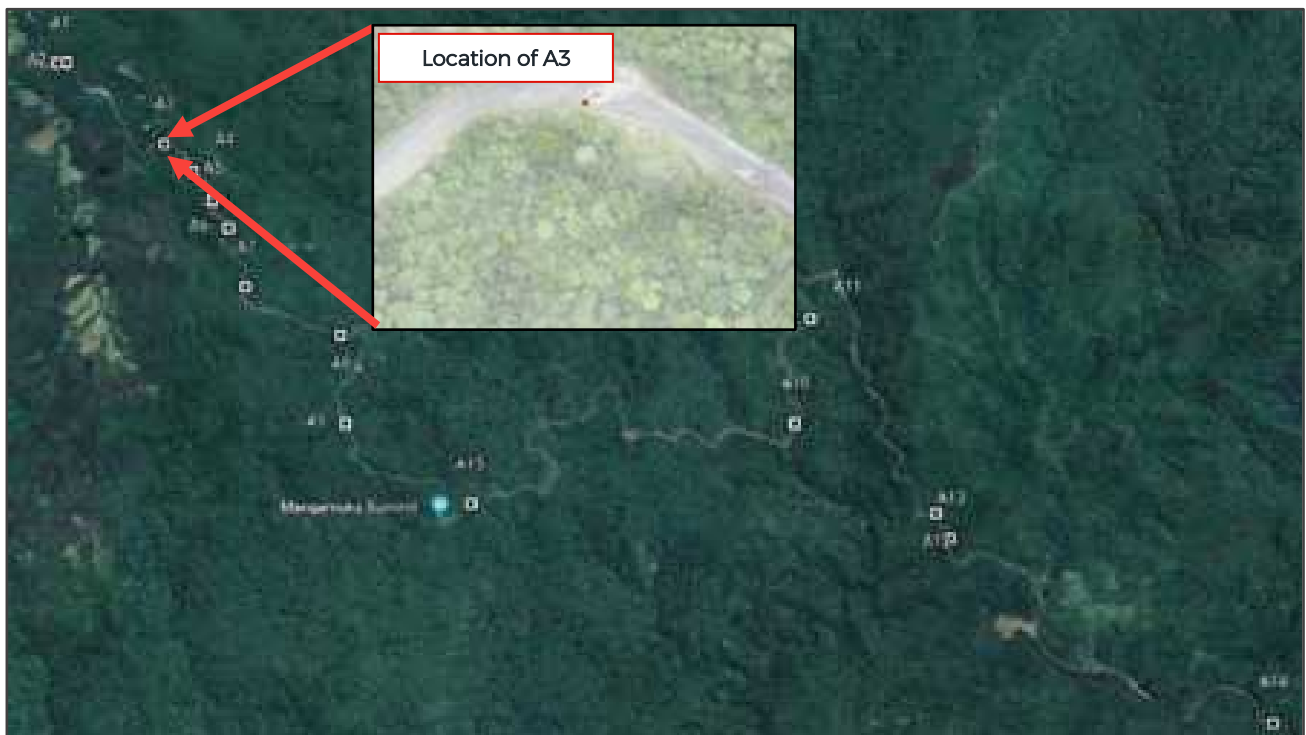
Figure 1-1: 10035/22A3 Site location Plan

This report covers the investigation and assessment at site 10035/22A3 (henceforth referred to as A3) and provides a recommended remedial solution. The Site A3 is located approximately 2.5km south of the northern extent of the Mangamuka Gorge at RS119 RP 13.33, approximately 18km southeast Kaitiāia. Following periods of prolong rainstorm events in July and August, a deep-seated movement has occurred causing significant slumping affecting the entire road along this section of SH1.

The landslide is likely caused by a material saturation resulting from the recent storm events and undercutting by Victoria River near the base of the slope. The site location is shown below in Figure 1-1 together with other slip sites.

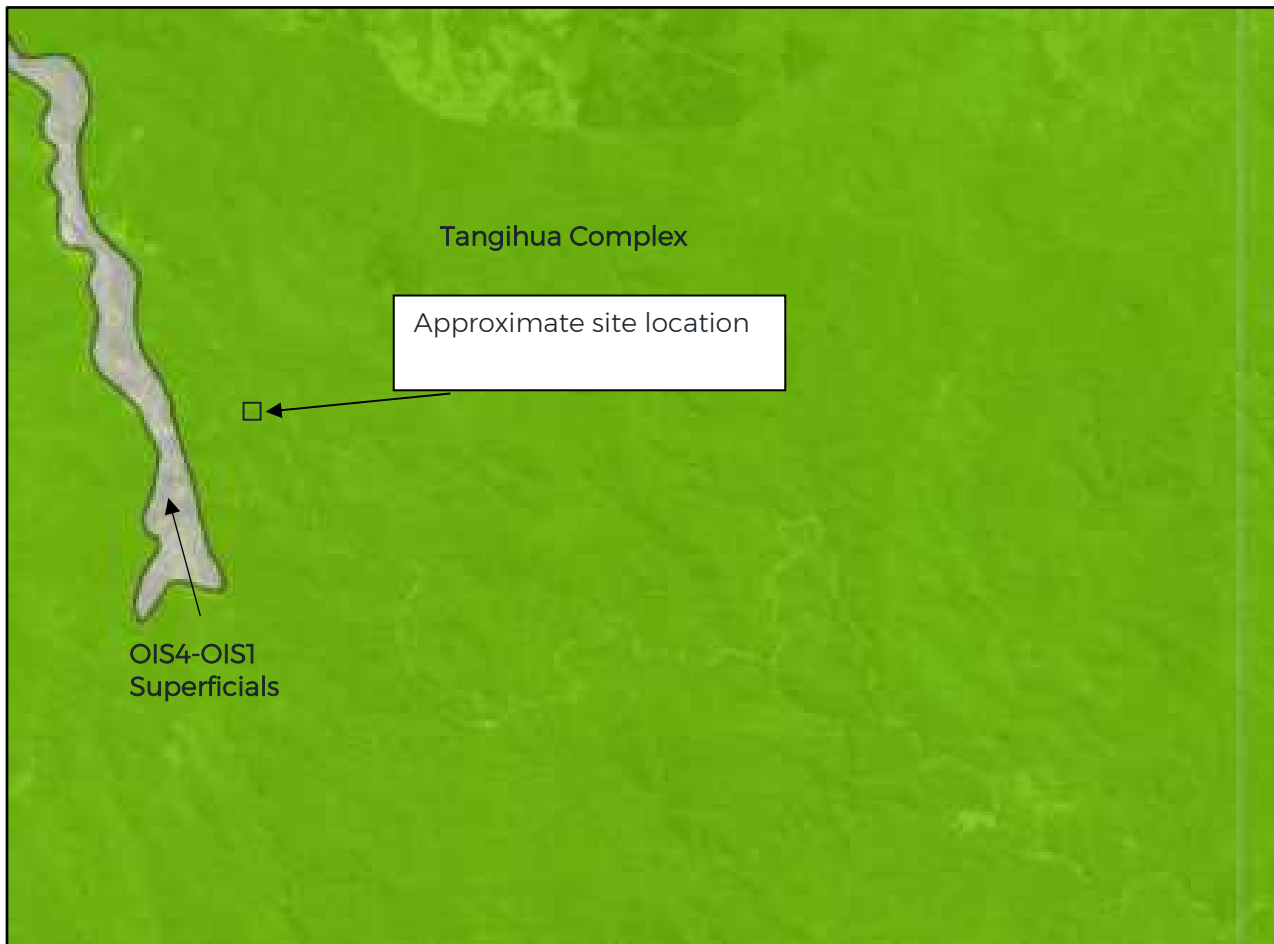
underlying the site expected to be highly fractured and degraded through original emplacement processes and further modified by weathering.

Figure 2-1: Regional geology

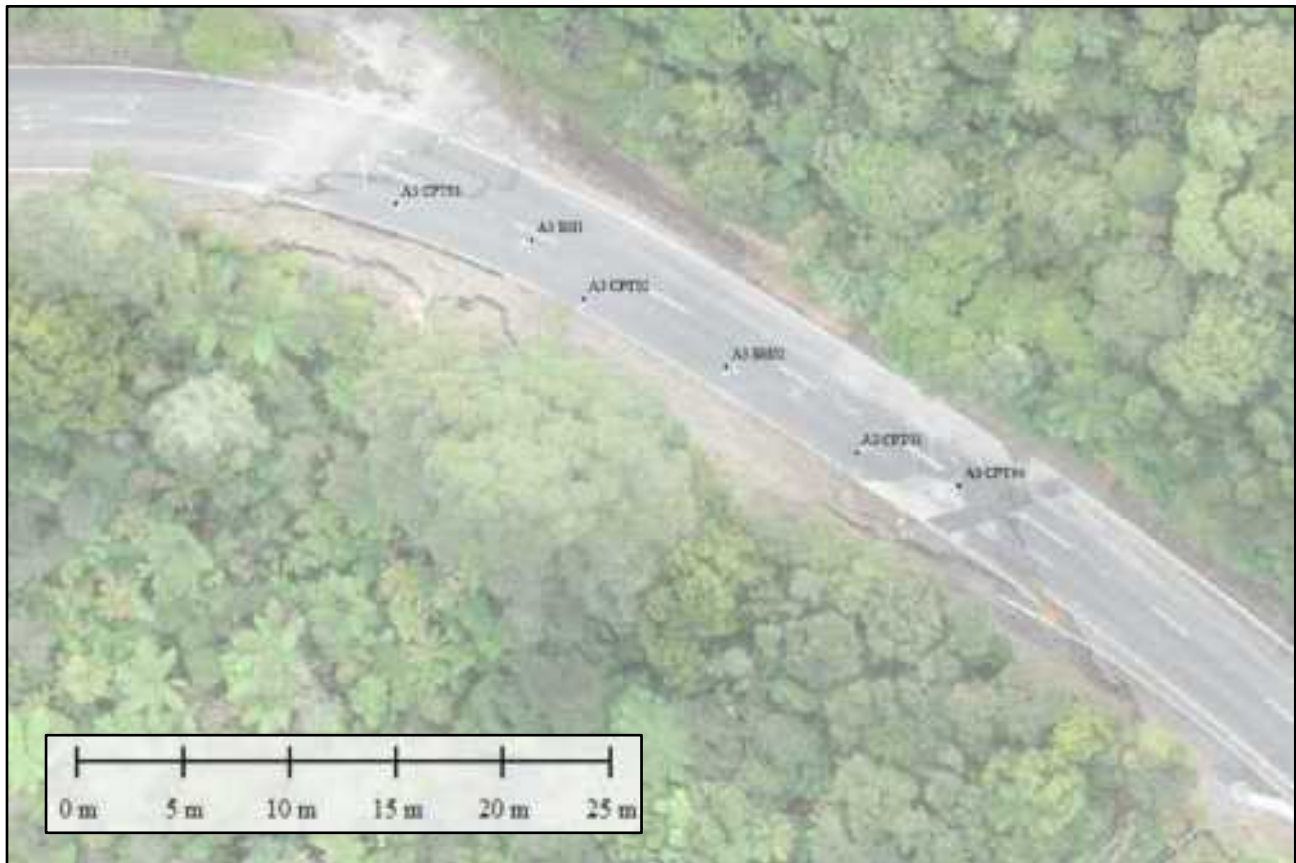
Figure 3-1: Exploratory hole location plan

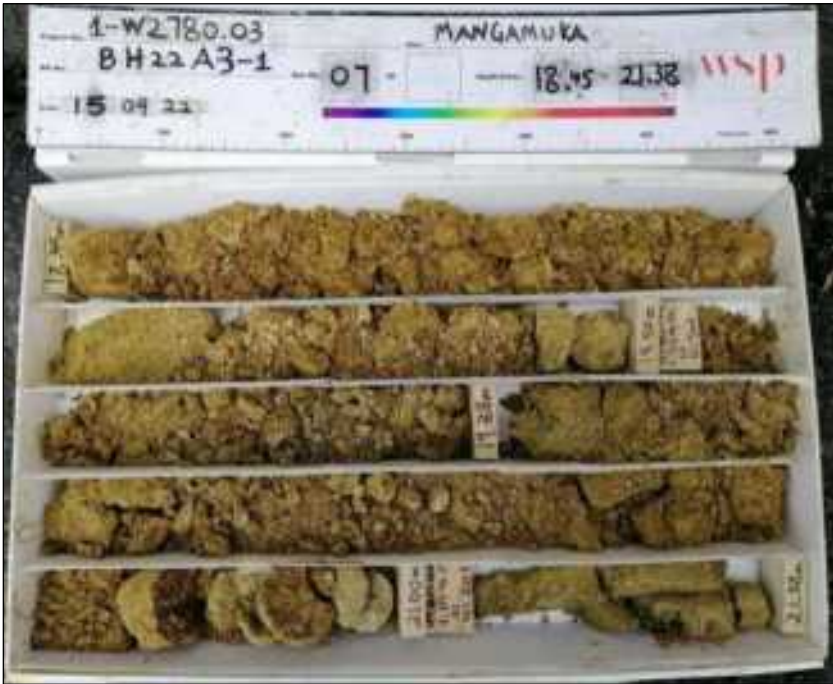
Photo BH22A3-1.7
18.45 - 21.38m.

Borehole located within southbound lane approximately 3m from headscarp.
Borehole terminated within MW Dolerite. Inclinator installed on completion.
Logged in accordance with NZGS Guideline of the Field Classification and Description
of Soil and Rock for Engineering Purposes, December 2005 & Engineering &
Development in Hazardous Terrain 2001, pg 365, Table 1.

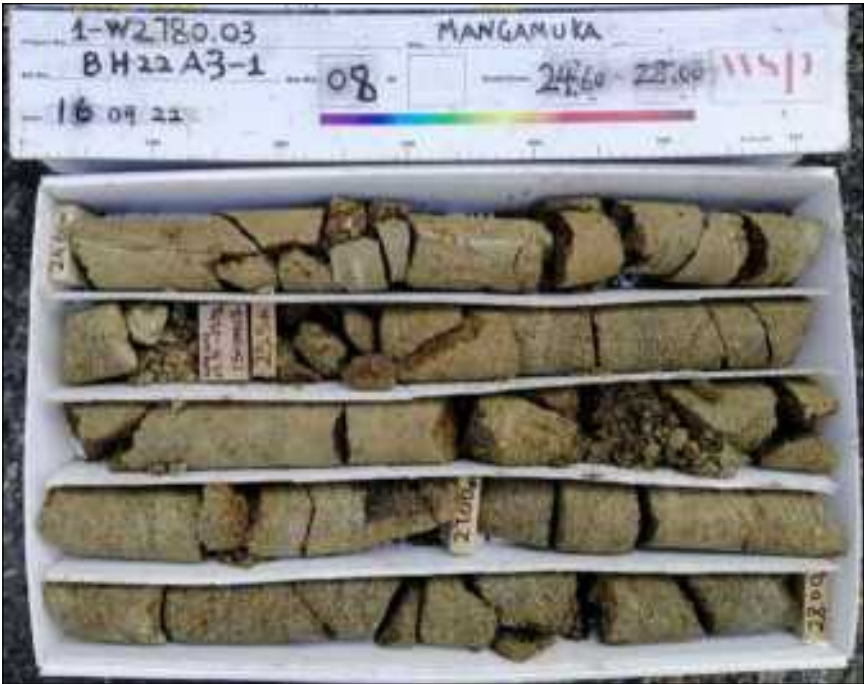
Photo BH22A3-1.9
24.60 -28.00m.

Borehole located within southbound lane approximately 3m from headscarp.
Borehole terminated within MW Dolerite. Inclinator installed on completion.
Logged in accordance with NZGS Guideline of the Field Classification and Description
of Soil and Rock for Engineering Purposes, December 2005 & Engineering &
Development in Hazardous Terrain 2001, pg 365, Table 1.

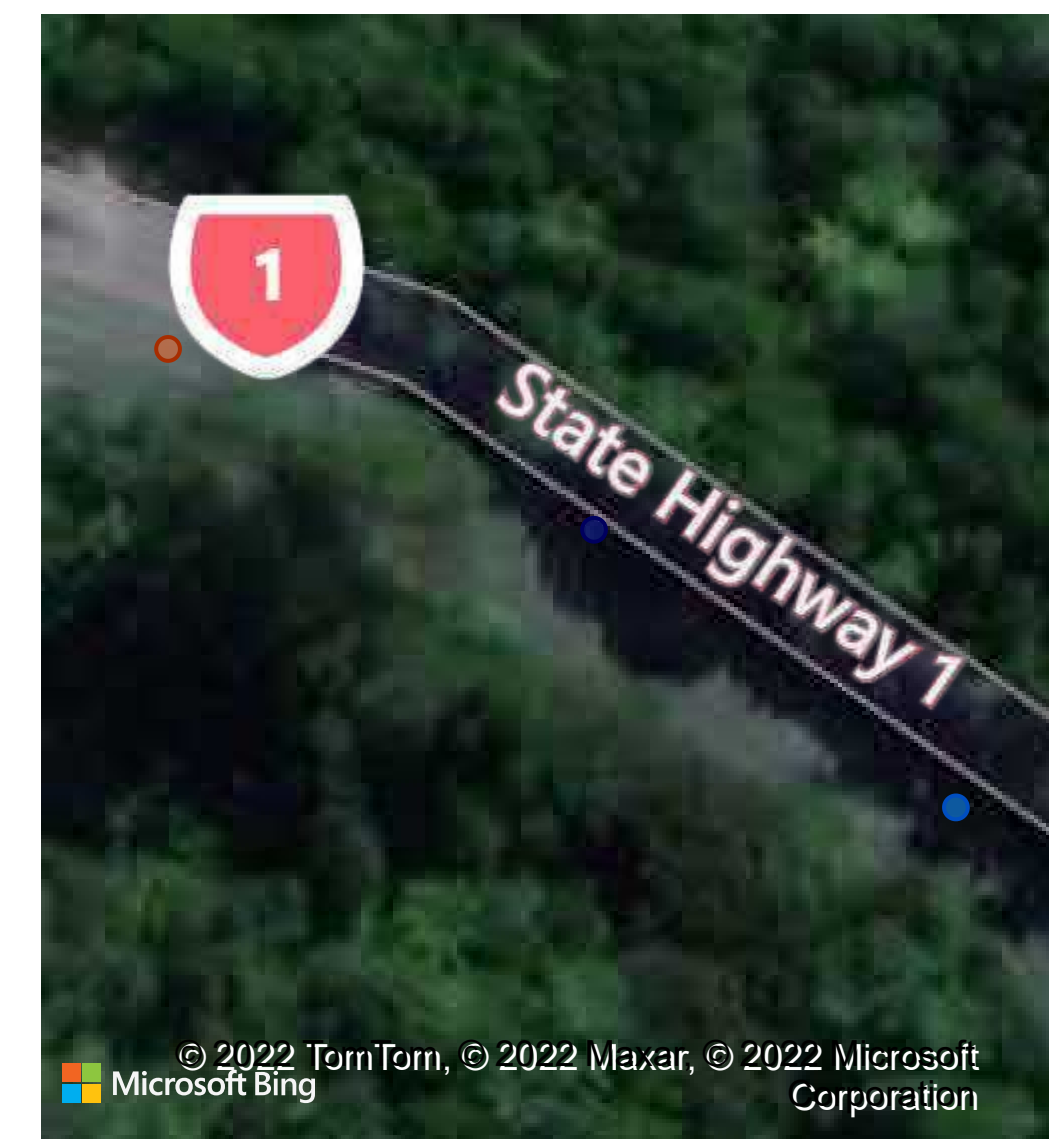
Mgorge A3BH01 A

The probe measurements so far indicate minimal movements have occurred in the A direction (up to 2mm), parallel to the downslope feature, with more movement being recorded in the B direction (up to 4mm), perpendicular with the headscarp and parallel with the wider grade of the hillside. This possibly coincides with the linear tension cracking north and south of the headscarp, which propagate perpendicular to road alignment.

The movement at 4.5m depth is assumed to initiate within the colluvium, with the deep movement possibly coinciding with the highly fractures rock and zones of core loss encountered during the drilling of A13-BH01. Inclinometer readings to continue over the coming weeks.

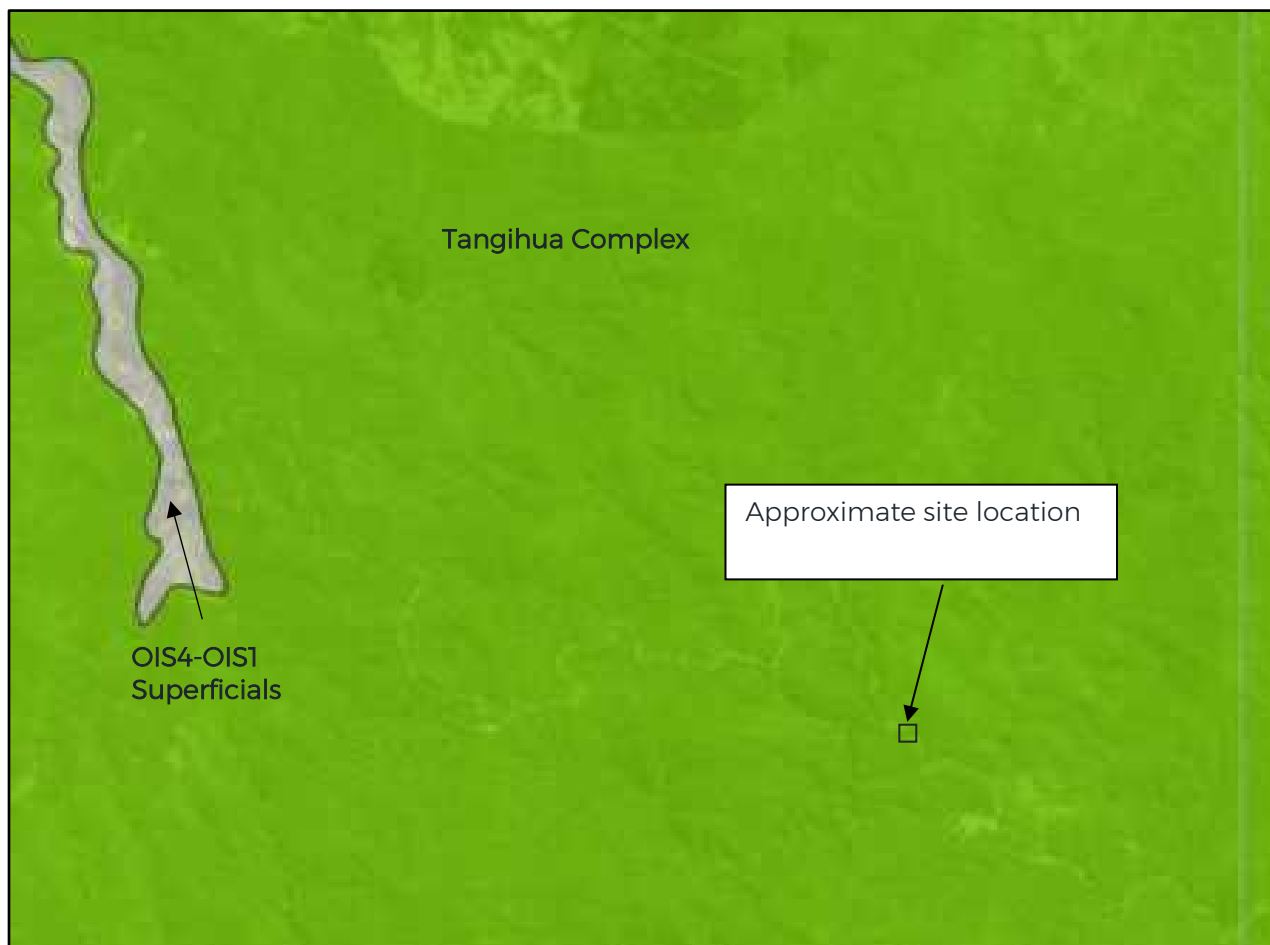
Figure 2-1: Regional geology

The 1:250 000 scale QMAP seamless digital data (GNS, 2013) indicates the site area to be underlain by the Undifferentiated Tangihua Complex in Northland Allochthon comprising basalt pillow lava, with subvolcanic intrusives of basalt, dolerite and gabbro; locally incorporating siliceous mudstone. (Figure 2-1).

The Tangihua Complex has been emplaced onto New Zealand through convergent plate tectonics and sea floor sliding. As a result, the material has been historically sheared with the rock underlying the site expected to be highly fractured and degraded through original emplacement processes and further modified by weathering.

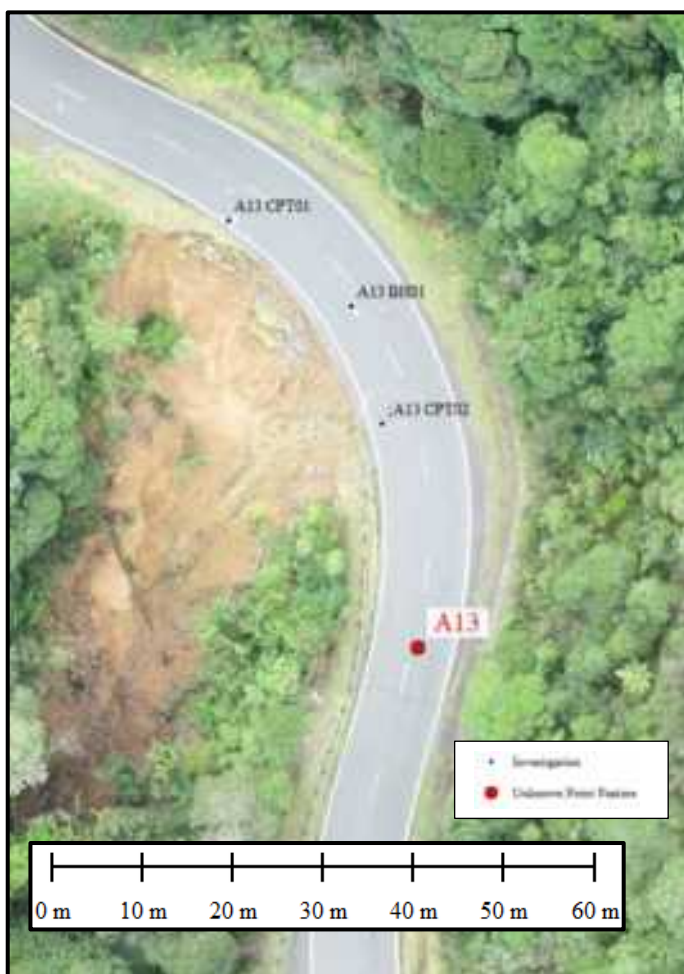
Figure 3-1: Exploratory hole location plan

- The intrusive drilling works was undertaken by Geocivil Limited with all of the boreholes logged in accordance with the NZGS *Guideline of the Field Classification and Description of Soil and Rock for Engineering Purposes*, December 2005 and *Rock for Engineering Purposes*, December 2005 & *Engineering & Development in Hazardous Terrain 2001*, pg 365, Table 1. Borehole and CPT locations displayed on Figure 3-1 below with logs displayed in Appendix A.

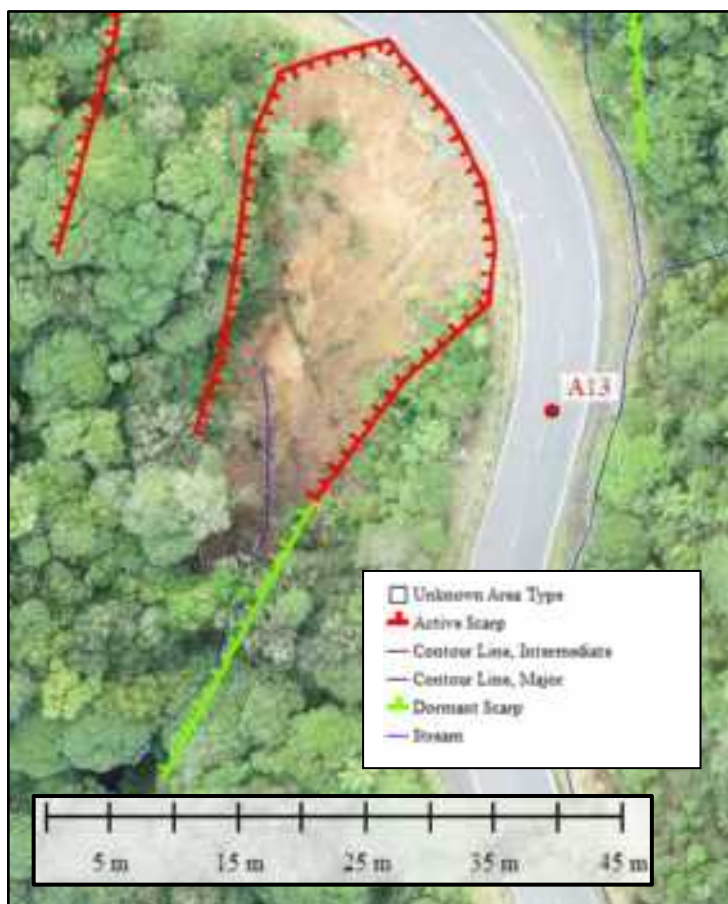
Figure 4-1: Geomorphological map

A terrain evaluation is presented below in Figure 4-1. Geomorphological mapping undertaken from both Lidar and aerial photography as well as site observations. The site area is comprised of steep slopes of approximately 20° – 30° and includes historic slip features manifesting as large gullies extending from the slope above to the stream below. It's expected that the material underlying the site and surrounding area to consist of colluvial soils resulting from recent and historical movement.

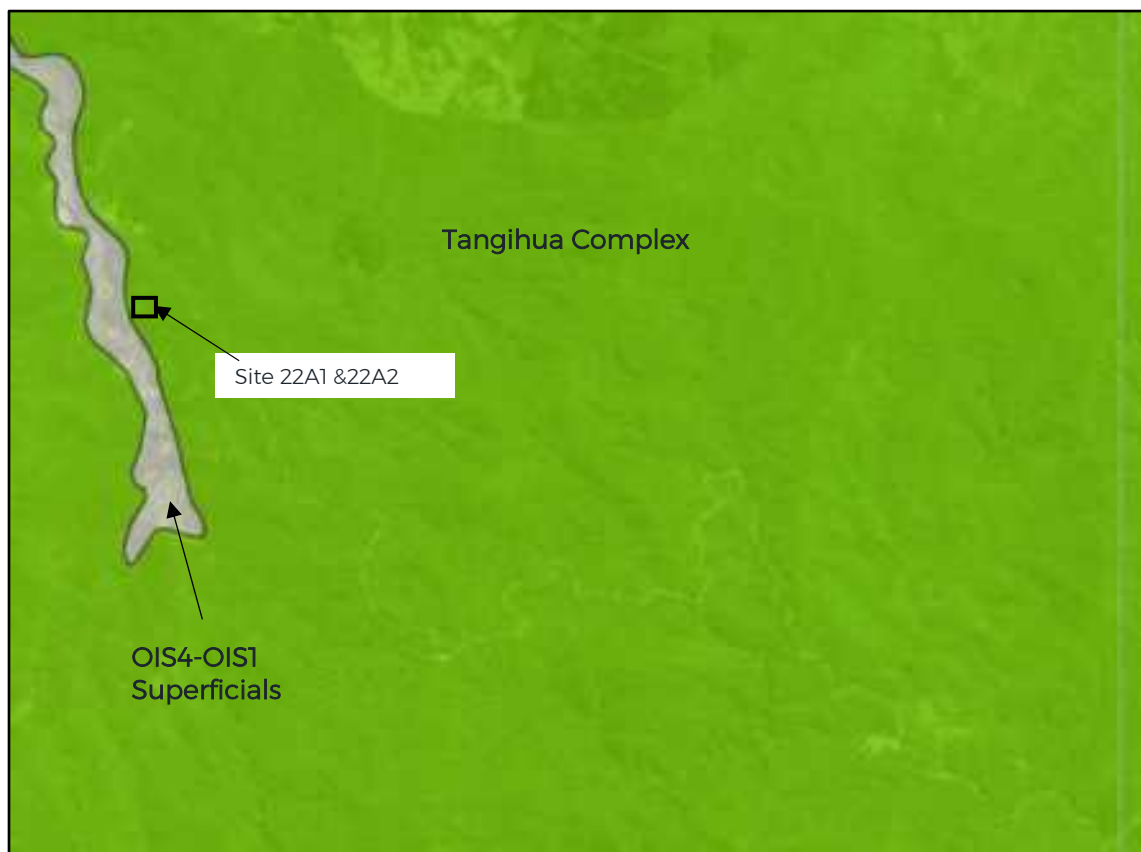
Figure 2-1: Regional geology

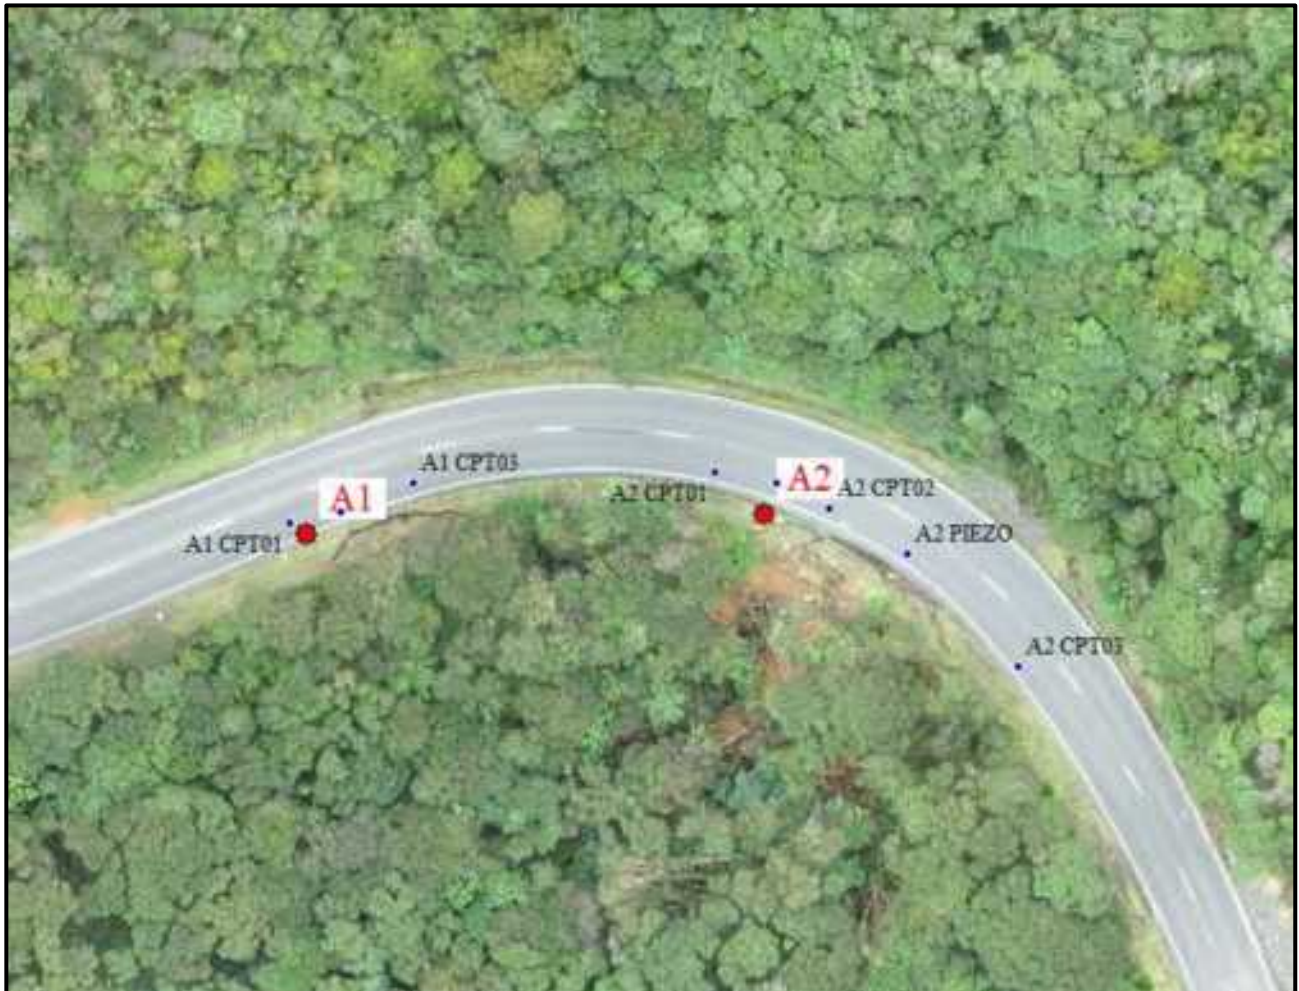
Figure 3-1: Exploratory hole location plan

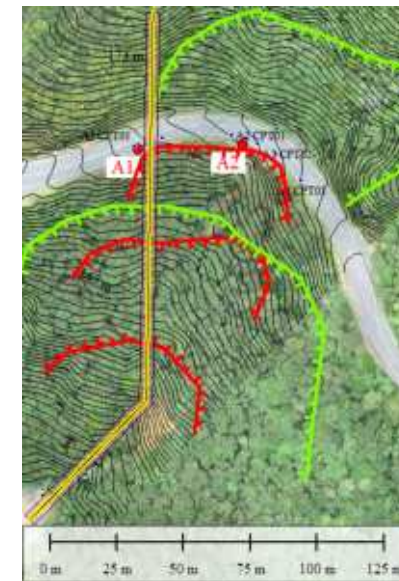
Conceptual Geological Cross Section

<p>Level 3, The Westhaven 100 Beaumont Street Auckland 1010 New Zealand</p>	Project: NZTA Northland Resilience and Emergency Works- Mangamuka, SH1		Job number: 1-11240.00
	Description: A1 Conceptual Cross Section		Revision:
	Drawn by: MWL	Checked by:	Date: 24/11/2022

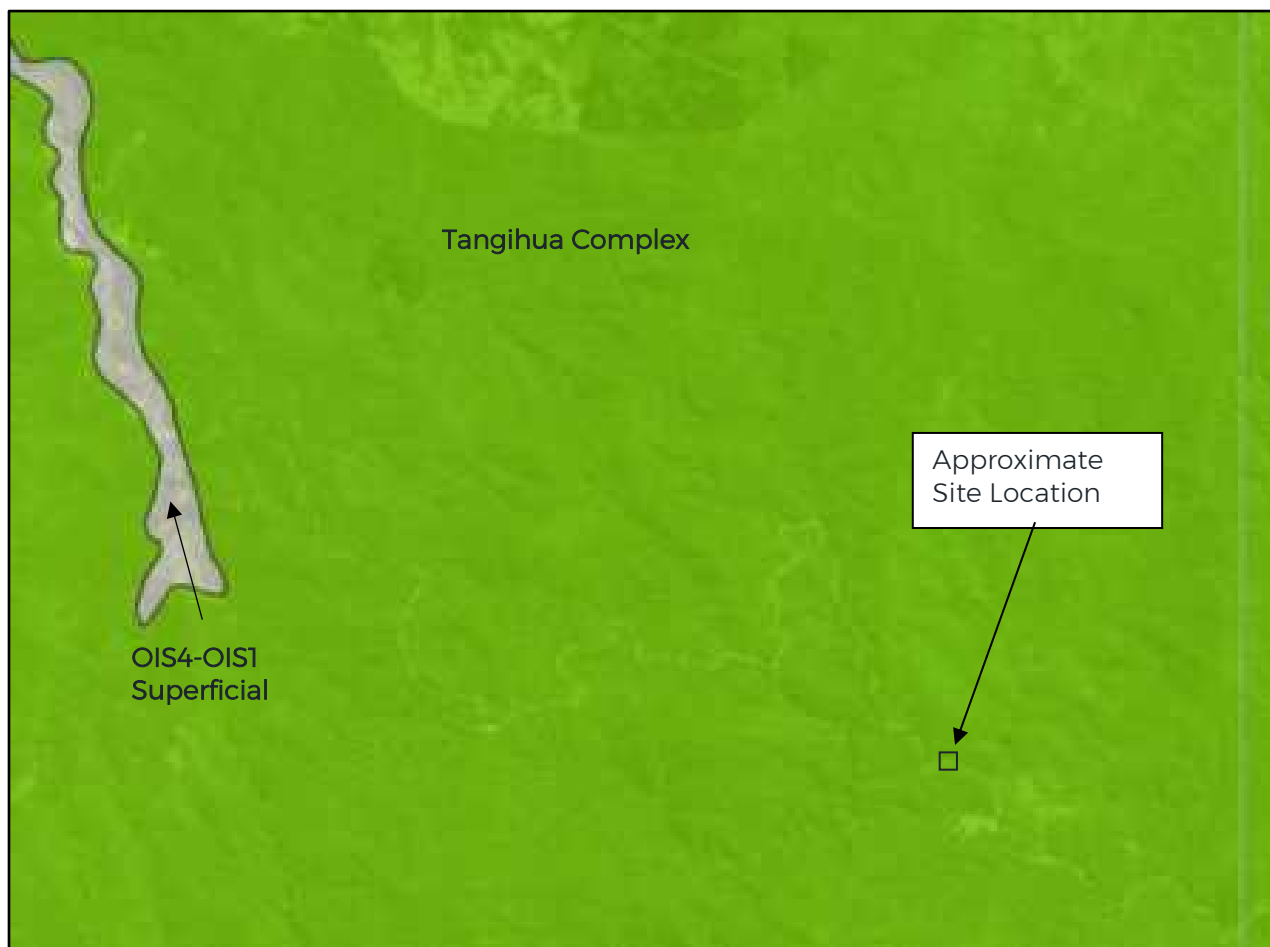
Figure 2-1: Regional Geology (GNS, 2012)

The 1:250 000 scale QMAP seamless digital data (GNS, 2013) indicates the site area to be underlain by the Tangihua Complex of the Northland Allochthon comprising basalt pillow lava, with subvolcanic intrusives of basalt, dolerite, and gabbro; locally incorporating siliceous mudstone (Figure 2-1). The Tangihua Complex has been emplaced onto New Zealand through convergent plate tectonics and sea floor sliding. As a result, the material has been historically sheared with the rock underlying the site expected to be highly fractured and degraded through original emplacement processes and further modified by weathering.

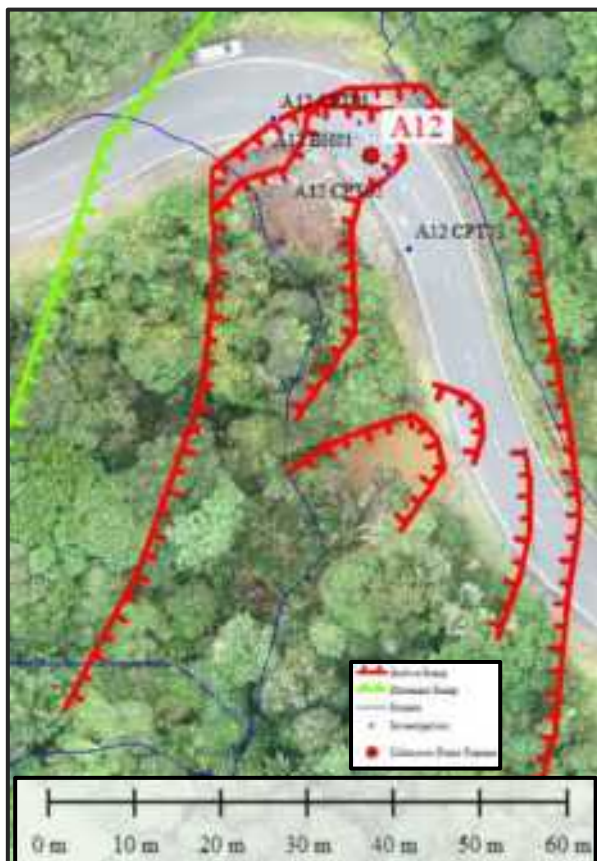
Figure 4-1: Geomorphological map

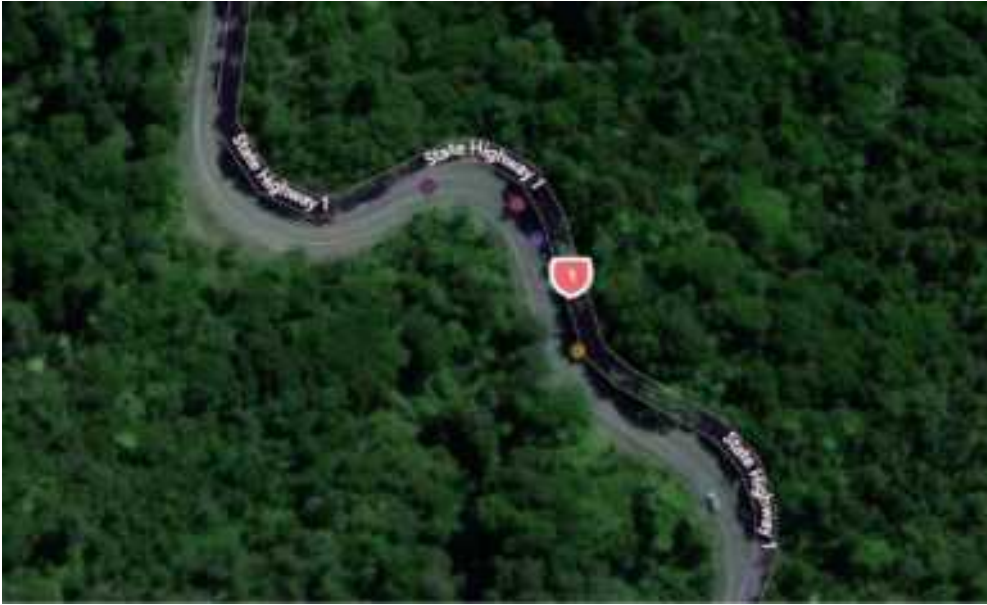
Figure 5-1: A12 Tilt Sensor Positioning

Tilt sensors data and rainfall sensors data is presented within Appendix C, collected from 14th September 2022. Tilt sensor positions shown below on Figure 5-1.

Mangamuka gorge experienced 21mm of rain between 4am 02/10/22 and 4am 03/10/22, resulting in the following movements at MA tilt sensor:

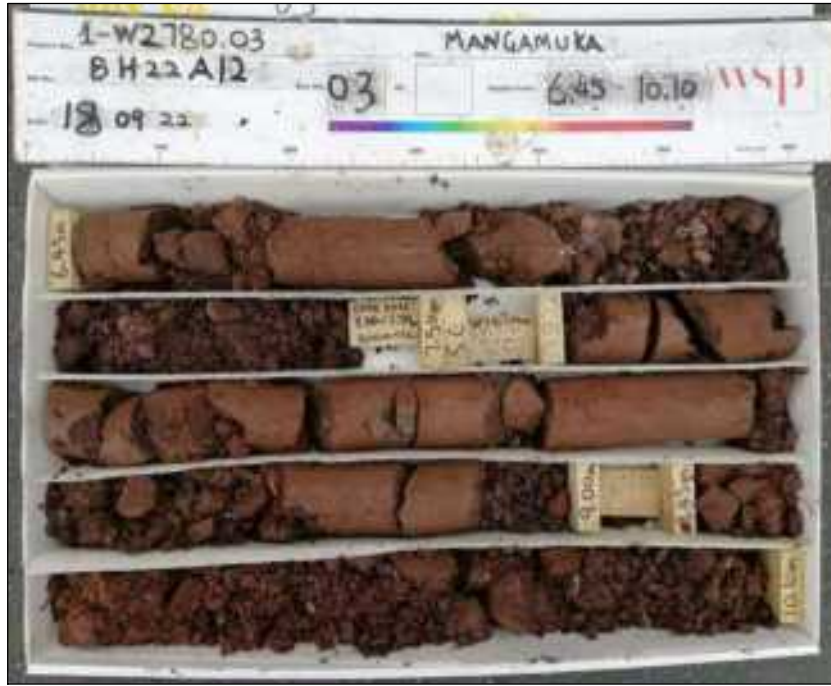
Photo BH22A12.3
BOX03: 6.45 - 10.10m.

Moderately degraded Tangihua Complex rock was encountered within BH01 comprising dark reddish-brown mudstone, weak with clasts predominantly of porphyritic dolerite. It is important to note that we recorded an SPT N value of 0 at 9mbgl. A potential deep seated shear surface was inferred at this depth (refer to the conceptual geological cross section at Appendix B).

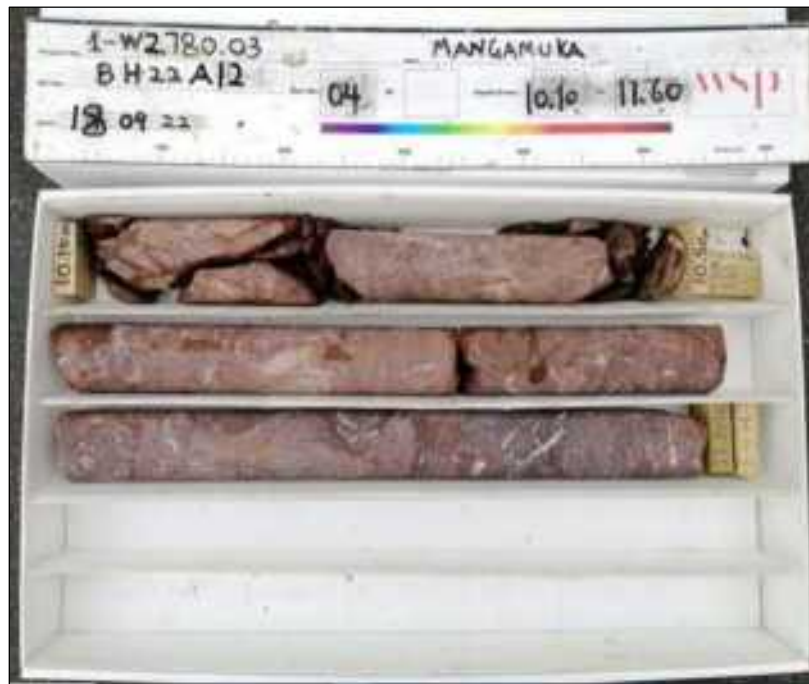
Photo BH22A12.4
BOX04: 10.10 - 11.60m.

Slightly weathered cataclastic volcanic rock was encountered in BH01 from 10.1mbgl to the base of the borehole. The material was described as reddish-brown mudstone and basalt, strong, with iron staining and zeolite veneer on the defect surfaces and zeolite veining.
