**FAR NORTH DISTRICT COUNCIL**  
**CONTRACT 7/18/101**

# **Road Maintenance and Renewals Contract**

**MONTHLY REPORT – JULY 2023**

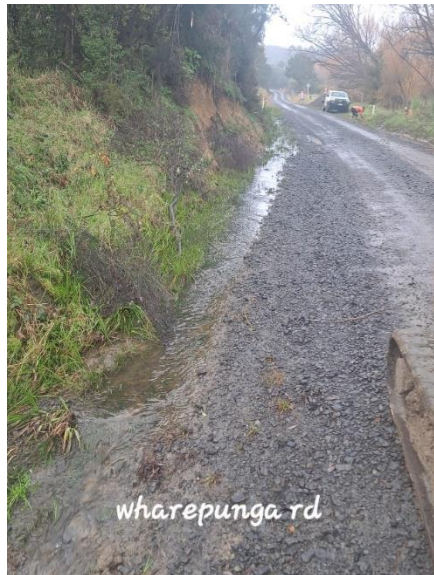
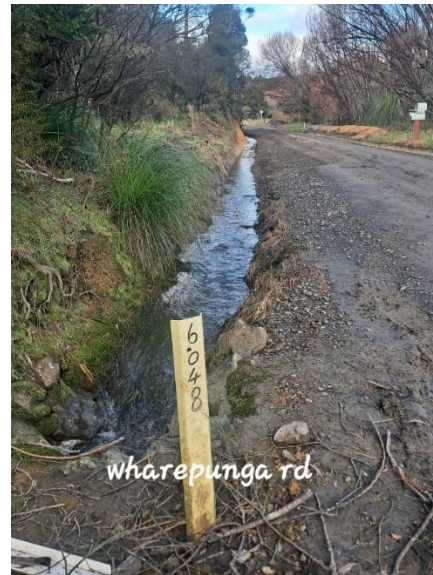
Ray's crew have managed to tick off a few more urgent culvert replacements and have made some good drainage improvements in historic flood prone areas. Installing larger diameter culverts, heavy water tabling and opening land drains will help with access for residents in the Otatau/Mataraua areas after Heavy Rain events.

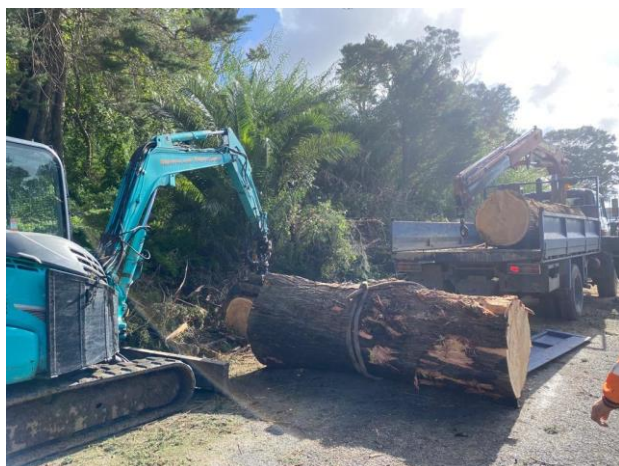
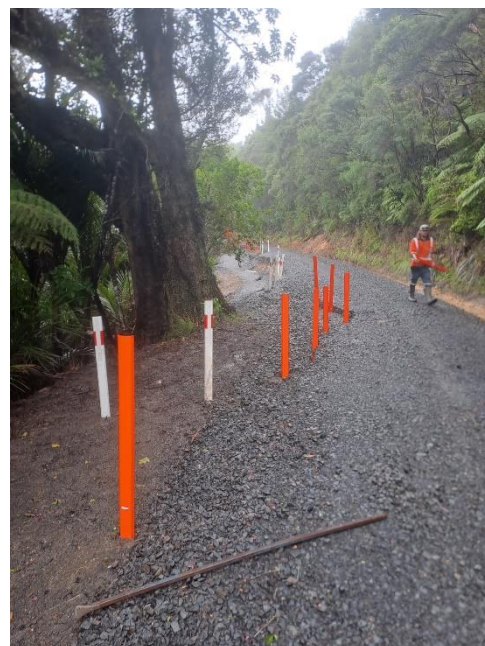
Other than the continuation works from previous weather events there were no major new emergencies this month. One large tree down across Parnell St in Rawene (below left) and one on Renwick Rd.

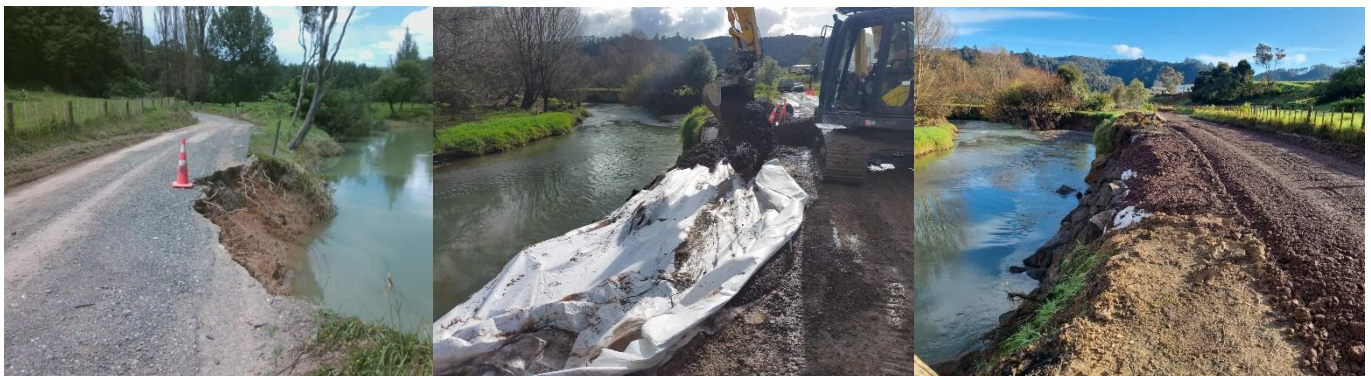
Started out on Rawhiti North Rd then had a call out while up there to attend to a new over slip on Rawhiti South Rd. Once they finished out East, they came into Doel Rd (see pictures below) and then onto Ngapipito Rd again for final slip tidy up and finished up the month on the other Coast on Waimamaku Beach Rd with an overlay of a storm scouring/drainage issue. They will continue through August with Ramsey Rd, Classen Rd 2.0 slip, then onto Taheke for more under slip repairs.

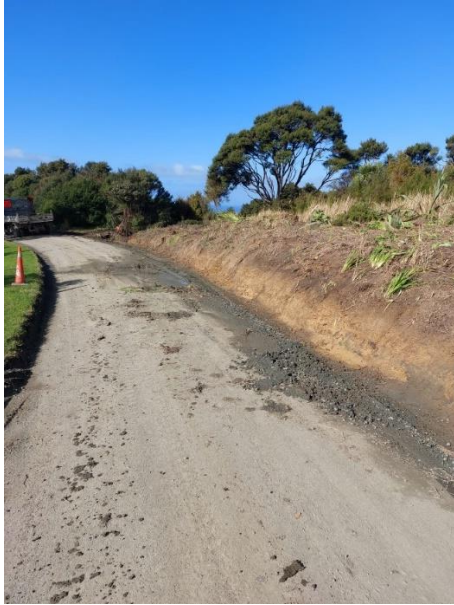
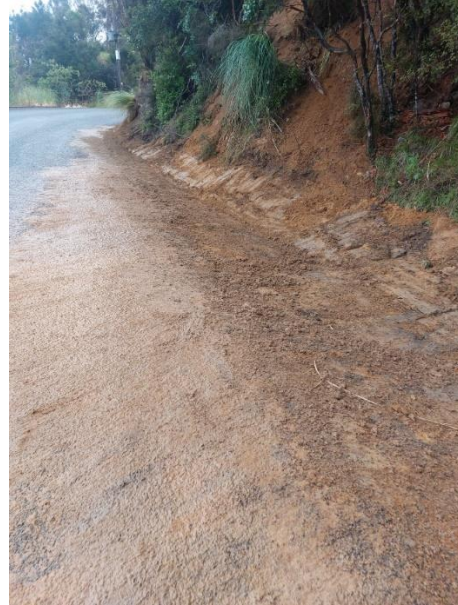
Attended under slips on Newton Rd along with full water tabling, a slip repair on Waiotemarama Gorge Rd and Vujcich Rd and rounded out the month with water tabling along Te Waiaroha Rd.

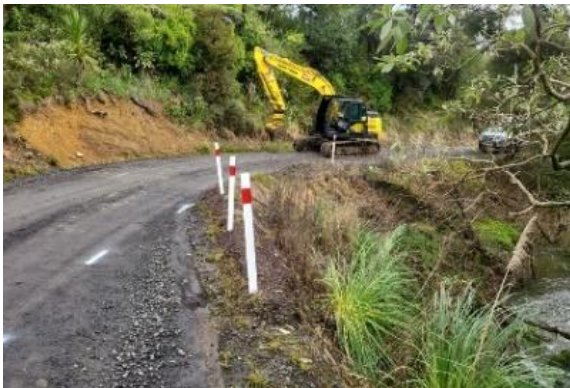
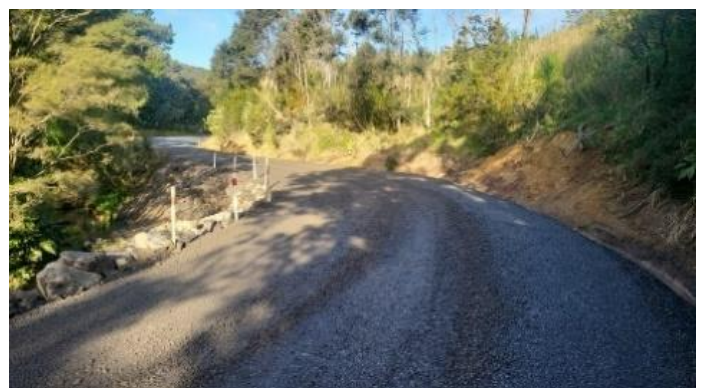
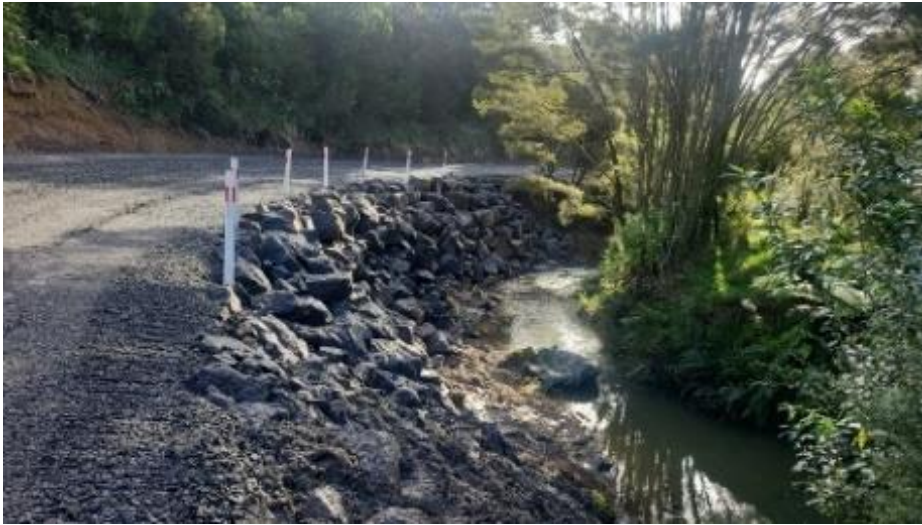
Taheke Road has several slips to repair in phase 2 and 3 works after our recent storm events. Hack has done an outstanding job with this phase 2 repair below. Everything from blocked side drains to creating positive water flow and clearing the over slips. They have also cleared the under slip and installed a rock spall retaining structure from the river's edge to road level. Great work in protecting the back from future flood waters.

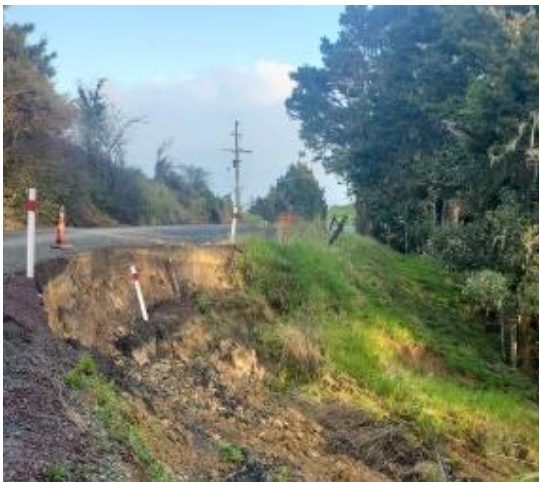
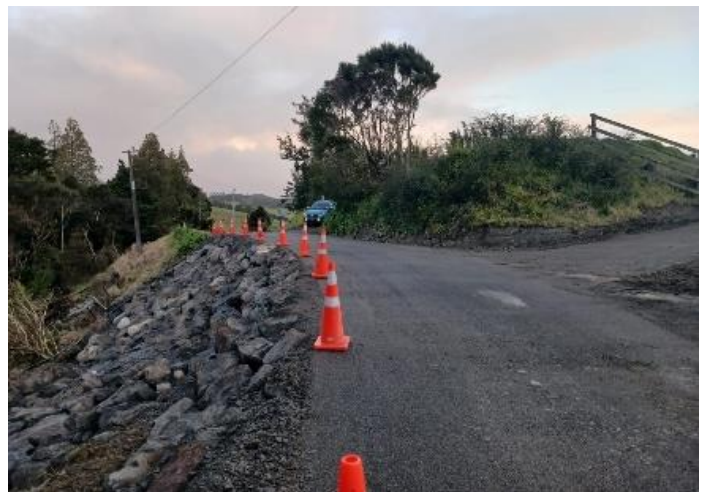
Moving onto Te Tio Road, the shoulder had given away, taking the chorus with it, as picked up later was damaged as well. Working with Chorus to restore connection to the communities and constructing the services within another retaining structure.

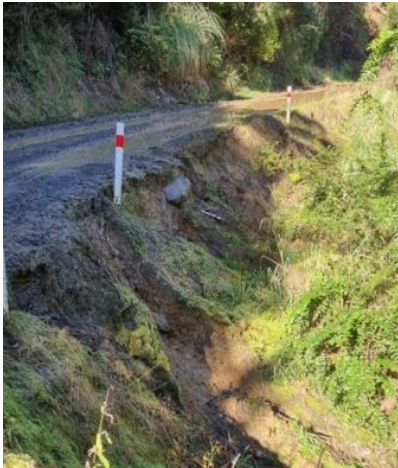
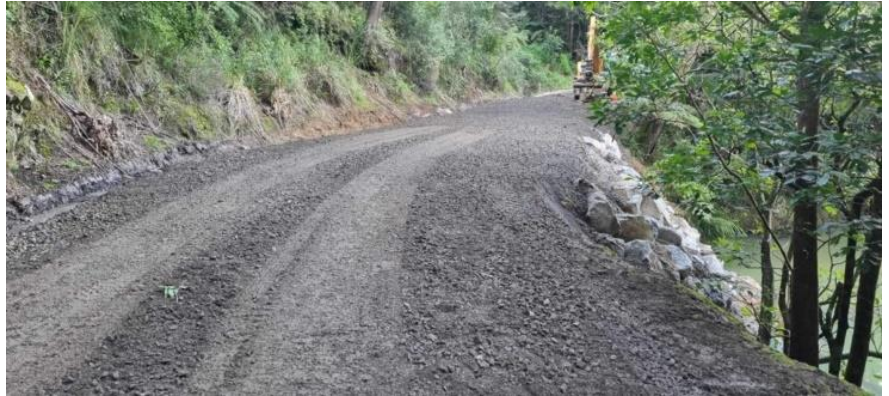
Before and after

Tokawhero Road has been a mountain of work we laid on Tarmac. They have been doing a great job with the large under slips to stabilise the bank by retaining with rock walls and clear drains and culverts around the area. Although a small back road and mostly used by forestry, we aim to make it driveable and user friendly for the upcoming logging seasons. Aligning SME subbies and Ventia heavy metal team to follow with an overlay on some much needed road will help our network in the long run.

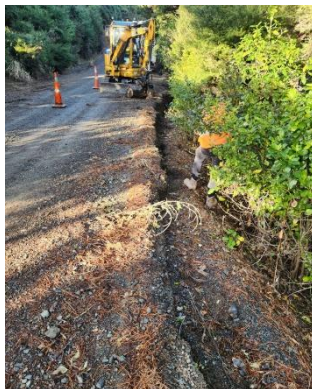
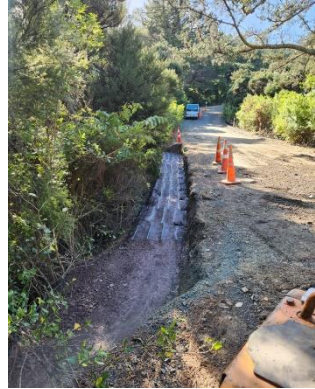
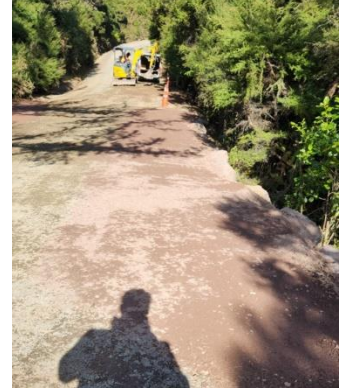
Our subcontractor team from Pristine Projects have showed their worth by delivering big and small jobs. They are also keeping truckies and plant hire services in the area busy by involving them with ongoing SME projects for Ventia. What more to say from the team clearing slips and side drains, relaying damaged culverts, and building rock spill retaining structures. All this work done on Pukewhao and Wharengaere Road.

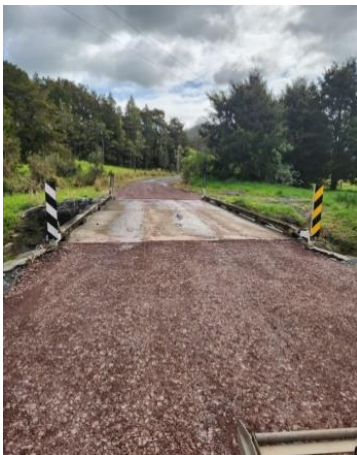
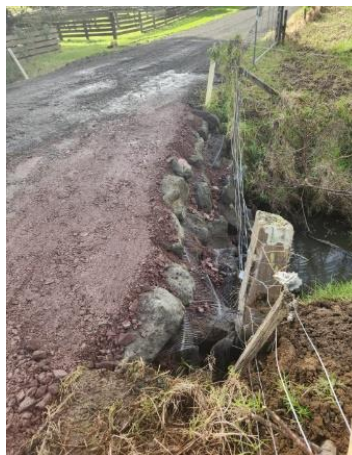
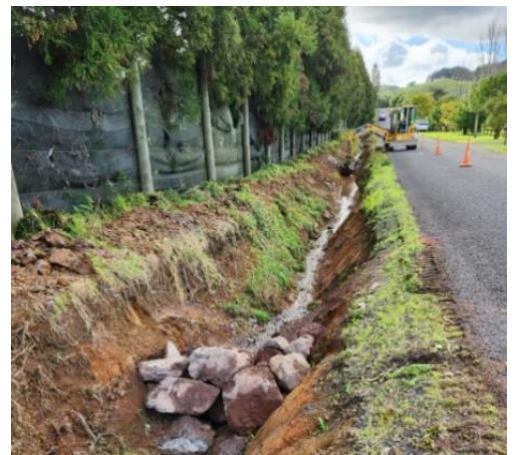
We have already moved them onto our May 2023 events to assist with the damages on our network. Waikuku Rd, Hooks & Falls and Equestrian Dr Road have been getting attention and looking great. See below in that order.

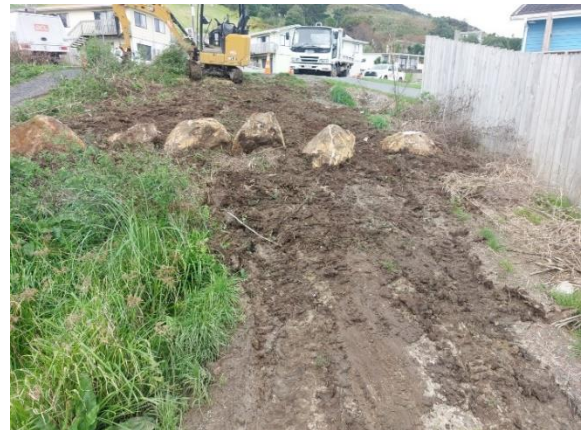
- Crack sealing
- Fairly Crescent Rock Placement to stop 4x4 accessing >>

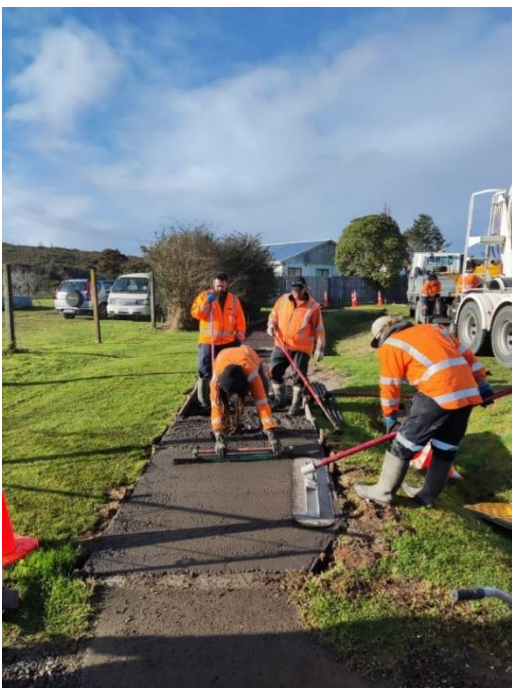
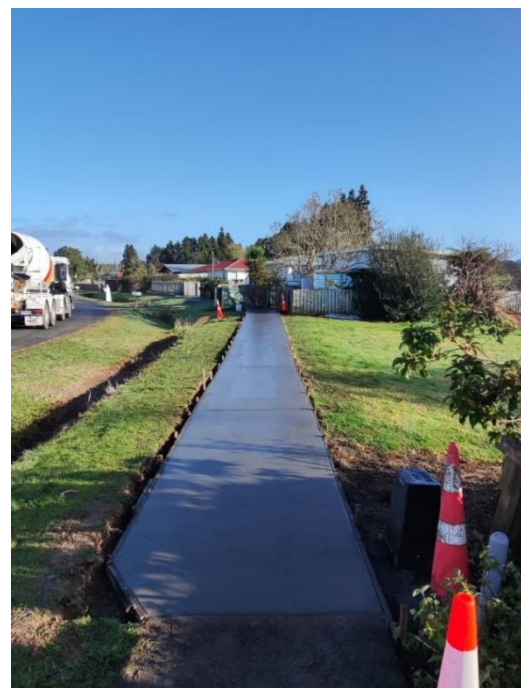
The concrete crew have almost finished footpath renewals on Puia St and Ohara St in Ngawha Springs. They've had some big days and will pour close to 50m<sup>3</sup> of concrete in Ngawha by the end of the week and then head back to finish off Clifford St in Kaikohe. Note the taper on the paths is to fit old narrow paths into the new 1.8m wide spec.

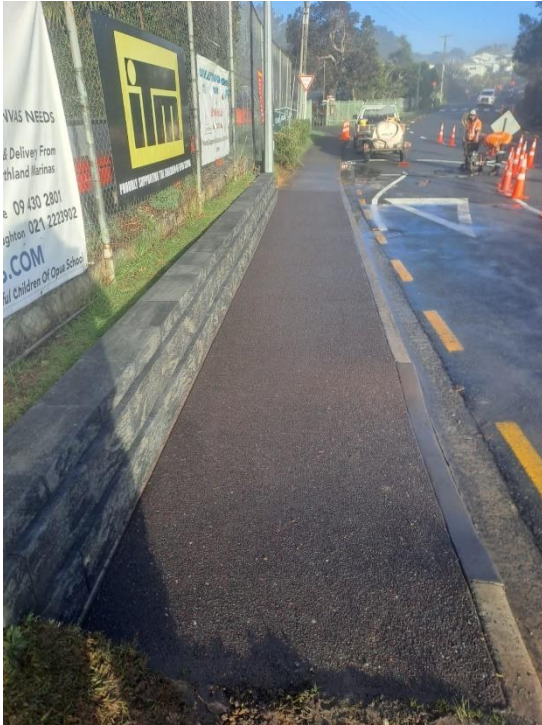
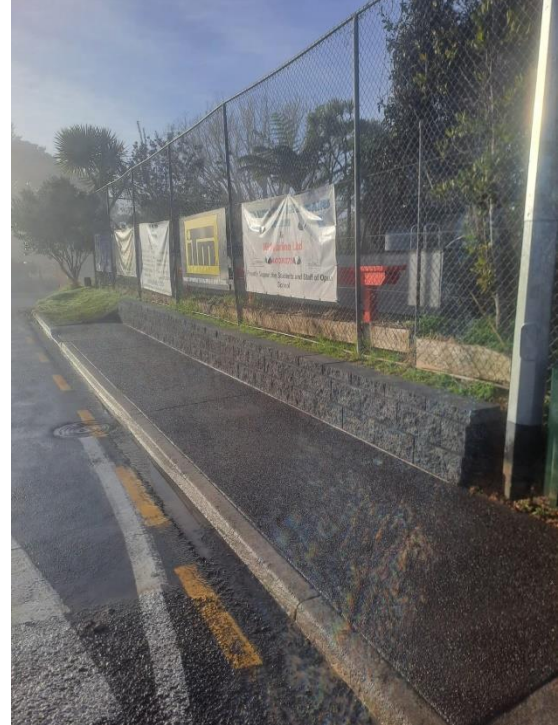
Also, earlier in the month they knocked off this little safety project on Kellet St, Opuia. The job involved extending the footpath by installing a new Keystone wall and kerb drop down. All down during the School Holidays.

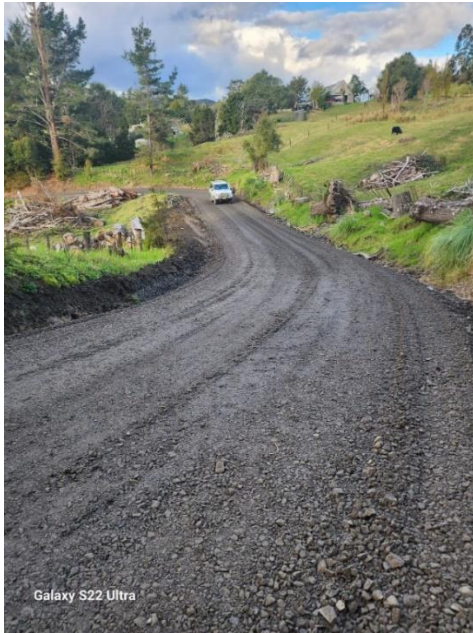
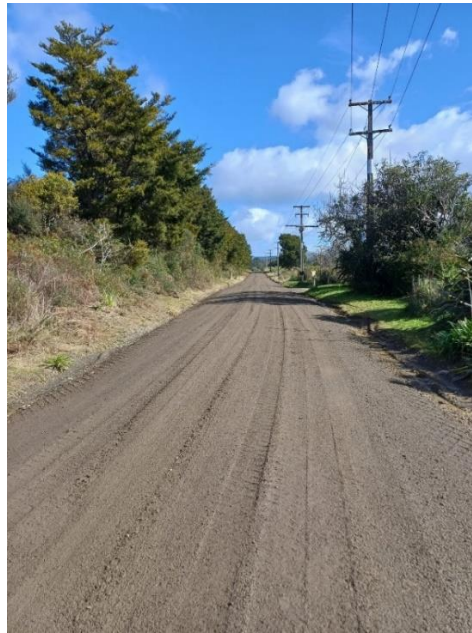
Punakitere Loop Rd – Wash out repairs completed by the pavement team. Recently damaged in the June event (a localised bit of flooding washed the road shoulder away and blocked all drainage)

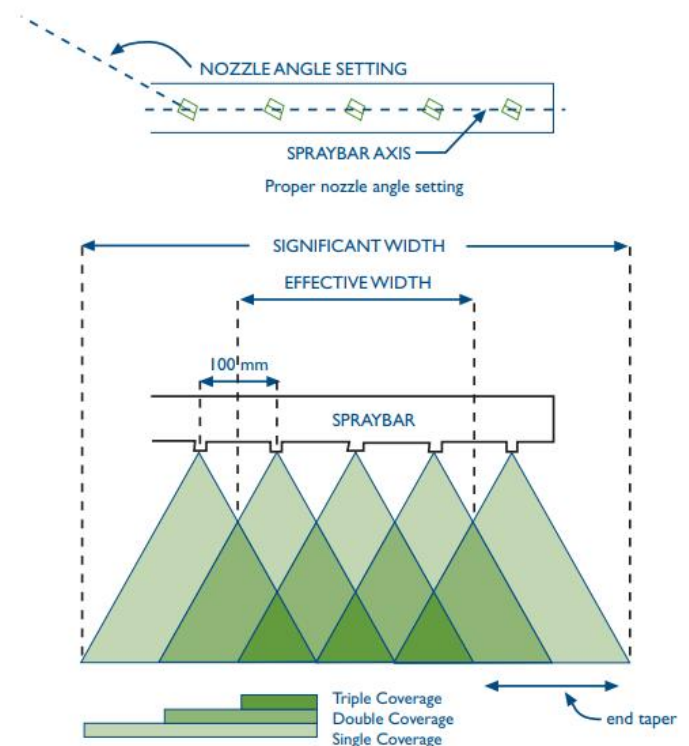
As part of the performance tests, the Bitumen Sprayer is checked to ensure that the "Spray bar" is set at the correct height (above the ground) and a Spray Test is completed to ensure that a Triple, Double and Single overlap are achieved across the bar when spraying. As per figure 10-4 below.

Figure 10-4 Spray fans overlap to give triple coverage of binder on the road.

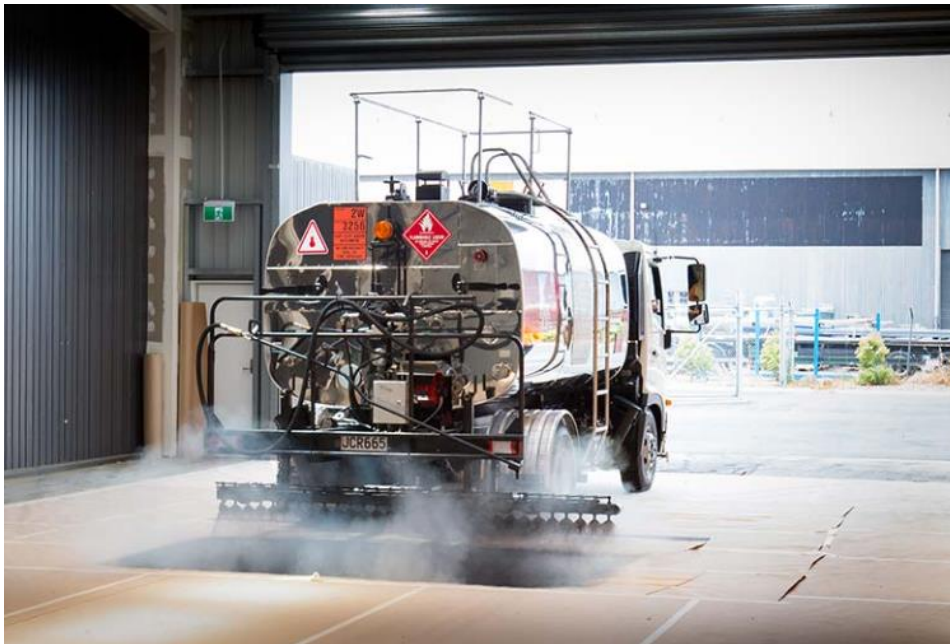
This is photo below also shows a “Spray Test” being undertaken. This is generally completed inside a large shed, where the floor is covered in craft paper and a set of carpet mats are set in place across the top of the craft paper in a tee configuration. A predetermined spray rate is entered into the Bitumen Sprayer and the Sprayer completes a spray run over the paper. After the spray test has been completed, the carpet mats are weighed, based on the predetermined spray rate the mats should now weigh a specific weight. By weighing the mats the accuracy of the Spraybar can now be determined.

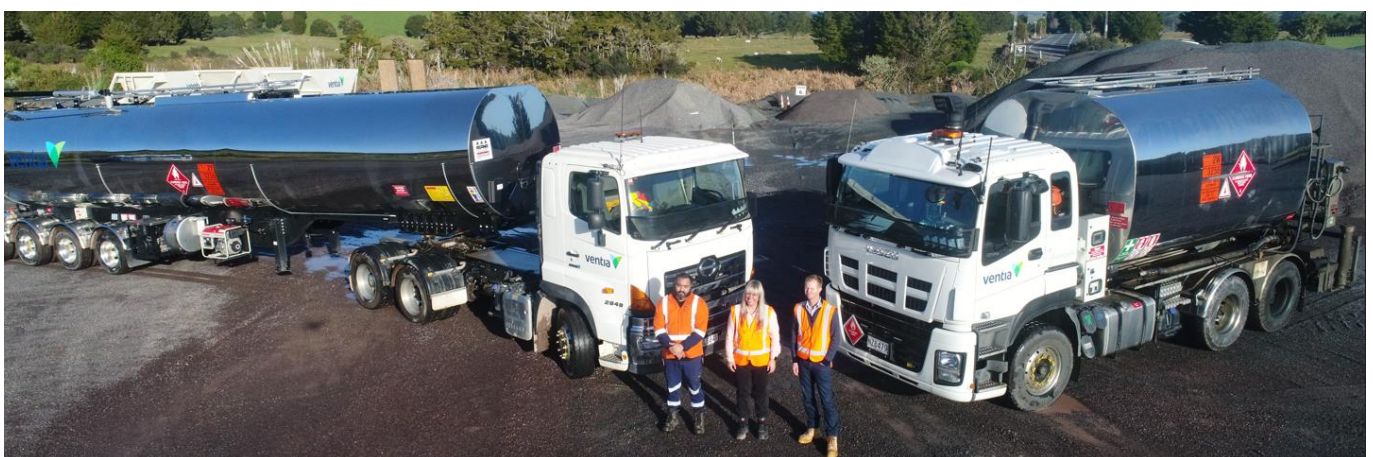
As part of our winter maintenance our bulk bitumen trailers have undergone internal tank cleaning, and our Bitumen Sprayer is having a ring-feeder fitted so it can now tow our 4-axle Bitumen Trailer.

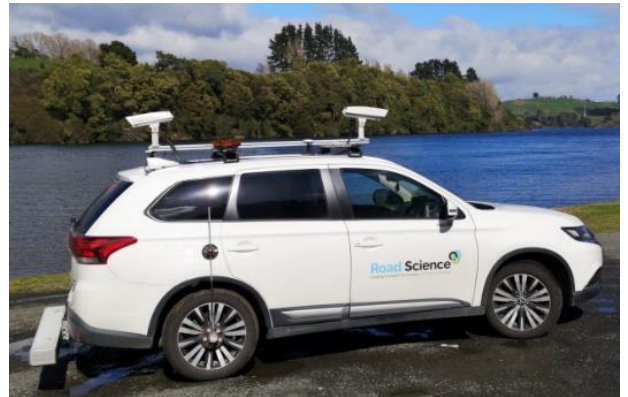
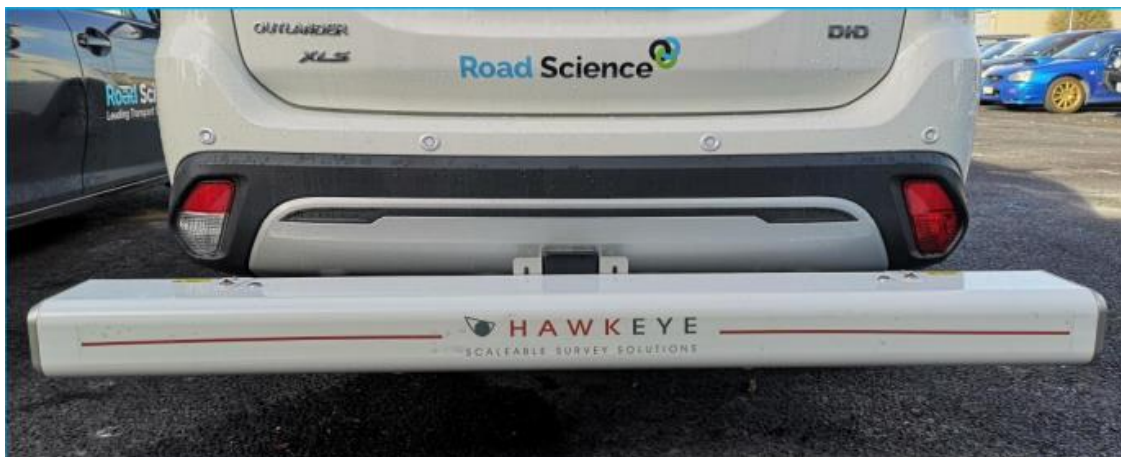
The Hawkeye survey vehicles use the latest in laser profiler technology to accurately and continuously record road and pavement information. This data is then related back to GPS or distance-based instruments. The laser profilers are Class 1 instruments (the most accurate type) and are able to measure texture in accordance with AG:AM/T013 and roughness in accordance with AG:AM/T001.

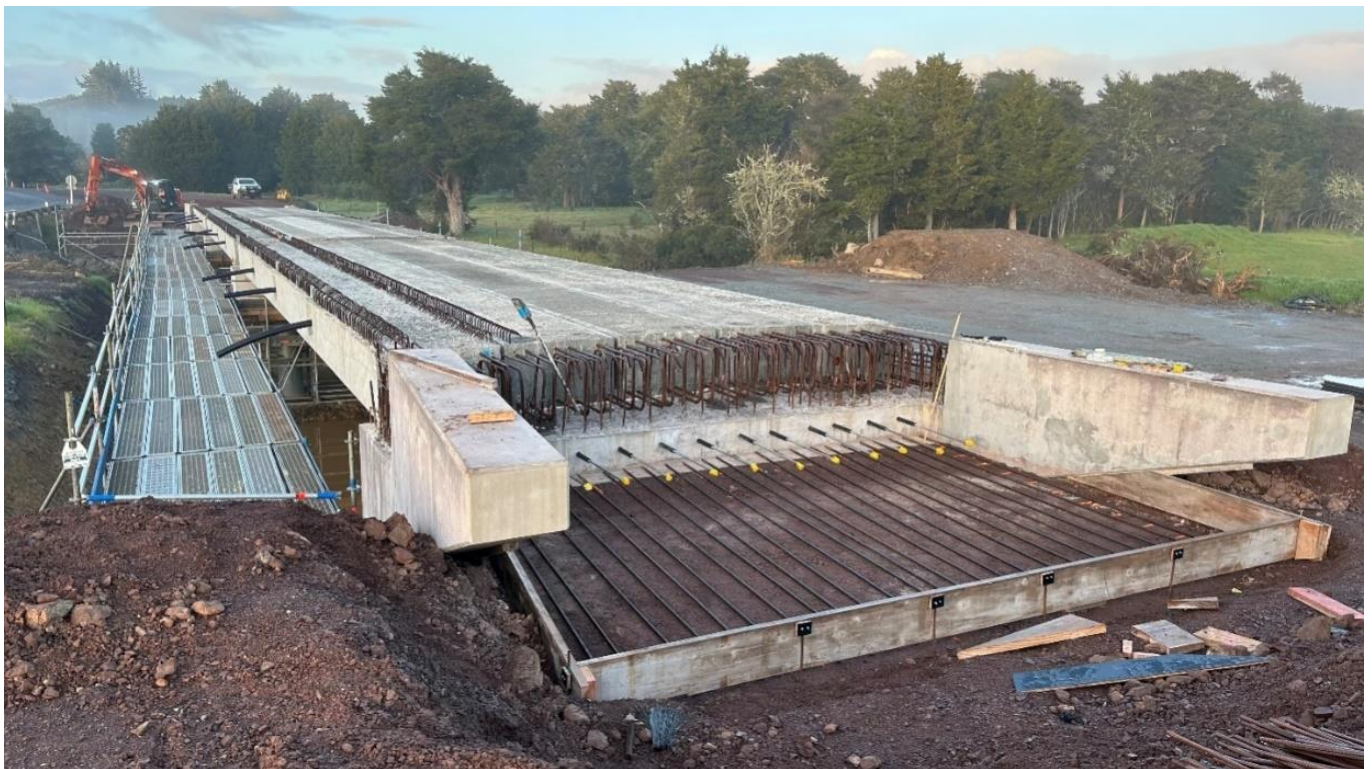
Pokapu Road Bridge Construction – And just like that, we have a bridge!!! Or at the least the majority of one. It's fitting that we just had Matariki. You can use a multitude of references here: A new year, a new bridge, it was written in the stars, the stars aligned, maybe even thank your lucky stars. However you want to say it, all beams have been successfully placed.

Over the next couple of weeks, work on the bridge will involve getting the infills completed and the settlement slabs boxed and poured, and more steelwork. Pavement construction on the bridge approaches and then the opening of the new Bridge in October.
