APPLICATION FOR RESOURCE CONSENT OR FAST-TRACK RESOURCE CONSENT

The proposal is supported by pile testing which has been undertaken by Stop Digging. This is found in [Appendix 3](#). Given access is from a limited access road, consultation has been undertaken with NZTA and this is found in [Appendix 4](#).

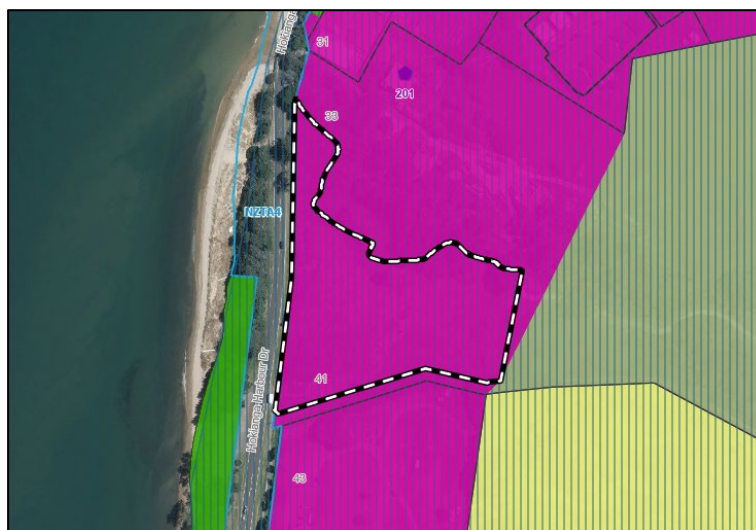
Figure 2 – Proposed Plan - Zone Maps (Source: Far North Maps)

The proposed activity is located in the Commercial Zone under the Operative District Plan. The site is located in the Mixed Use Zone under the Proposed District Plan. The zoning is outlined in [Figure 1](#) & [Figure 2](#). There are no resource features of relevance.

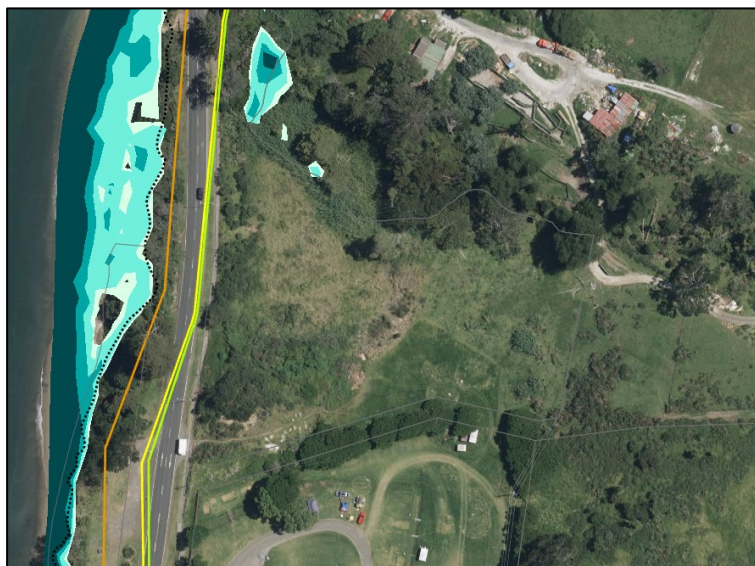
Figure 3 – Hazard Maps (Source: NRC Local Maps)

The site has minimal areas covered by coastal flooding hazards; the proposed cabin sites are outside those areas. The site is implicated by HAIL (Refer Figures 3 & 4).

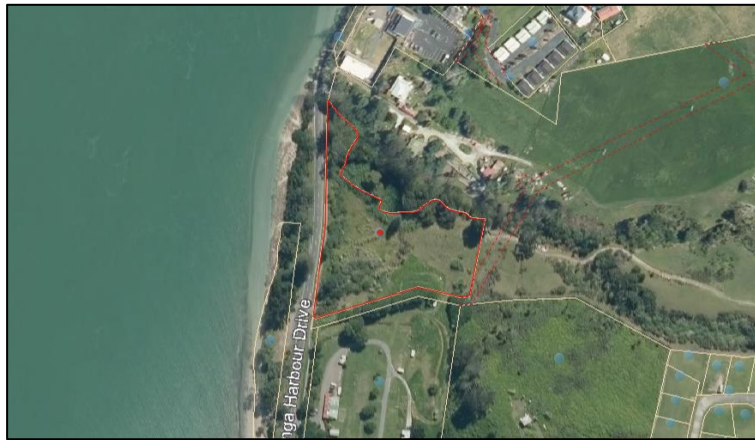
Figure 5 – Aerial Map Prior to Development (Source: Prover Maps)

The site is relatively flat and outside of built development is grassed pasture with some scattered vegetation. This is outlined in Figure 5 & 6 below.

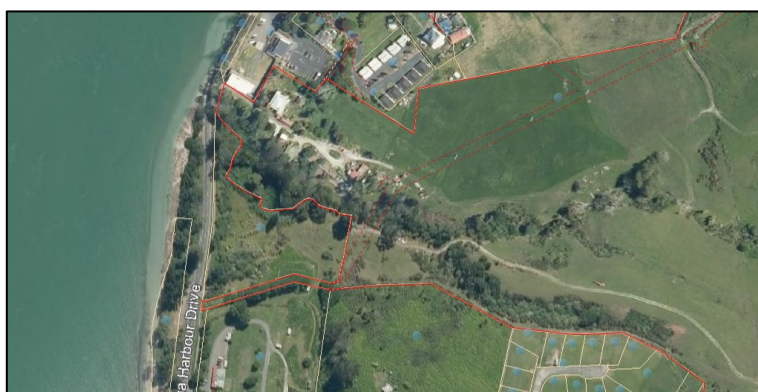
Figure 7 – Adjoining Persons (Source: Prover Maps)

Effects on persons who are owners and occupiers of the land in, on, or over which the application relates, or of adjacent land must be disregarded when considering effects on the environment (s 95D(a)). Those adjoining properties are shown below in [Figure 5](#).

Section 7 of this report provides a graphic and table of the relevant adjacent properties that this assessment relates. The relevant persons associated with the assessment are found in [Figure 5](#) in Section 7.0 of this report.

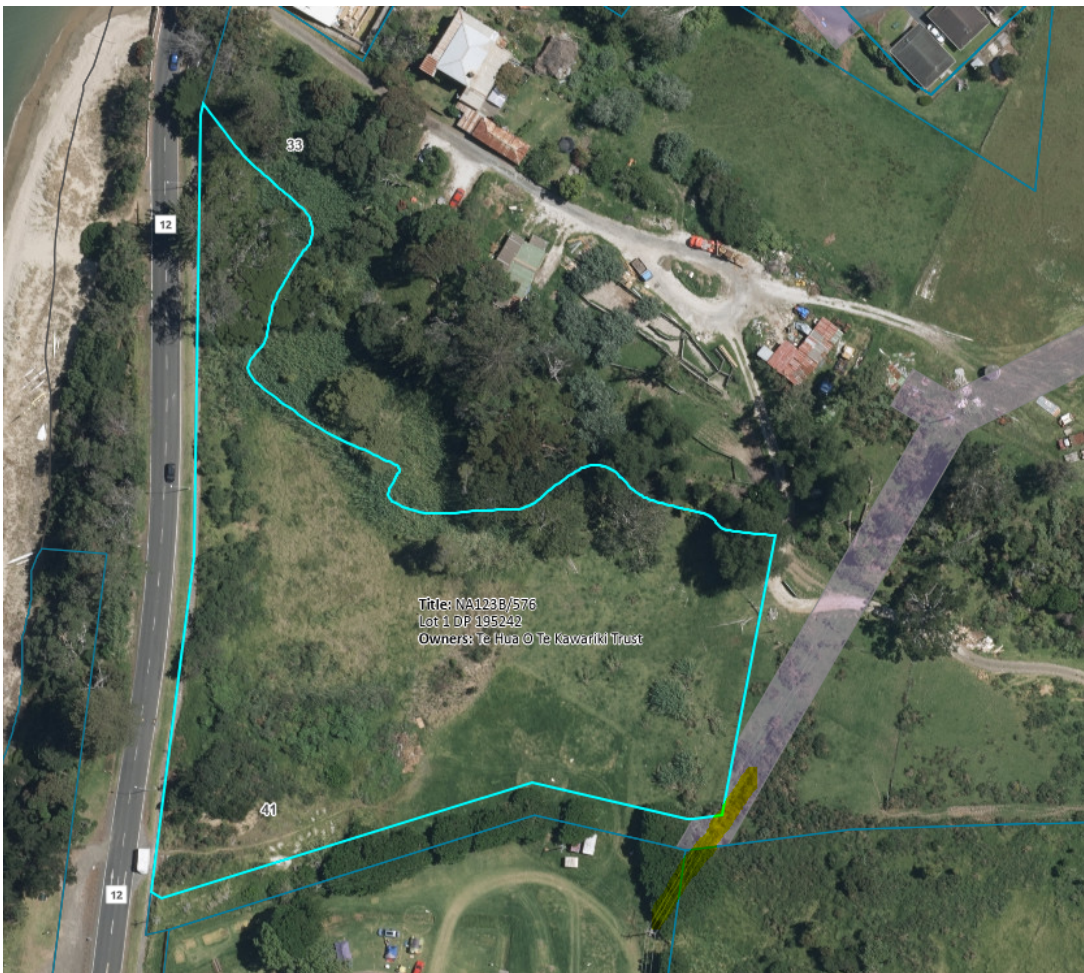
SHEET:
SITE PLAN - INFF
CALL OUT

NOTES - INFRASTRUCTURE	
ALL PROPOSED INFRASTRUCTURE TO CONNECT TO EXISTING INFRASTRUCTURE IN PLACE ON SITE	
SUBMAIN CABLE WILL EXIT MAIN SWITCH BOARD ROOM BY DRILLING THROUGH FLOOR THEN TUNNING ALONG THE FOUNDATION CONCRETE IN A 32mm GREY ELECTRICAL CONDUIT, JUST UNDER THE CLADDING OF THE BUILDING	
THEN TRENCHED UNDER THE BUILDING TO UNIT 01 TO A 15-WAY WATERPROOF DISTRIBUTION BOARD MOUNTED ON THE SIDE OF UNIT 01 @ 1000 AFFL	
SUPPLY CABLE TO EACH UNIT AND PUMP CHAMBER WILL COME FROM THIS SUBBOARD IN A COMBINATION OF TRENCHING & CLIPPING UNDER THE SUB-FRAME

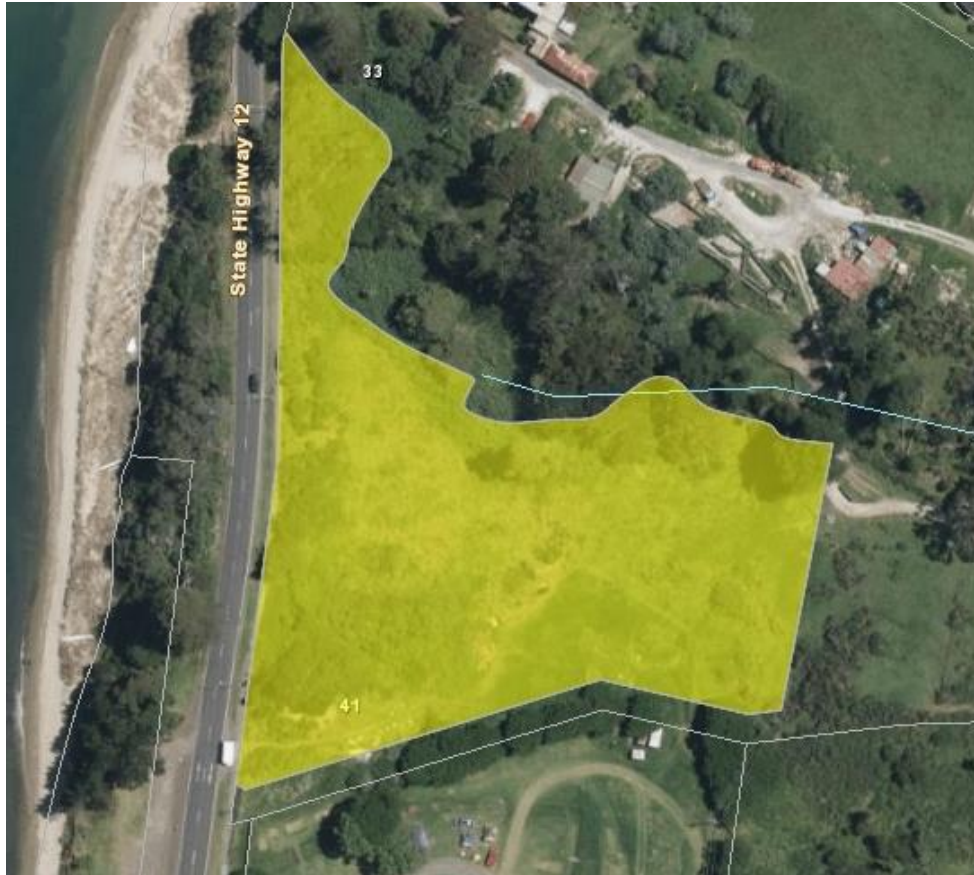
In achieving the purpose of the Act, a range of matters are to be given particular regard. This includes:

-
- d) the maintenance and enhancement of public access to and along the coastal marine area, lakes, and rivers:
 - e) the relationship of Maori and their culture and traditions with their ancestral lands, water, sites, waahi tapu, and other taonga:
 - f) the protection of historic heritage from inappropriate subdivision, use, and development:
 - g) the protection of protected customary rights:
 - h) the management of significant risks from natural hazards.

In context, the relevant items to the proposal and have been recognised and provided for. Section 6(e) is directly relevant to the proposal.

Cook Costello has been engaged by Far North Holdings Ltd to undertake a contaminated Primary Site Investigation (PSI) at 41 State Highway 12, Opononi, which is legally described as Lot 1 DP 195242, as depicted in Figure 1.

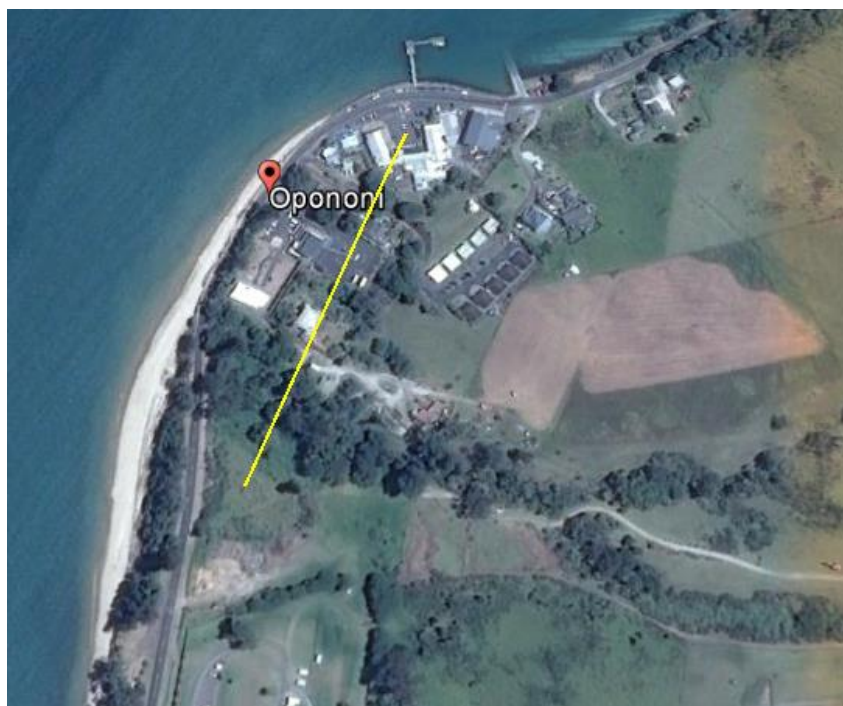
The proposal is considered to result in less than minor effects on the environment and through assessment, there are considered to be no affected persons.

11.0 CONCLUSION

The site is presently in a similar state to that presented in Figure 3, although vegetation on the south and central western part of the site (where the proposed Cultural Centre is proposed to be located) has been mulched, as shown in Photograph 1.

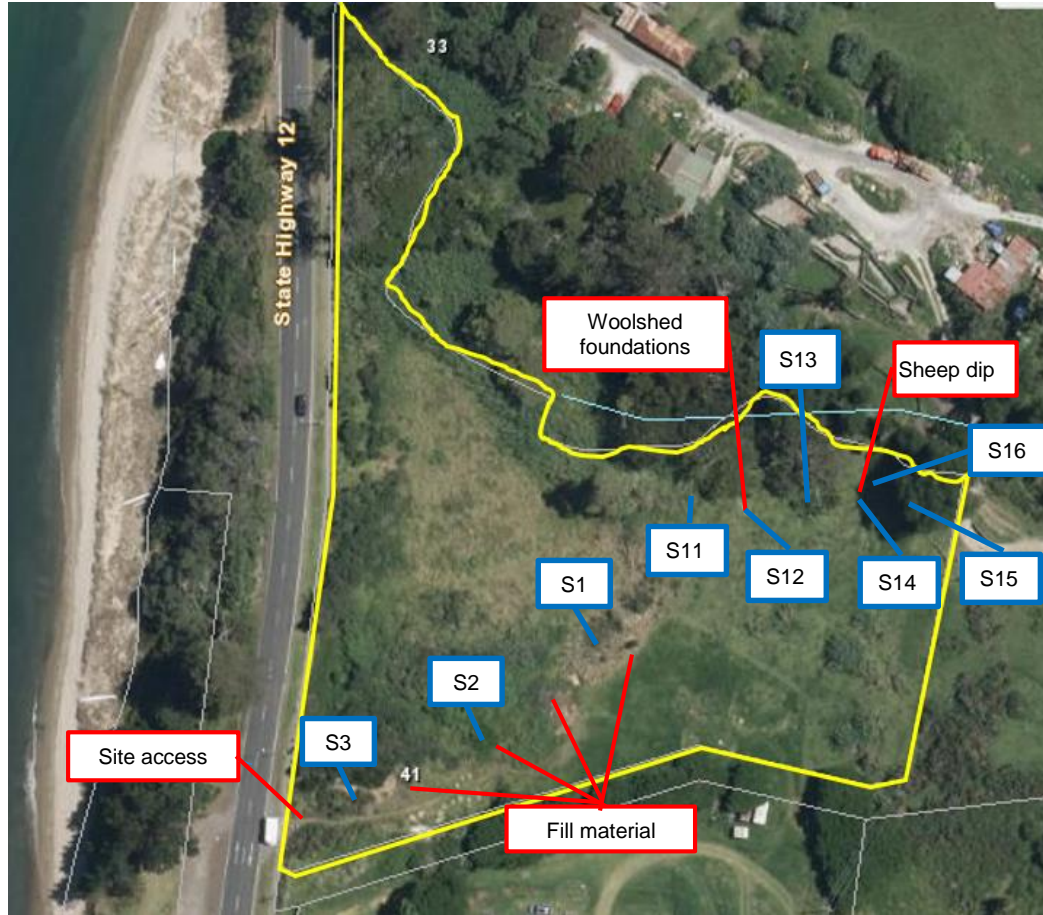
Figure 5: Key features (red) and sampling points (blue) on the site.
Yellow line approximates site boundary.

Depicted below (in Figure 5) are the key features of the site as observed during the site visit on 17 January 2018.

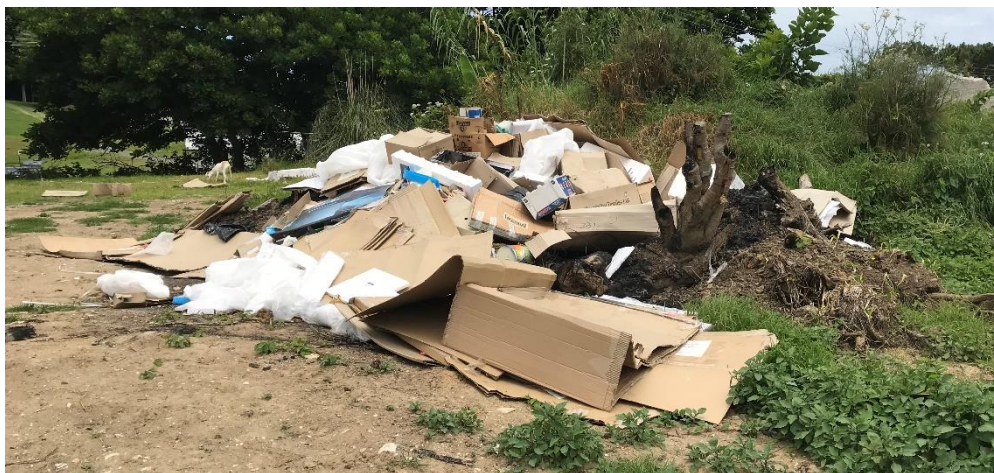
Photograph 2: packaging type waste (28-Dec-2017) – now burnt

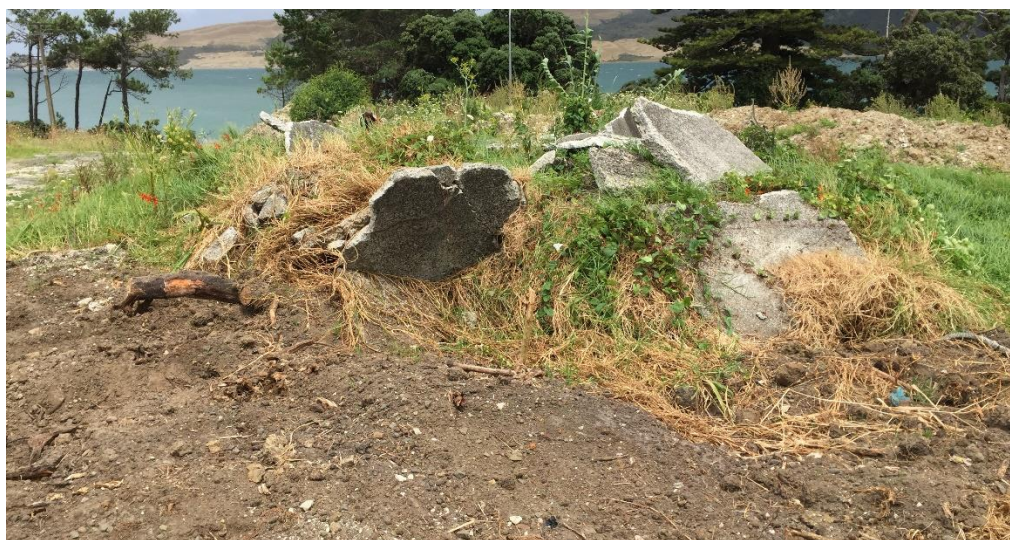
Photograph 3: concrete waste

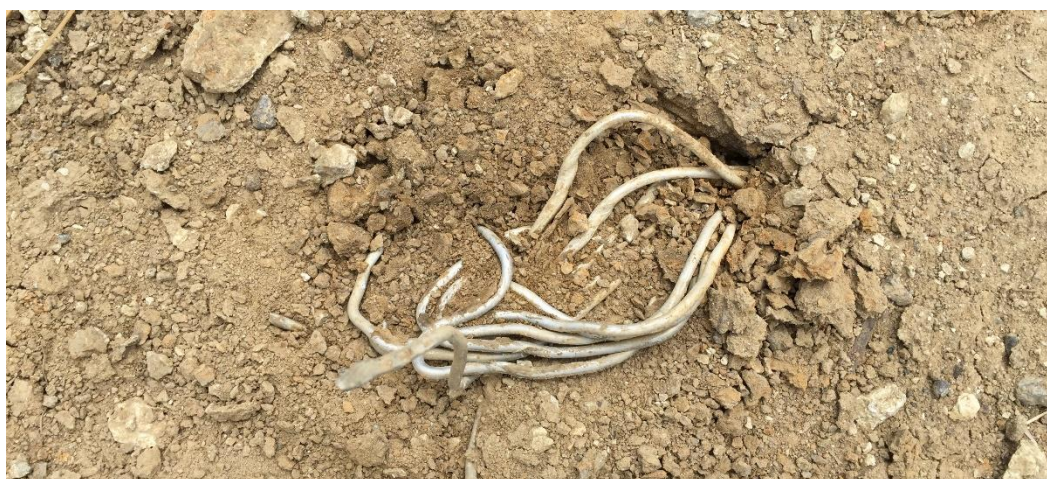
Photograph 4: electrical wire

There is evidence of extensive filling in the south western and central portion of the site, with waste being placed/pushed over the slope towards the proposed building site. A range of fill material was observed during the site walkover and an earlier visit on 28 December 2017. This material was predominantly soil, but included green waste, concrete, electrical wire, PVC piping, pieces of Copper Chrome Arsenic (CCA) treated timber and cardboard. Small amounts of non-asbestos fibre cement were observed, as well as vitreous china pipe, a tyre, 20L plastic drum and vacuum cleaner (Photographs 1 - 8). All photographs were taken on 17 January 2018, unless otherwise stated.

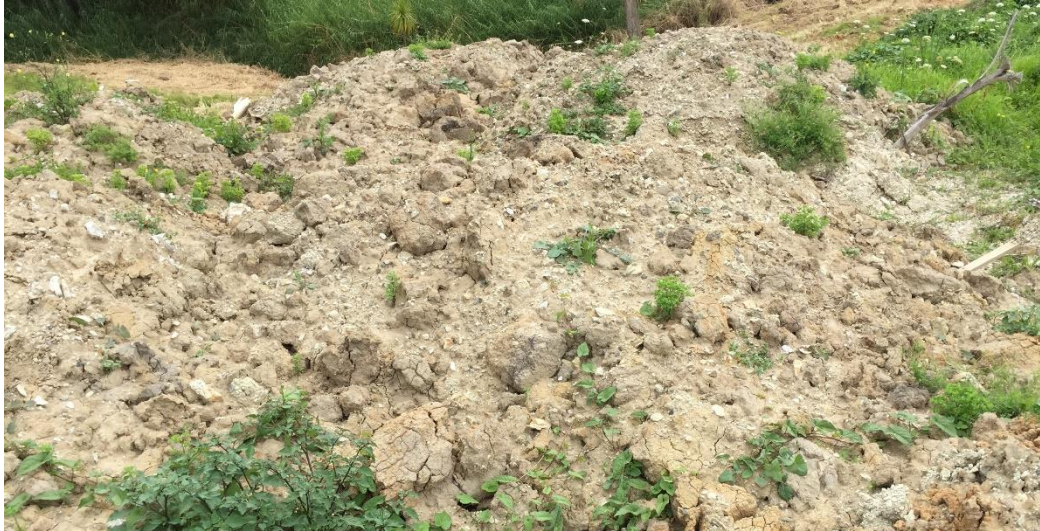
Photograph 8: typical type soil used as fill material

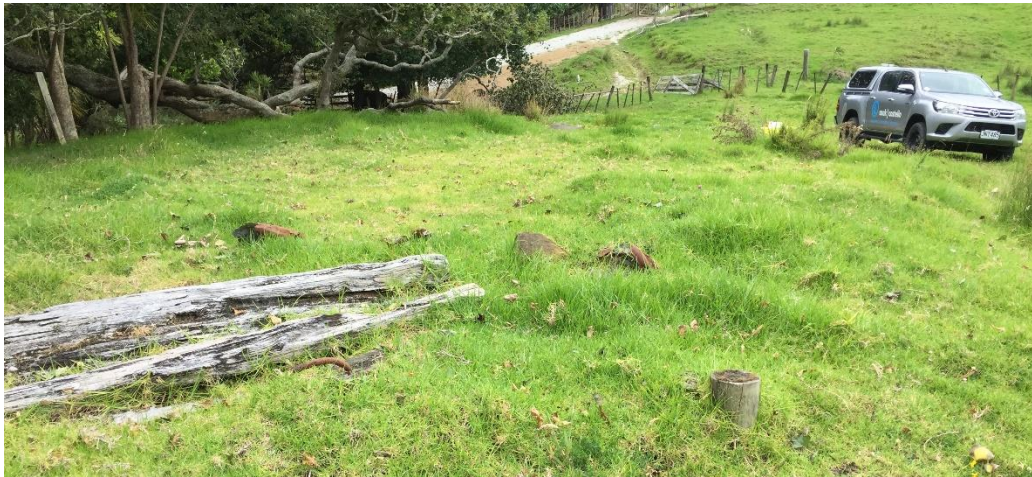
Wayne Baker showed Cook Costello personnel the location of the woolshed, sheep dip and associated yards. Where the woolshed used to be located was slightly elevated above background soil. As a portion of the floor of the woolshed had a slated floor, debris (manure, soil etc) is likely to have increased the height of the ground beneath the shed. A woolshed foundation post was still visible (Photograph 9). The greenish colour of the post would indicate that it has been treated with CCA.

Photograph 9: location of woolshed and sheep dip (beyond) – looking east

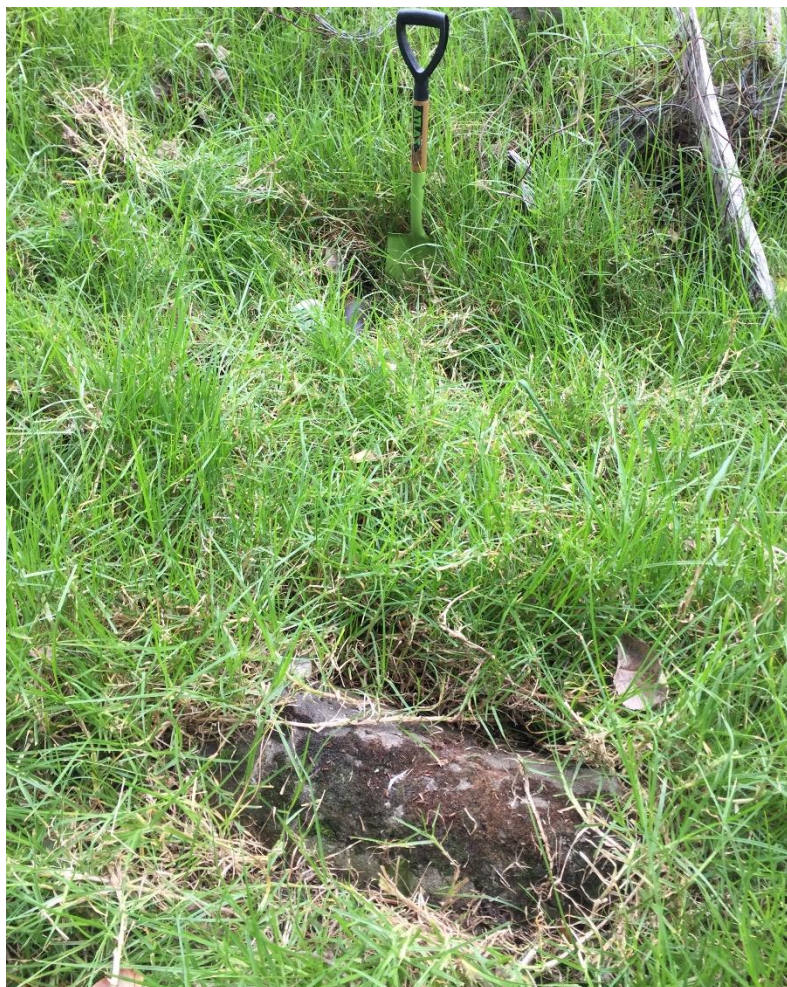
Photograph 10: sheep (pot) dip – concrete curb edge in foreground

The sheep dip (Photograph 10) was located to the east of the woolshed and is consistent with a pot bath style of dip (Photograph 11).

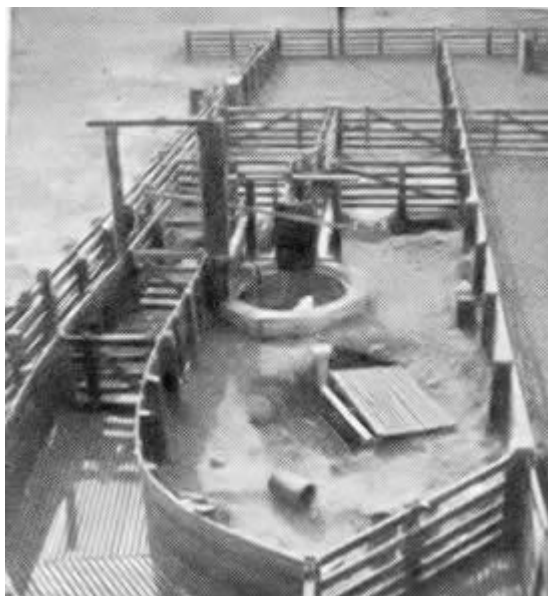
Photograph 11: Pot bath with curved race and covered sump
<http://www.mfe.govt.nz/publications/hazards-land/html/appendix-10-photographs-sheep-dip-structures>

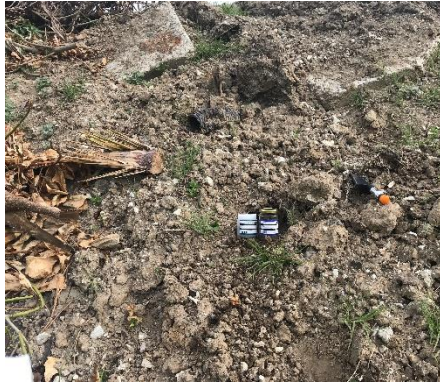
Photograph 12: Sample Site S1

Soil sampling locations and characteristics are presented in Photographs 12-20.

Nine locations were sampled on the site – three (S1-S3) of Piece of Land 1 on 28 December 2017, and six (S11-S16) on Piece of Land 2 on 17 January 2018, as depicted in Figure 5. The sample location, depth and site characteristic are detailed in Table 3:

Surface soil samples were chosen based on changes in soil type/appearance and/or characteristics for S1-S3, and location for S11-S16. S16 was sampled at a depth of approximately 0.15m below ground level (bgl) to identify contaminants potentially unaffected by surface leaching.

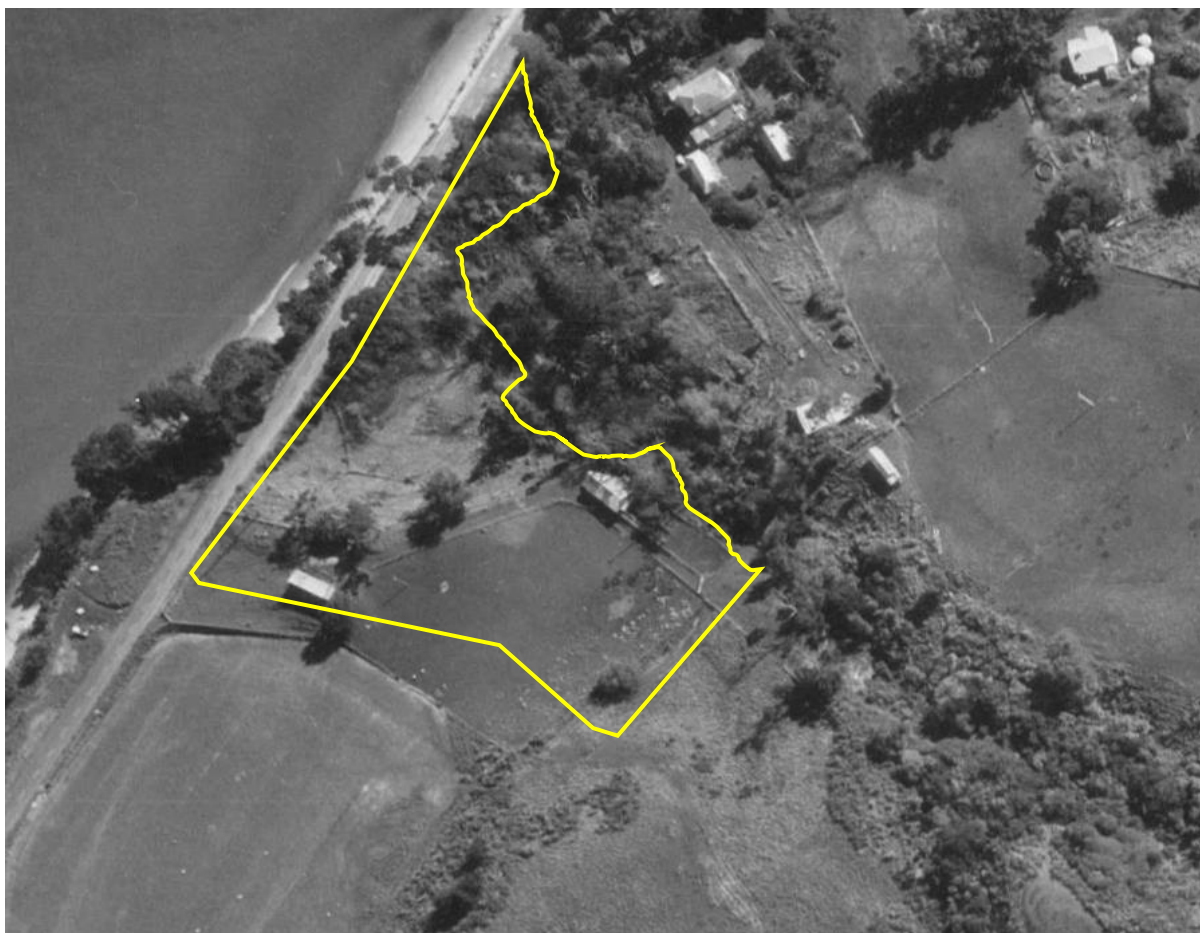
Photograph 21: 1 August 1966 (Retrolens)

The Pieces of Land are shown in Figure 2 on a 1966 aerial photograph when the woolshed, stockyards and sheep dip existed on the site.

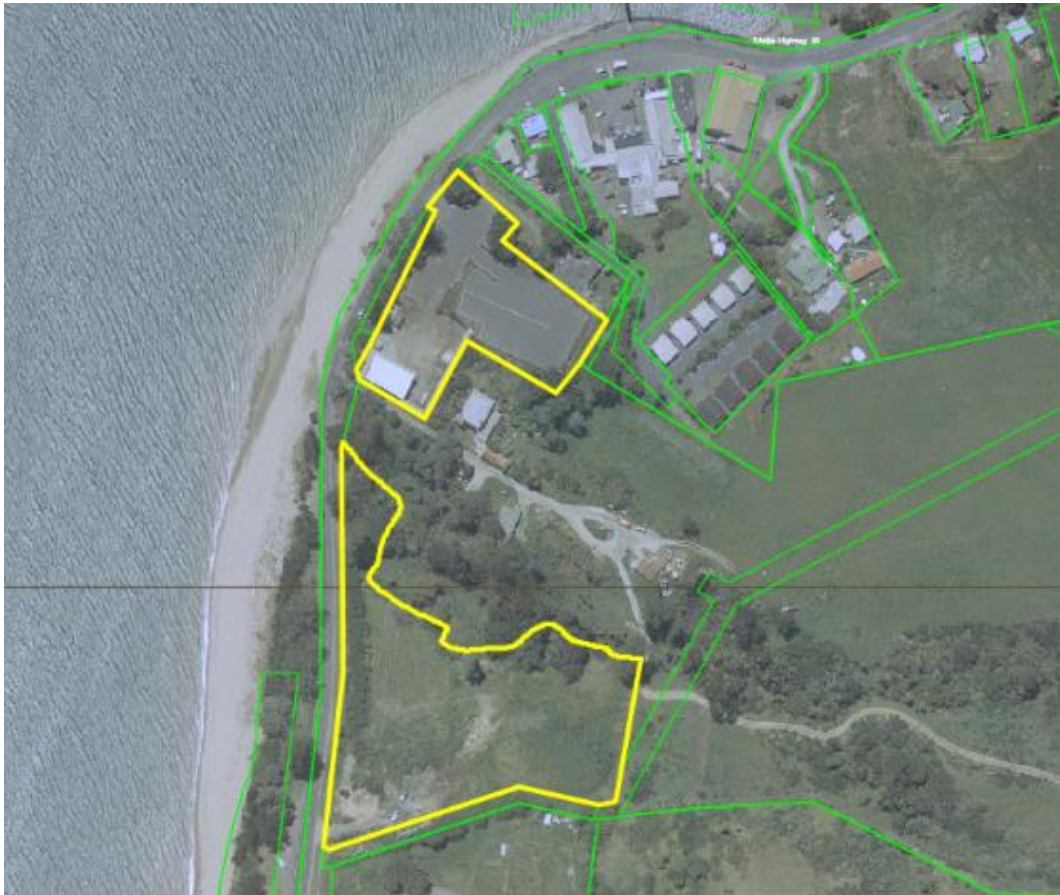
Figure 1: Commercial Hub at the northern 31 State Highway 12 (Lot 1 DP 164181) and the Cultural Centre at the southern 41 State Highway 12 (Lot 1 DP 195242)

The proposed development is located in Opononi, on the southern side of the Hokianga Harbour. The site spans two properties with the Commercial Hub at the northern #31 State Highway 12 (Lot 1 DP 164181) and the Cultural Centre at the southern #41 State Highway 12 (Lot 1 DP 195242). These two properties are situated on the western side of State Highway 12 and are separated by the entrance to #33 State Highway 12 (Pt Lot 1 DP 209937). It is proposed to link the two development areas together by pedestrian access.

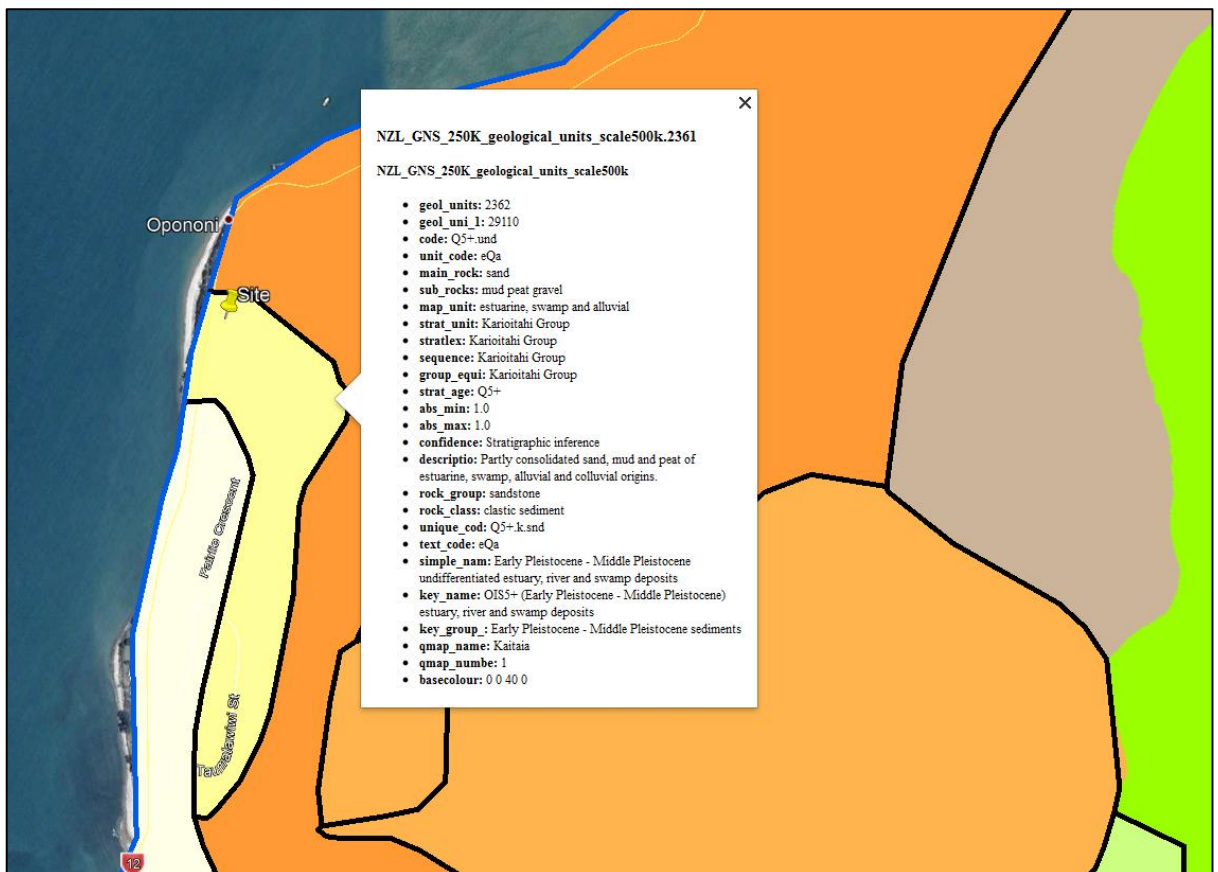
Figure 2. Excerpt from a geological map of the area (GNS Science: 1996 - Geological Map 1 - Kaitaia, scale 1: 250 000)

With reference to the GNS Science Geological Map 1 - Kaitaia (1996; scale 1:250,000) (Figure 2) it is interpreted that geology of the property consists of:

“Omm: Northland Allochthon of the Motatau Complex; Micritic cocclith foraminiferal muddy limestone, commonly with redeposited glauconitic sandstone beds.”

The property at #31 with the existing buildings is located within Omm: Northland Allochthon, while the southern property, #41 is located within eQa: alluvial deposits. The geological

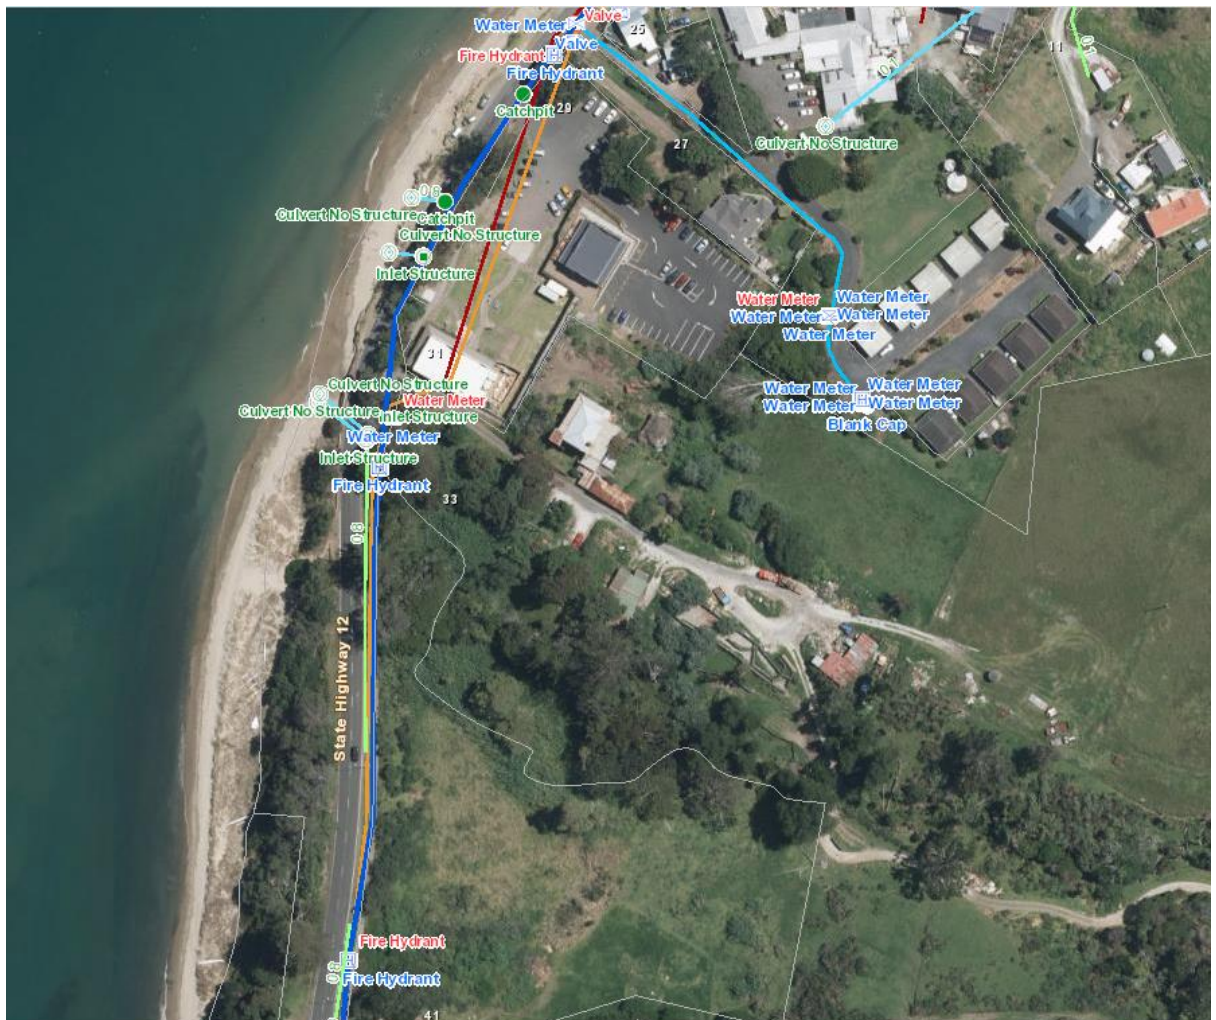
Figure 3. Aerial Imagery & services (FNDC GIS Maps)

Based on Aerial Imagery and existing Council services are presented in Figure 3:

- The general landform slopes to the west at a gentle to moderate grade
- The Opononi Stream flows south-east to north-west between the two properties. Mature trees and vegetation line the slopes of the stream. The northern property has only a minor proportion covered in vegetation of which is grass lawn and a few mature trees. The southern property is covered in pasture with a few mature trees.
- Reticulated stormwater, water supply and wastewater pipes are available within the road corridor outside the properties.

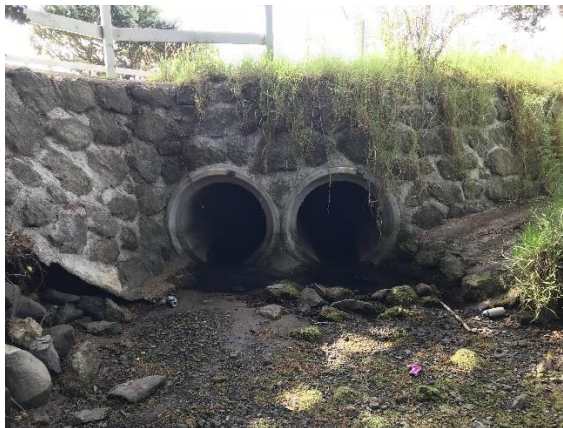
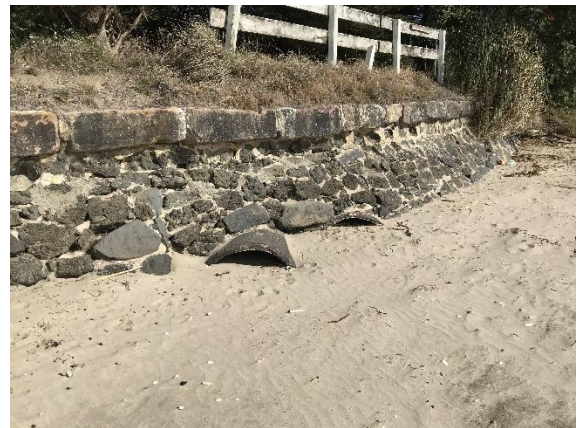
Figure 7: SH12 double Ø1050 culvert. Upstream LHS IL OTP 1.3m, downstream RHS

The double culvert outlet is almost completely blocked by accumulated beach sand and while this will cut down during sustained flow for the purpose of assessing the extreme flood elevation case it is assumed the culvert conveys no flow. Under this scenario the road acts as a broad crested weir with a length of 7.5m, side slopes of 1:12, and crest level at OTP 3.44m. At the Q_{100+cc} design flow the flood depth is 0.49m, giving a flood elevation of OTP 3.93m. While the backwater effect will marginally raise the flood level higher adjacent to the development
