FAR NORTH DISTRICT COUNCIL
CONTRACT 7/18/101

Road Maintenance and Renewals Contract

MONTHLY REPORT – MAY 2023

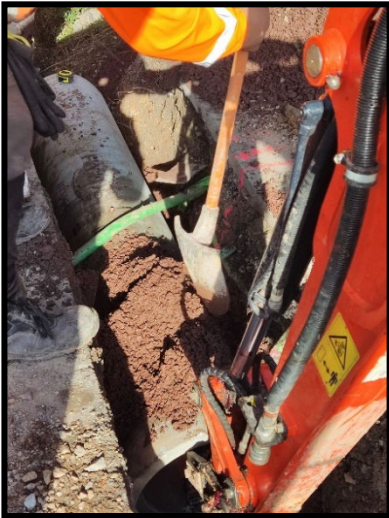
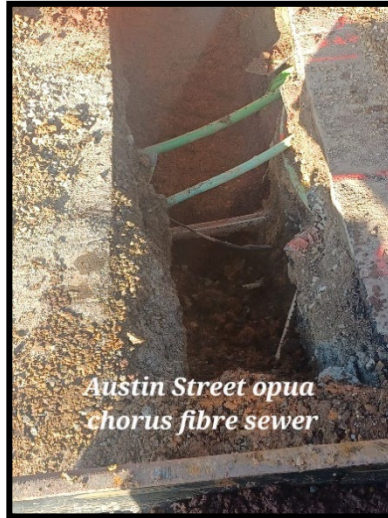
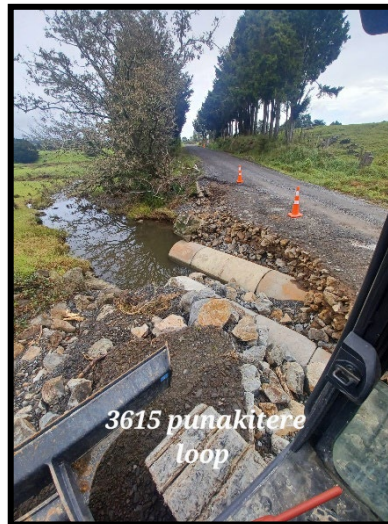
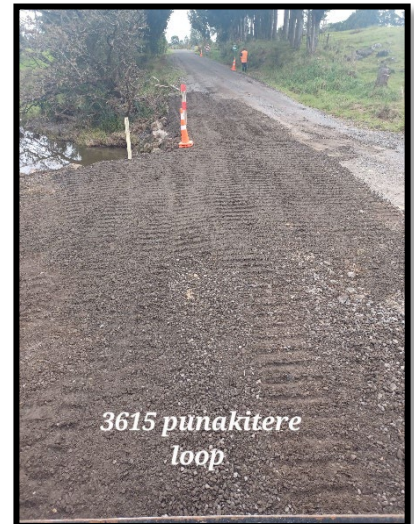
The drainage crew has been busy cleaning up slips and washouts after the heavy rain at the start of the month. They spent most of their time in the Matawaia/Pokapu area and have just gotten back to doing what they love, laying pipe! Pics attached of culverts going in between services on Austin Street, Opuā.

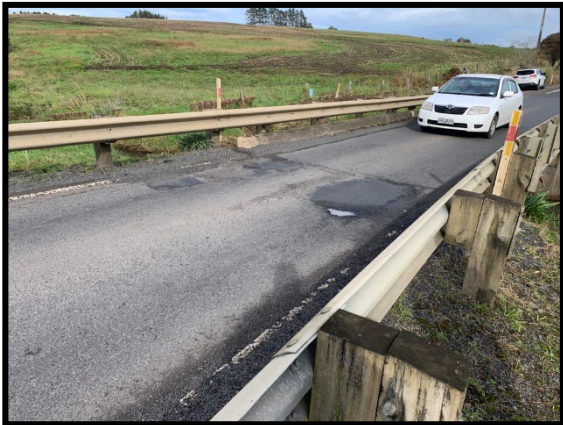
Wiroa Rd – One lane bridge – Potentially some downstream opening is required with an under sized culvert on private property causing the Bridge to flood in high intensity.

A one-off section on Temporary repairs this month. With the overly wet year so far, the sealed network has been put under extended stress which has caused pavements to fail sooner than desired. At present the following areas are planned for some temporary repairs to get us through Winter with a plan to then carry out more extensive repairs once the weather allows in Sept/Oct. The temporary repairs will look temporary in that they will be patched overlays of asphalt to take out the rutting and reduce the chance of water ingress through winter.

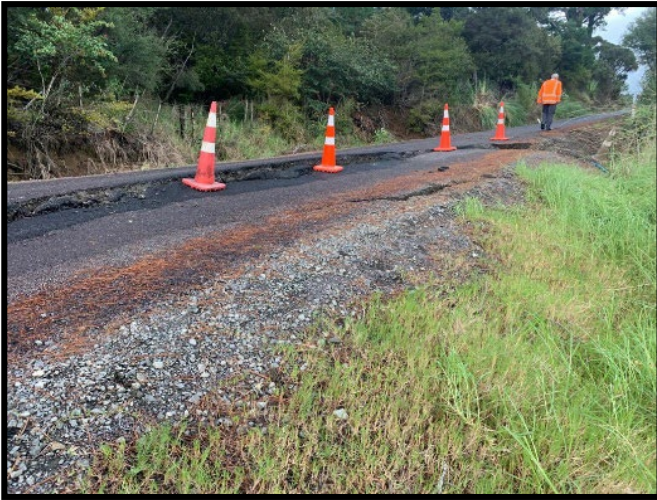
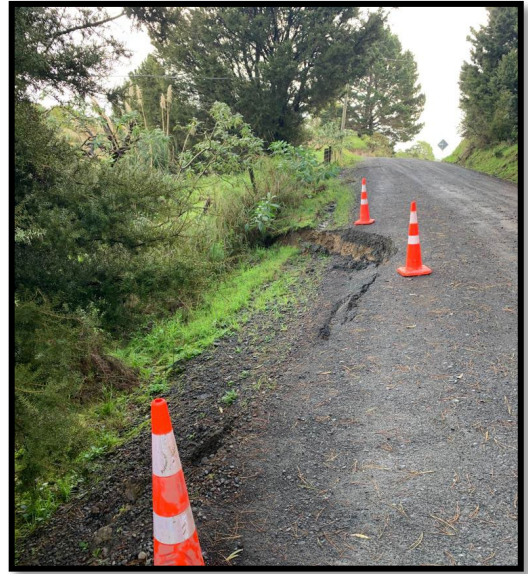
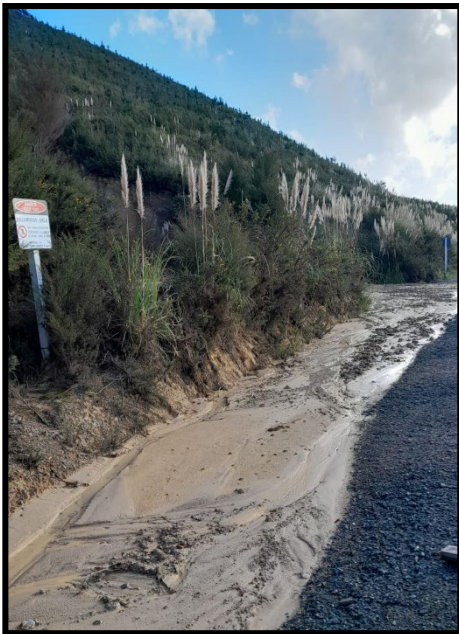
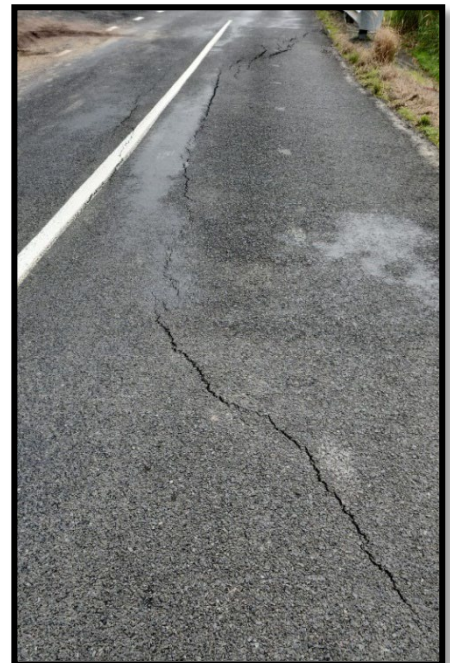
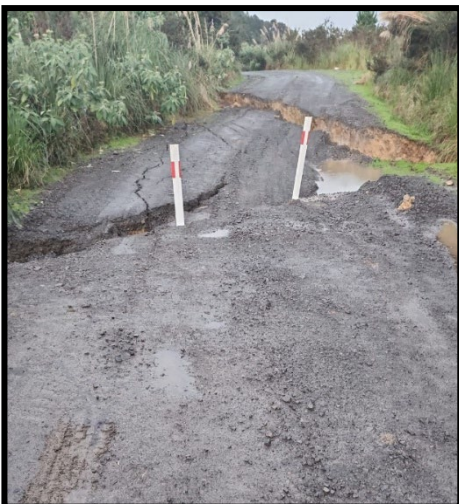
Photos from May rainfall.

The Far North, such as Waimate North, has been hammered by downpours. Photo / Peter de Graaf

A MetService meteorologist has described the rainfall dousing parts of Northland today as "astounding".

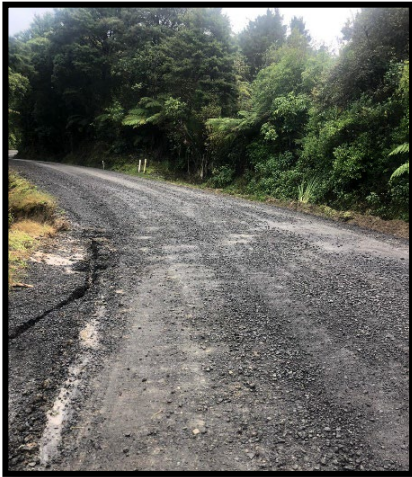
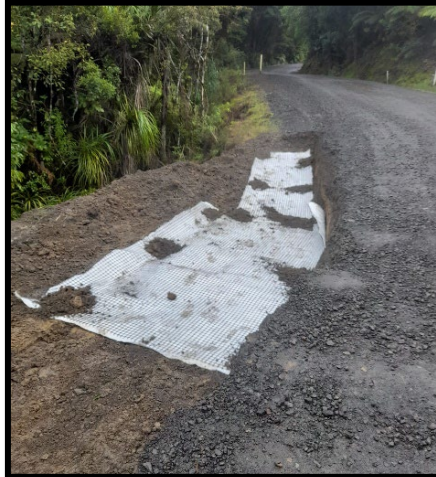
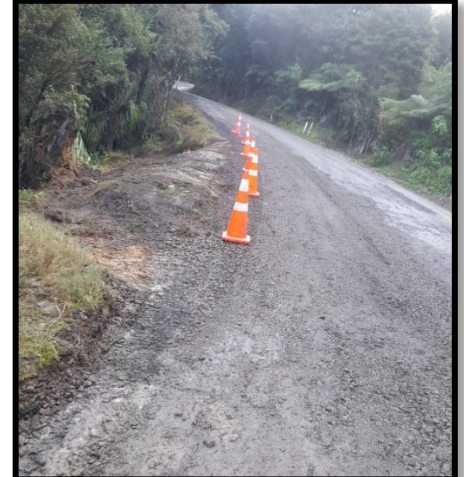
The team stepped away from Gabrielle Phase 2 works when the May rain came – Taheke Rd took a beating with lots of under Slips (Left to right, before, mid phase and after on one of these)

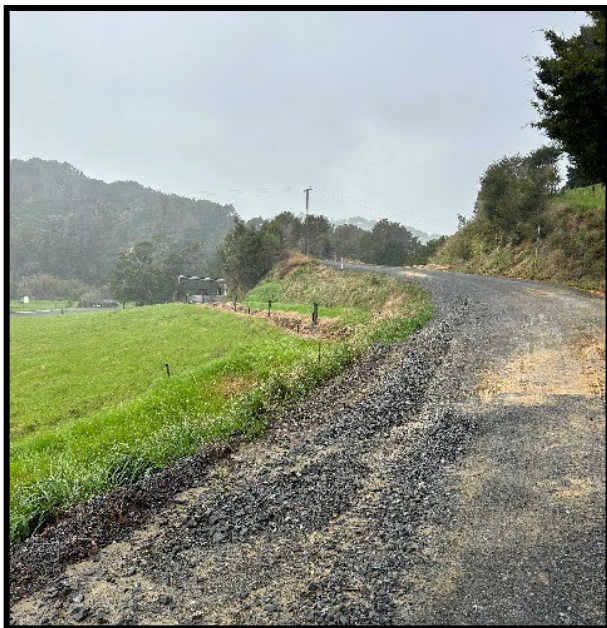
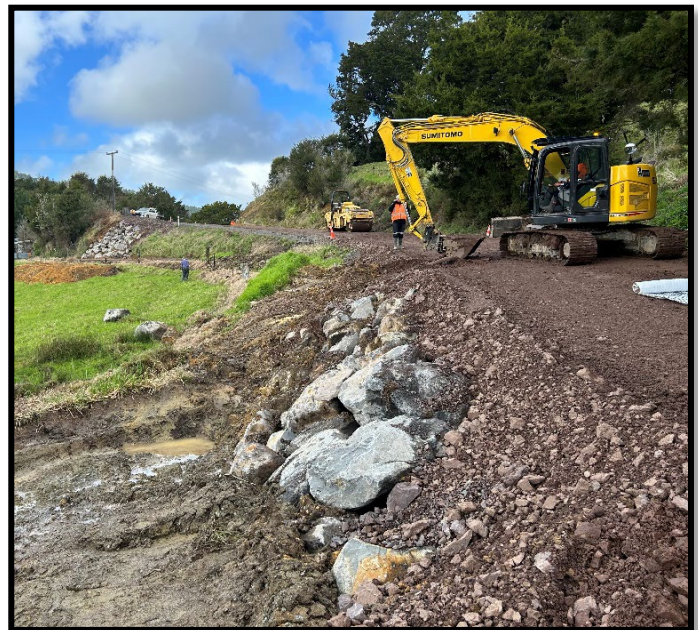
Marlow Rd Under slip (left to right before to mid phase looking south). This is a tricky spring-based pavement slip more than an under slip. A subsoil drain has been installed against the right-hand bank at a depth of 1m to intercept this water.

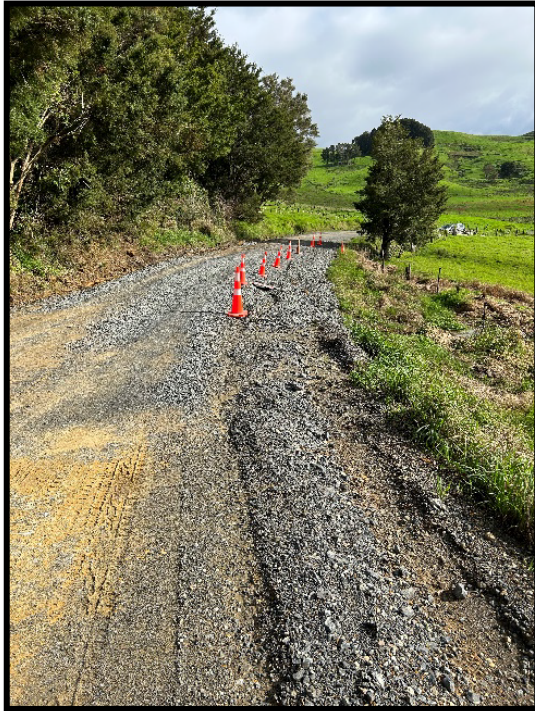
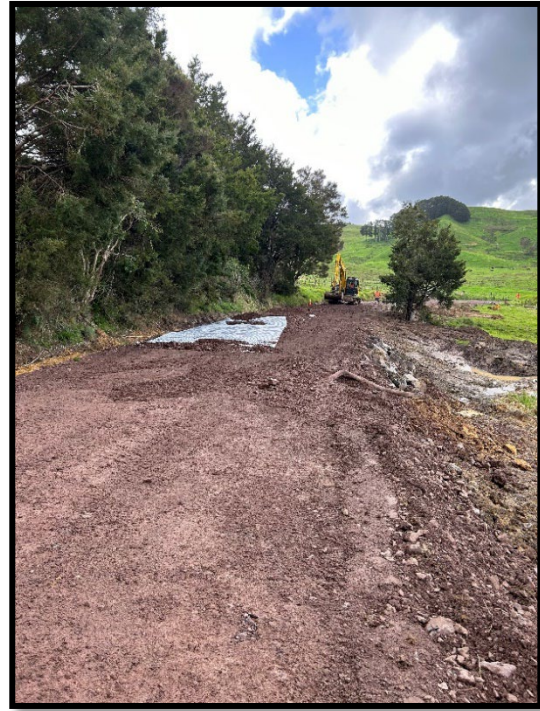
Marlow Rd Under slip (left to right before to mid phase looking north)

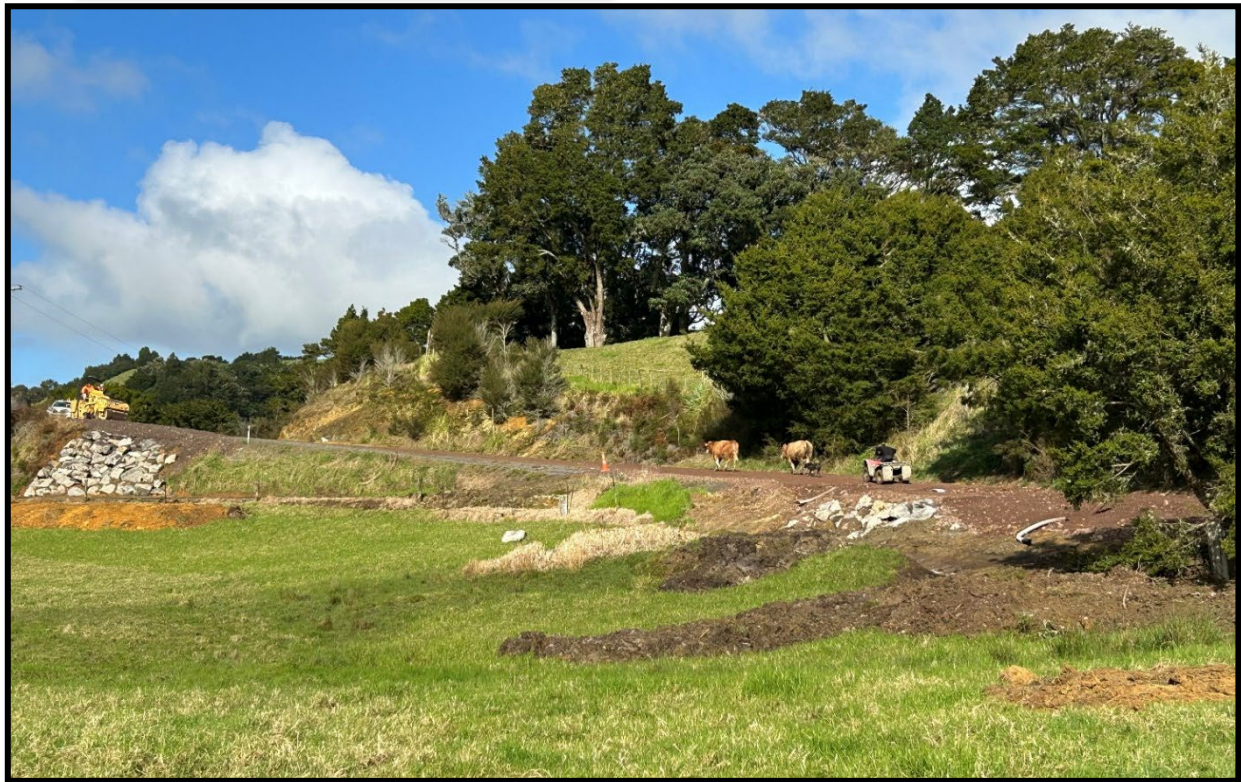
Marlow Rd Under slip (local traffic moving through site) note to the left a second small drop out type slip having been rock armoured.

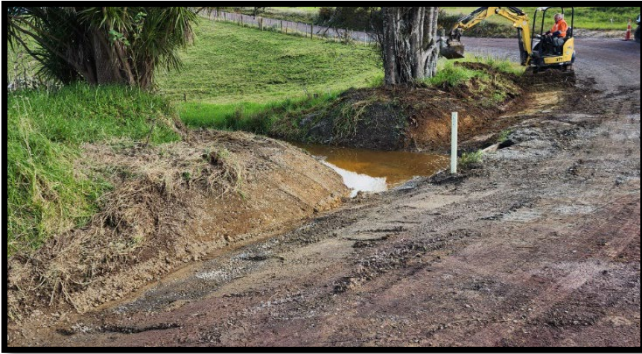
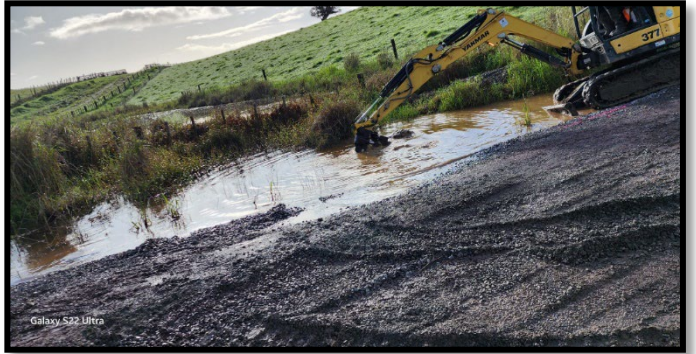
The crew carried out culvert clearing, culvert installation, minor slip repairs and general water tabling along Oromahoe road and for the last 3 weeks have been on Motukiore Road. The team will be moving onto McIntyres Road from next week to focus on some major scouring and water table reinstatement with a few culvert inlet and outlets cleared.

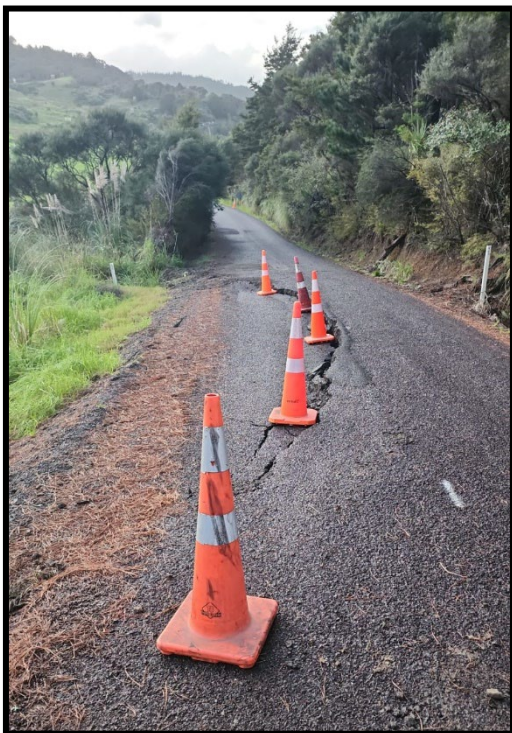
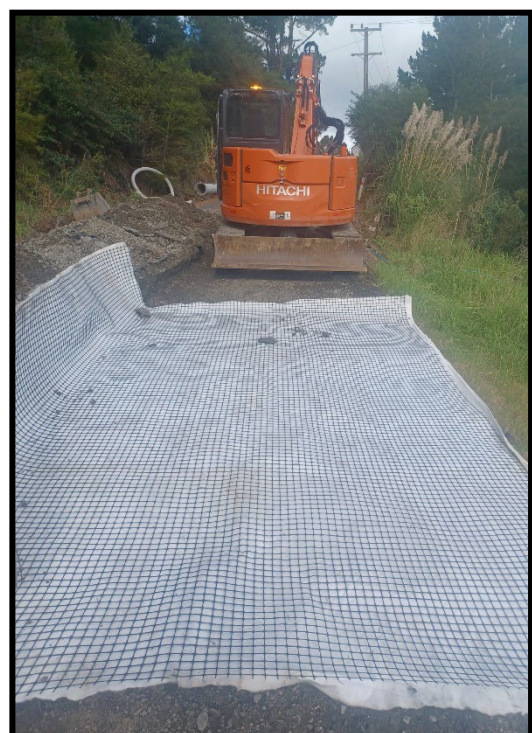
With a lot of damage across the network out West Omanaia School Rd was prioritised for obvious reasons. School! Everyone wants to send the kids off to School each day but unfortunately the school had to be closed for a few days while we attended to an under slip. The under slip was excavated and we found a large amount of water pumping down the road through what we believe to be an old redundant watermain which is still be arranged by the 3 waters alliance. School was back open after the weekend thankfully.

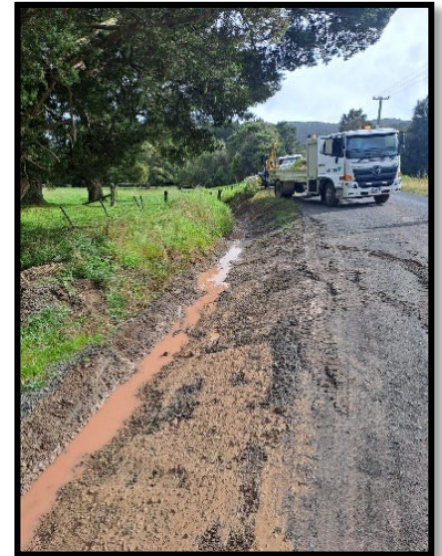
Footpath Team

Water tabling and culvert clears throughout the Russell area, McIntyres Rd and general clean-up of smaller remaining trees throughout the network. They jumped back into footpath replacements on 12/6 so not a huge amount of Phase 2 works for them this month been.

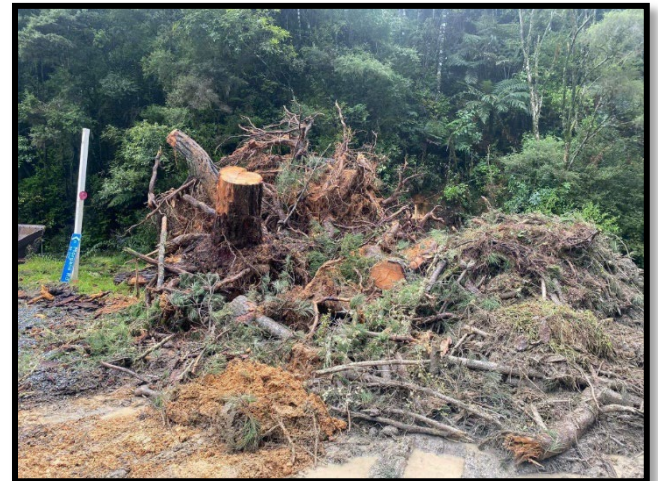
Northland Treeworks

Continued with area wide tree recovery from cyclone Gabrielle phase 2 and 3, and also May initial response. There are millions of photos of trees been cleared but this one will do for a change. You will be sick of seeing tree pictures like we are 😊

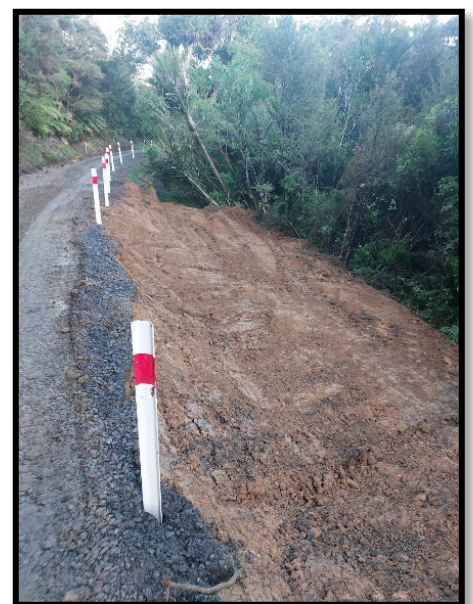
DCL

Have been working on May rain event phase 1 activities and Gabrielle phase 2 works. Roads include slips/under slips and culvert clears/water tabling on various roads around the network including Pokapu Rd, Hairiru Rd, Duddy Rd, Waimatenui Rd.

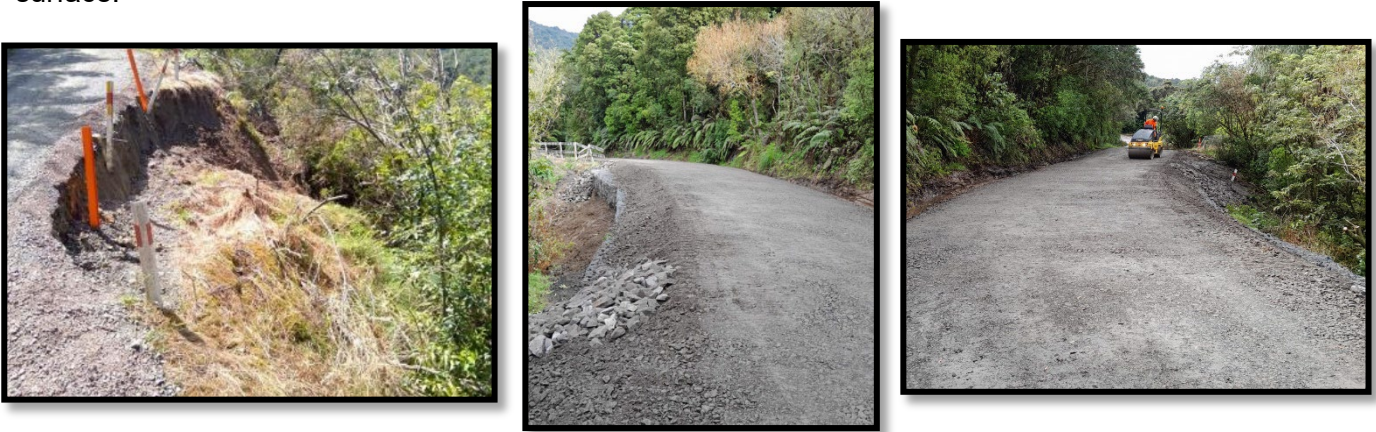
The team have been delivering jobs out West and the repair on our network is in good hands. On Wekaweka Road, JR Hack have cleaned inlet and outlet on culverts, reform and clean side drains and constructed three new retaining structures with gabion baskets and correcting the camber on the final road surface.

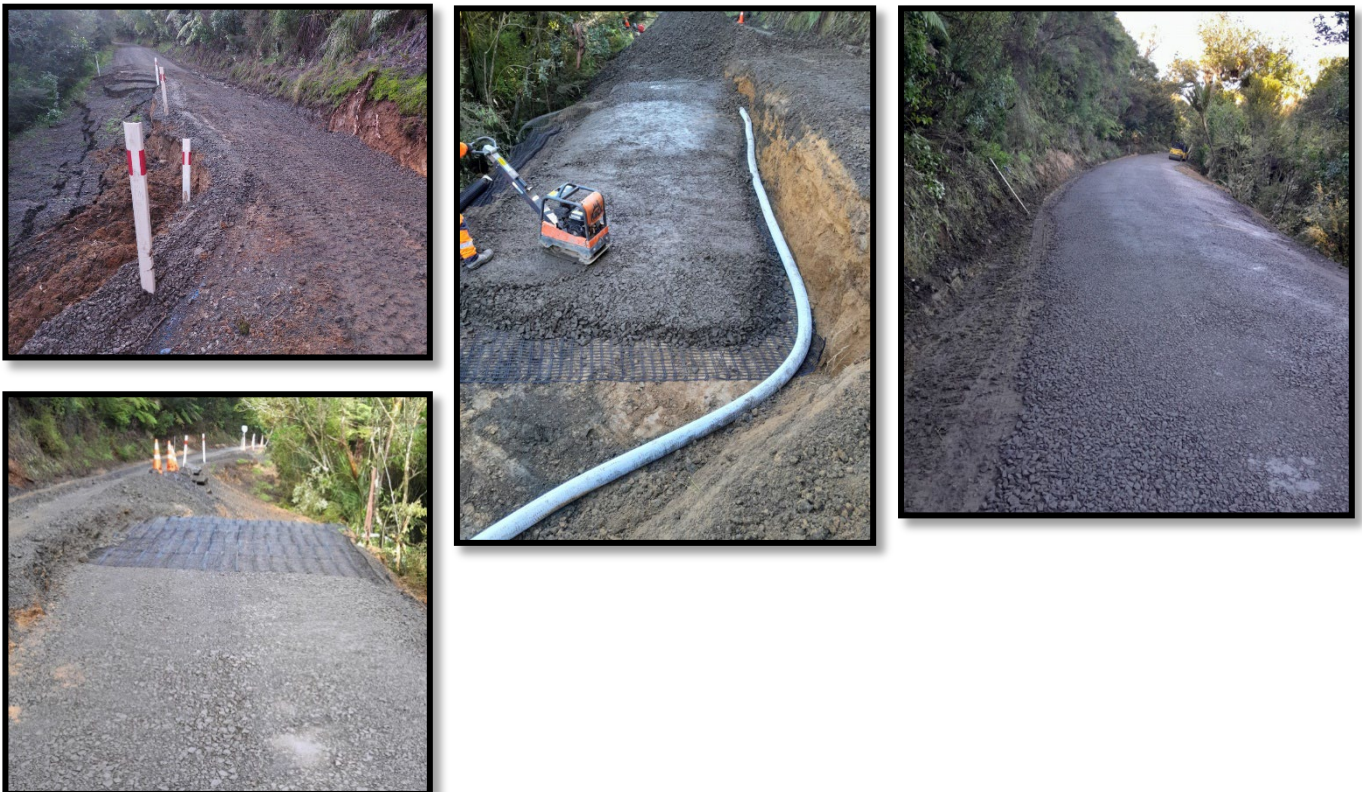
On Classen Road, the urgent need was there for constructing new layers and backfill the heavy impacted road. Hack made use of subsoil drains to drain the trapped water beneath the surface. Then by wrapping the new layers in geogrid, which anchored it back to the harder existing road layers, the road reconstructions were successfully completed in a short timeframe.

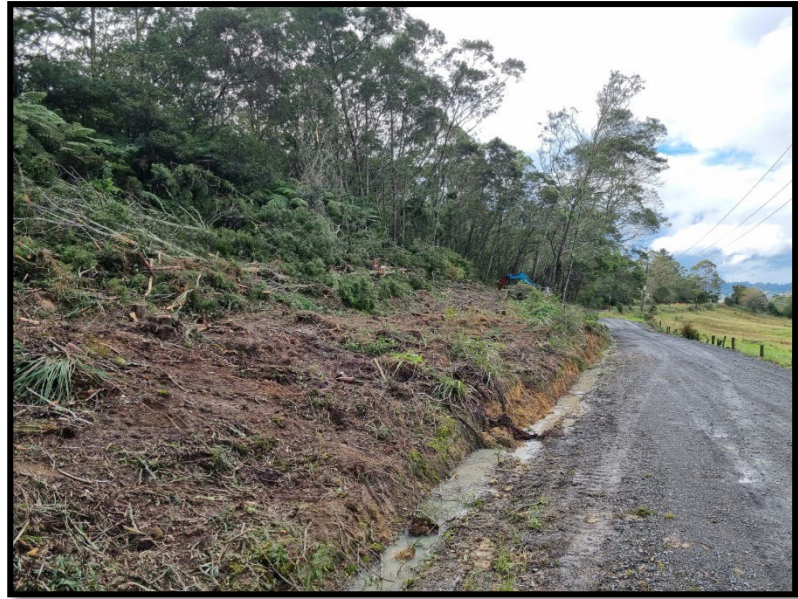
OS Treeworks

Completed the remaining trees around the Kawakawa area including Albert St, Domain Rd, Mill Rd, Settlement Rd and Greenacres Dr. This picture is a great improvement on a section of road that regularly features on our afterhours call out chats with FNDC customer services. With hundreds of wattles on the lean it was awesome to be able to get rid of the lot so no more calls during the night now for this!

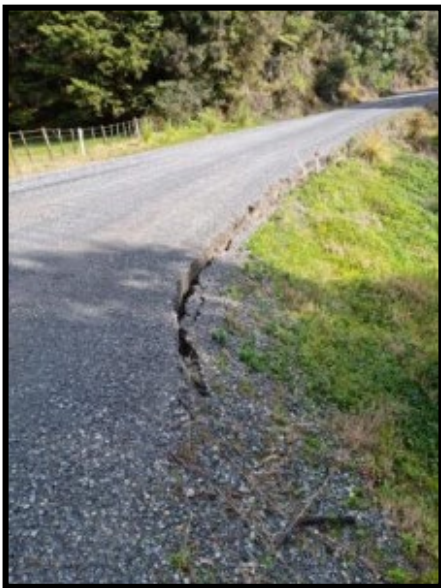
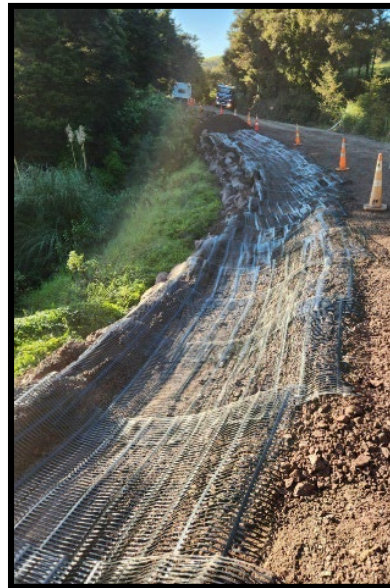
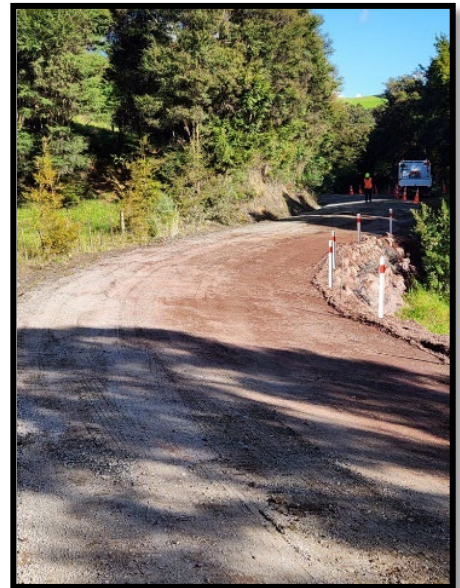
On Mangakaretu Road, Pristine Project have cleaned inlet and outlet on culverts, reformed and clean side drains and relaying culverts to create positive flow where needed. The work they are doing on Matawaia-Maromaku Road has involved renewals on under slips and top ups on dropouts to repair. With this work building their confidence and knowledge and having the ability to self-perform TMP, we hope they can deliver more work like below with Ventia in the future which this SME requirement for Phase 2 has allowed us to grow this opportunity with them previously not there.

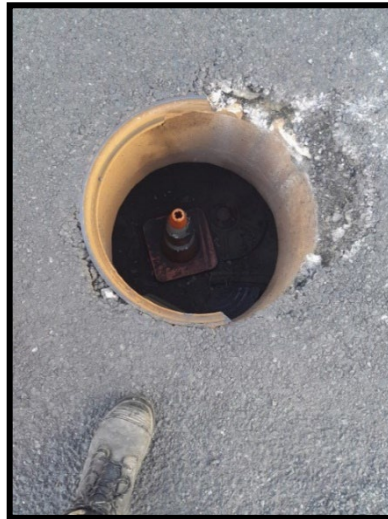
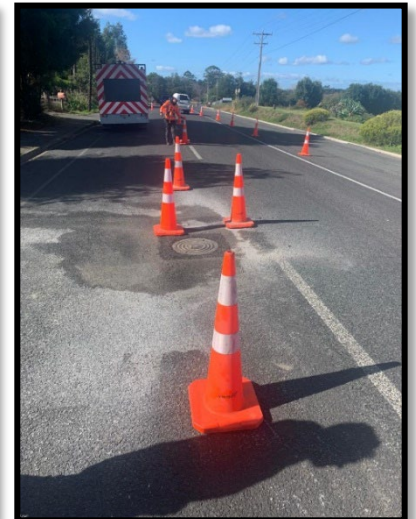
- Temporary repair on problem areas on Recreation Drive in Kaikohe
- Repair for damaged manhole on Waipapa Rd. Before and after below.

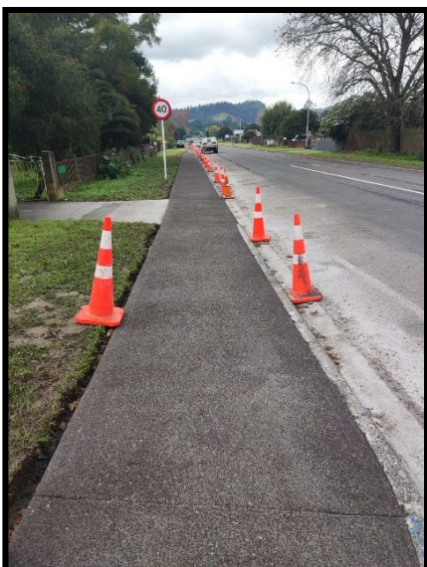
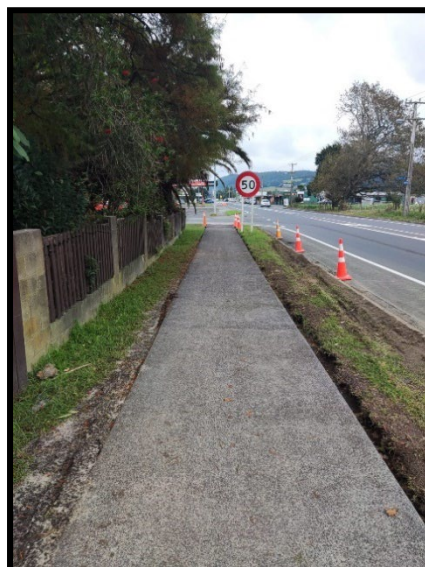
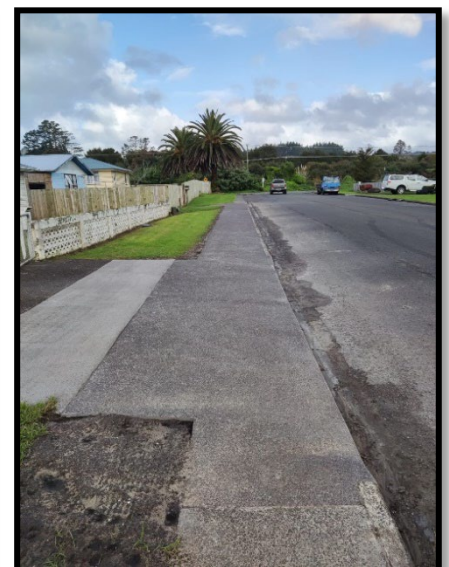
The concrete crew managed to replace 500m² of footpaths and vehicle crossings this month despite the rain we've had. They have a few sections left on Otiria Rd and Nisbet St in Moerewa before heading west to Kaikohe.

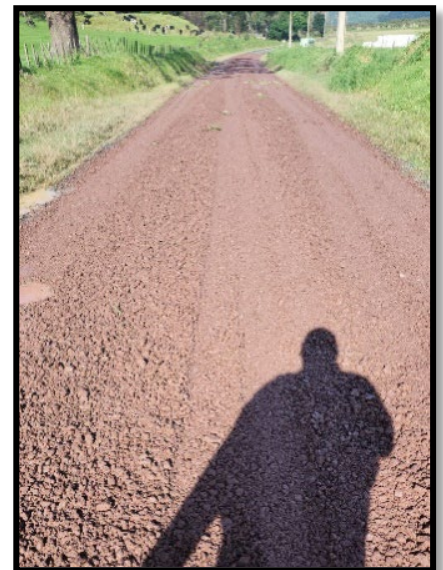
We have put running course on Motukiore Rd, Waiare Rd, Mangakaretu Rd, Waiotemarama Gorge, Whaakaurau Valley Rd. With all the potholes across the network we have pulled our heavy metals crew off towards the end of the month to focus on running course/maintenance metaling across the critical areas on the network.

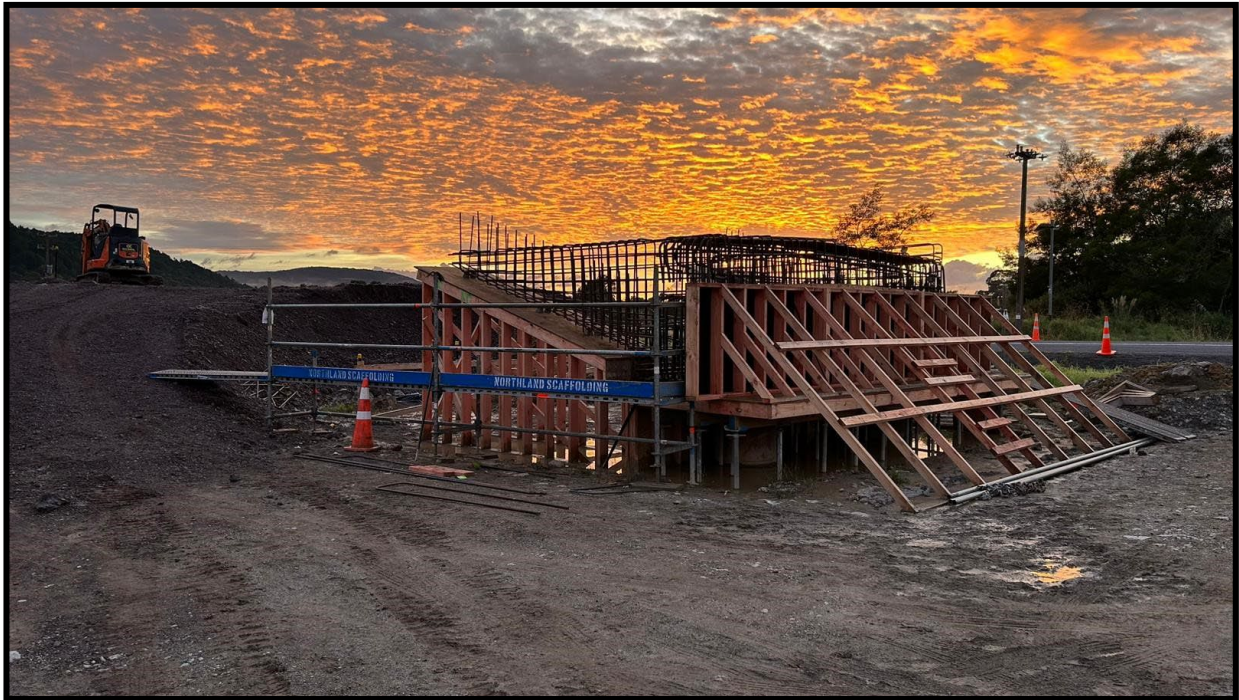
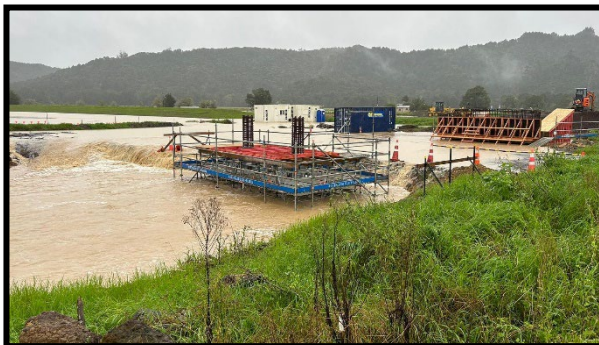
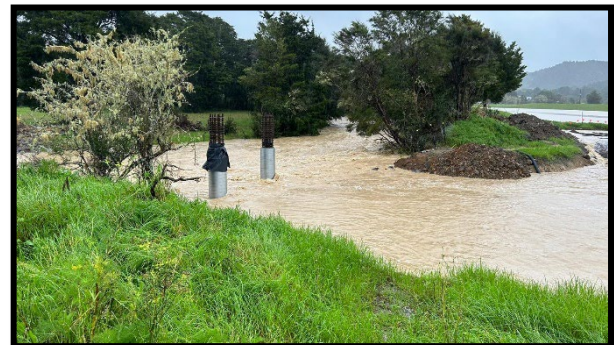
1. Pokapu Road Bridge Construction – on site work has been hampered a lot this month with the river level rising significantly due to all the rain. The site completely flooded middle of the month and some of the surrounding community had to be evacuated. This even just highlighted the importance of this project again and the team are still very eager to deliver the bridge completed at the end of October. The Abutments and Pier C headstock are ready for concrete with works around Pier B slightly behind due to the location in the river. The bridge approaches have also been formed with the hard fill on both the North and south sides now in. Still a few months to go on the project. The bridge concrete structure will go up over the next few months before we start with the pavement realignment in August 2023.

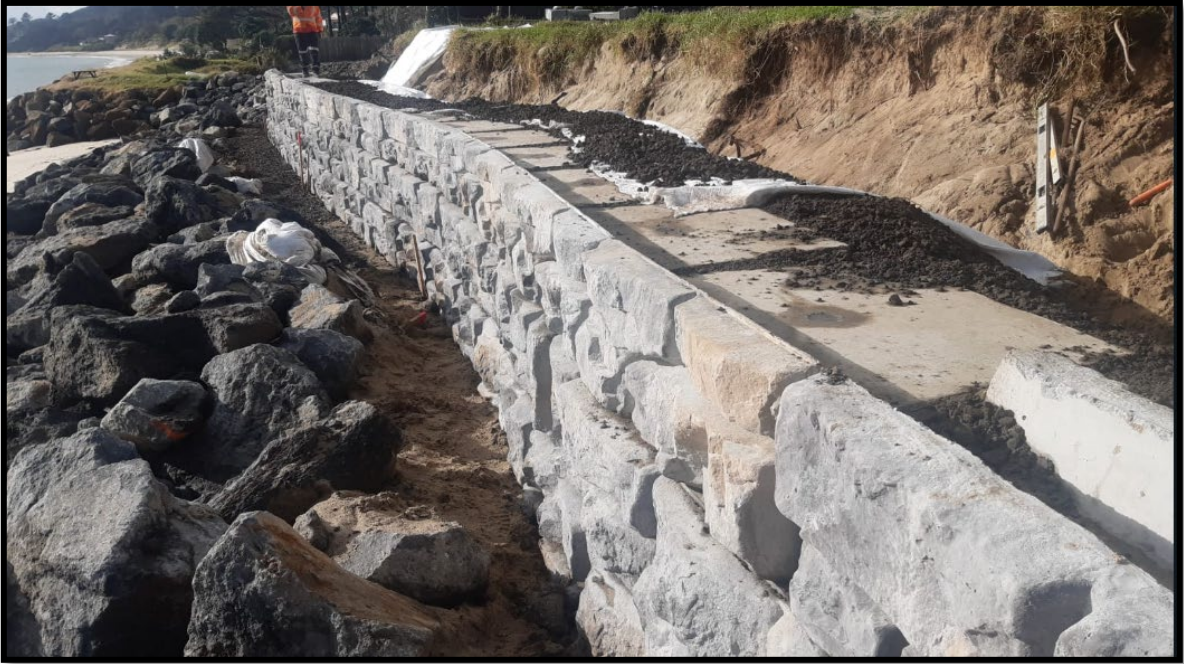
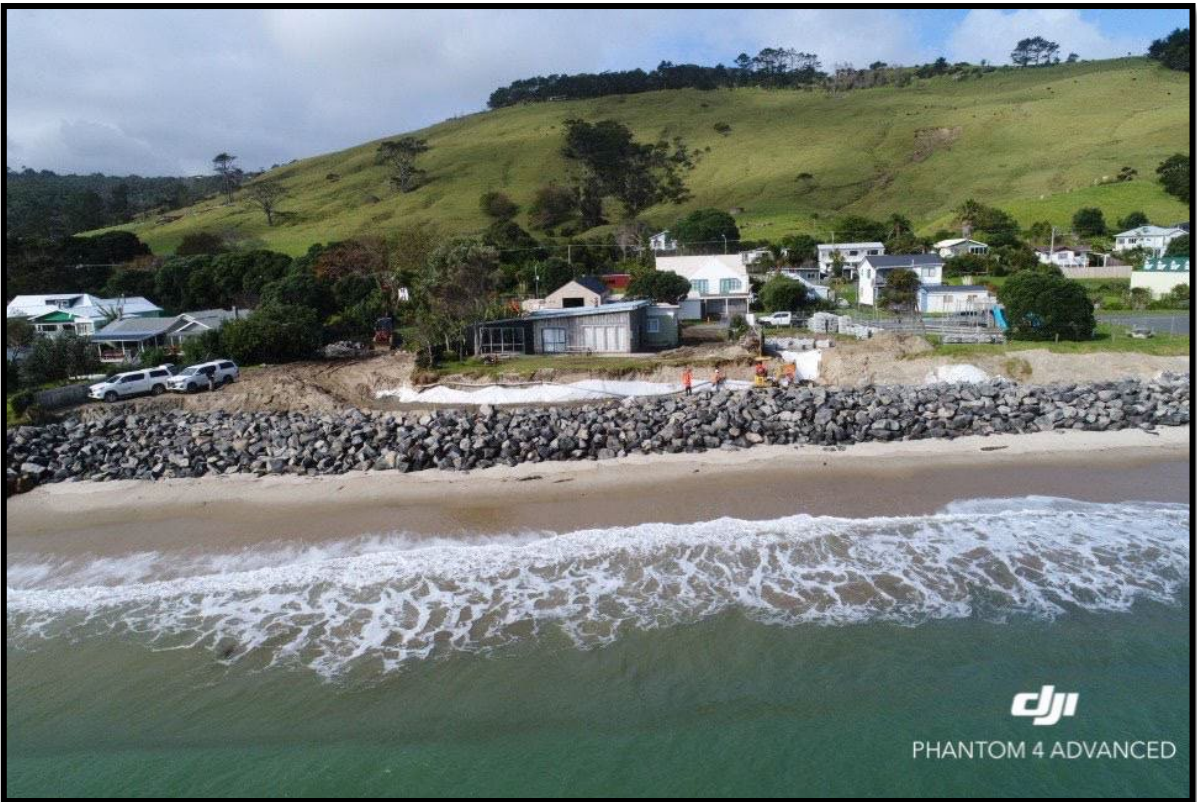
2. Freese Park- Seawall – Construction team are doing a 120m seawall construction on Freese Park in Omapere. Seawall is 100% complete. The team will be installing 120 precast Redi rock concrete blocks for the next 2-3 weeks followed by DOC inspired ramp and steps as access to the beach.
