SH11 Paihia to Waitangi Shared Use Path

Preliminary Design Report Waka Kotahi NZ Transport Agency

Reference: 511738-0000-REP-JJ-0001 Revision: 1

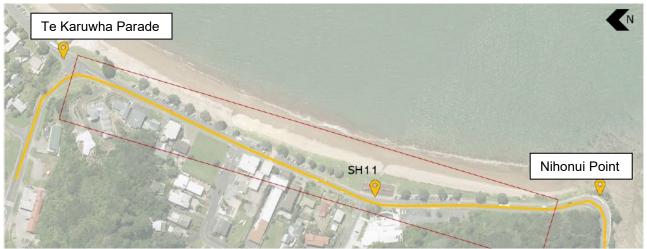
Figure 1: Project Extent of Paihia to Waitangi SUP

Refer to the extent of work shown in Figure 1, along SH11 Marsden Road, connecting from the north of Nihonui Point to south of the roundabout with Te Karuwha Parade.

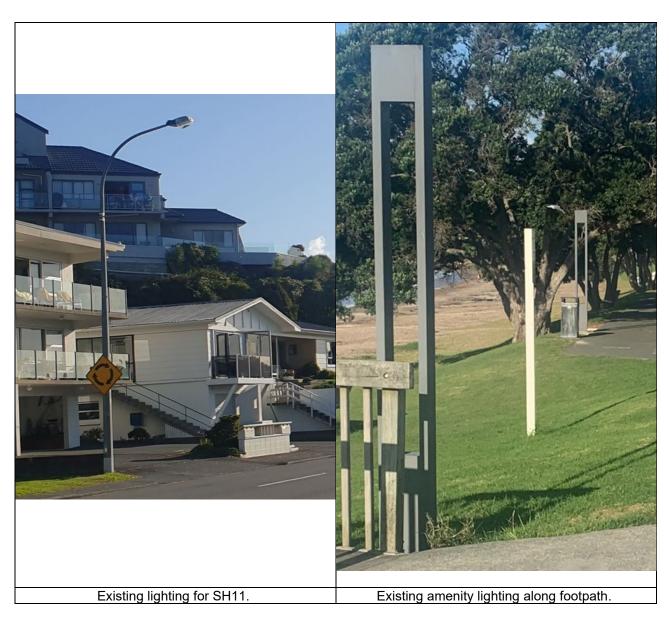
Existing lighting around the proposed SUP area consists of road lighting serving State Highway 11's carriageway and amenity lighting for the waterfront footpath.

The existing light fittings appear to be a Sylvania Roadster, however the wattage was not ascertainable from site visits, nor was the information available in FNDC or Waka Kotahi records. As a result, the lighting design for the SUP will exclude any contribution from these fittings as they cannot be verified through calculations without further information. By not taking the existing lighting into account, it doesn't limit future options for upgrading the roadway lighting.

A number of the amenity lights along the footpath clash with the new route of the SUP. These will need to be removed with cabling pulled back to the nearest fitting to make way for the SUP.

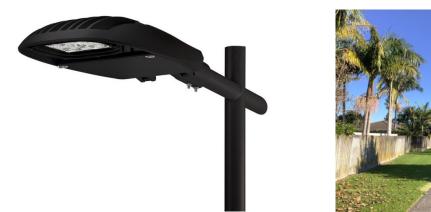
- Type L1 ADLT XSP High Output Series
- Optic Type II Long (2LG)
- 29W; 3770 lumens
- 4000K
- NEMA 7 pin + DALI
- Black Finish

The type L1 light poles are proposed to be mounted on ADLT's proprietary PS Pole with a black finish as their design is more visually compatible with the light fitting. The black finish will also minimise the visual impact at night.

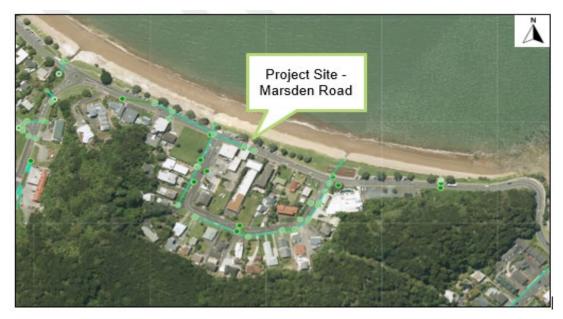
Figure 3: Existing Pit and Pipe network in green (Source: FNDC SW GIS Map)

Figure 3 below provides an example of the existing pit and pipe network along Marsden Road. There is currently no known stormwater treatment devices for stormwater flows captured along Marsden Road.

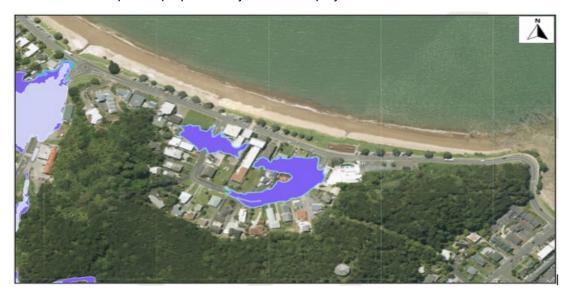
Figure 4: 1% AEP Flood plain (Source: FNDC (Flood modelling_GHD, 2007))

Existing flooding has been assessed by GHD (*source: FIDC (Flood modelling _GHD 2007)*). It shows no flooding on the project site during a 1% AEP storm event. In Figure 2-3, there is some flooding away from Marsden Road and in the private properties adjacent to the project.

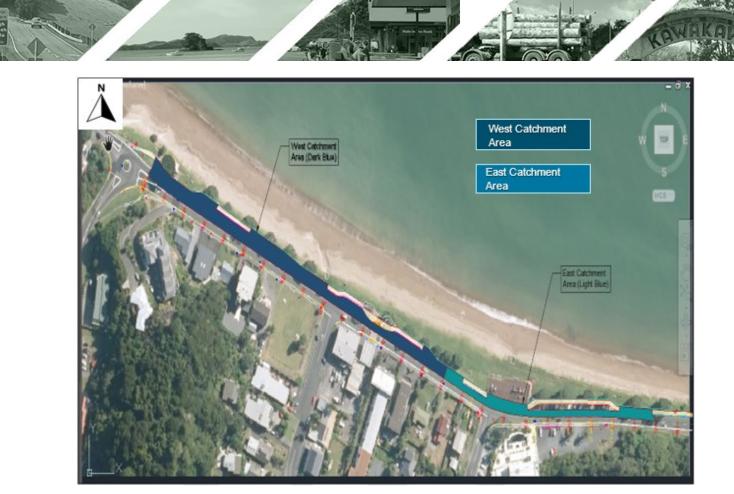
Figure 6: Catchment Area Map

- a) West Catchment Area (CA= 0.272 ha)
- b) East Catchment Area (CA= 0.112 ha)

The total area of the proposed stormwater catchments is 0.384ha (including the portion of the SUP that flows towards the road in a few locations). The SUP is assumed to consist of impervious area only i.e. road and SUP with no grass.

Catchment area - East					
Catchment area - East	1121.749				
	0.1121749	ha	CA length	195	m
Patienal flama @ (2.781.014)	44.292	1/2	Flaw		ve le et
Rational flows @ (2.781 CIA)	44.283		FIOW	s @ P2W P	roject
	0.044	m3/s		(East CA)	
Numbers of CP Required	3.0	no's			
Existing CP's in CA	1.0	no's			
Recommendations :	Need to provide	Min. (2) C	P in this CA		
Catchment area - West	2725.163	m2			
	0.2725163	ha	CA length	296	m
Rational flows @ (2.781 CIA)	107.543	l/s	Flow	s @ P2W P	roject
	0.108	m3/s		(West CA)	
Numbers of CP Required		no's			
Existing CP's in CA	0.0	no's			
-					
Recommendations :	Need to provide	Win. (6) C	P's in this C	A

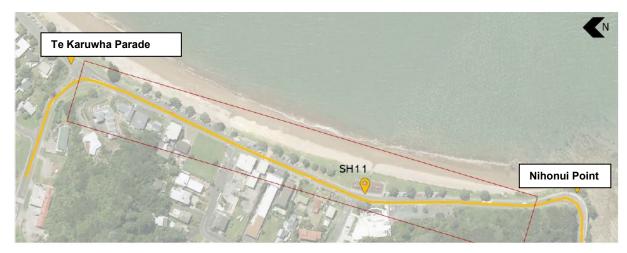
Figure 1: Project Extent of Paihia to Waitangi SUP

Refer to the extents of work shown in Figure 5-2, along SH11 Marsden Road, connecting the Paihia Waterfront Development design from the north of Nihonui point to south of the roundabout with Te Karuwha Parade.

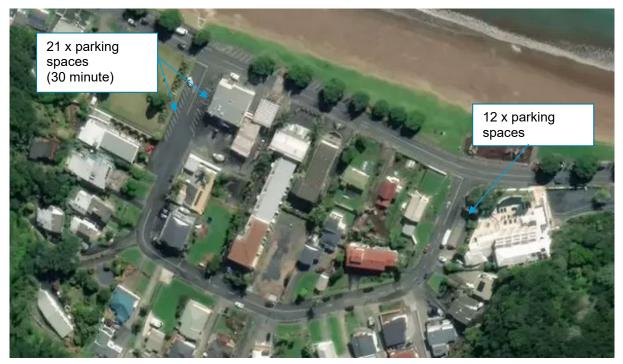
Figure 2: Existing parking on Davis Crescent

- A number of the car parking spaces are occupied by freedom camping vehicles and motorhomes
- Vehicles with boat trailers commonly park for a short stay either across the westbound angle parks or in the P10 westbound spaces to purchase bait and supplies from the suprette.

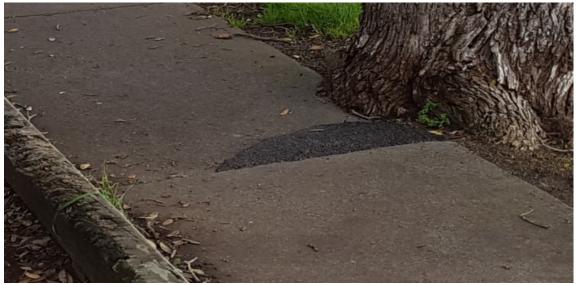
Fig 1 – The buttress roots of this tree have lifted the concrete footpath (creating a trip hazard)

• Trees produce strong hydraulic forces as their roots swell (when water is available). This can happen quickly – pohutukawa has the capacity to imbibe large amounts of water. The roots swell rapidly – sometimes overnight – and can displace large structures and crack concrete.

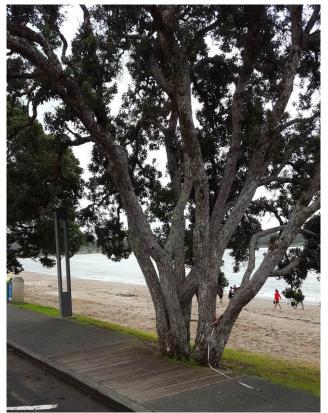
Fig 2 – Getting too close to the tree puts pedestrians – and particularly cyclists – at risk of an overhead impact with the trunk.

- The tree trunks are a practical overhead obstacle close to the path, i.e. it is possible to ride or walk into some of the trees because they intrude slightly into the path (similar to the trees along Tamaki Drive in Auckland).
- Cutting down (lowering grade) immediately adjacent to the tree often results in direct root damage and compromise tree health overall (See Fig 3 below).
