Application for change or cancellation of resource consent condition (S.127)

Pursuant to Section 127 of the Resource Management Act, the Far North District Council (FNDC) is seeking to vary the conditions of an existing resource consent (RC 2250199-RMALUC) that enables slip repairs within a Council owned site at 574 Whangaroa Road. Under slipping on the western side of Old Church Road has impacted the historic Hall site and resulted in debris material accumulating around the Category II historic building. The proposed works include the construction of retaining walls to protect the site from further slipping.

The scope of this design is to retain the slip on Old Church Road, incorporate kerb and channel stormwater design and incorporate upgrade works around Whangaroa Community Hall to address issues raised in the engineering assessment. The site location is shown in the figure below.

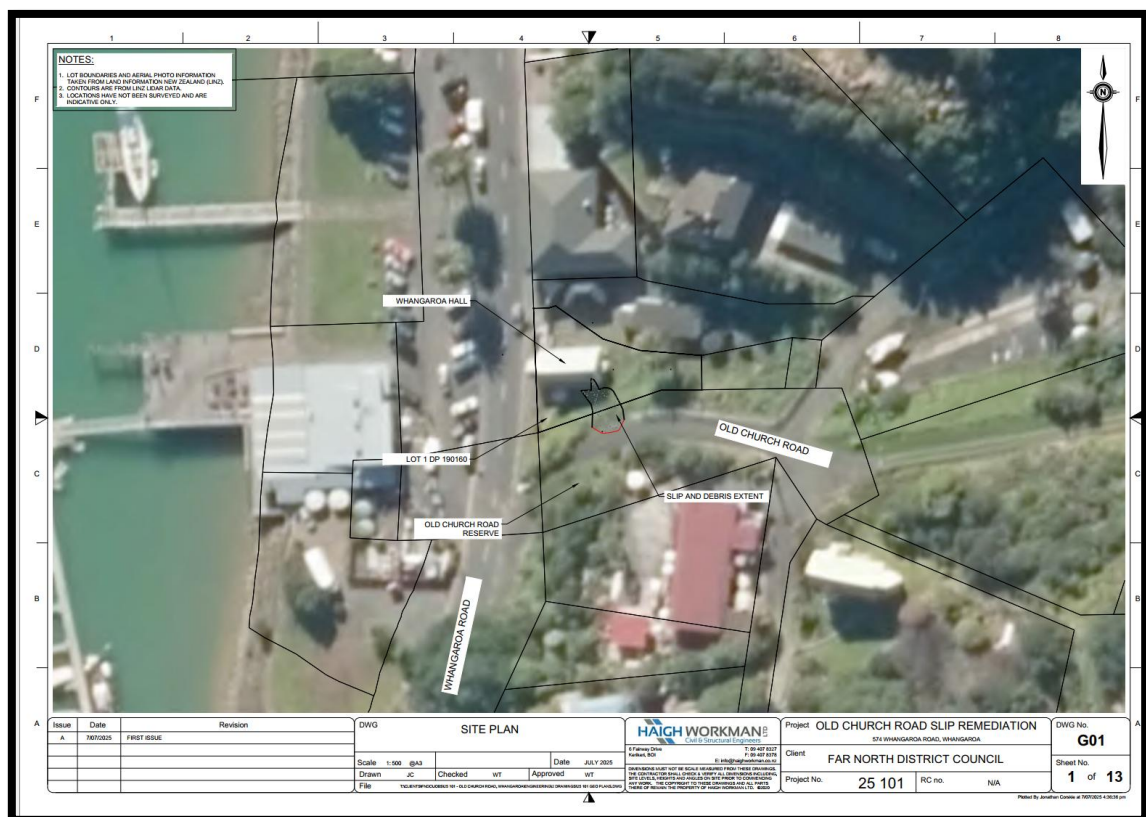
Figure 1 – Site and slip location plan

- 1.1. Far North District Council is seeking to vary an existing land use consent resource consent (RC 2250199-RMALUC) that authorises repairs and stabilisation work at the Whangaroa Community Hall site that has resulted from slipping on the adjacent Old Church Road. The site location is 574 Whangaroa Road, Whangaroa and is legally described as Lot 1 DP 190160.
- 1.2. The previously consented slip repair works have been redesigned to remedy more recent slipping that occurred during Cyclone Tam earlier this year in April. The project scope now includes remedial works required within the adjacent Old Church Road that is within the FNDC designated road network.
- 1.3. A plan prepared by Haigh Workman Engineers showing the slip location within the application site area and the adjacent Old Church Road is shown in **Figure 1** below.

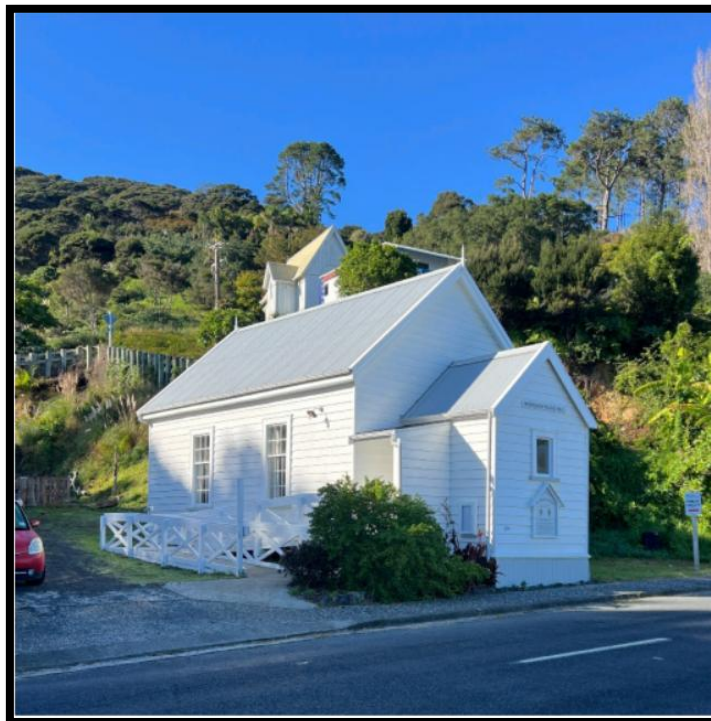
Figure 2- Whangaroa Community Hall site Lot 1 DP 190160

- 3.3. Lot 1 DP 190160 contains the historic Whangaroa Community Hall that was a former church building constructed in 1840 (refer **Photo 1** below). The timber building is an HPT Category II registered building. The site is a mapped scheduled heritage site in the ODP and PDP. The church building is located on the lower western part of the site. The site slopes upward towards the southern boundary with Old Church Road to the rear. Site vehicle access and parking is on the northern side of the building.

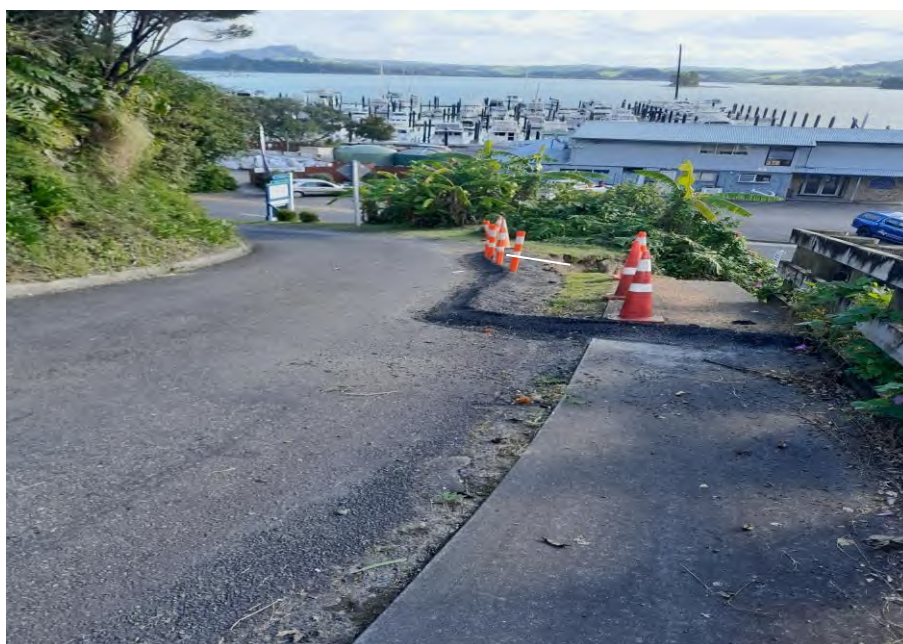
Figure 2 – Old Church Road looking west

Further upslope of the slip is a retaining wall with tie back anchors that was installed in 2013 following debris flowing through the infrastructure below in 2011. The retaining wall was constructed by Rintoul Civil and signed

off by PK Engineering. The existing retaining wall upslope consists of 300 SED poles embedded 3.0-3.2m (above rock) with RB32 anchors of unspecified length (estimated as 10m from drawings).

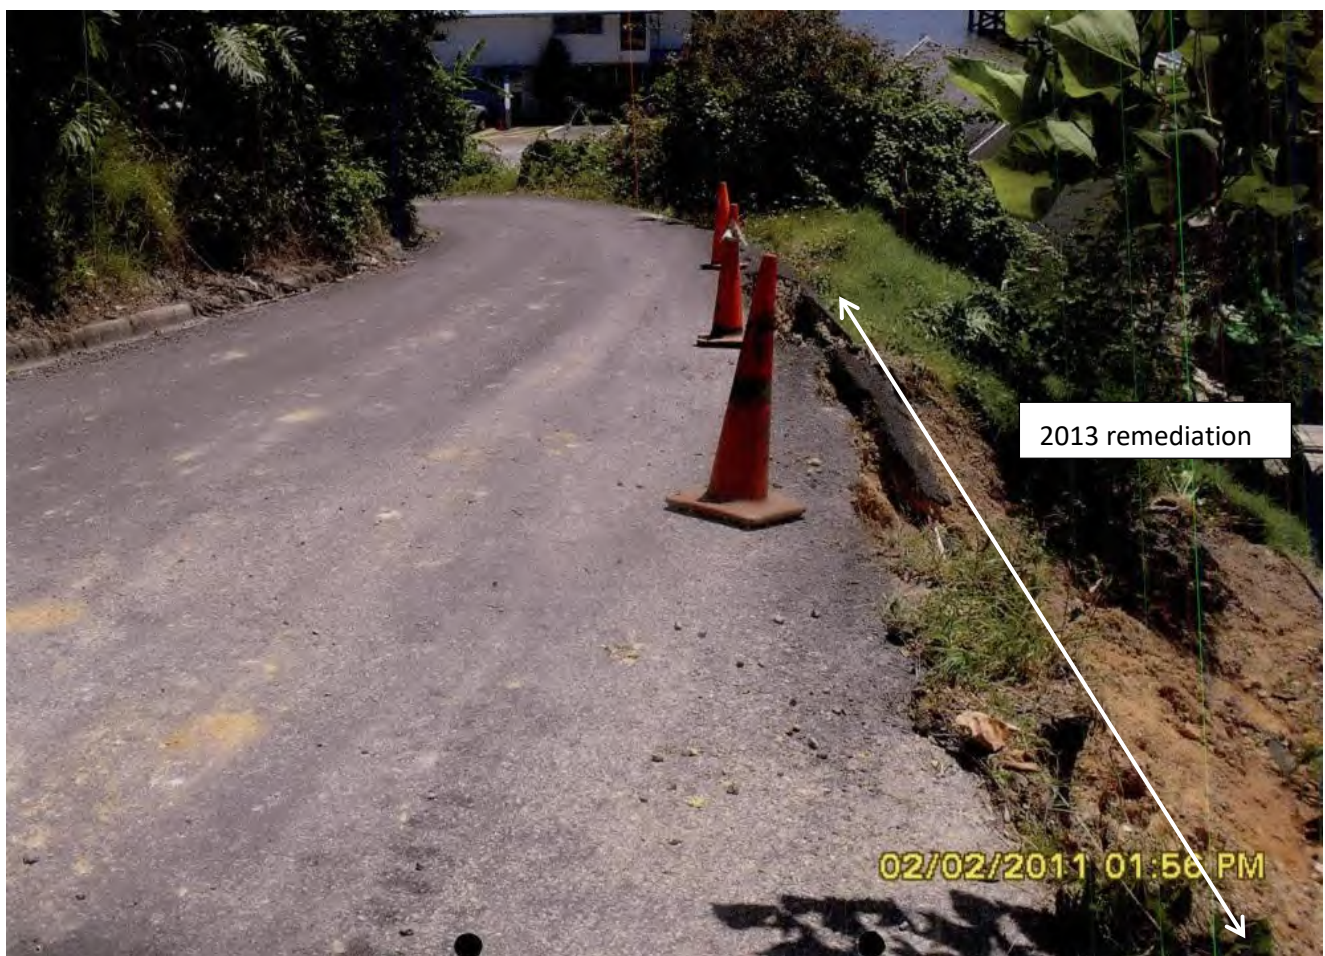
Figure 5 – Undermining/slip on old church road immediately upslope of Whangaroa Community Hall

The property file for the Whangaroa Community Hall has not been viewed but it is understood that it does not contain anything of significance due to the age of the building. From work on adjacent properties, it is understood that in 2011 a slip occurred with debris flowing through the immediate boundary of the site. A risk of damage to the church is noted from files. The culvert on Old Church Road breached and directed water over the road which caused undermining with mud and debris depositing around the Whangaroa Hall.

1. A small timber retaining wall be built around the building and the ground shaped to achieve 300mm clearance below the existing hall bearers.
2. The existing stormwater pipe condition should be assessed as it is recorded as being located beneath the Whangaroa Hall on FNDC maps.

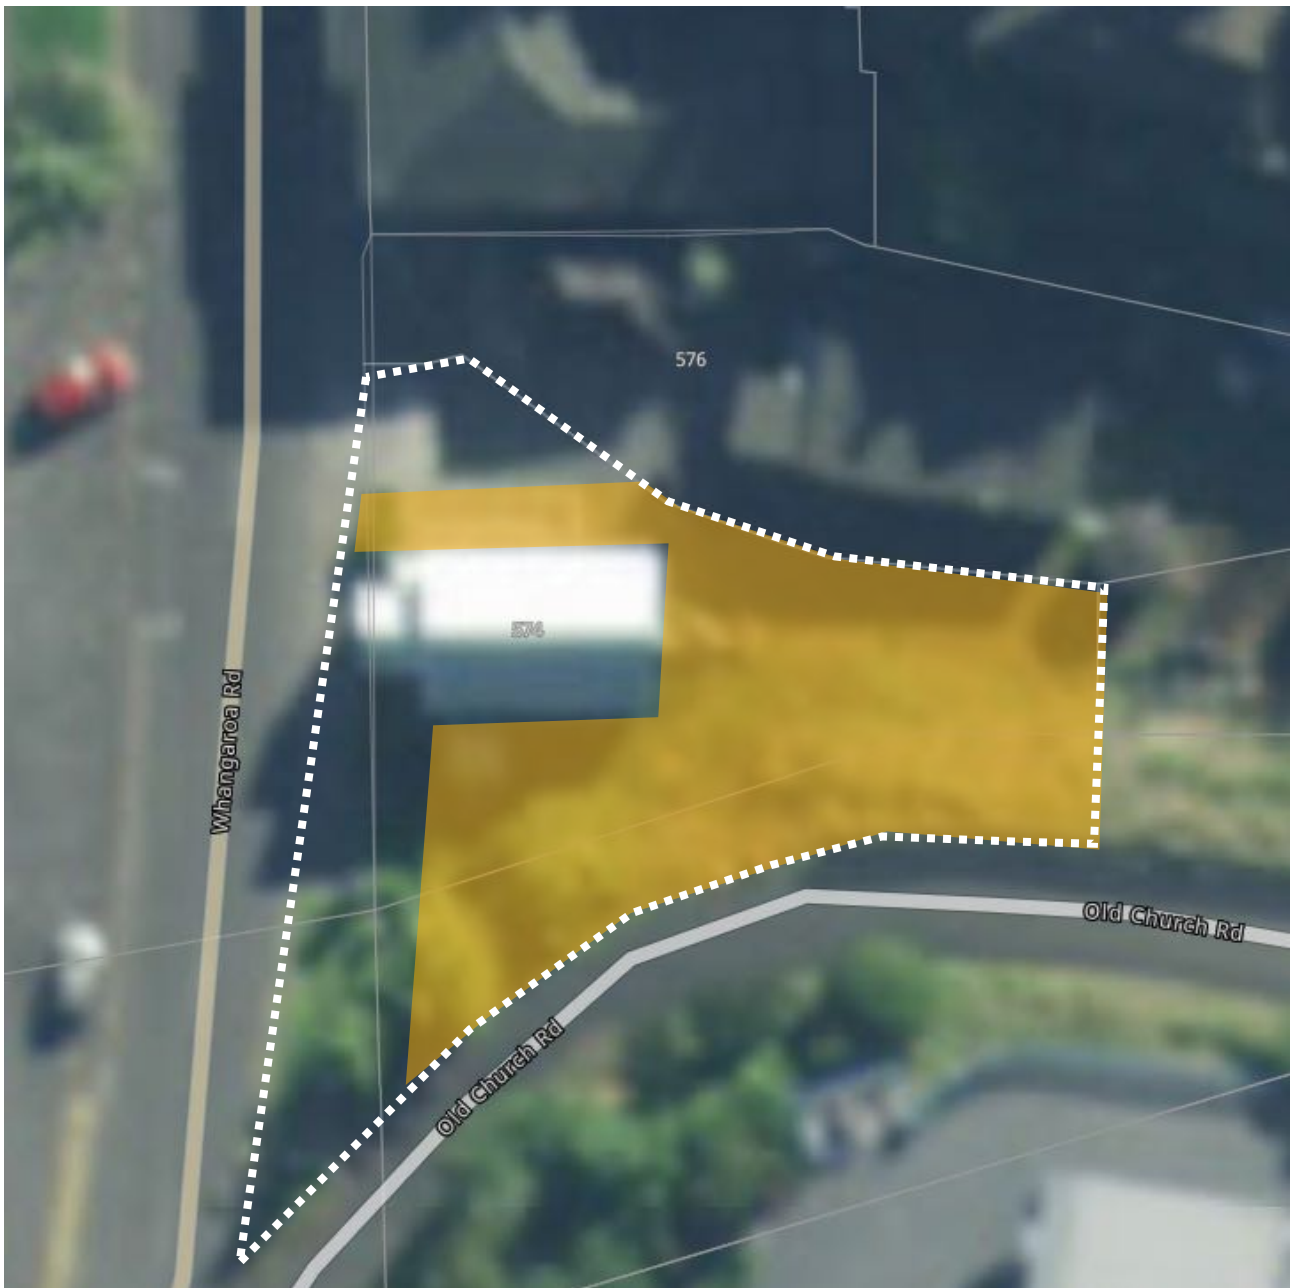
Figure 5. Aerial photography showing the project area (indicated by the white broken line) in relation to areas to be subject to archaeological monitoring

1. All preliminary excavations necessary for the project in the area depicted in Figure 5 will be overseen by a qualified archaeologist to assess the presence of pre-1900 archaeological remains.

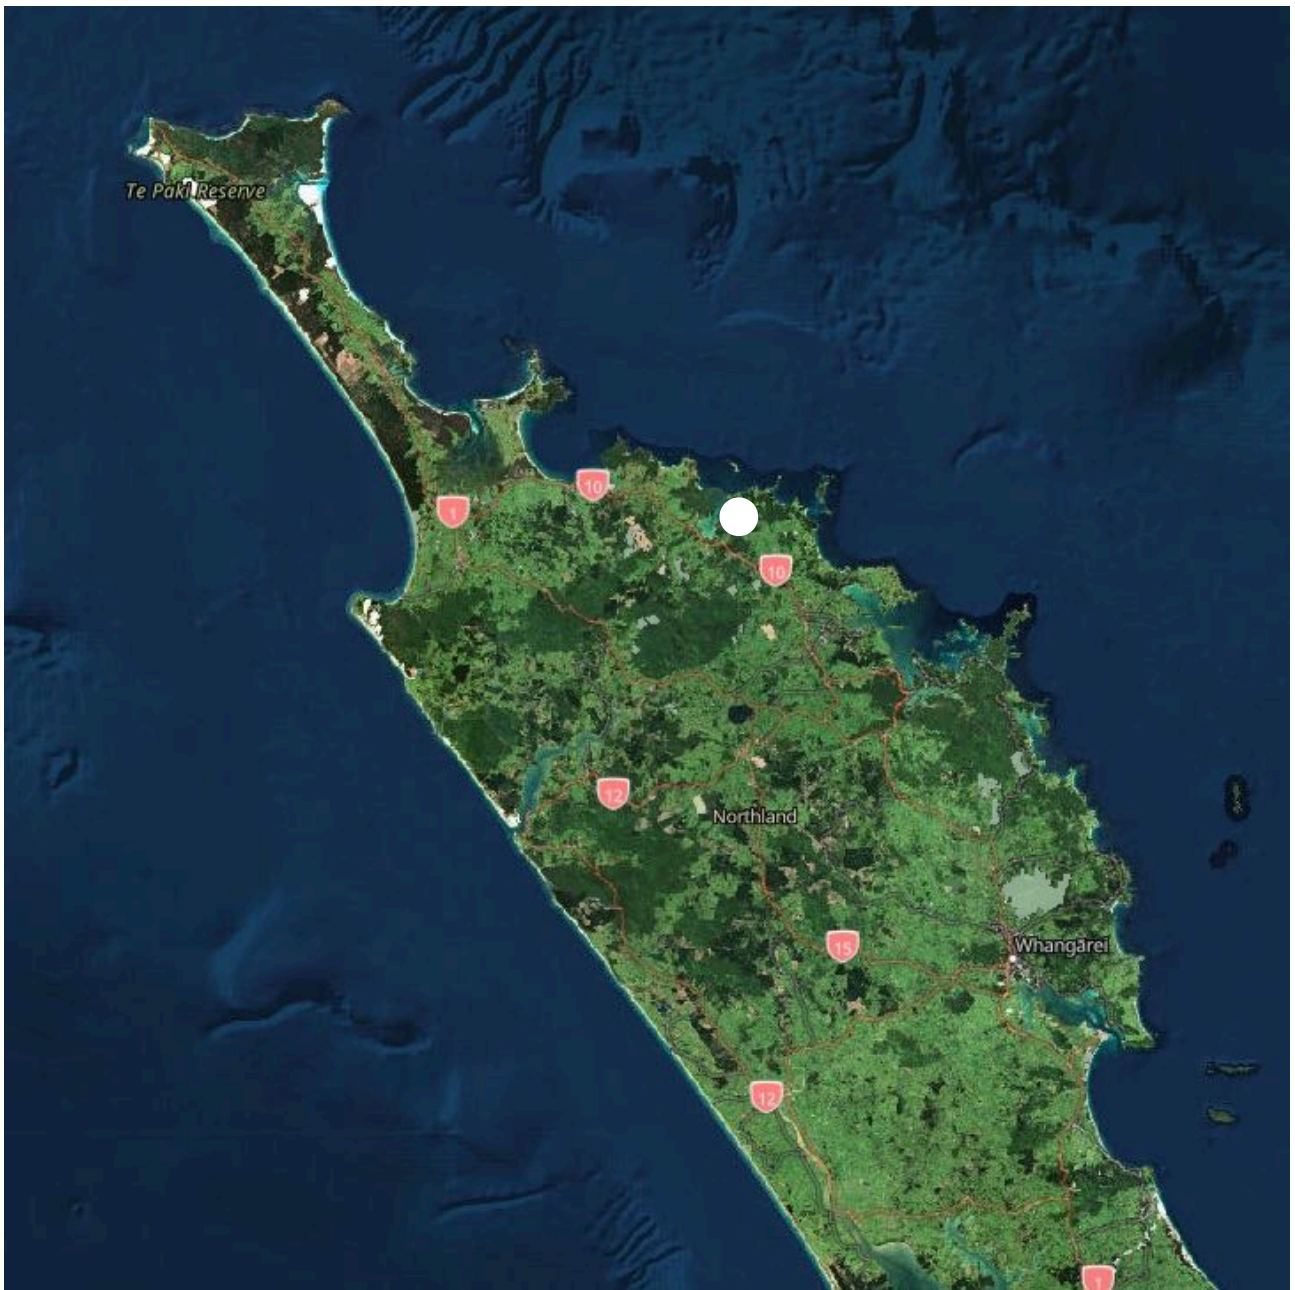
Figure 1. General Location of slip remediation works and associated excavations (indicated by white dot).

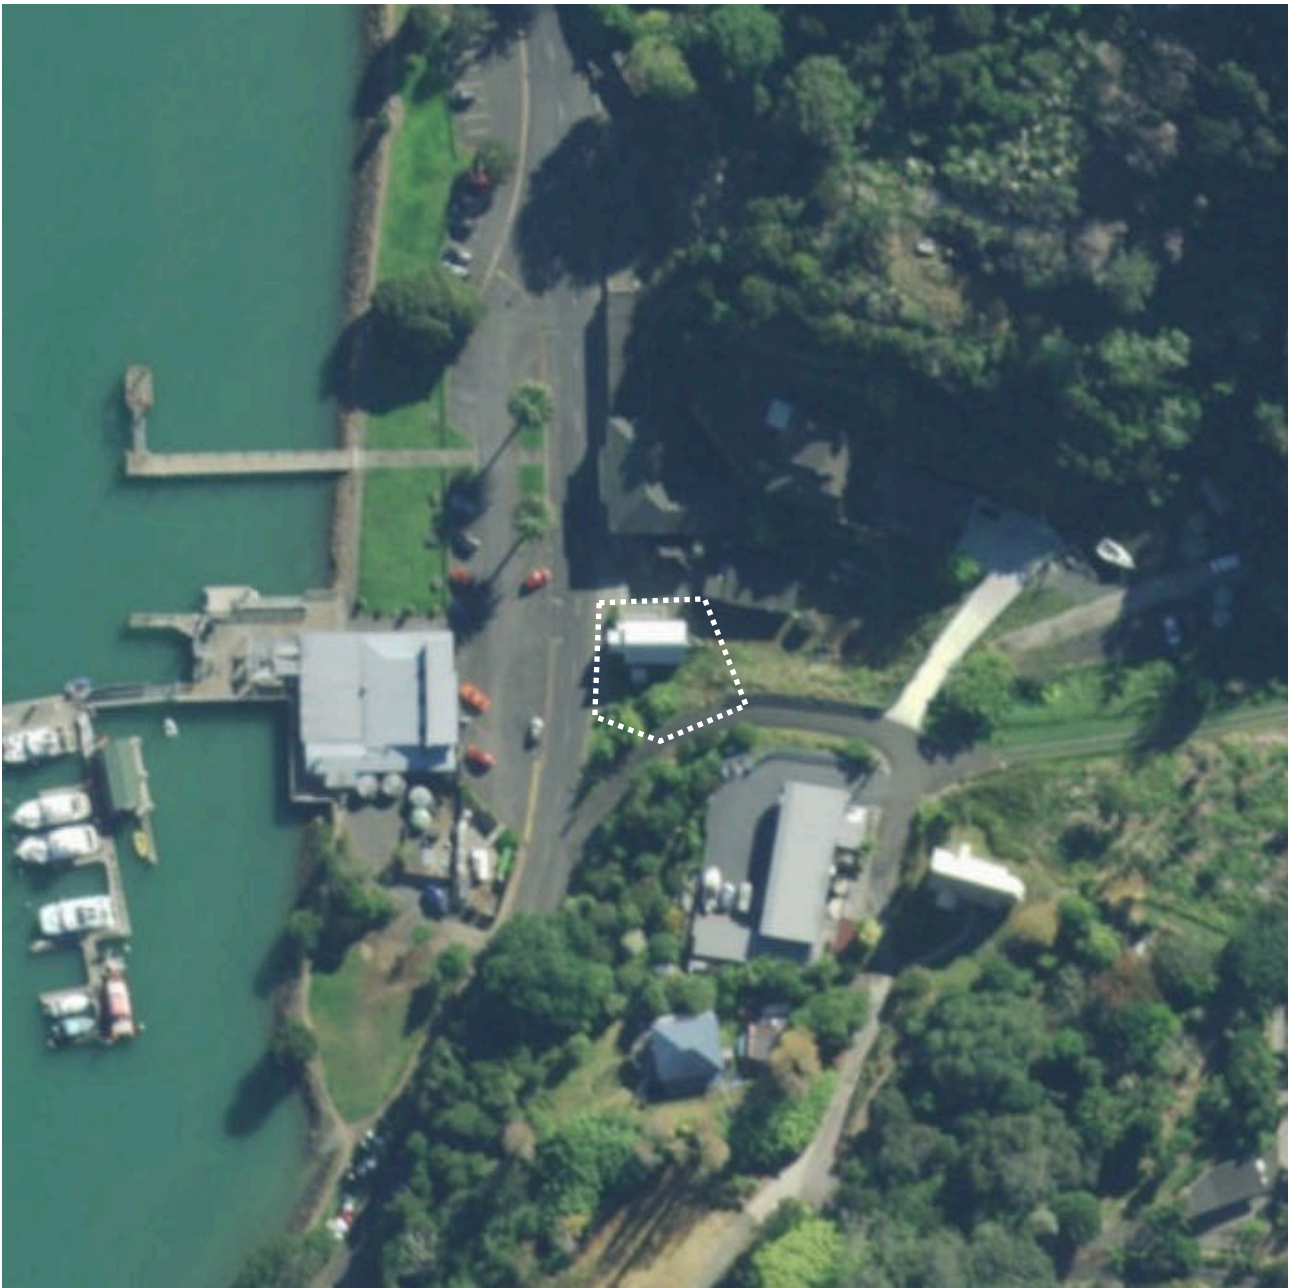
Figure 2. Detailed location of slip remediation works and associated excavations (indicated by the white broken line).

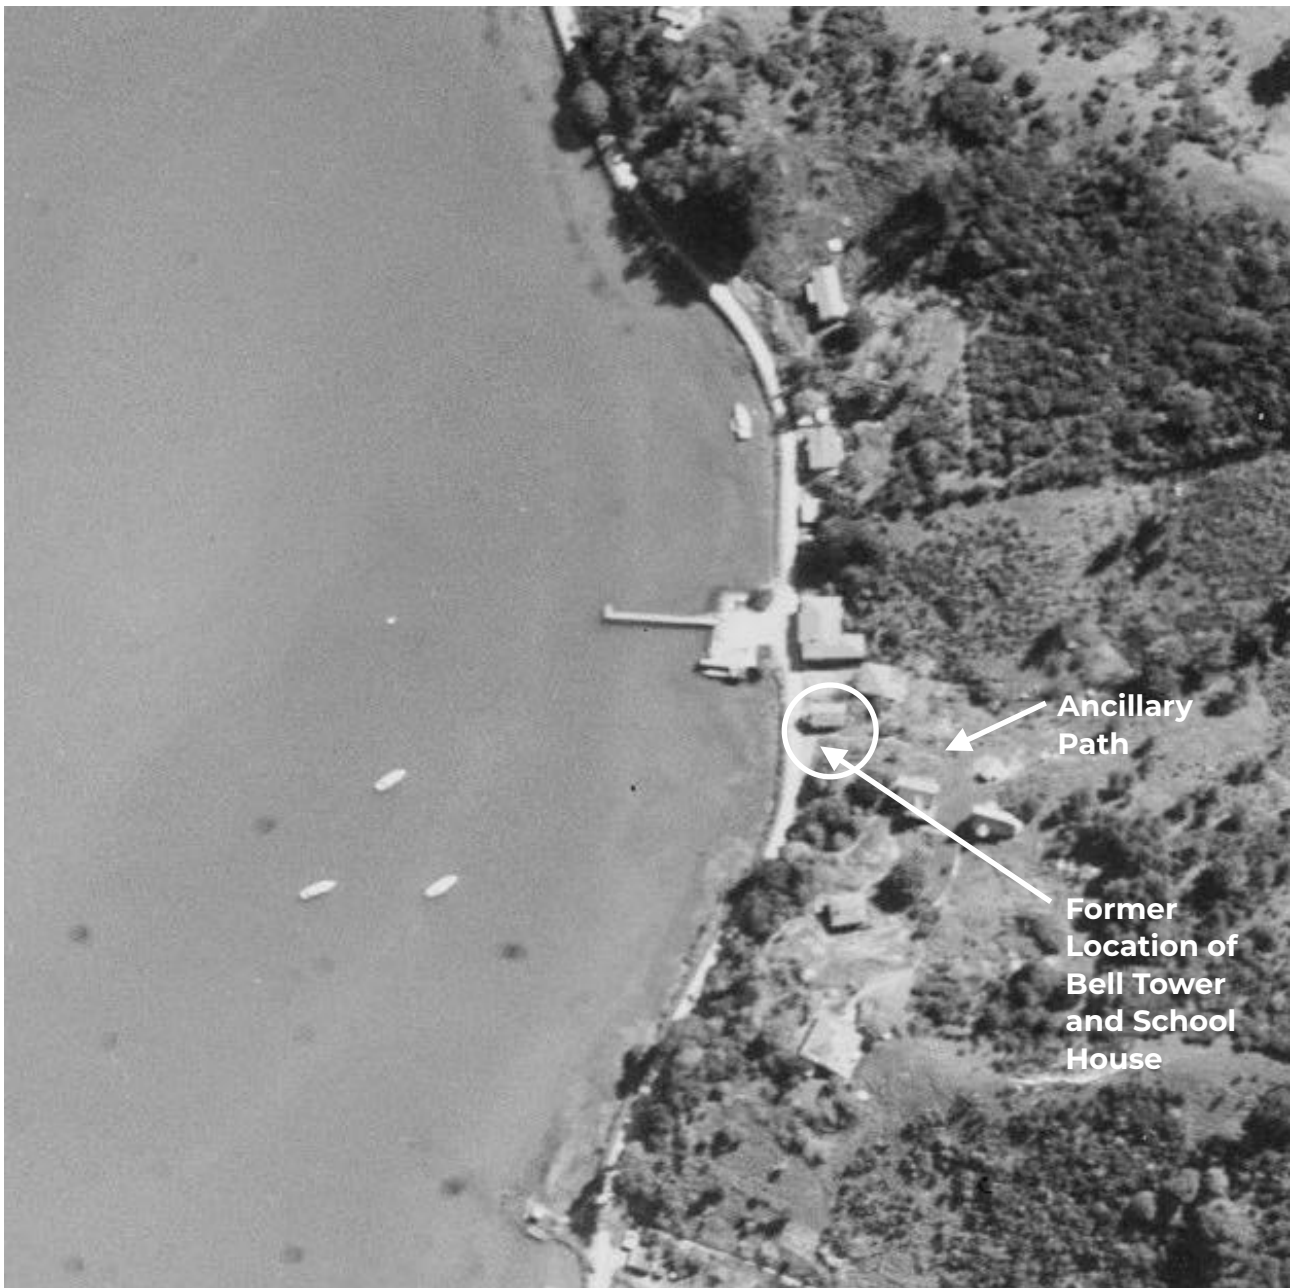
Figure 9. Detail of 1950 aerial photography showing the project area (indicated by the white circle).

An examination of aerial photography held within the RetroLens database shows considerable changes within the area around 574 Whangaroa Road. The earliest available aerial photography shows that in 1950 the present corridor of Old Church Road has not yet been formed, and primary access to St Paul's Church being located further to the south along Whangaroa Road (Figure 9). A small, barely visible, ancillary path does seem to extend from the location of St Paul's Chapel – which at this time would likely have been the Whangaroa Country Office – to St Paul's Church. Likewise, a number of buildings shown in early photographs of Whangaroa Village including the chapel bell tower and school house have been removed (see: Figure 6 and Figure 7).

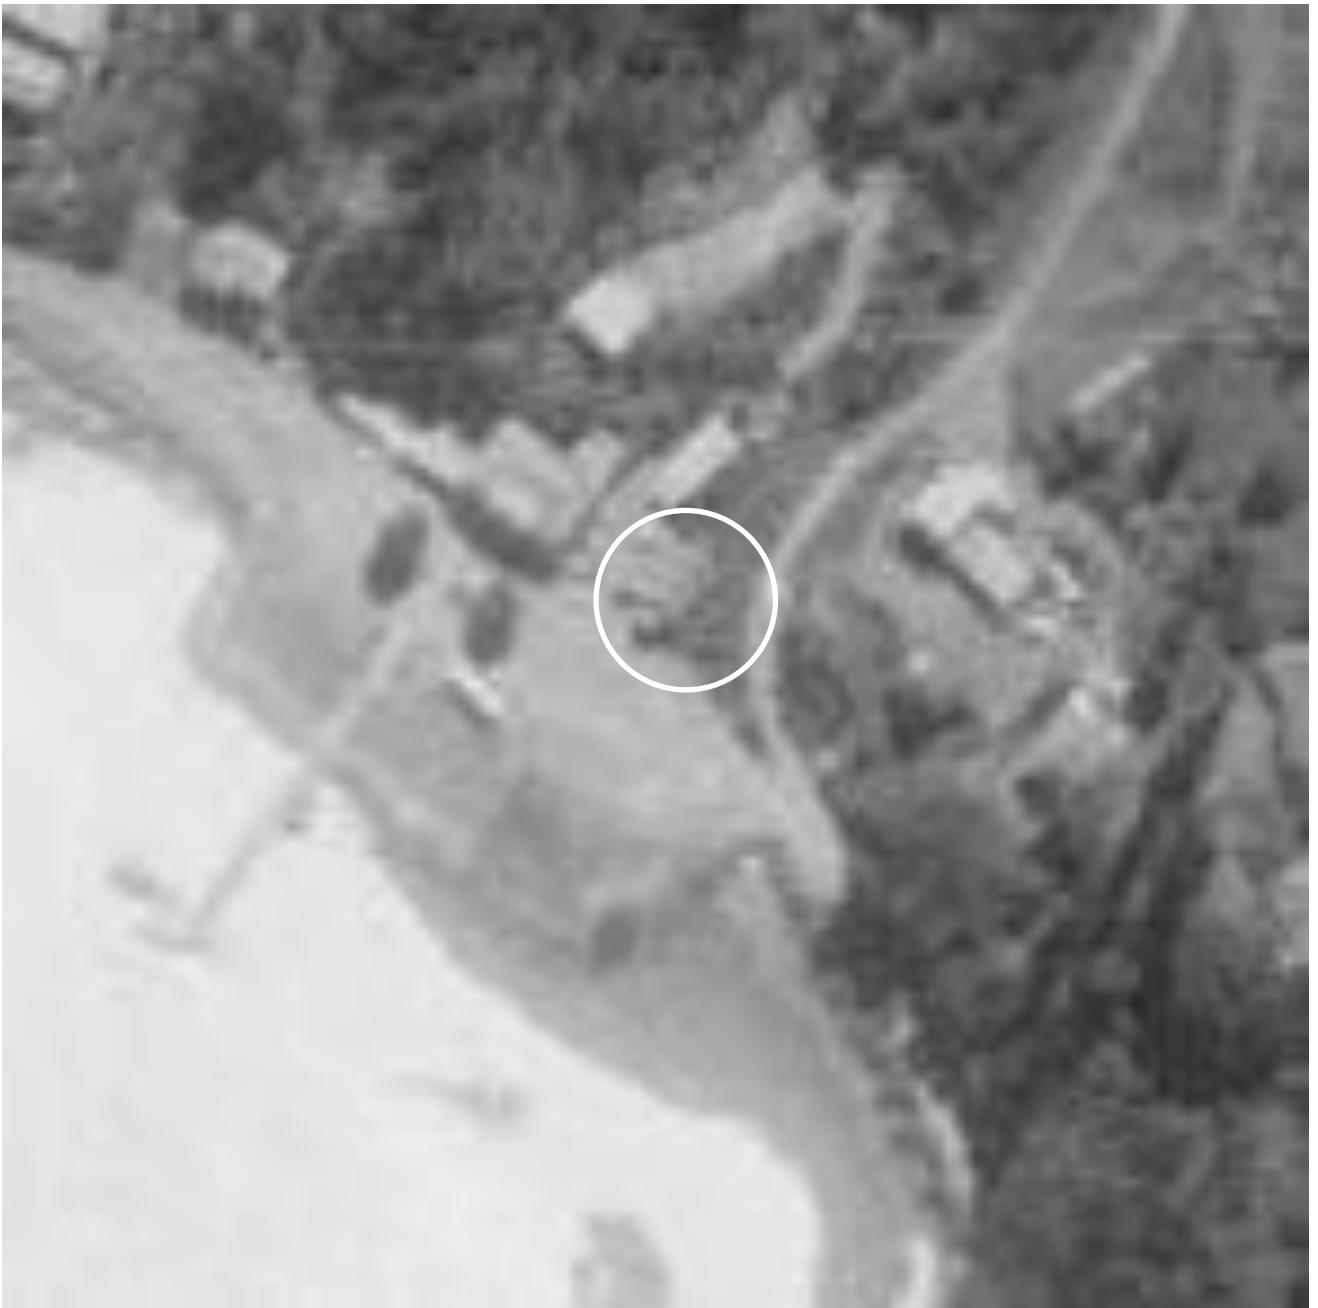
Figure 10. Detail of 1977 aerial photography showing the project area (indicated by the white circle).

By 1977, the corridor of Old Church Road has now been formed and additional structures now occupy the surrounding slopes, while land reclamation efforts have been undertaken along the foreshore (Figure 10). By 1981, the Whangaroa Village area appears largely as it does today, with a number of residential, commercial and recreational developments clearly visible (Figure 11).

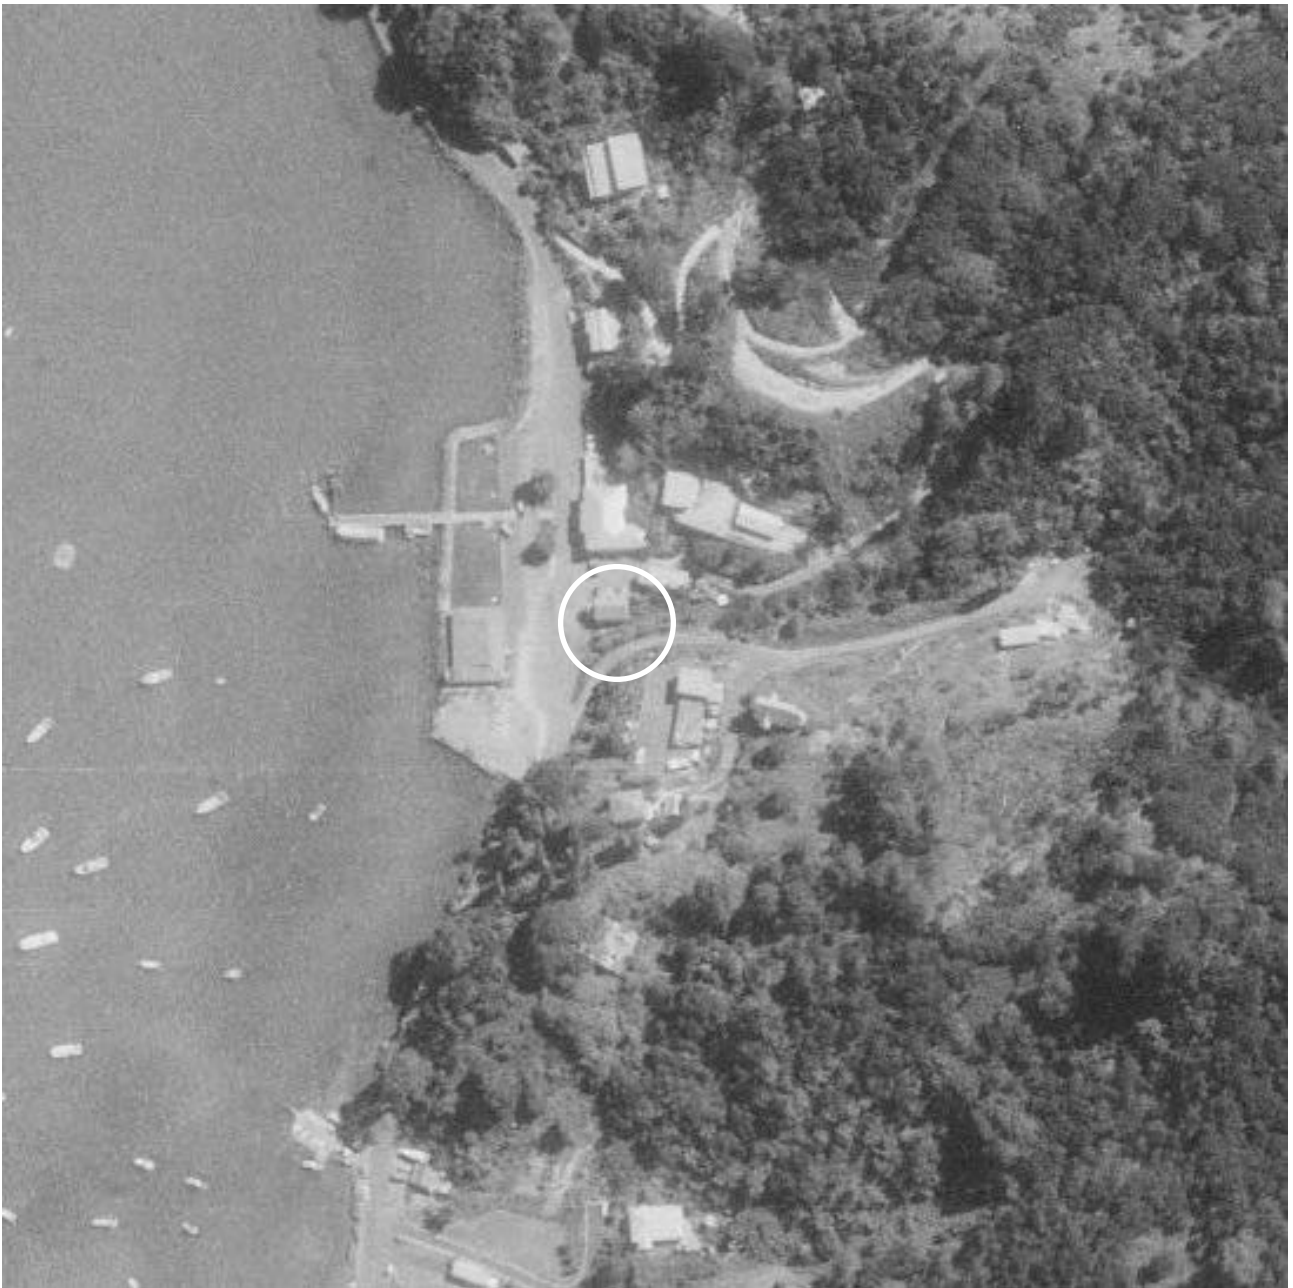
Figure 11. Detail of 1981 aerial photography showing the project area (indicated by the white circle).

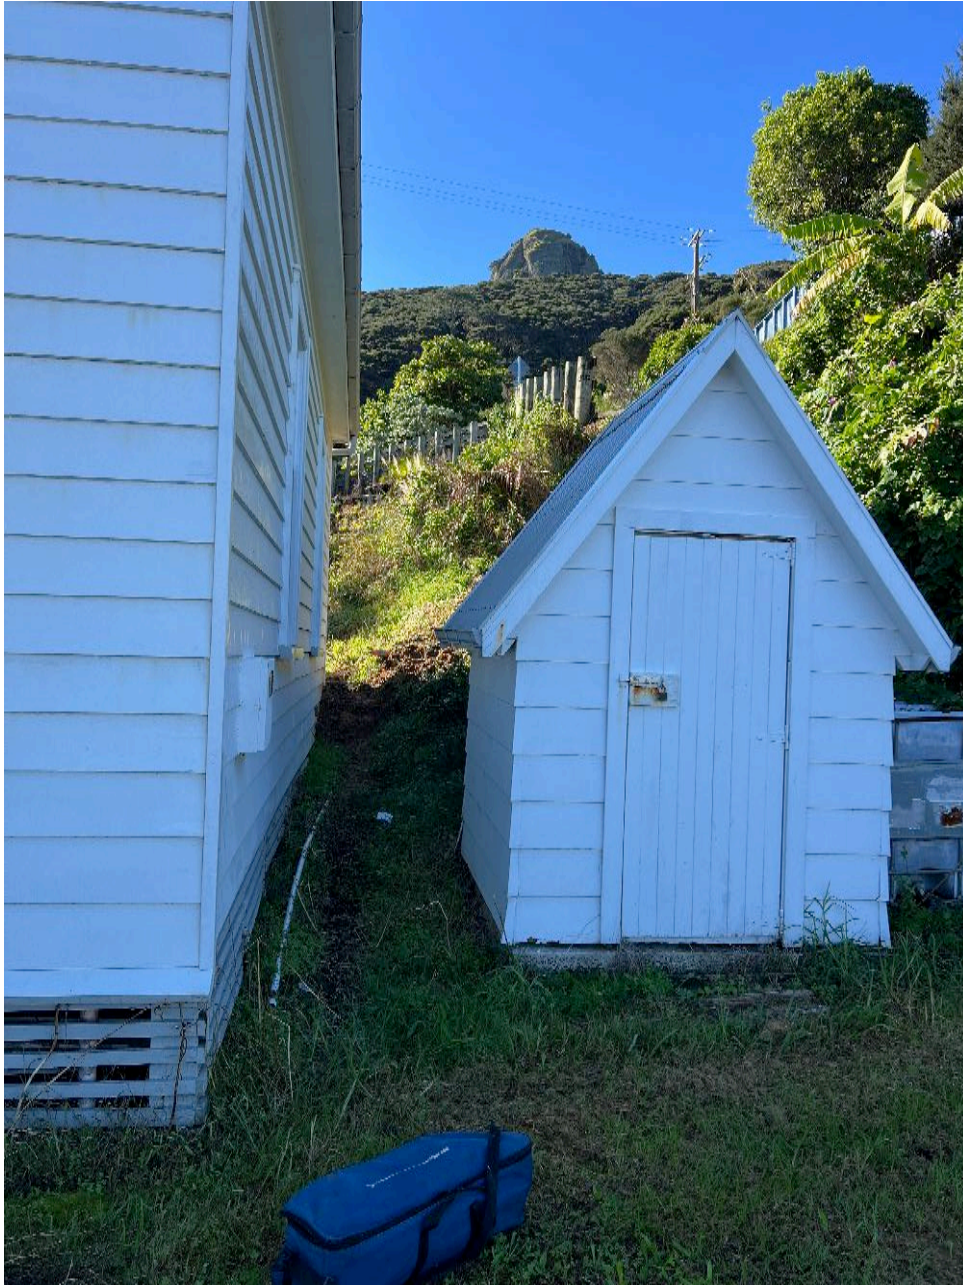
Figure 15. View east along the southern extent of 547 Whangaroa Road. Note slip material in centre of image.

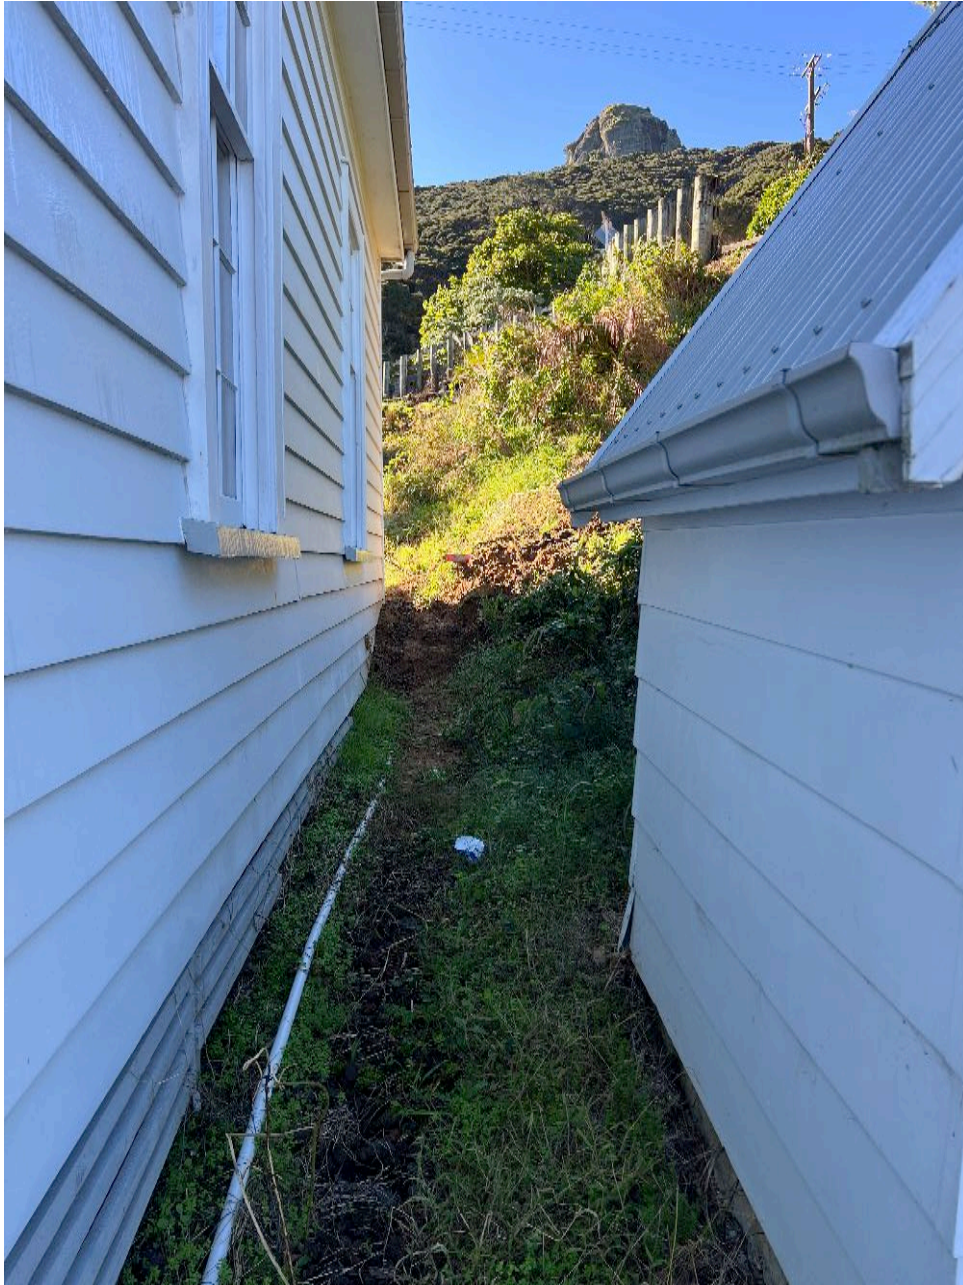
Figure 16. View east between the Whangaroa Community Hall and the modern ancillary structure. Note slip material in centre of image.

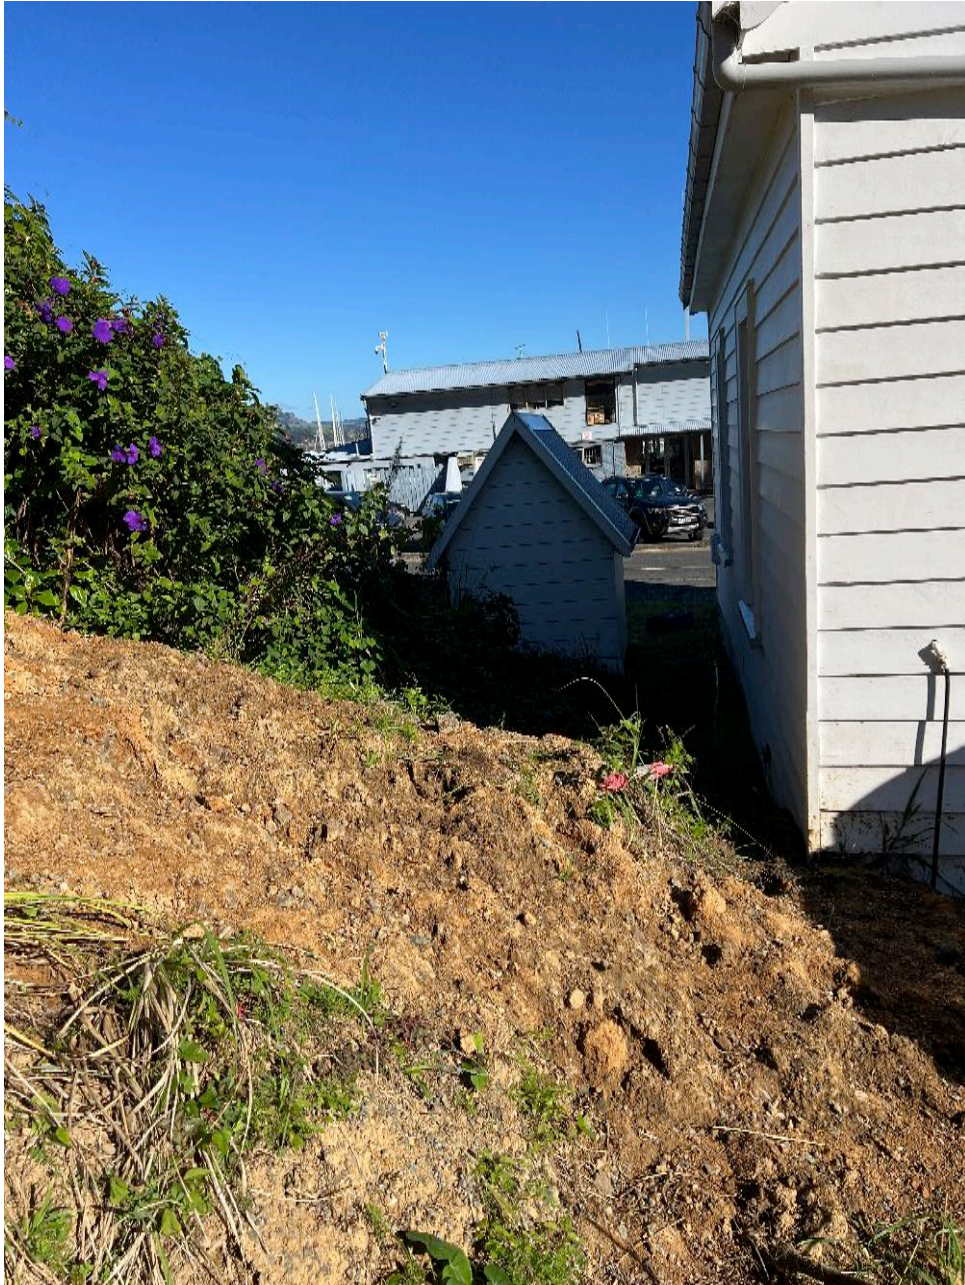
Figure 17. View west from the rear of the Whangaroa Community Hall. Note slip material in image foreground.

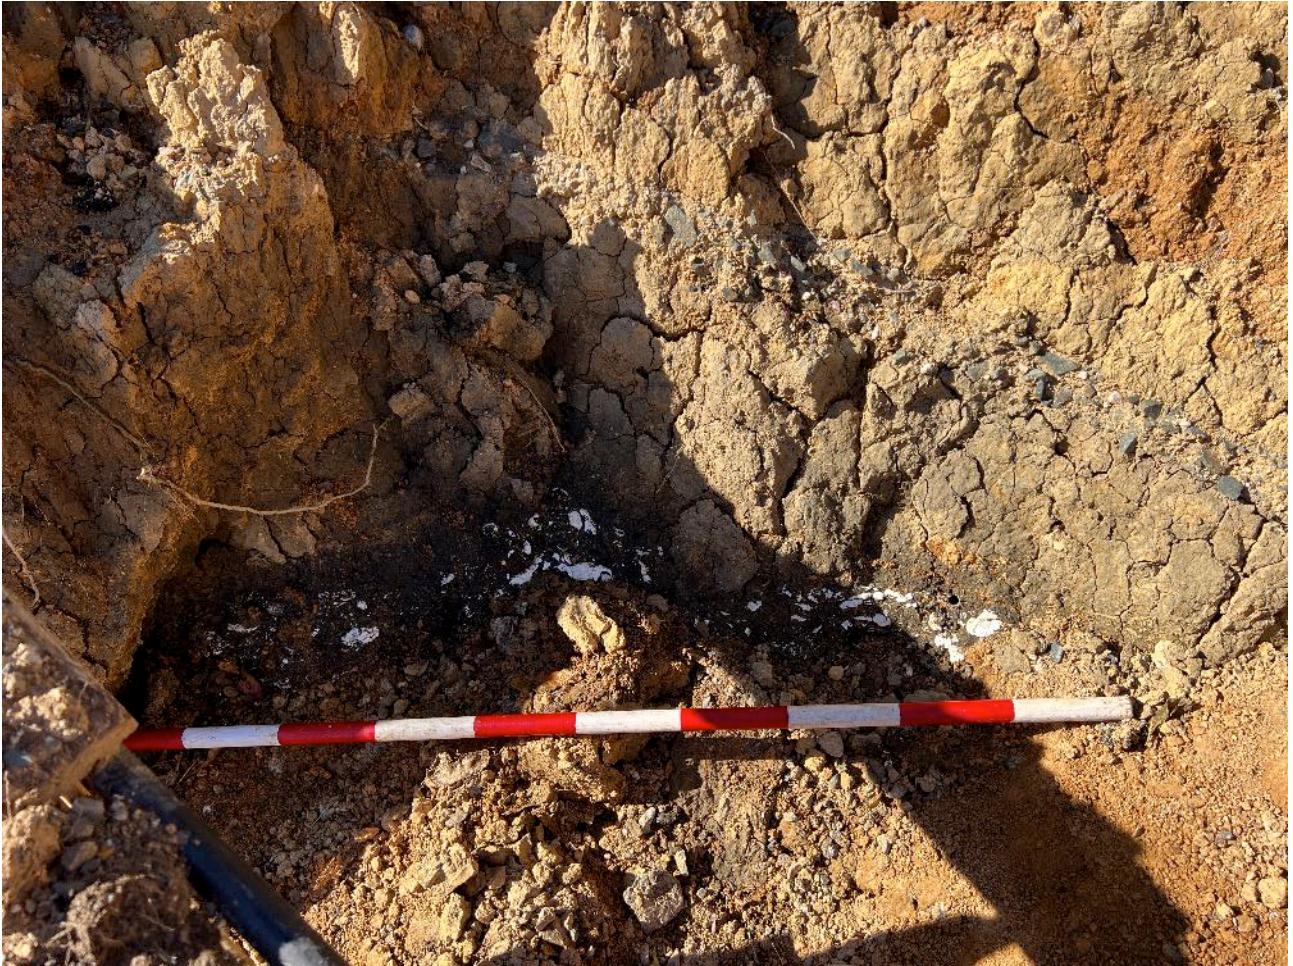
Figure 21. Exposed midden deposit.

The confirmed archaeological site is a layer of marine shell midden – approximately 10cm thick and 80cm in length, comprised largely of tuatua, with isolated instances of oyster (Figure 21). The shell is within a matrix of dark brown silt and no other inclusions (eg. charcoal or heat modified rock) were noted. The deposit was visible within the exposed slip scarp, and located approximately 1m below the existing road surface of Old Church Road. Subsurface probing was unable to establish the extent of this deposit and it is likely to extend beneath the footprint of Old Church Road.

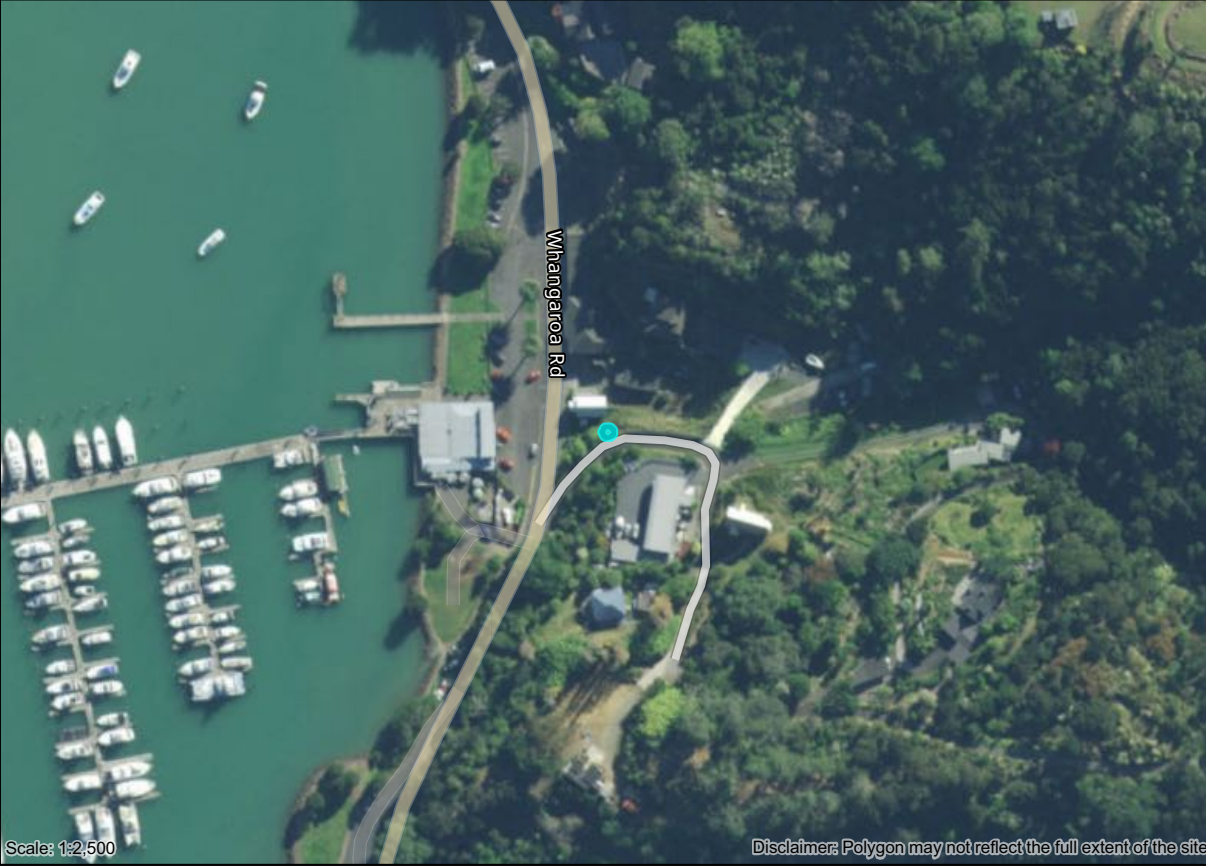
Scale: 1:2,500		
Disclaimer: Polygon may not reflect the full extent of the site		
Finding Aids to the Location of the Site: Exposed by slip and located 1m below existing surface of Old Church Road.		
Brief Description: Shell midden exposed by slip		
Condition of Site when last visited: Fair

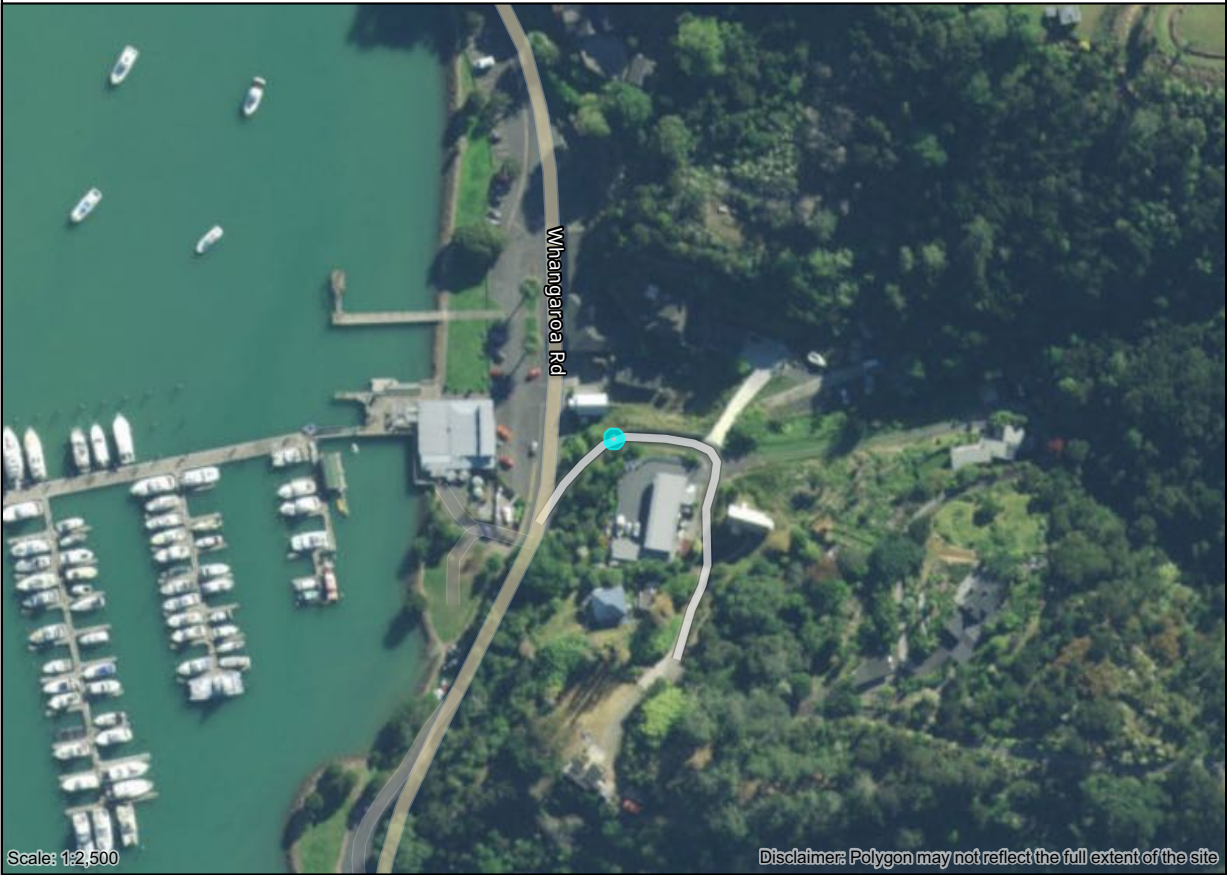
Finding Aids to the Location of the Site:
Located 1m below existing corridor of Old Church Road

Brief Description:
Gravel layer - historic road surface

Visible in exposed slip scarp. Layer of gravel approximately 5cm in thickness. I was not able to conclusively establish if this is pre-1900 in origin. The layer may be an early/mid 20th century road surface. Historical records show there was a path to St Paul's Church in this location, and the layer may be associated with the path. The site will soon be covered when the existing slip is remediated.
