HIGH LEVEL CIVIL ENGINEERING ASSESSMENT

Stage 1 – Lot 1 DP53506, Goffe Drive, Haruru

Prepared for Andre Galvin

25/10/2024

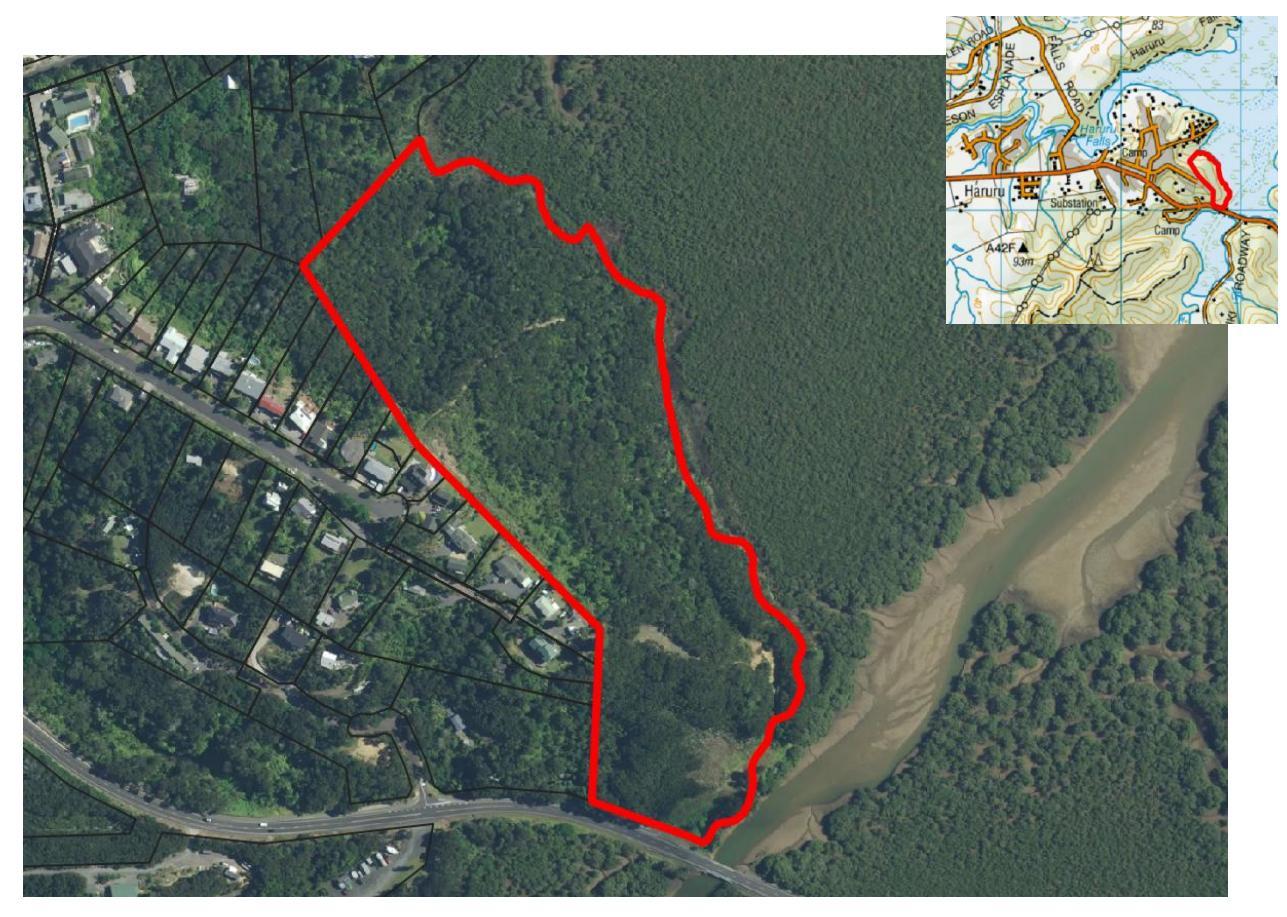
Figure 1. Property location *The property is highlighted red, north to top of page, boundary approximate only, image from LINZ.*

The subject property is the Lot 1 DP53506 and is 69,960 m² in area. The property is bounded by residential lots to the west and north, estuary to the east, and Puketona Road/State Highway 11 (SH11) to the south. The location of the site is presented in Figure 1.

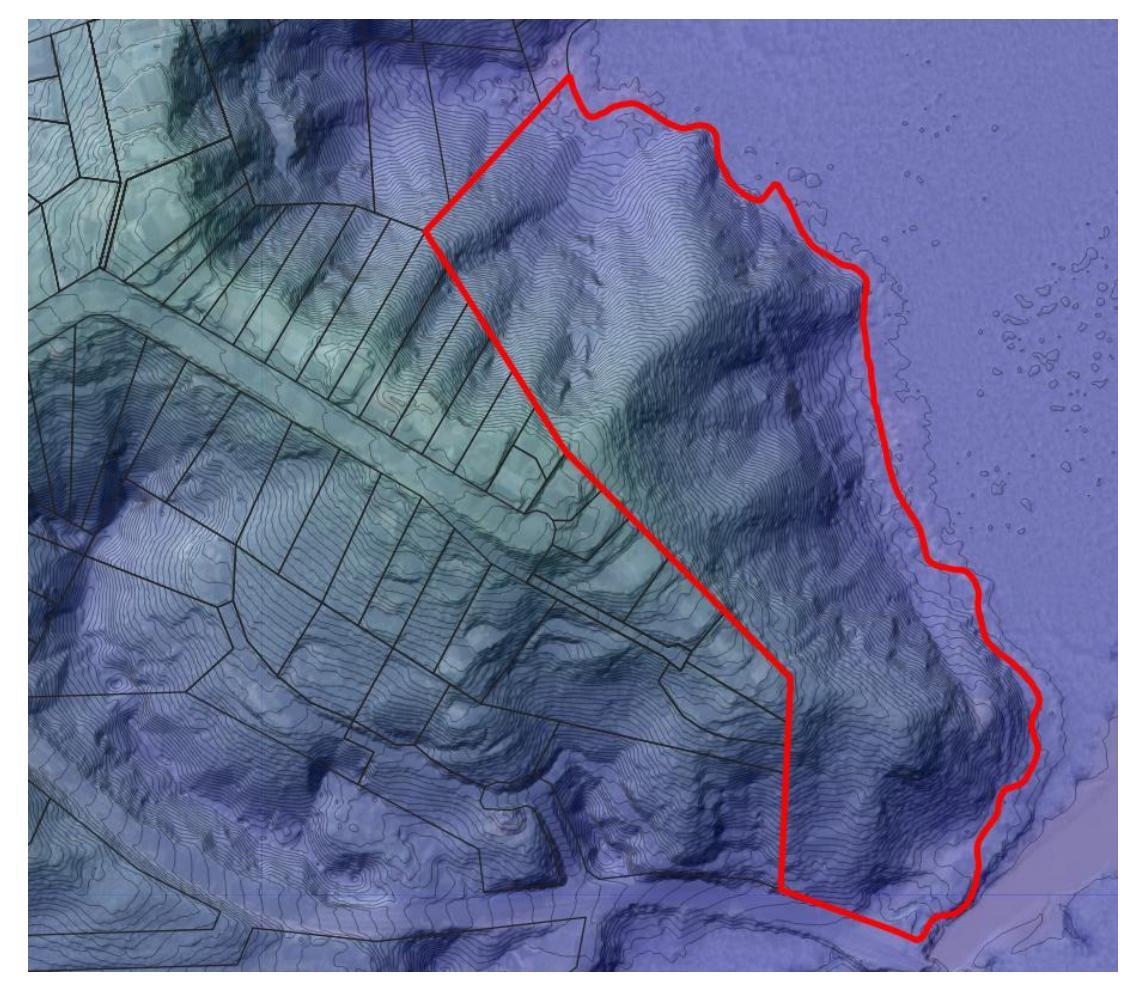
The geomorphology of the area is shown in Figure 2 below using a digital elevation model derived from the 2018 Northland Regional Council (NRC) Light Detection and Ranging (LiDAR) dataset and 1m contours.

Figure 2. Site Geomorphology Site boundaries indicative only, contours are shown at 1m intervals with blue shading lower elevations and green shading higher elevations, north is up the page. DEM courtesy of NRC

The property is located within an area that has experienced historic land movement. The dwellings located on the northern side of Goffe Drive appear to have been constructed along a ridgeline. It is considered that earthworks have been carried out to form relatively flat building areas with fill material pushed out to the north. Numerous historic landslips can be seen extending down from the relatively level building areas on Goffe Drive, extending down to the base of the hillside. Historic landslip features can also be observed on the southern side of Goffe Drive that also extend to the base of the hillside. A number of more stable spur ridges extend from the ridgeline between the landslips.

The geomorphology observed in the historic aerial images from 1951 and 1971 is considered to be relatively consistent with the geomorphology presented in Figure 2, with numerous historic landslips seen extending down from the ridgeline (currently Goffe Drive), extending down to the base of the

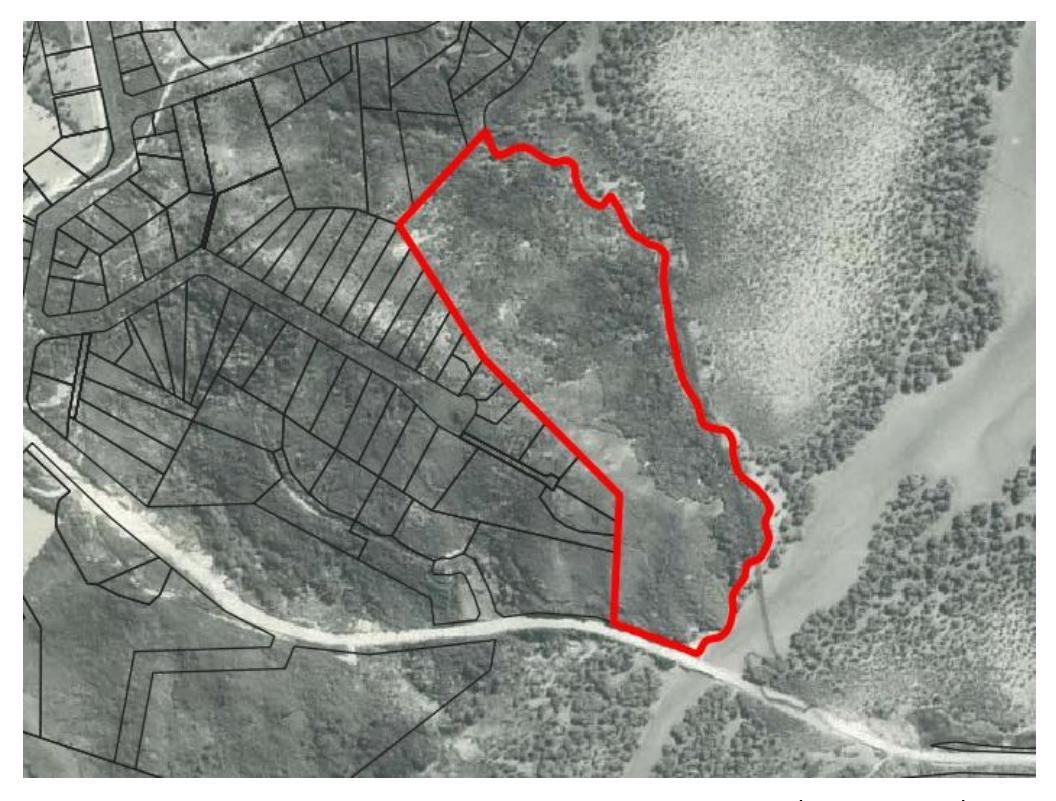
The historic aerial image from 1951 is presented in Figure 3. In the image, the area surrounding the site is mainly undeveloped, with Puketona Road/SH11 present.

Figure 3. Retrolens 1951 Aerial Image North at top of page, historic aerial image from Retrolens, approximate property boundary shown in red.

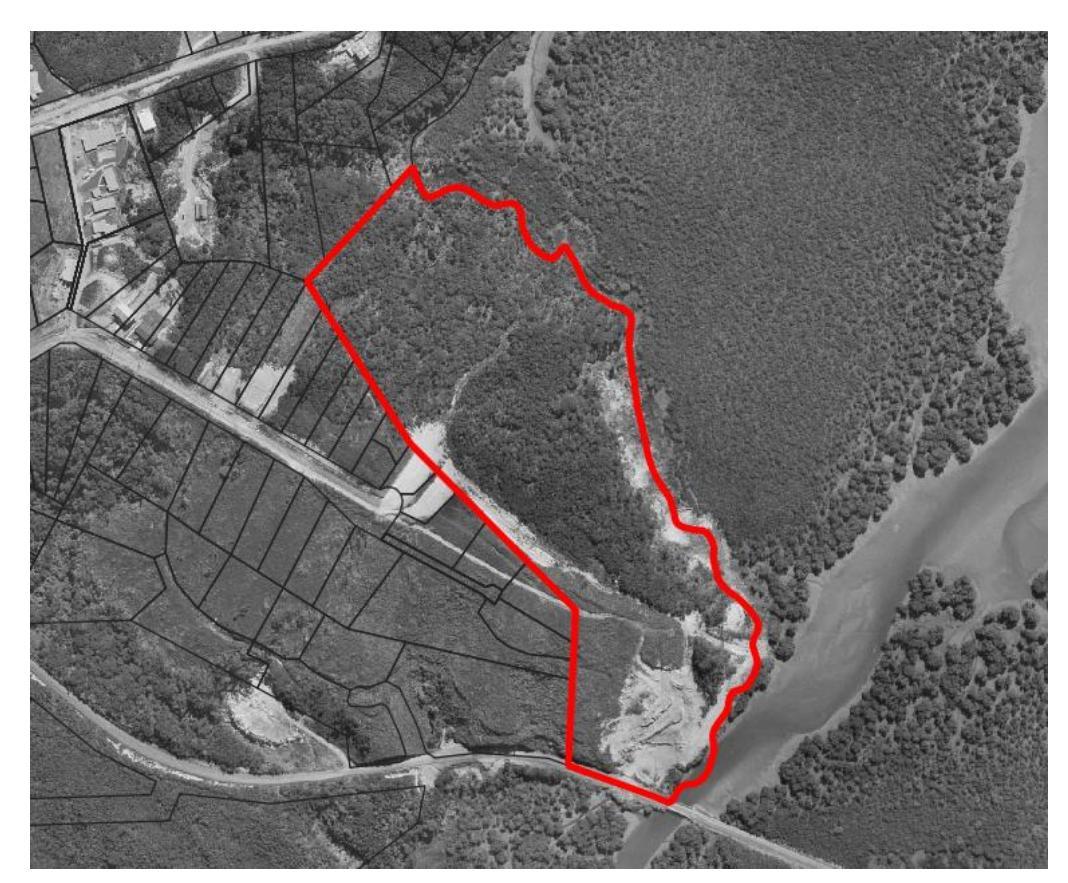
A historic aerial image from 1971 is presented in Figure 4. In the image, Goffe Drive has been formed with some houses present and earthworks taking place. On the subject site, what appears to be a quarry is present in the southern portion of the property along with earthworks near the western property boundary and part of the eastern property boundary. Fill is also inferred to be present near part of the eastern property diacent to the estuary.

Figure 4. Retrolens 1971 Aerial Image North at top of page, historic aerial image from Retrolens, approximate property boundary shown in red.

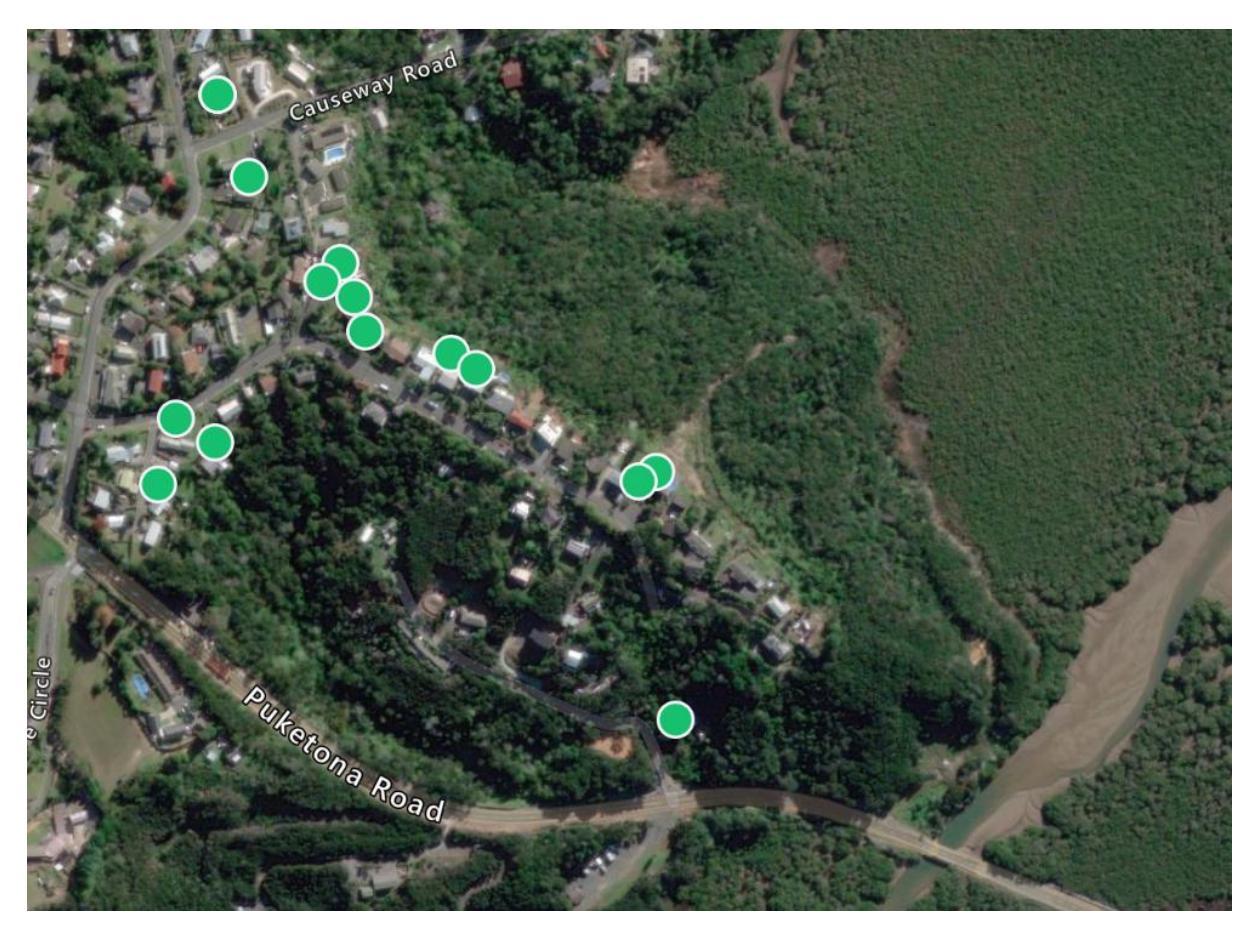
The Earthquake Commission (EQC) Natural Hazards Portal Claim Map shows that a number of properties in close proximity to the subject site have had EQC claims made due to natural hazards affecting the property. Claims have been made at 16, 18, 20, 22, 28, 30, 44 and 44a Goffe Drive and at 2 Kaipariki Rise between 2007 and 2008. From the portal, the claim event type are shown to be Storm or Flood and Landslip, with the claim type being Land or Building, Land. Based on this, it is expected that the properties have been affected by land movement. Please note that the EQC files have not been obtained as a part of this assessment. An extract from the portal map showing the location of the claims is presented in Figure 5.

Figure 5. EQC Claims North at top of page, extract from EQC Claims Portal. Green dots indicate EQC claims

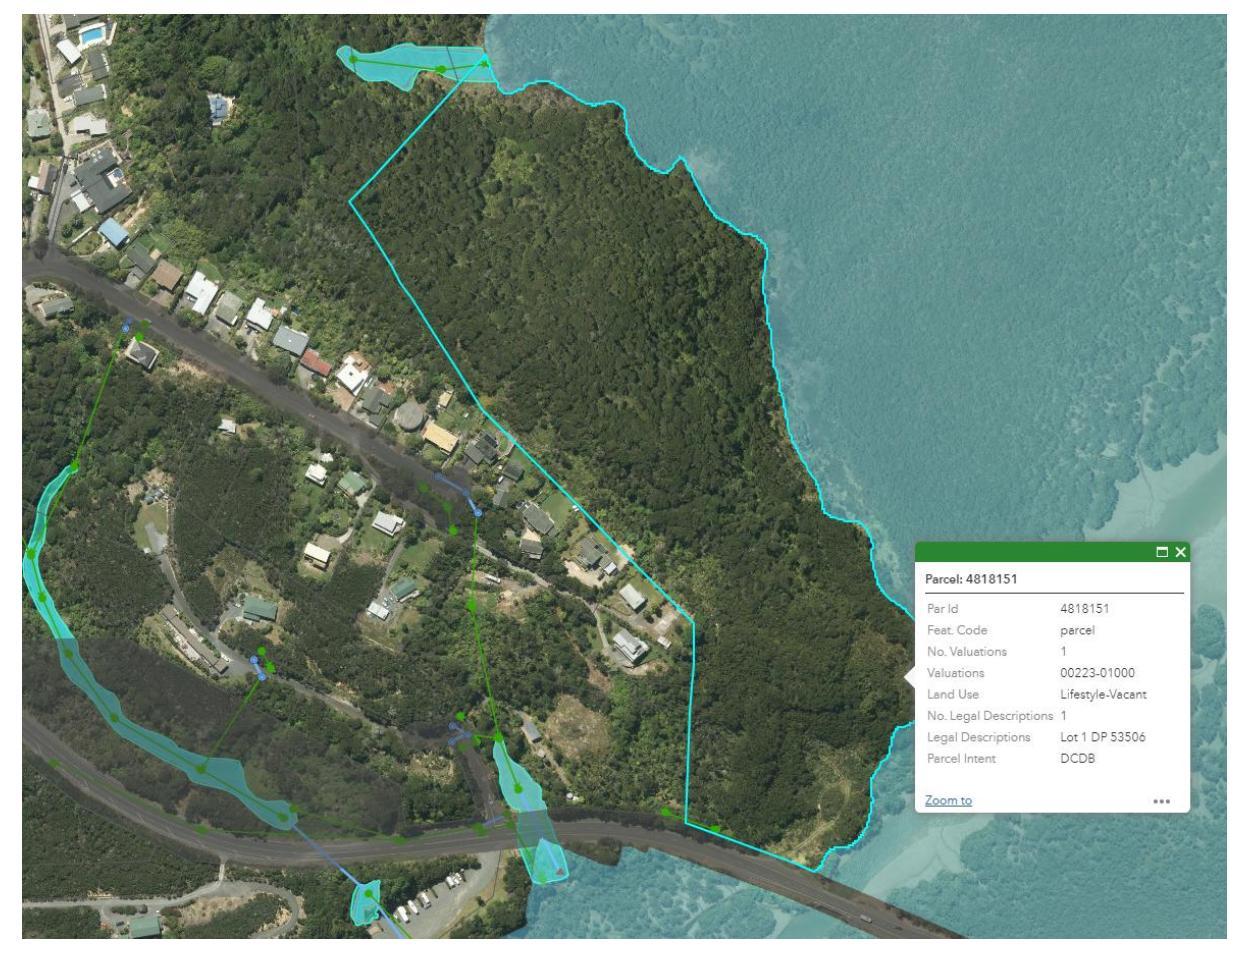
A small portion in the northern extent of the property is mapped by the FNDC as being affected by flooding. An extract from FNDC maps presenting the extent of flooding is presented in Figure 6.

Figure 6. FNDC Flood Extent North at top of page, extract from FNDC Maps

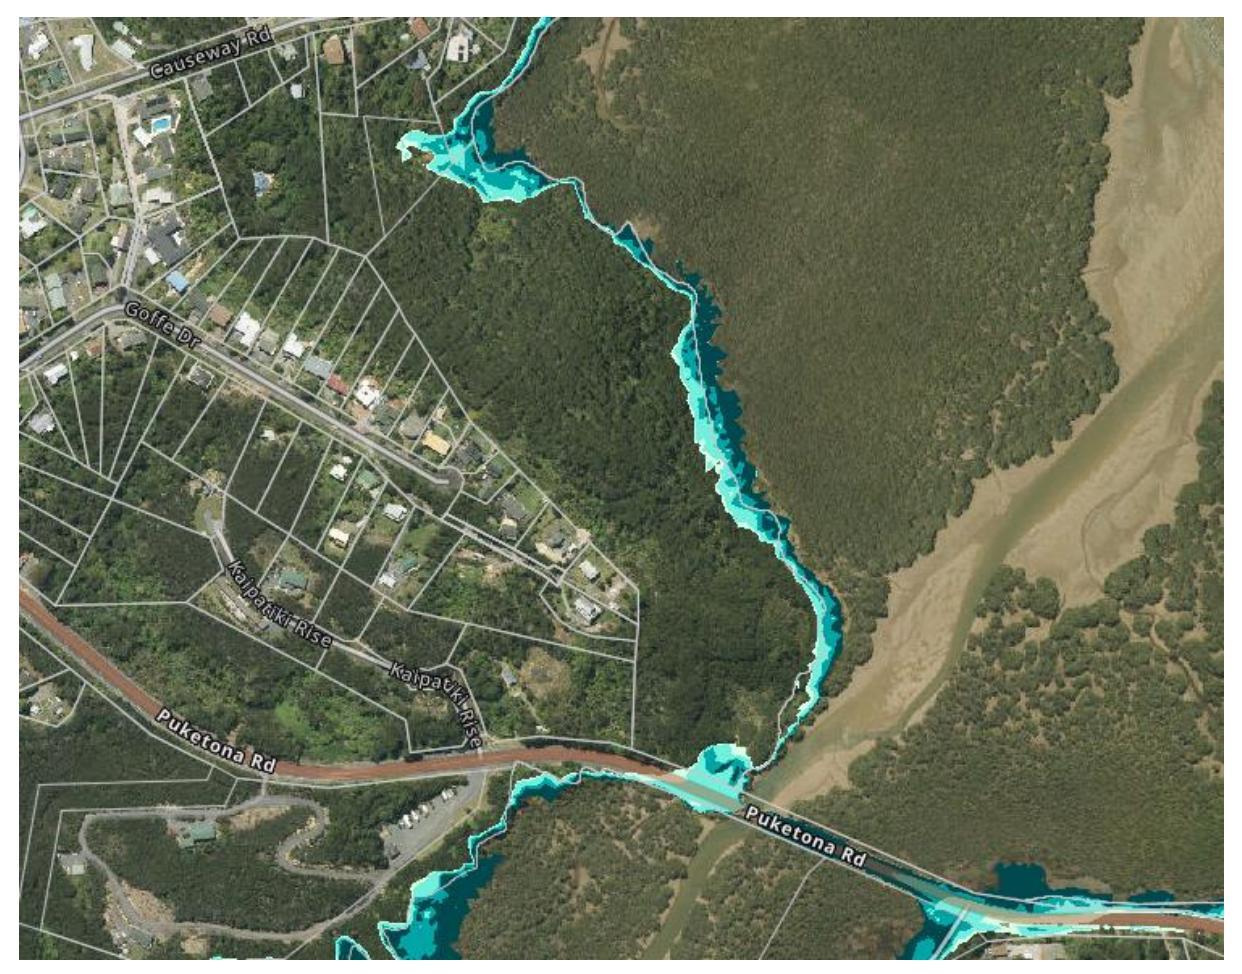
The site is mapped by the NRC as being affected by the predicted current, 50-year and 100-year coastal flooding events as shown in Figure 7. The predicted extent of flooding is limited to the area adjacent to the north-eastern and eastern property boundaries and in the southern portion of the property adjacent to Puketona Road/SH11.

Figure 7. NRC Coastal Flood Extent North at top of page, extract from FNDC Maps

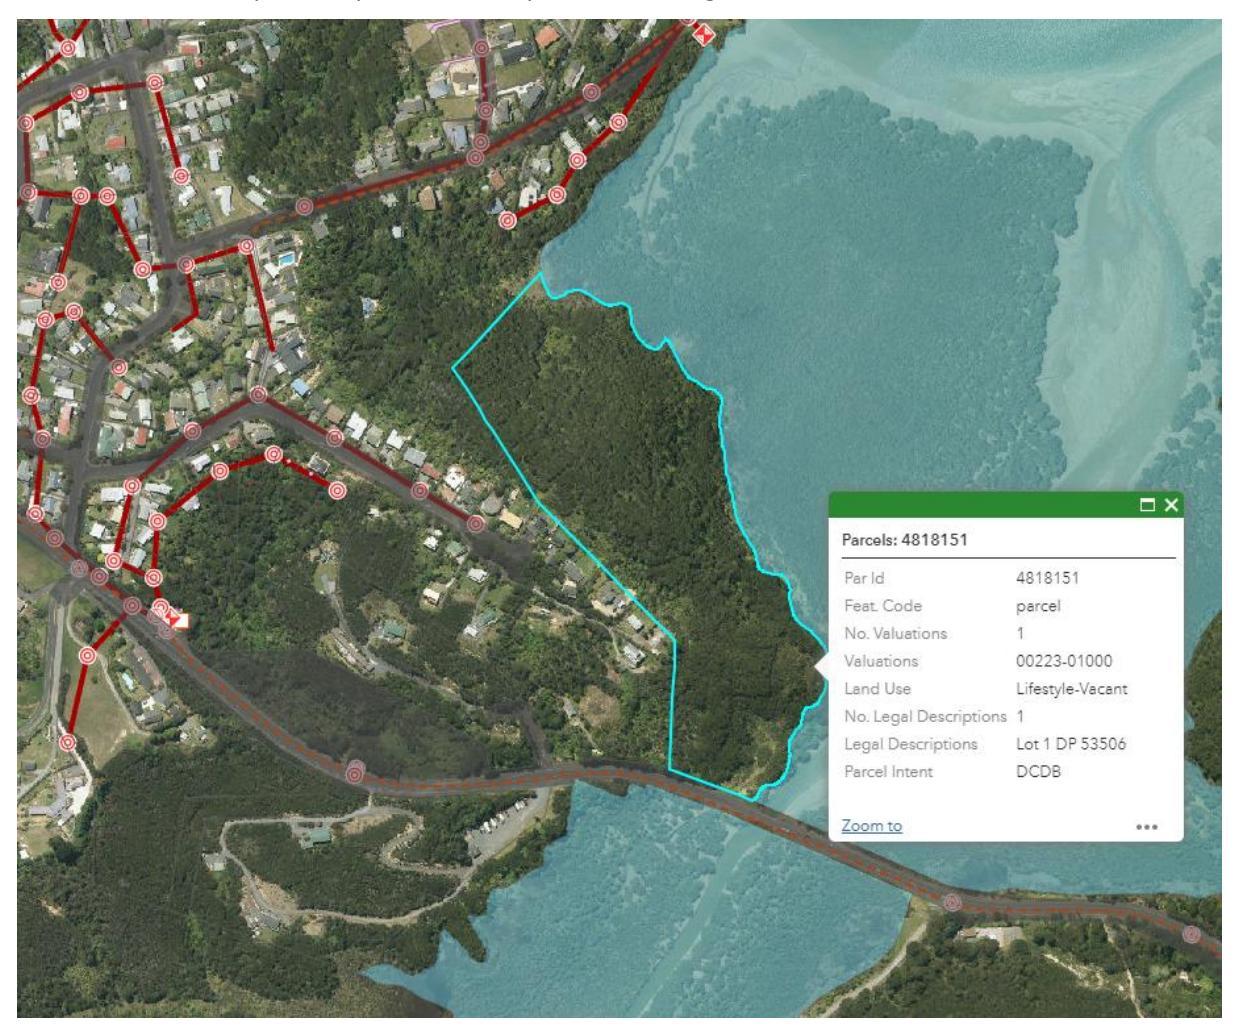
FNDC maps indicate that a 450mm diameter PE Rising Main present in the road reserve of Puketona Road/State Highway 11, near the southern property boundary. A 150mm diameter uPVC Gravity Main is present along the northern side of Goffe Drive that terminates at a manhole located adjacent to 34 Goffe Drive. An extract from FNDC maps showing the location of wastewater reticulation in close proximity to the site is presented in Figure 8.

Figure 8. Wastewater Reticulation Services North at top of page, extract from FNDC Maps

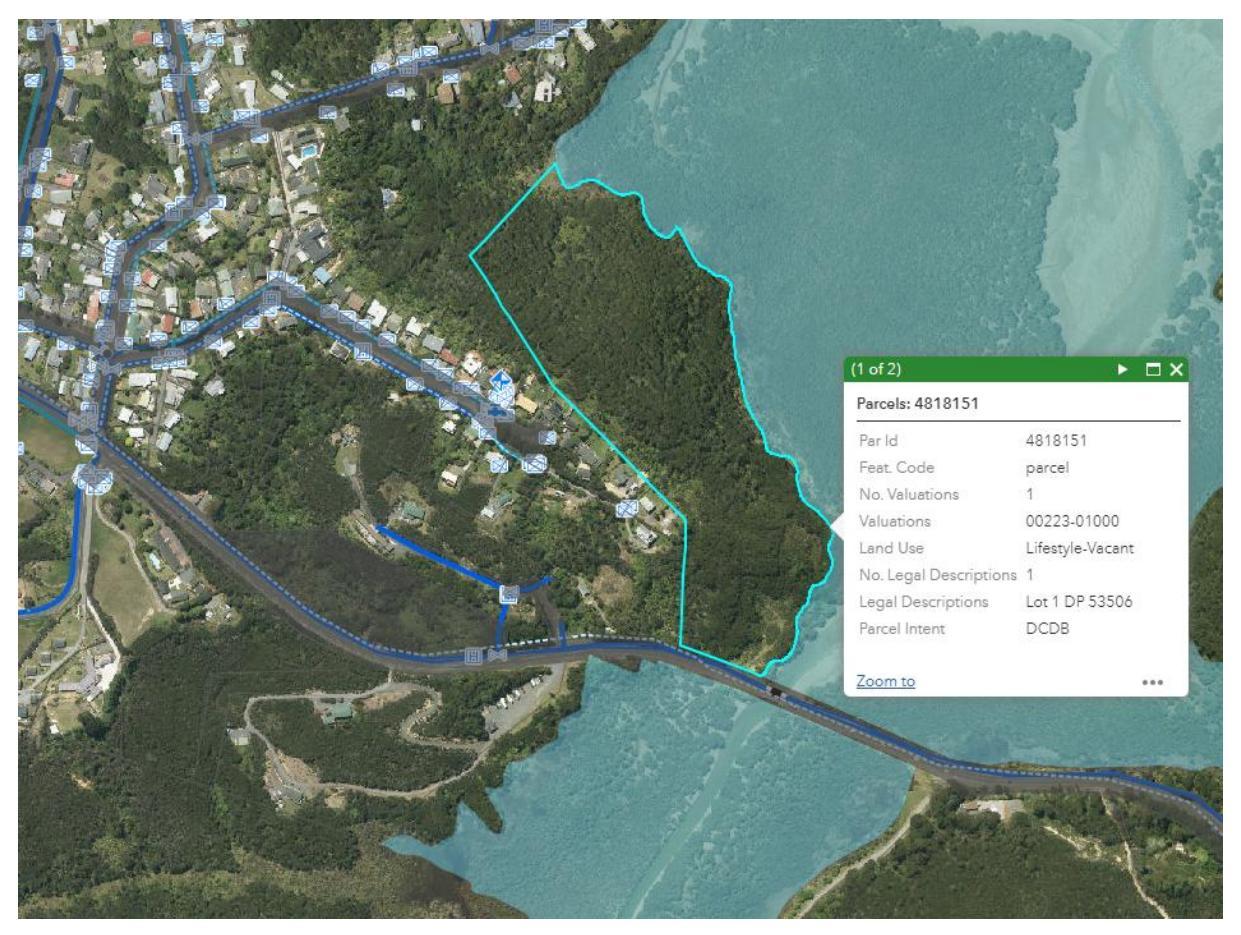
FNDC maps indicate that a 150mm AC and 200mm uPVC diameter Pump Supply Mains are present within the road reserve of Puketona Road, near the southern property boundary. A water supply tank is present at 40 Goffe Drive. A 40mm diameter uPVC rider main, 150mm AC diameter pump supply main and 150mm diameter AC pipe main appear to be connected to the tank. An extract from FNDC maps showing the location of water reticulation in close proximity to the site is presented in Figure 9.

Figure 9. Water Reticulation Services North at top of page, extract from FNDC Maps
