Application for resource consent or fast-track resource consent

Name/s:	James Massey and Jane Alison Massey		
Property Address/ Location:	272 Tauranga Bay Rd, Kaeo		
	Postcode

• A new prebuilt single level minor dwelling with a roof area of 73.5m² and a floor area of 54.2m² will contain a bedroom, bathroom, kitchen and living room. Access to the minor dwelling will be off the same driveway from Wiroa Road as the existing principal dwelling. The minor dwelling in this case is located 45 metres to the principal dwelling.

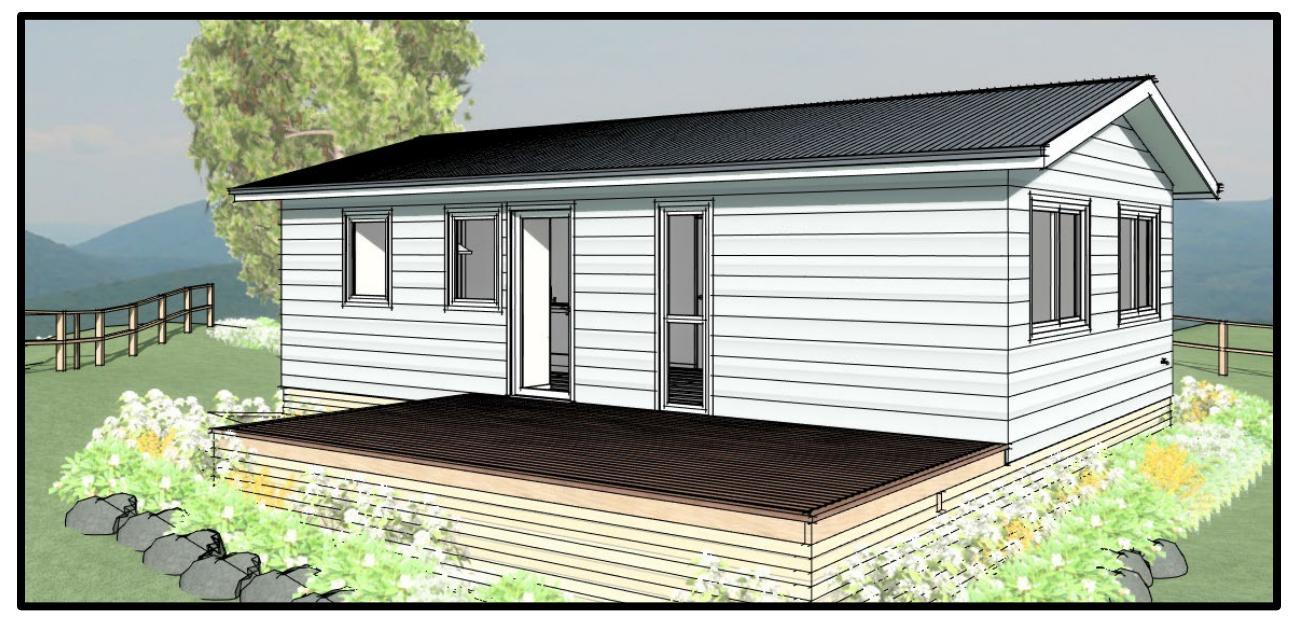
Figure 1: Perspective of dwelling

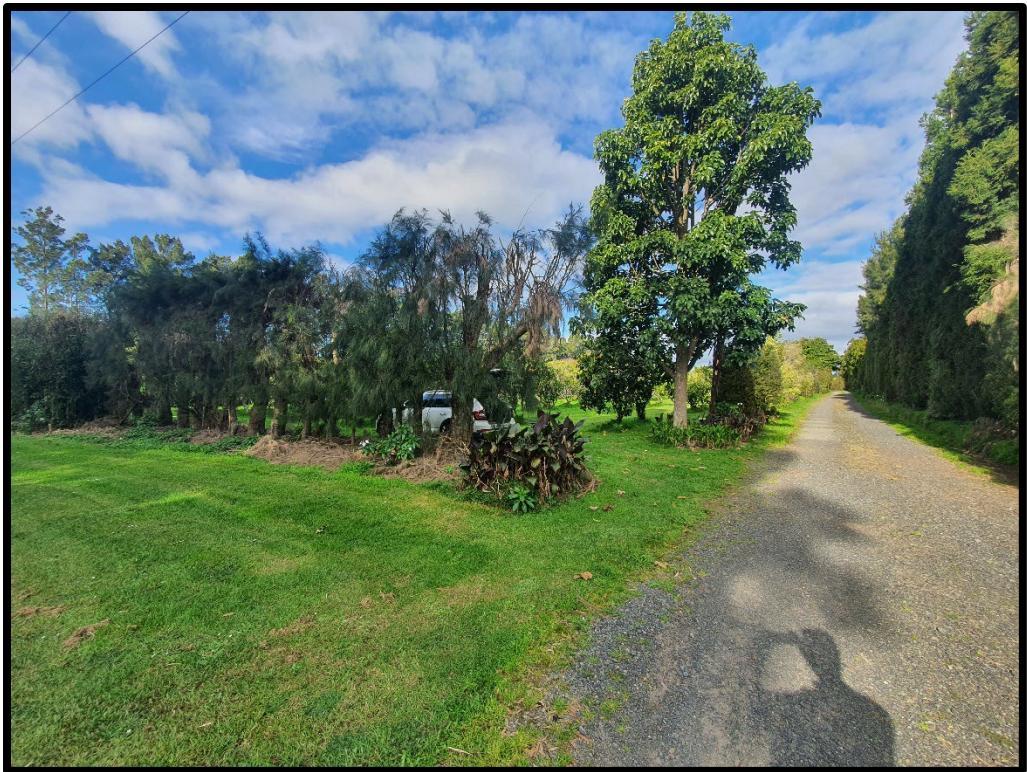
Photo 1: View of driveway access to property – To service both the existing dwelling and minor dwelling

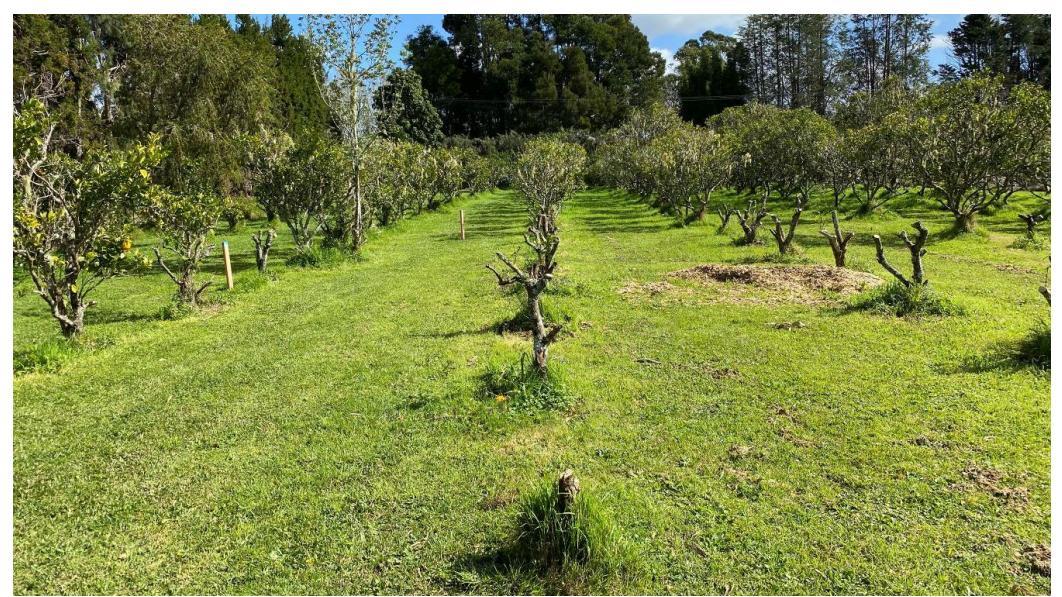
Photograph 1: Showing existing citrus trees and shelter belt on the flat to slightly sloping site.

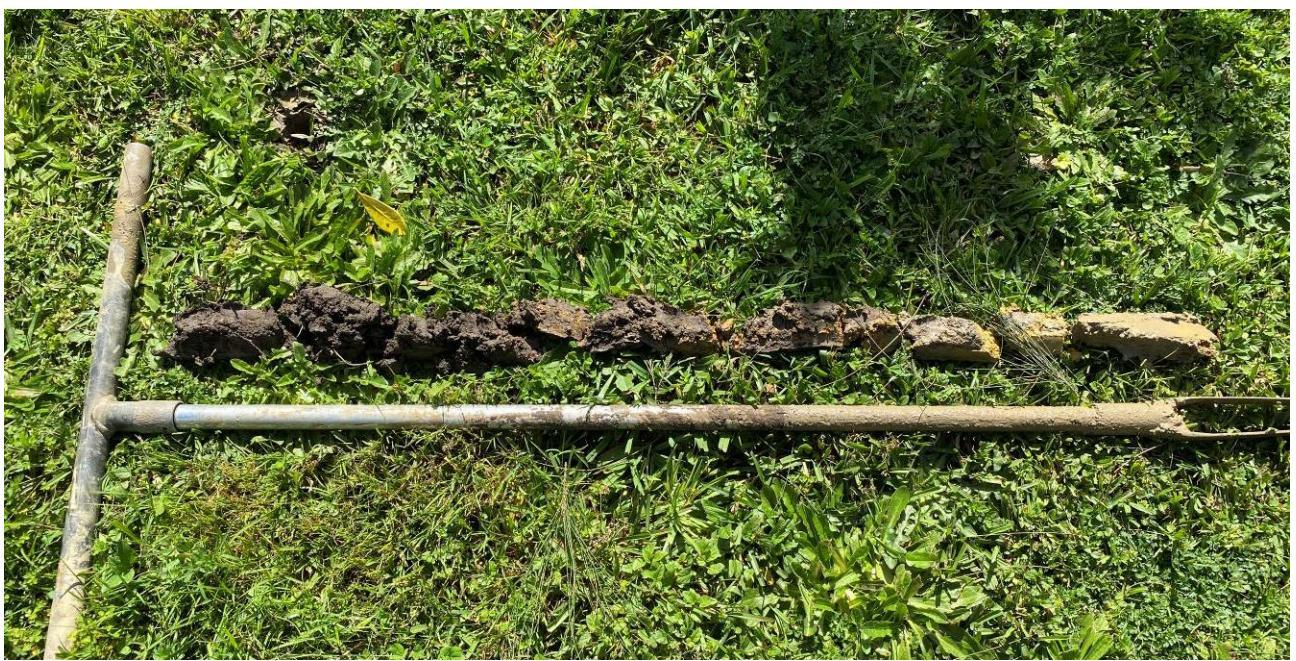
Photograph 2: Borehole 3 showing 300mm of category 5, slightly moist, brown topsoil followed by category 5, moist, brownish orange, silty clay to a depth of 600mm. From 600mm soils were moist, category 6, orange, silty clay. Soils were saturated with groundwater at this location at 1000mm depth.

The borehole logs showed soils to be category 6 clay with slow draining characteristics. Refer to the Borehole Logs, Section 9 and Photograph 2 showing soil layers.

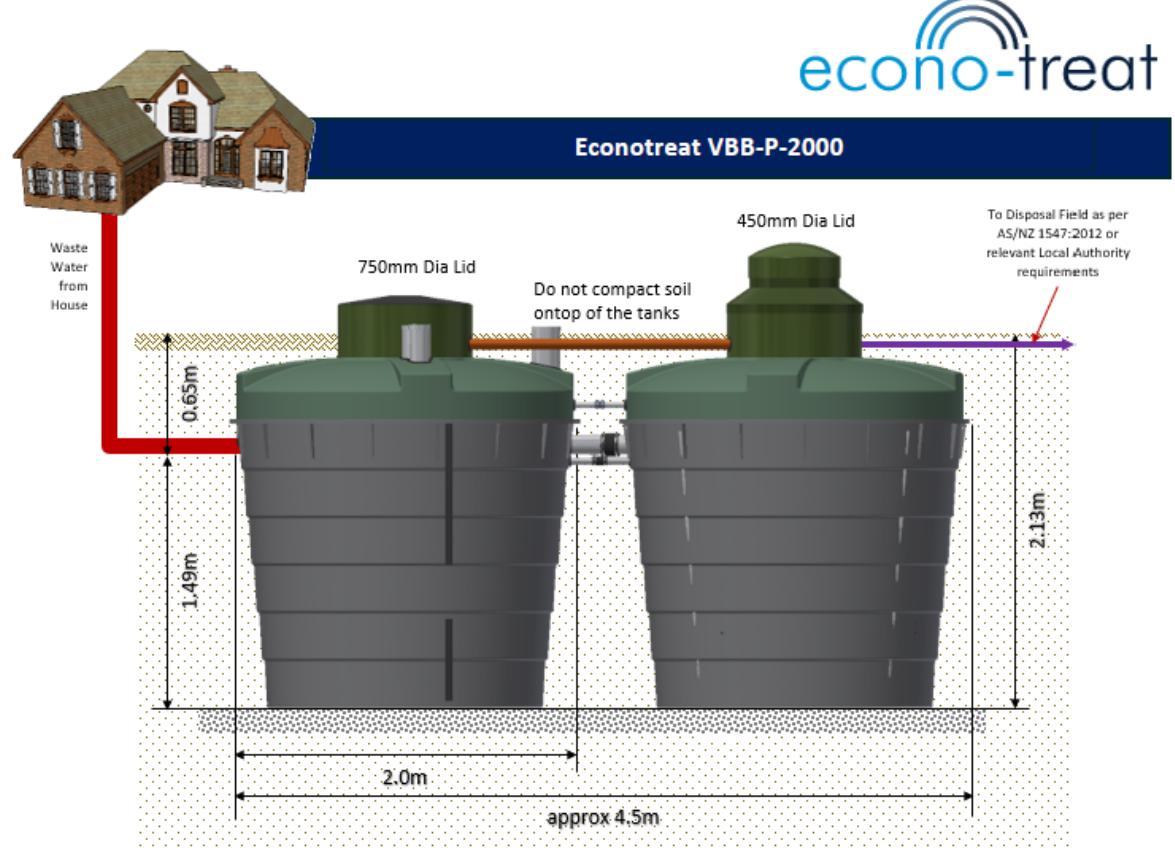
Proposed system: Econotreat VBB-P-2000 (plastic) or Econotreat VBB-C-2000 (concrete)

Effluent will be disposed of via a robust secondary treatment system which complies with the New Zealand Building Code. The system is to have a high output quality of: BOD5 equal to or less than 20g/m³ and TSS equal or less than 30g/m³, in line with NZS1546.3:2008 and the New Zealand Building Code. The system is to have emergency storage and be fitted with an alarm to protect against system failure.

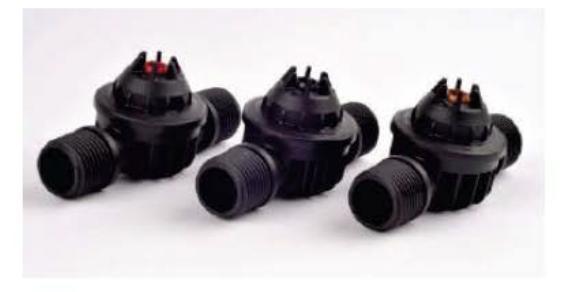
Install Dripperline Non Leakage (DNL) device which will hold back water inside the dripperline laterals and manifolds.

NOTE: Netafim UniRam CNL™ is a commercial dripperline that has a "non-leakage device" built into its drippers and prevents water draining out of them when the system is shut-off. It will hold back 1.4m of water within the drip system. This dripperline should be considered for projects where water drainage is undesirable.

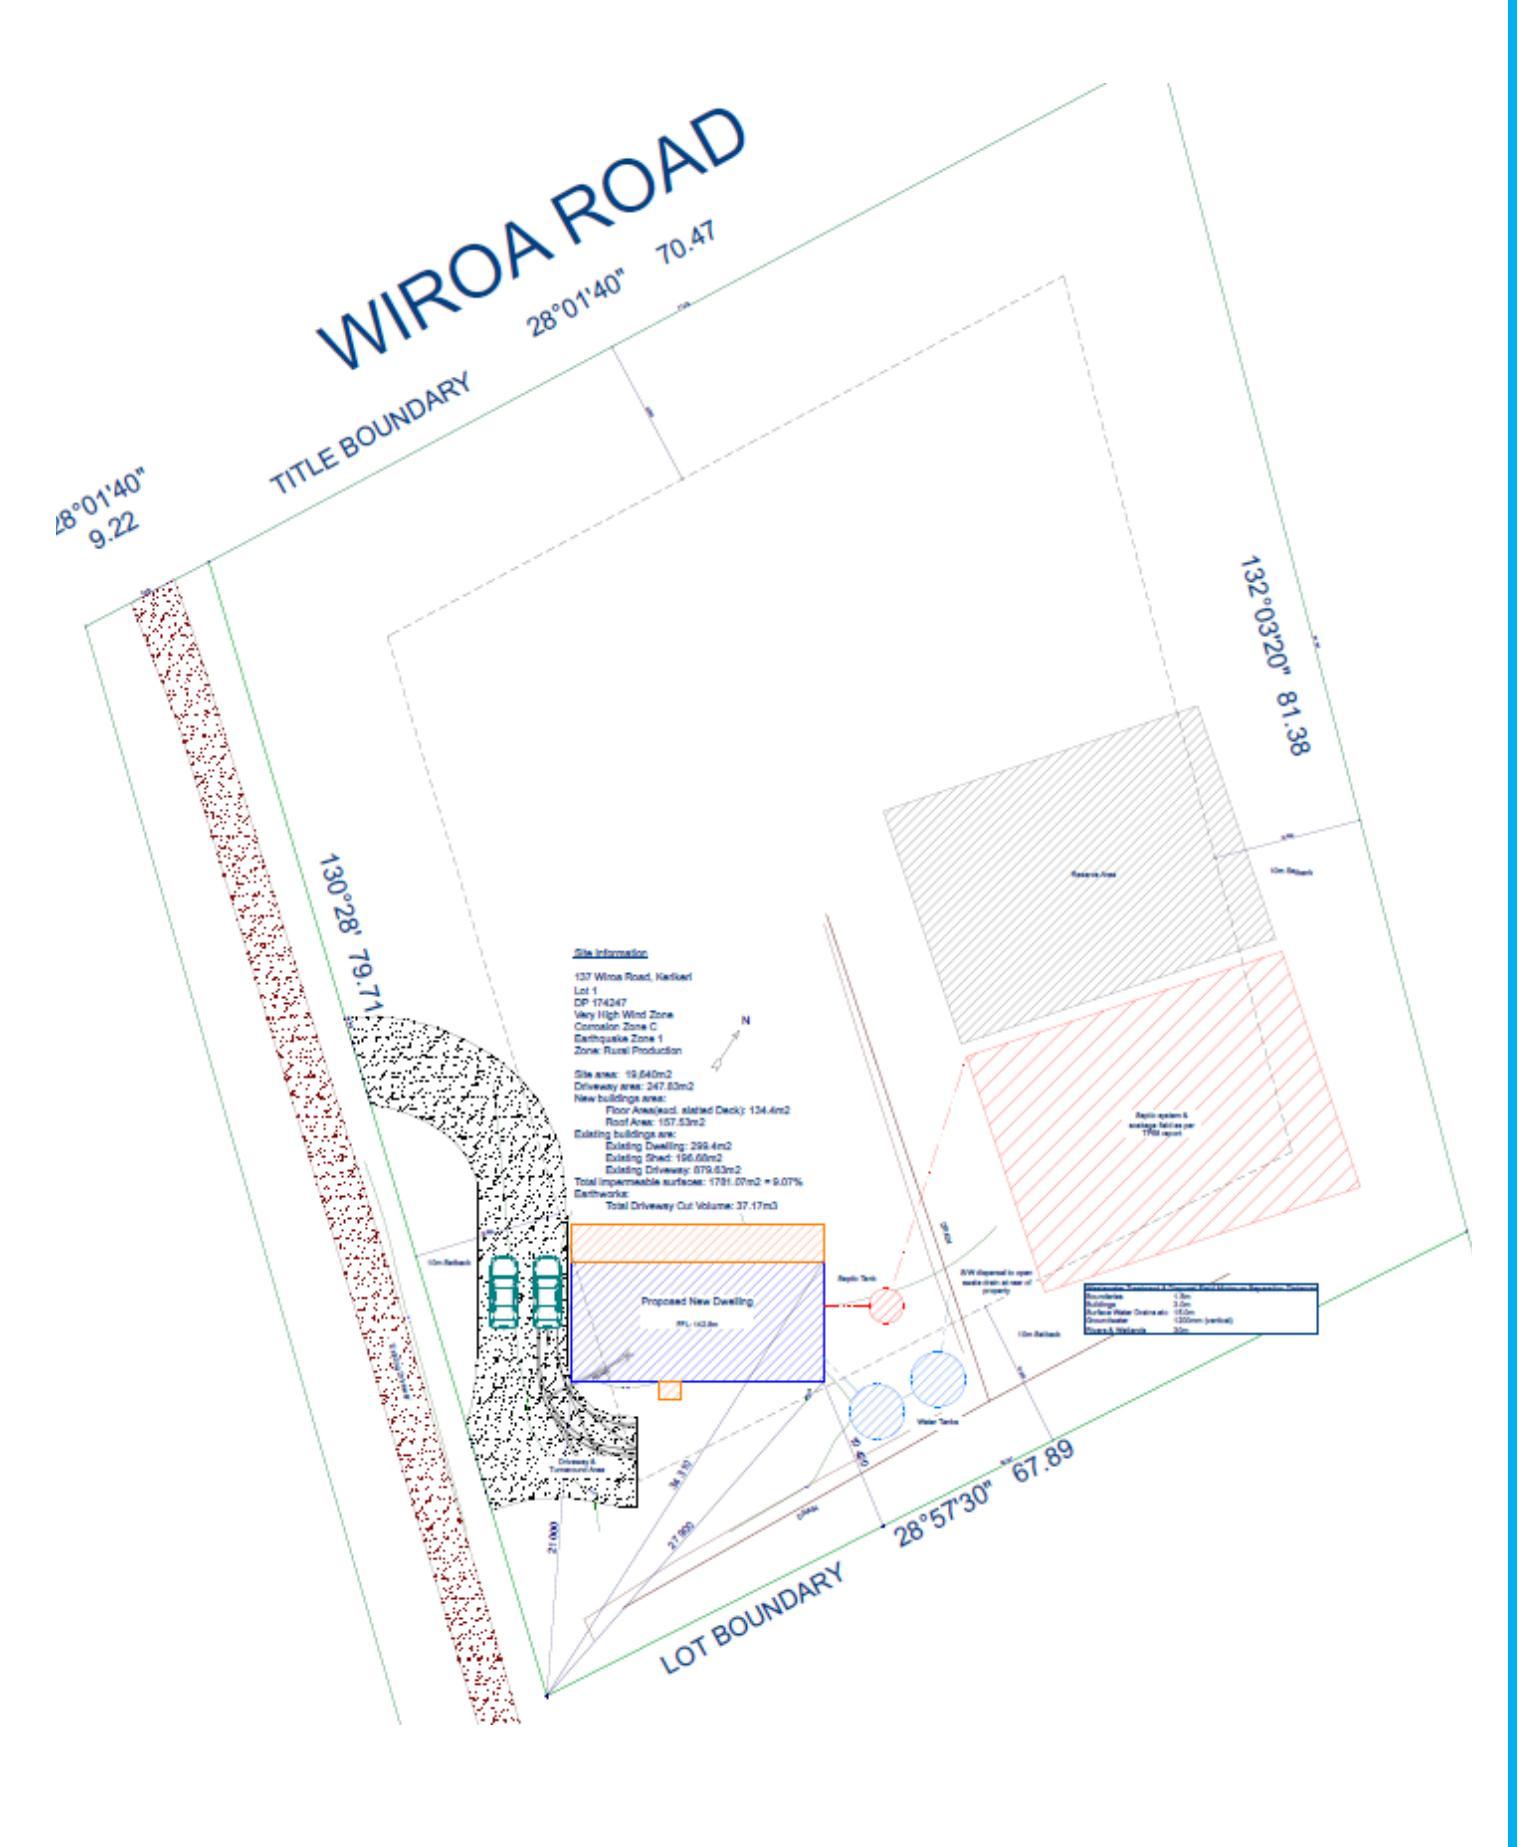
FIG 2: PROPOSED BUILDING SCHEME (ADVANCE BUILDING NOV 2023)

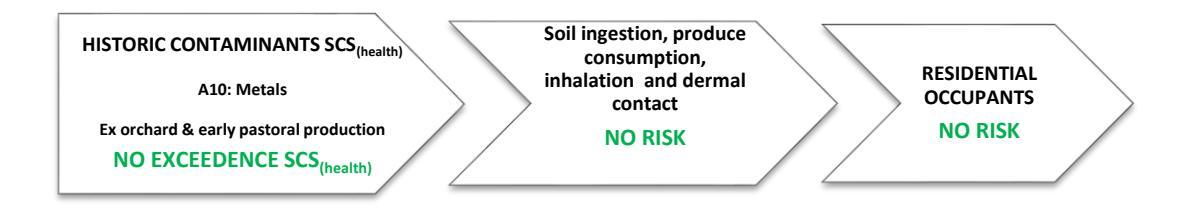
FIG 6: FINAL QUANTITATIVE CSM

It should be noted that the future construction may result in elevated soil heavy metals e.g. from the use/ storage of bulk CCA tanalised timber, causing a site that has been screened at a given point later having levels raised in excess of SCS_{(health).} It is recommended that in the event of building that any outside storage of bulk treated timber be covered by tarpaulin and located within an area of existing or intended driveway or parking area during the building phase, so as to avoid potential contamination of lawn and garden areas from leaching. CCA-treated wood must not be burnt, as arsenic is volatised to air and residual in the ash in excess of the SCS_(health) (ERMA 2003).

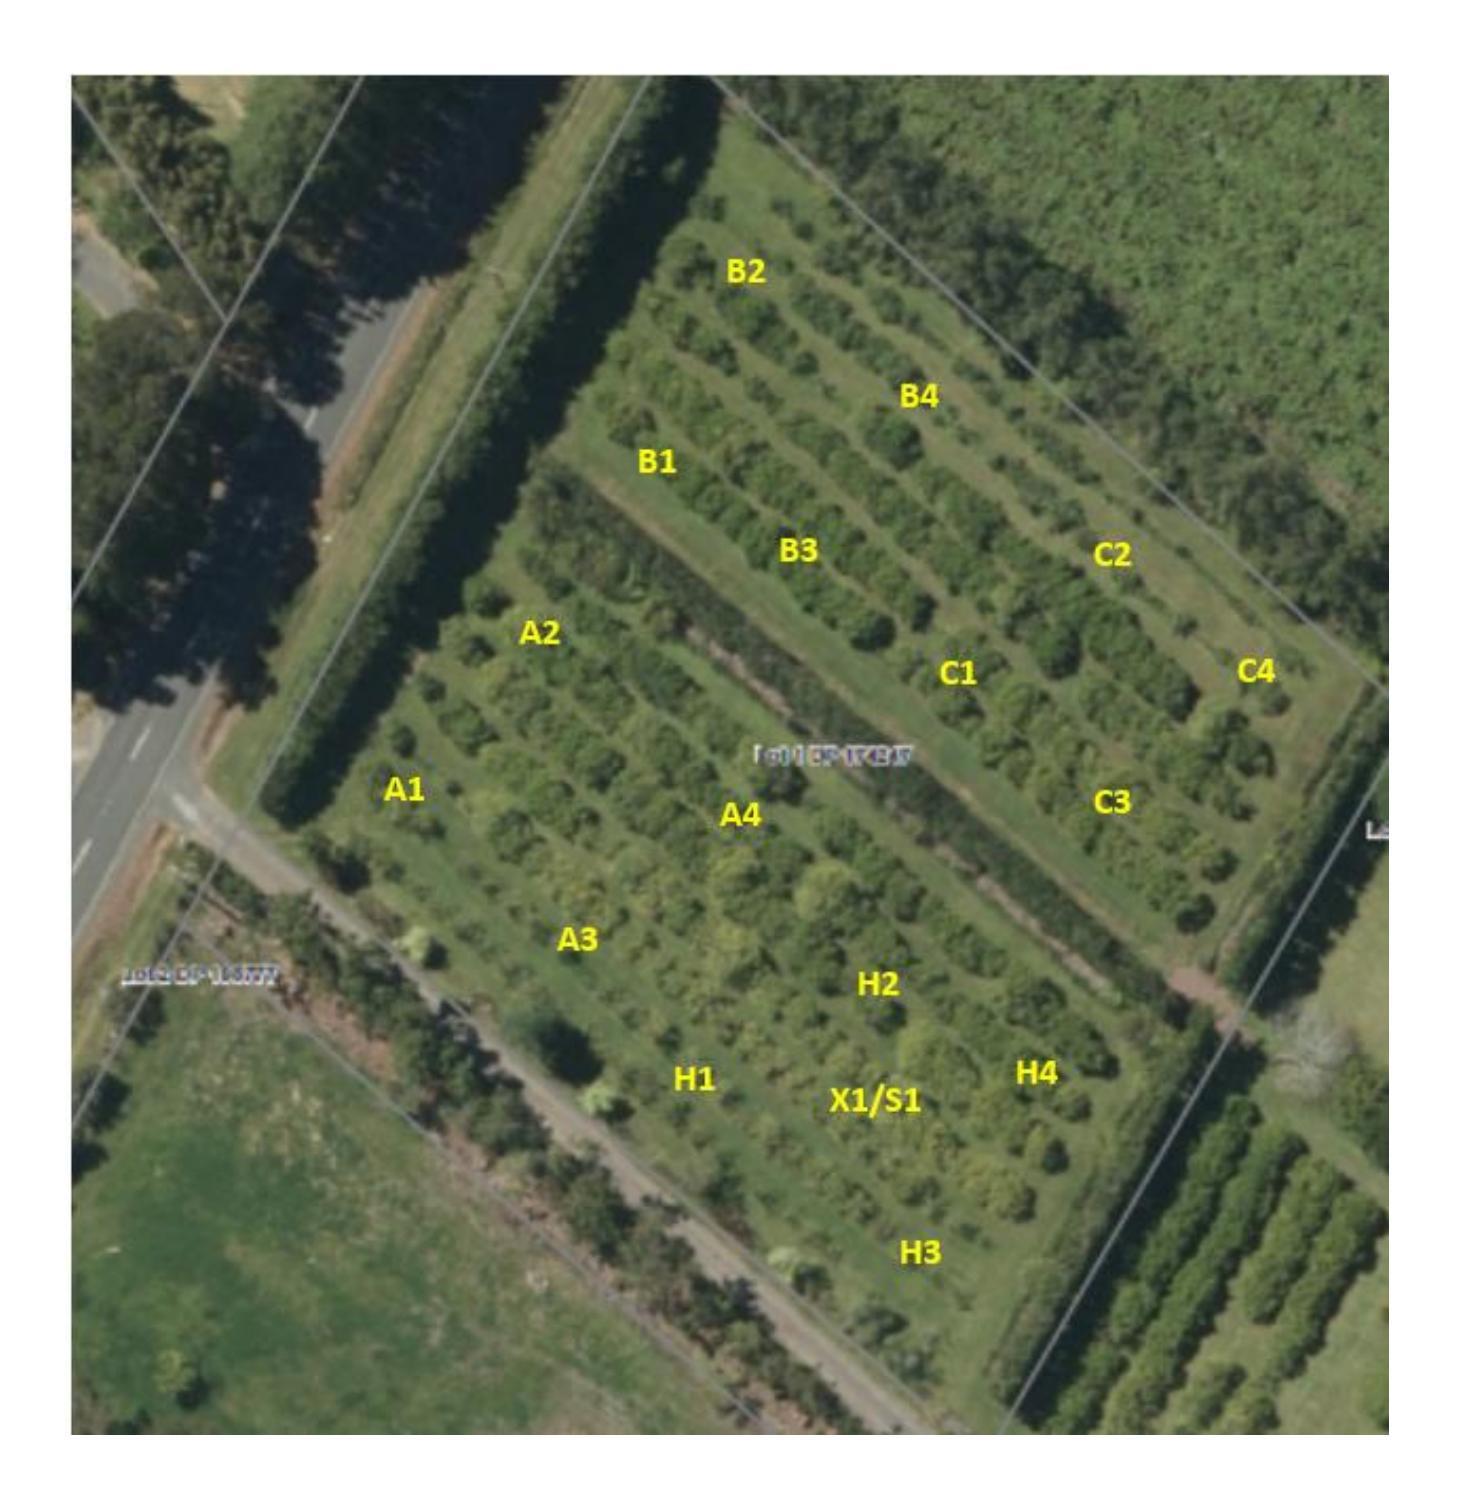
APPENDIX 2: SAMPLE PLAN

A SERIES COMPOSITE A1 A2 A3 A4 – HEAVY METALS B SERIES COMPOSITE B1 B2 B3 B4 – HEAVY METALS C SERIES COMPOSITE C1 C2 C3 C4 – HEAVY METALS HSERIES COMPOSITE H1 H2 H3 H4 – HEAVY METALS

X1 & REPLICATE S1 – HEAVY METALS A1 A4 H1 H4 COMPOSITE- ORGANOCHLORINES B2 B3 C2 C3 COMPOSITE- ORGANOCHLORINES
